Bengkulu & West Sumatra Earthquakes, September 12, 2007, Structural Damage Report

Teddy Boen*

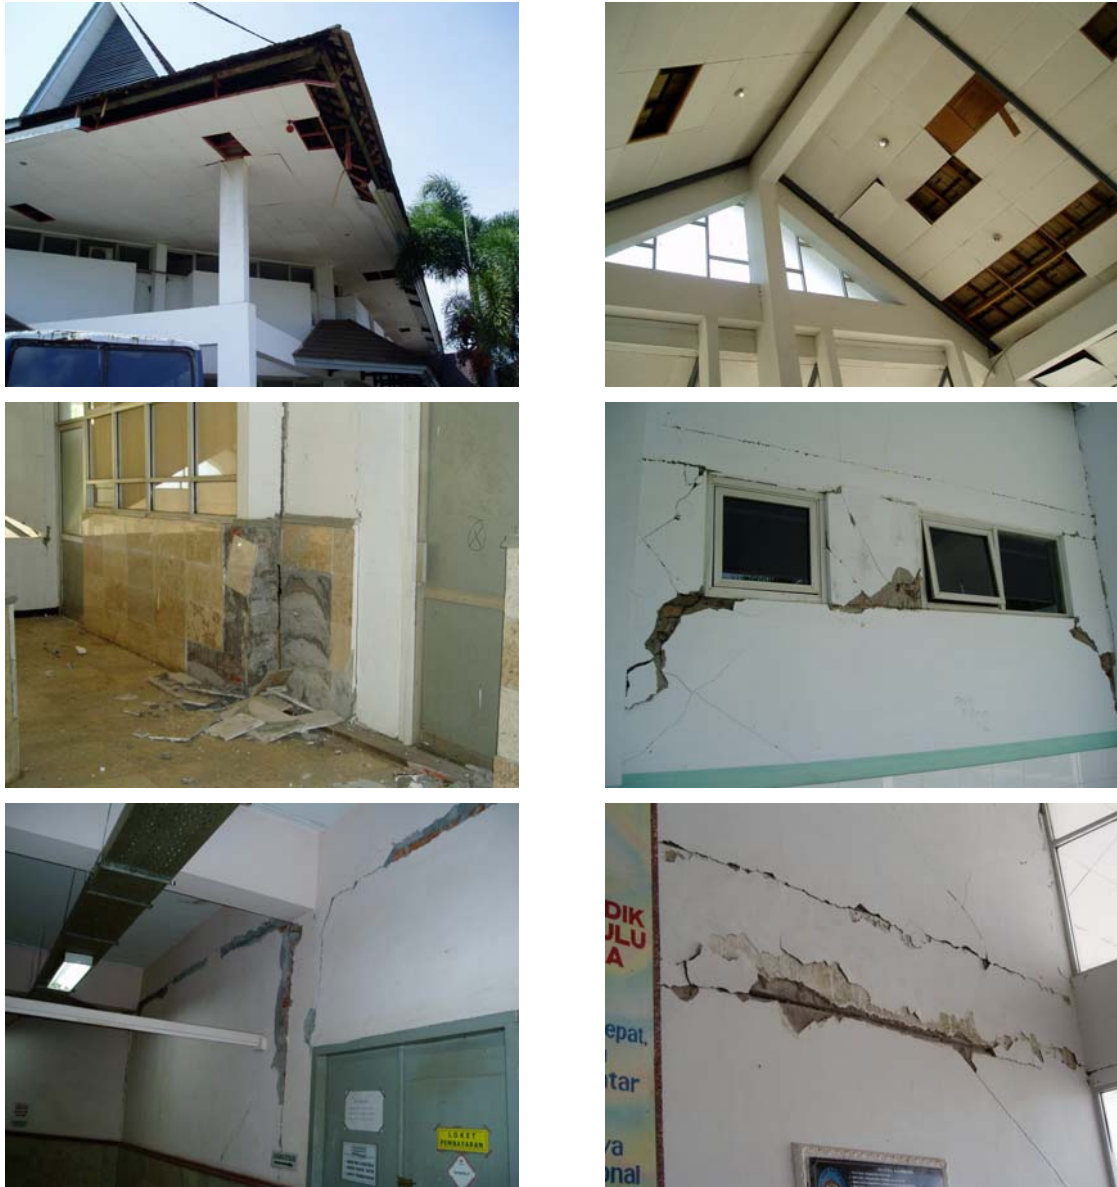
Figure 4.: Non-structural damage at M. Yunus hospital, Bengkulu

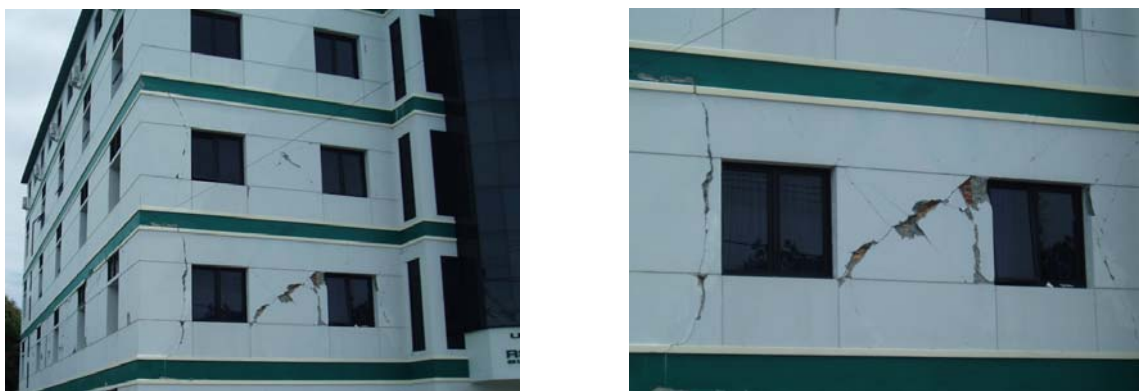
Figure 5.: Non-structural damage at Bunda Medical Center hospital, Padang, West-Sumatra

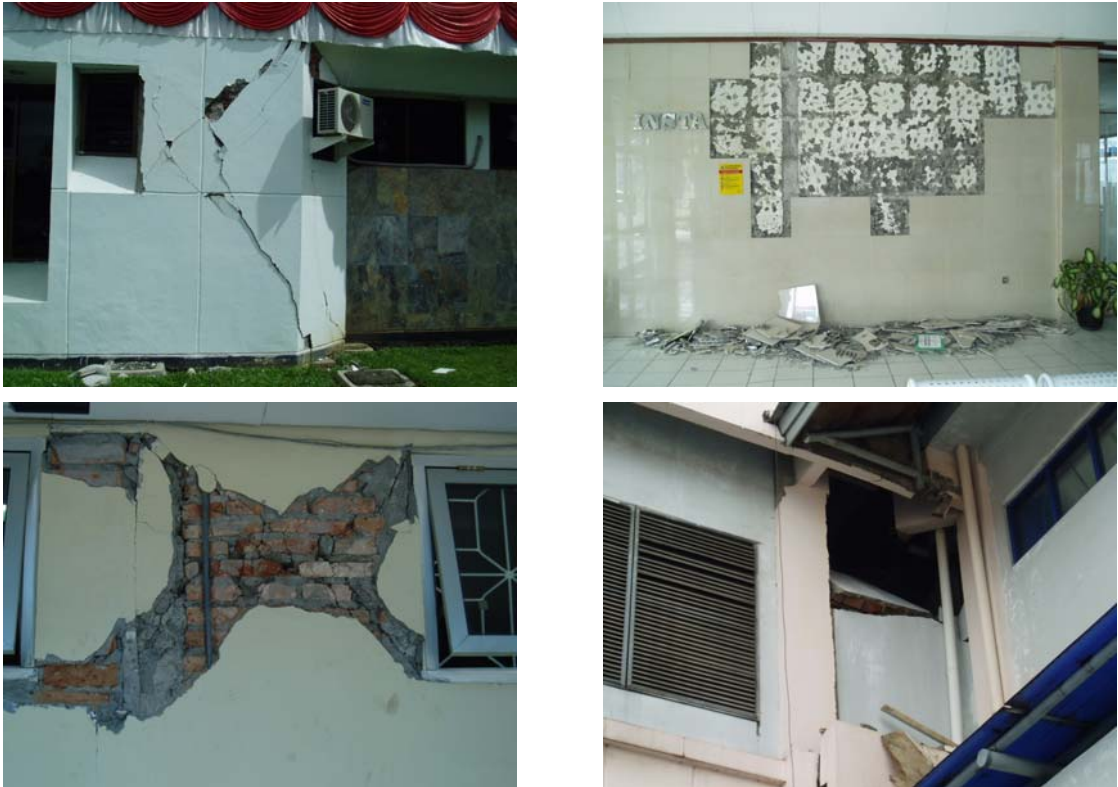
Figure 6.: Non-structural damage at M. Djamil hospital, Padang, West-Sumatra

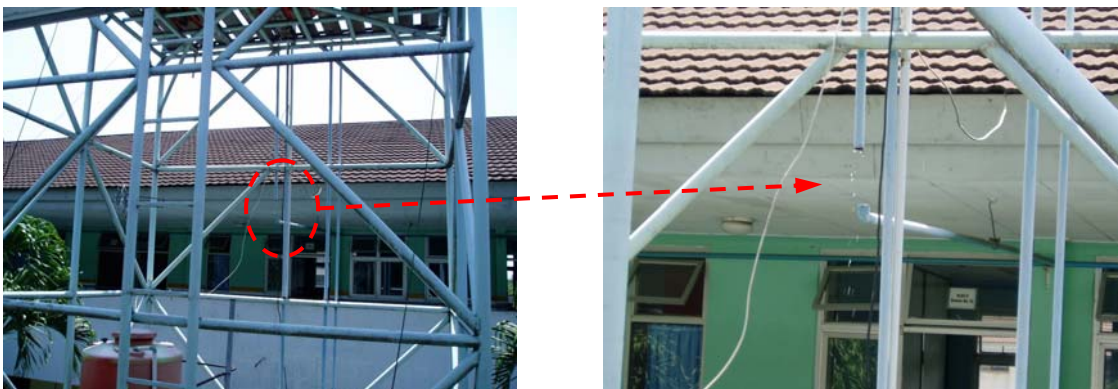
Figure 7.: Broken water pipe at M. Yunus hospital, Bengkulu

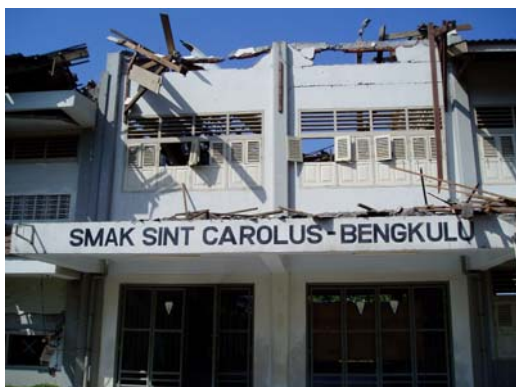
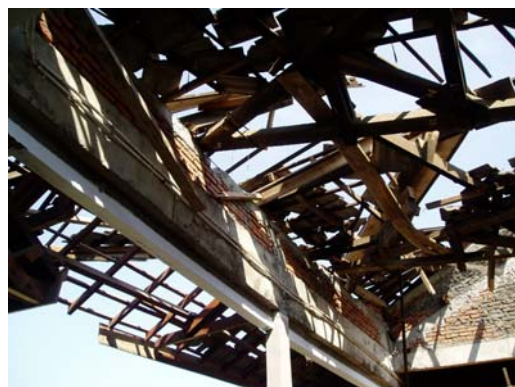
In Padang, two showrooms collapsed. In Bengkulu, one “engineered” school building, SMAK Sint. Carolus, was damaged. This building was also damaged due to June 4, 2000 Bengkulu earthquake. One building was demolished and replaced by the new one. In the September 12, 2007 earthquake, the roof of the newly constructed building collapsed.

The main cause of damage and / or collapse was because the buildings were not designed to withstand the seismicity of West Sumatra. Also poor quality of concrete and detailing contributed to the collapse of those engineered buildings. Some other “engineered” buildings suffered minor damage. In general it can be stated that the damage to engineered buildings due to the September 12, 2007 and September 13, 2007 earthquakes were negligible. This is understandable because the epicenter is some 125 km away from the West Sumatra and Bengkulu. As was the case during the Aceh Dec 2004 earthquake, only poorly built engineered buildings were damaged or collapsed.

The damage of SMAK Sint. Carolus, the newly constructed building

Figure 10.: Damage of engineered buildings

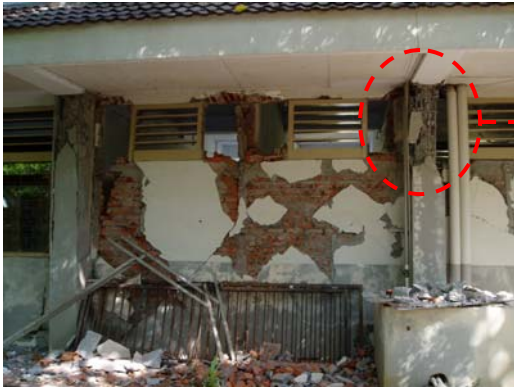
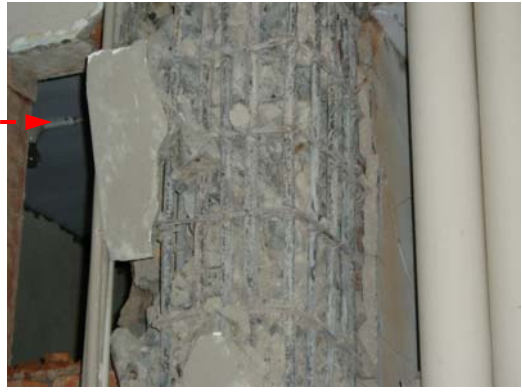
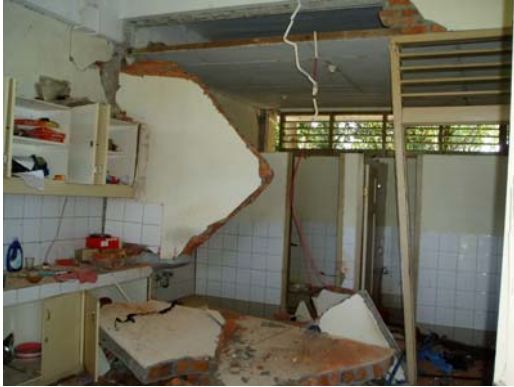
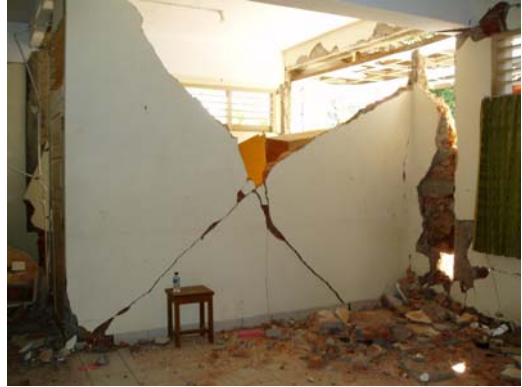
SMAK Sint. Carolus

Figure 10. (Cont'd): Damage of engineered buildings

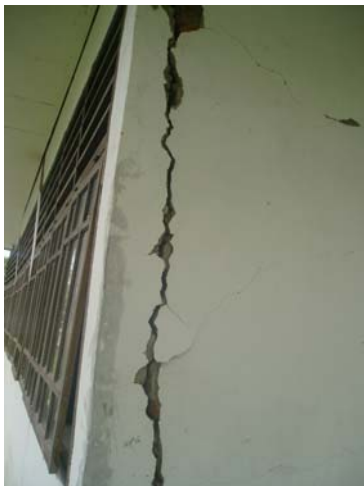
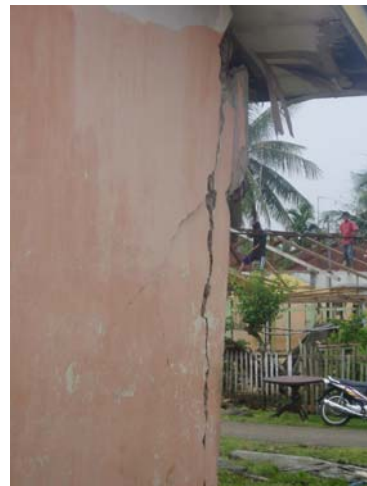
Puskesmas Pal 30 Village, Lais, North-Bengkulu SMUN 1, Pal 30 Village, Lais, North-Bengkulu

Figure 12.: Walls tend to tear apart

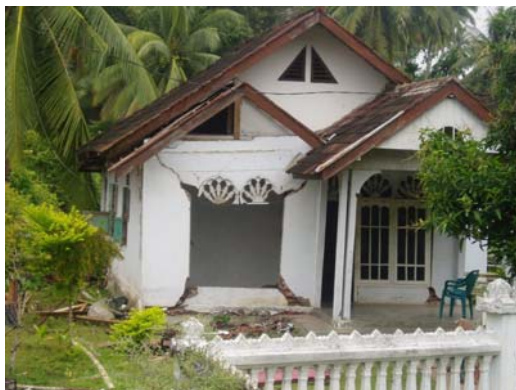
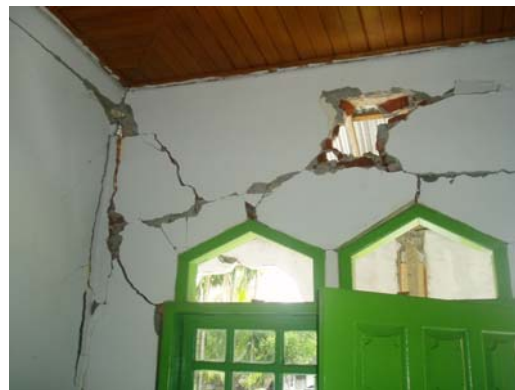
Pondok Kelapa Village, Lais, North-Bengkulu Pasar Palik Village, Lais, North-Bengkulu

Figure 13.: Failure at corners of openings

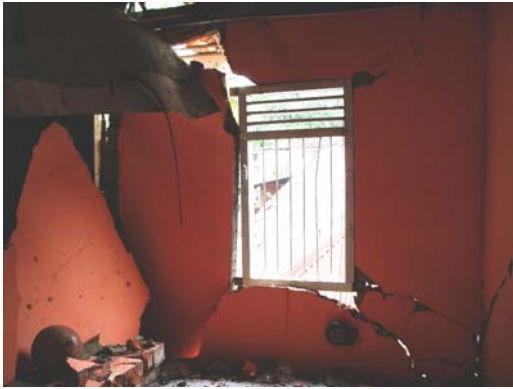
Pal 30 Village, Lais, North-Bengkulu

Figure 13. (Cont'd): Failure at corners of openings

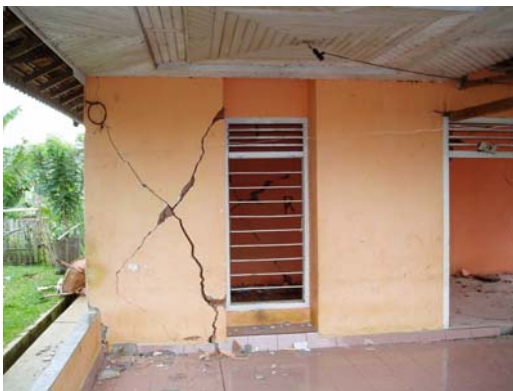
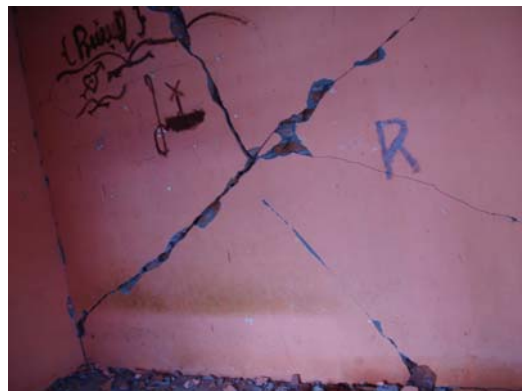
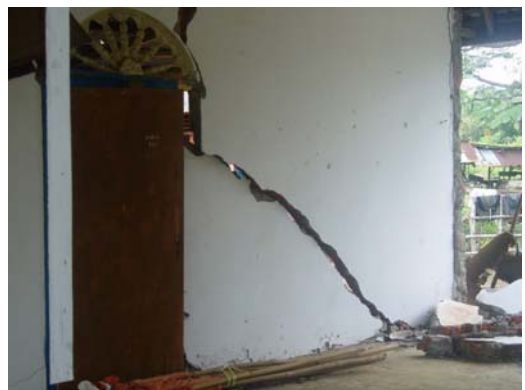
Figure 14.: Diagonal cracks in walls due to out of plane loading

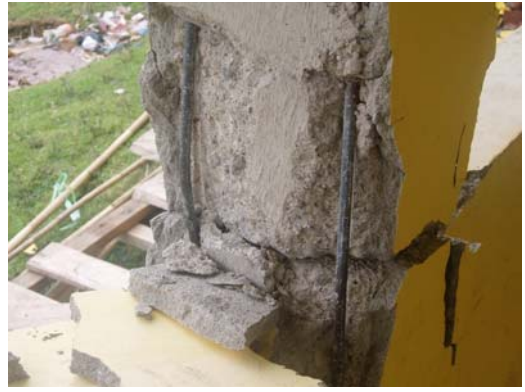
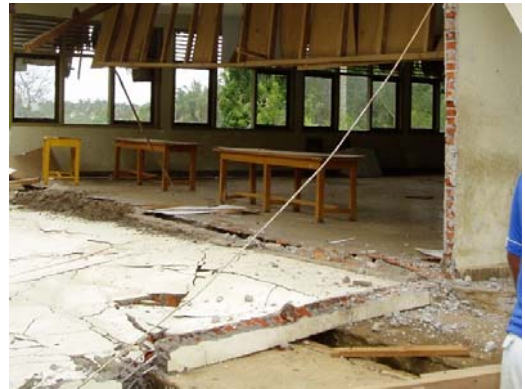
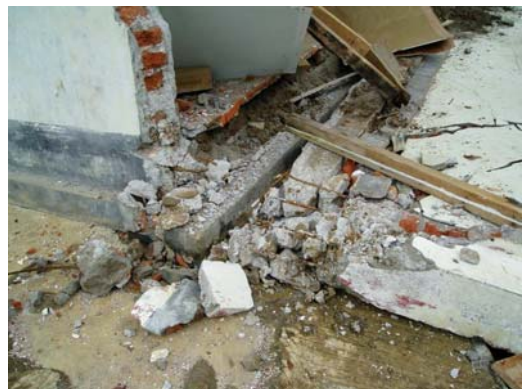
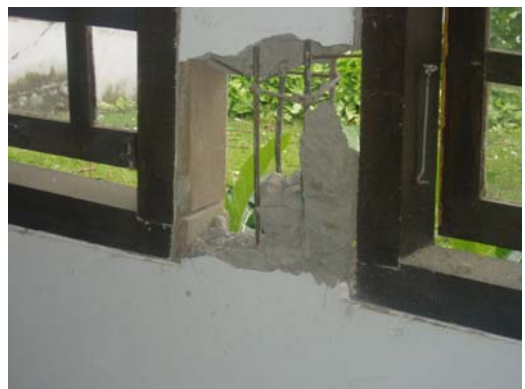
However, like in other areas in Indonesia, the reinforcement of the practical columns and beams are mostly not in accordance with the requirements as mentioned earlier. The reinforcing bars detailing are also not appropriately done for earthquake resistance. The buildings are not designed well and constructed based on the wrong prevailing practice. Non-engineered masonry buildings failures due to seismic shaking are caused by out-of-plane bending failure of walls, and / or in-plane shear failure and resulted either in total structural collapse or could result in “typical” damages such as walls tend to tear apart; walls tend to collapse; failure at corners of walls; failure at corners of openings; walls tend to shear off diagonally and additional shear due to twisting or warping for unsymmetrical building. Factors contributing to such failures are weak connection between wall and wall, wall and roof, wall and foundation; seismic forces are not properly transferred into the supporting walls and frames.

In general, the damage and collapse of the non-engineered reinforced masonry buildings during the September 12, 20007 and September 13, 2007 earthquakes are mostly caused by the poor quality of materials and poor workmanship, resulting in, among others poor detailing, poor mortar quality, poor concrete quality, and poor brick laying. It is a common practice that roof trusses are not strongly anchored to the ring beams. Non-engineered buildings in this category include one or two stories houses, house shops, religious and school buildings.

Figure 16.: Poor reinforcement detailing and poor workmanship

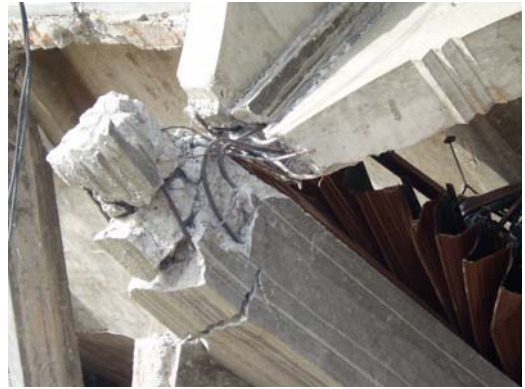
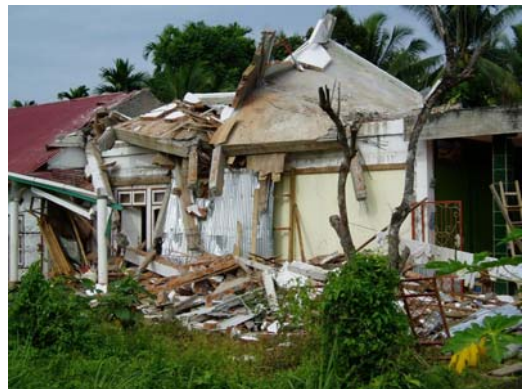
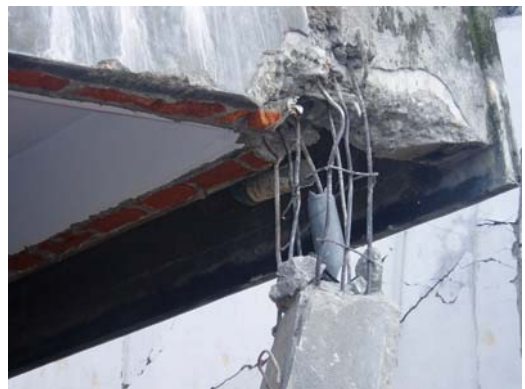
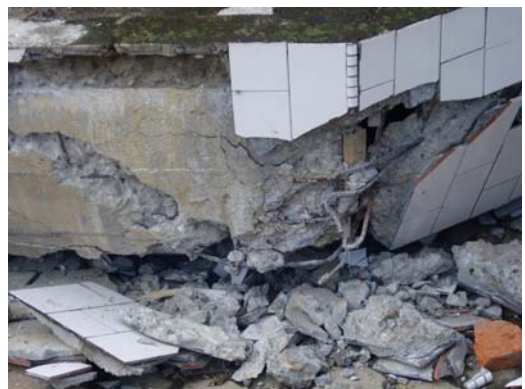
Figure 16. (Cont'd): Poor reinforcement detailing and poor workmanship

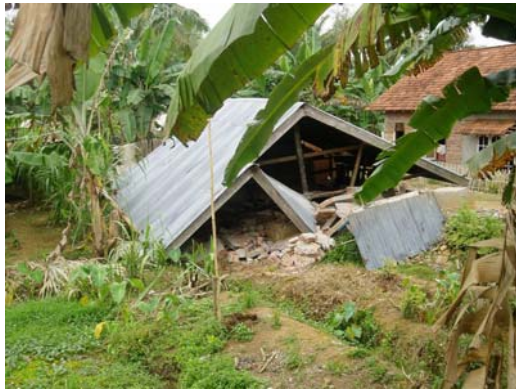
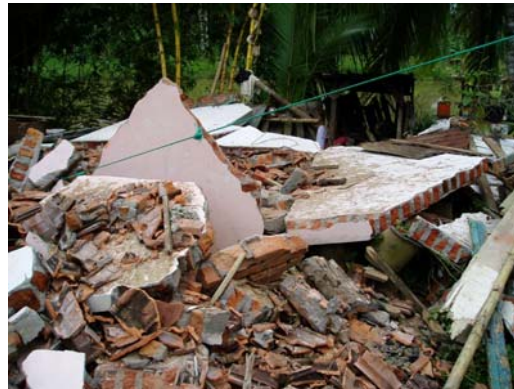
Figure 18.: Totally collapsed buildings

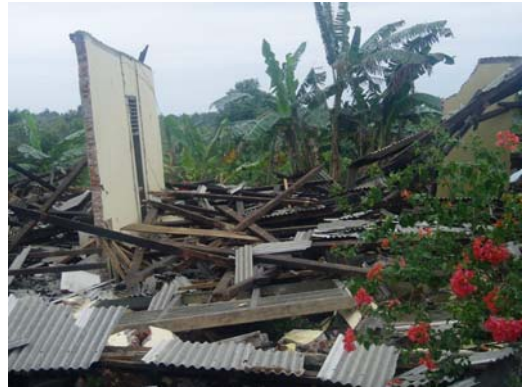
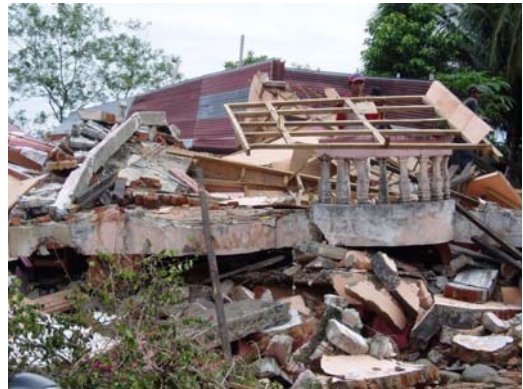
Figure 18. (Cont'd): Totally collapsed buildings

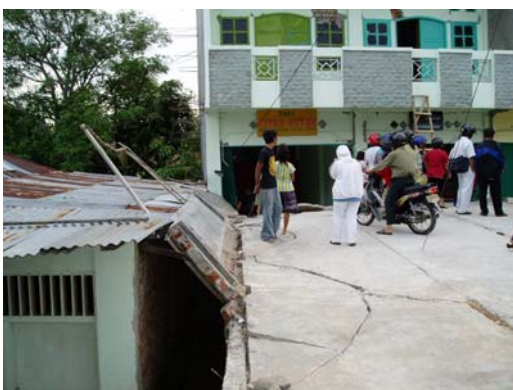
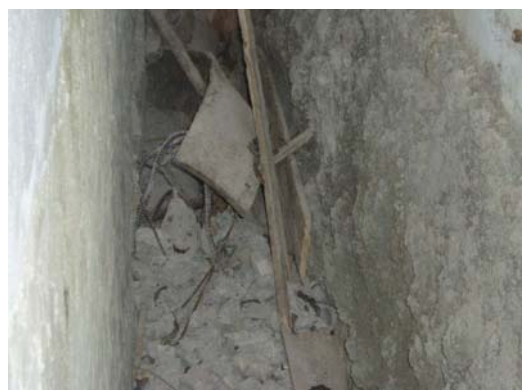
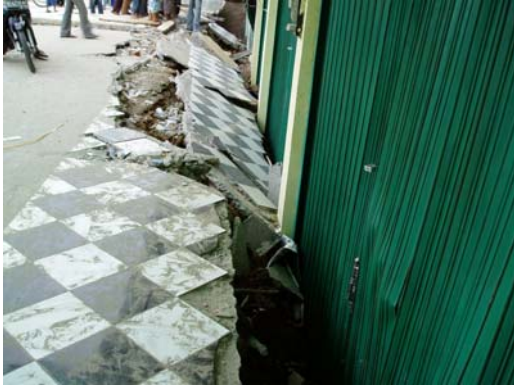
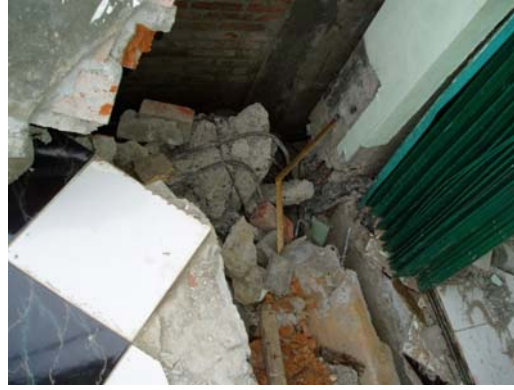
A two story shop house building with a first soft story was damaged. The media and local people reported that the damage was by settlement of the ground, however, no evidence of settlement could be seen and the damage was because of the first soft story.

Figure 19.: Collapsed of “first soft story” building at Padang Jati Rd., Tanah Patah, Bengkulu

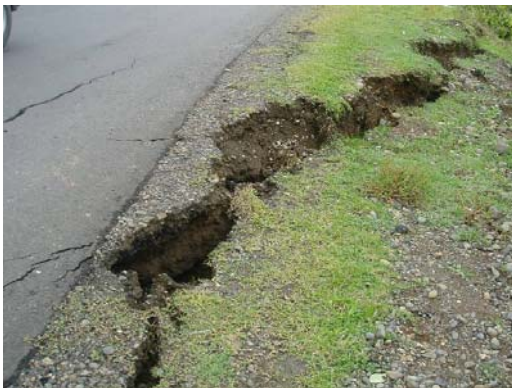
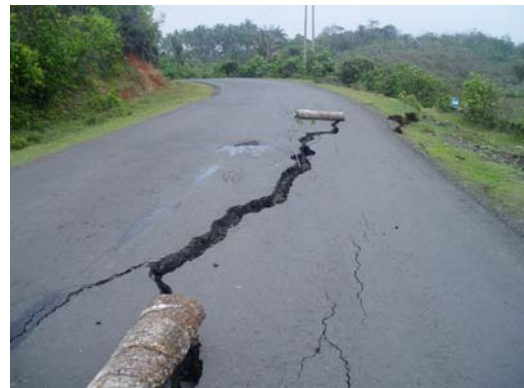
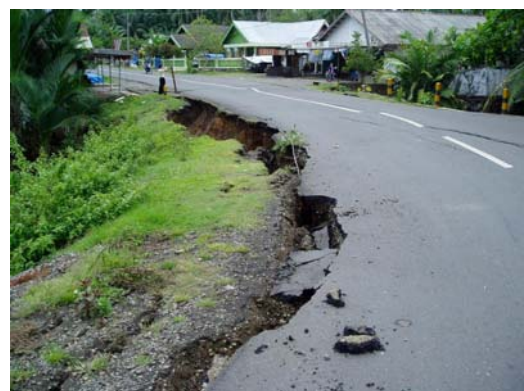
Although some non-engineered masonry buildings were damaged by the September 12, 20007 and September 13, 2007 earthquakes, almost all infrastructures are practically intact. Several cracks were observed particularly at Lais along the road from Bengkulu to Lais. However the cracks occurred in limited areas only. There was indication of potential landslides along the roads.

Figure 22.: Cracks along roads from Bengkulu to Padang

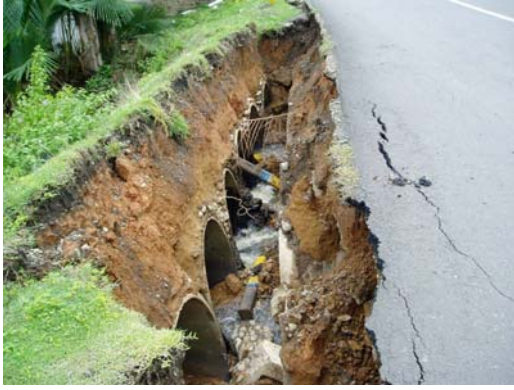
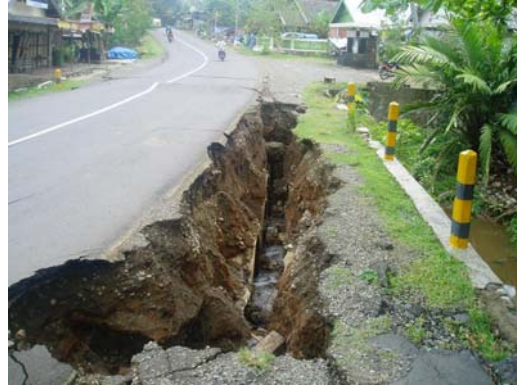
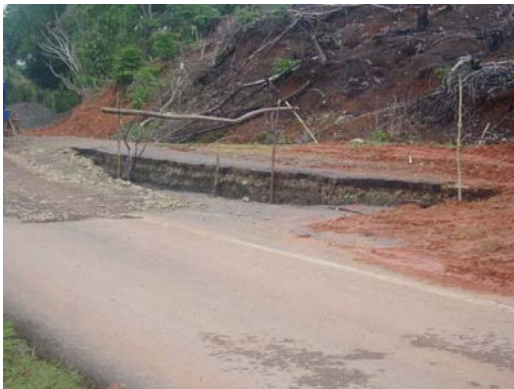
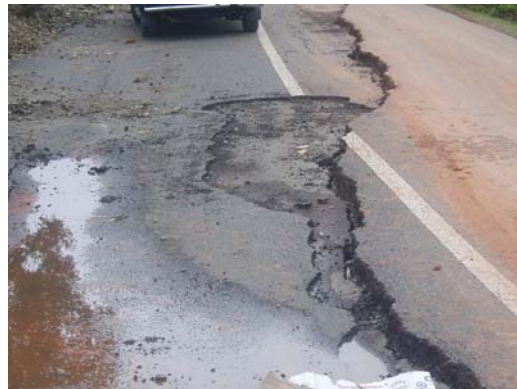
Figure 22. (Cont'd): Cracks along roads from Bengkulu to Padang

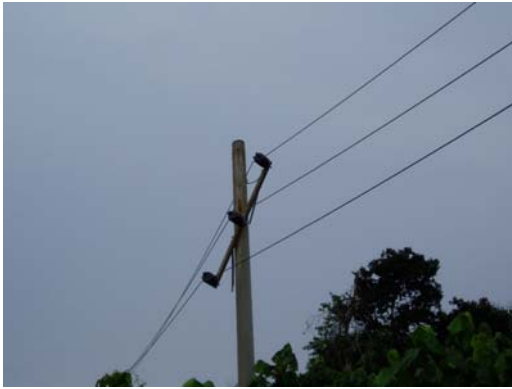
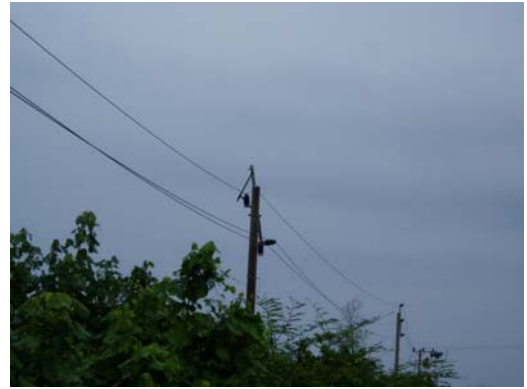
From Lais to Ketahun

There was a slight disturbance in electrical power supply. Some of the electric poles were damaged. One bridge was slightly damage along the road at Pal 30 Village, Lais, North-Bengkulu. Telecommunication towers, railways and port were practically not affected by the earthquake.

Figure 23.: Electric poles damage

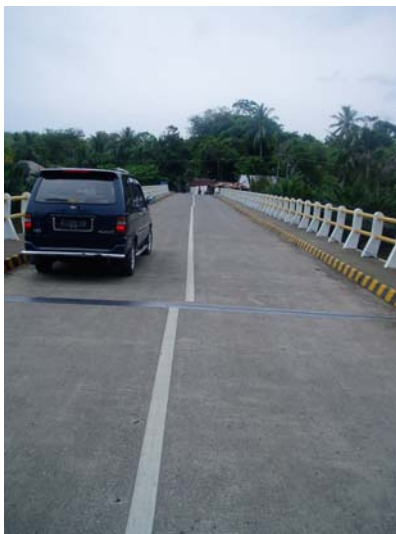
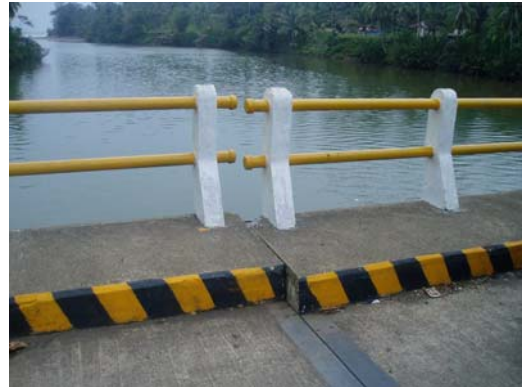
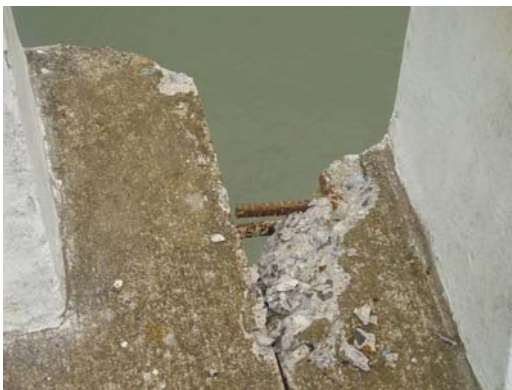
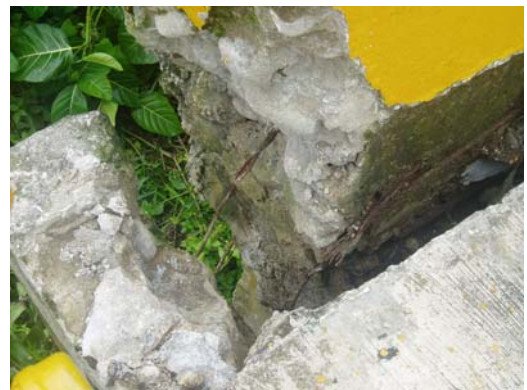
Figure 24.: One bridge was damaged at Pal 30 Village, Lais, North-Bengkulu

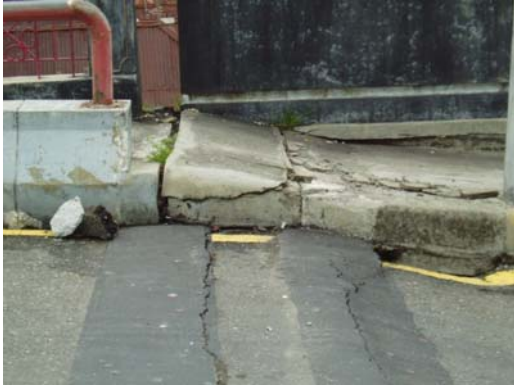
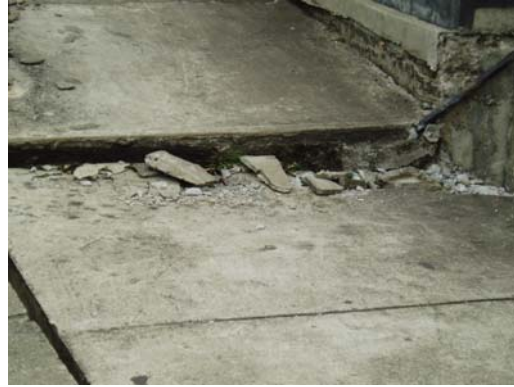
Figure 25.: Minor damage at bridge in Padang, West-Sumatra
