**EARTHQUAKE ENGINEERING  
RESEARCH INSTITUTE  
NEWSLETTER**

**MAGNITUDE 8.1 EARTHQUAKE  
IN MEXICO  
SEPTEMBER 19, 1985**

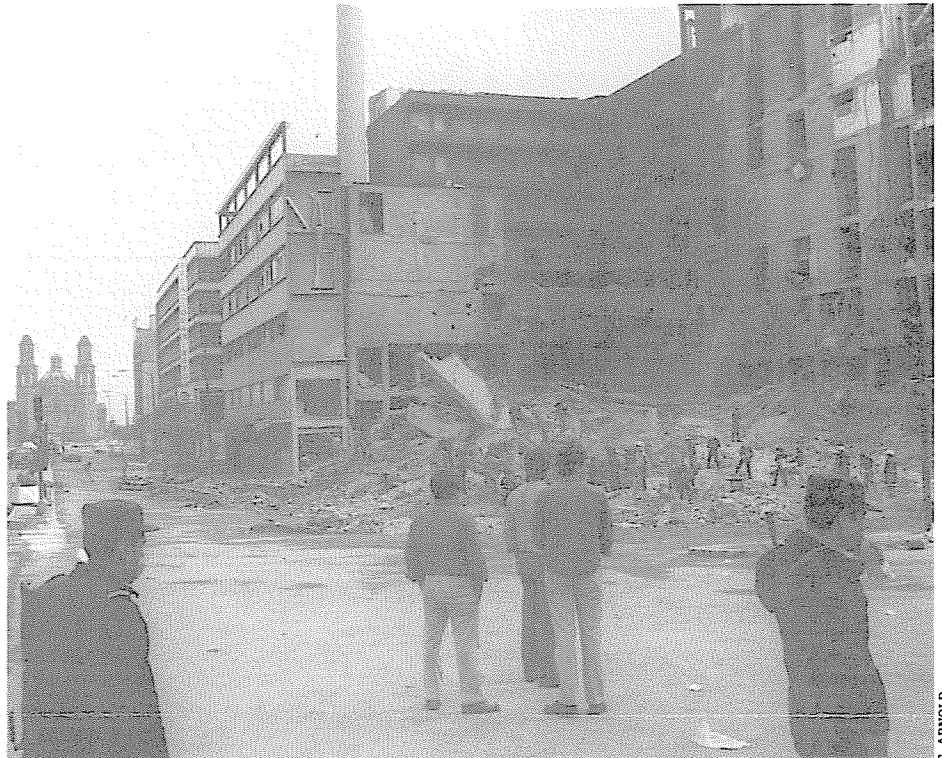
Collapsed St. Regis Hotel

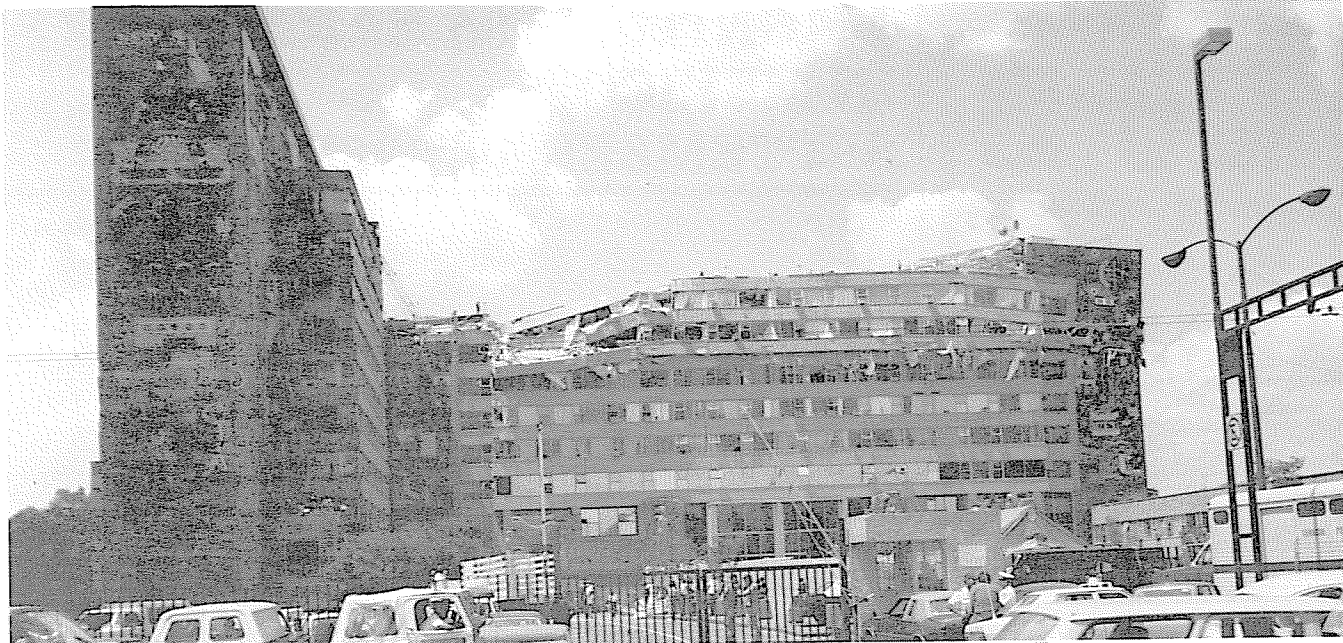
Damage to the Ministry of Communications and Transportation building. Accompanying ground-level records at this site.

The structure was seriously damaged, with many portions of the upper floors collapsing, and the damage was the primary reason why communications with Mexico after the earthquake were impossible.
