Reconnaissance Report of Geotechnical Observations
for the 4 March 1977 Romanian Earthquake

T. L. Youd
U. S. Geological Survey
Menlo Park, California
Open File Report 77-375

GEOTECHNICAL EFFECTS

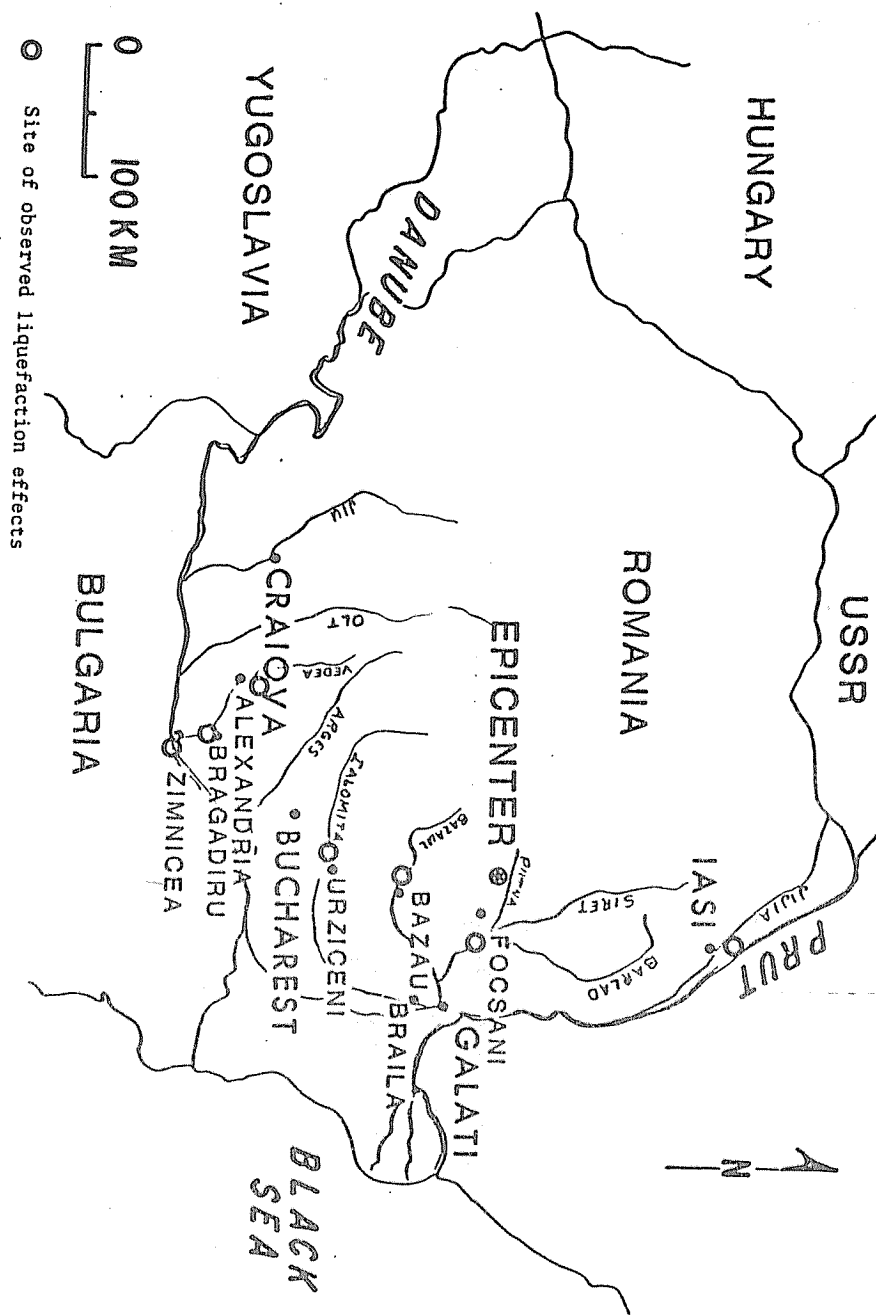
Fig. 1.--Map of Romania showing cities where major earthquake effects

have led to some significant damage, had they occurred in heavily populated areas. The localities at which liquefaction effects were observed are plotted on Fig. 1, and are described in the following paragraphs.
