Cape Mendocino, California, April 25-26, 1992

(Photographs provided by Tom Varner (EERI 1989) and Laura Varner, Dames & Moore.)

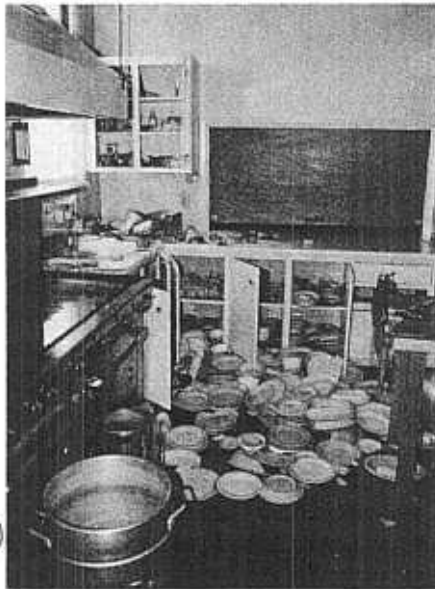
Kitchen in the Ferndale Volunteer Fire Station

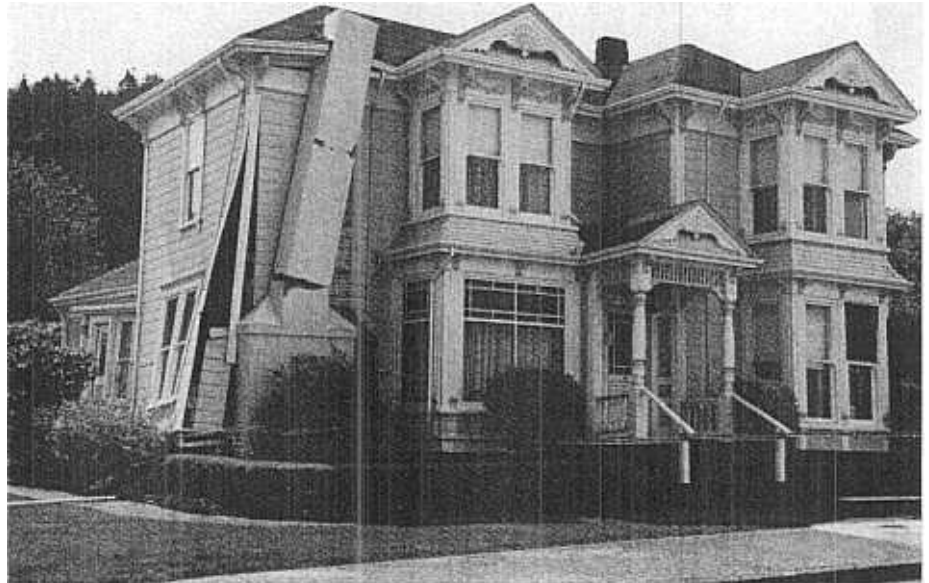
Damage to a Victorian house in Ferndale

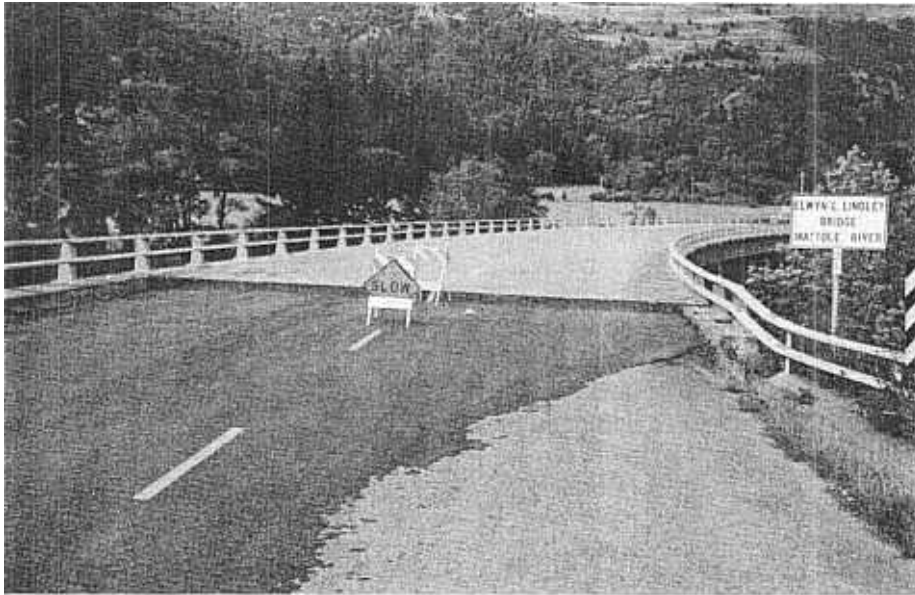
Approximately 6" of settlement occurred at the approach to the Lindley Bridge over the Mattole River

U.S. Highway 101 remained open with some temporary closures for bridge inspection and cleanup of minor landslides. Most of the highway bridges closest to the epicenters experienced settlement of the fill adjacent to the bridge abutments and concrete spalling at joints. Local roads had some closures for inspection, cleanup, and minor repairs.

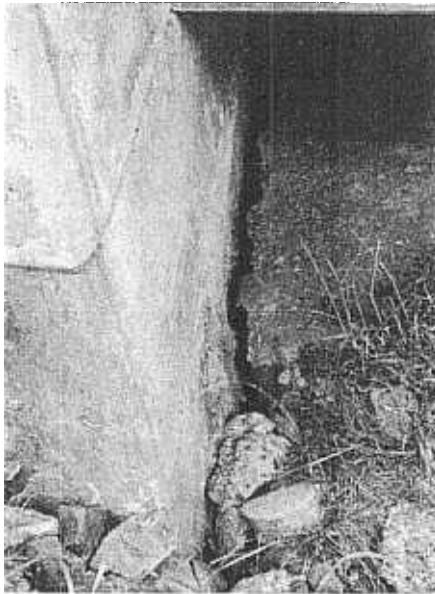
Soil movement at the Lindley Bridge abutment

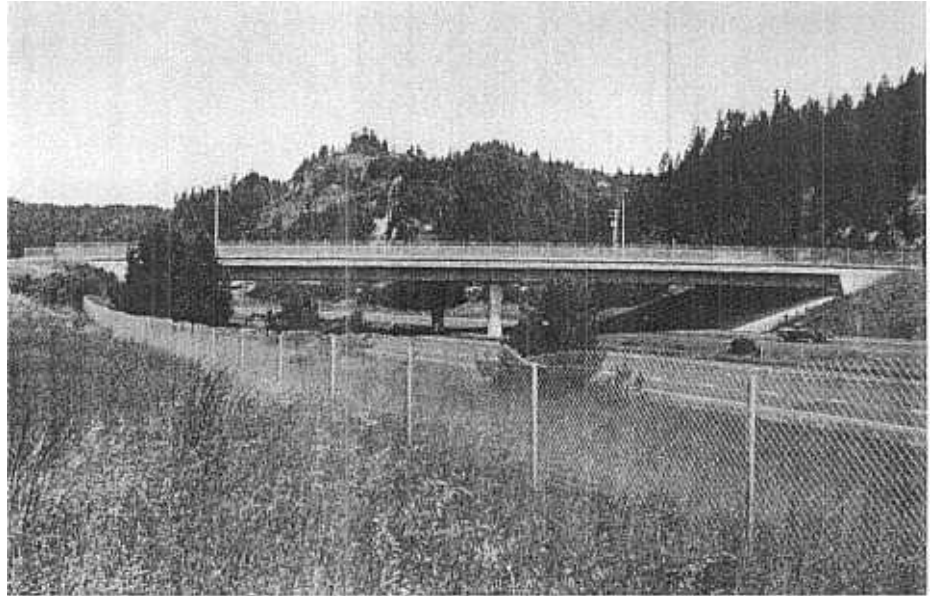
obtained. Of particular interest was the 2g or greater peak acceleration recorded at Cape Mendocino, discussed earlier, and a 0.69g record obtained in Petrolia. Acceleration levels of 1.25g were recorded at an abutment of the Painter Street Overcrossing, while the ground acceleration was 0.55g. Details are in California Division of Mines and Geology CSMIP Report OSMS 92-04.

Painter Street Bridge - 1.25g recorded at top deck

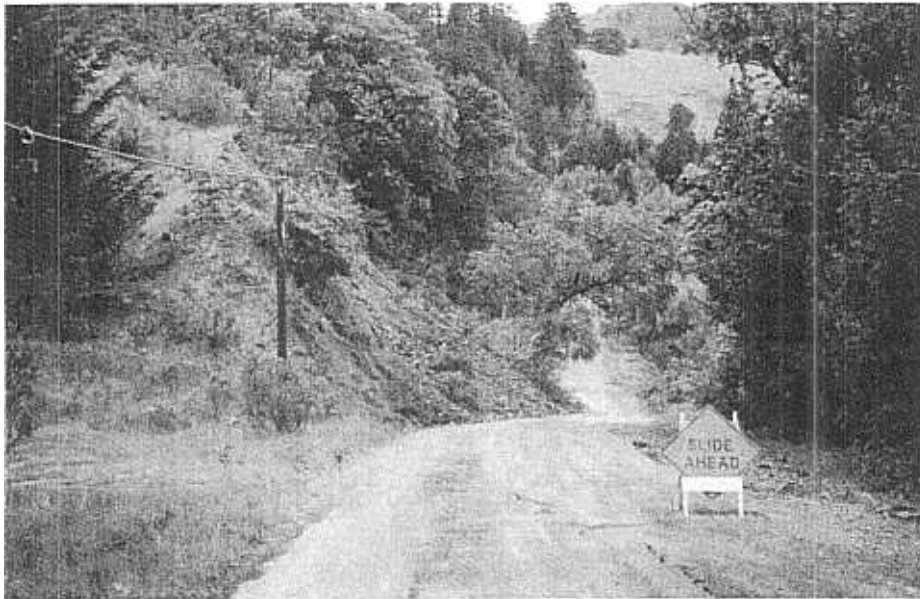
Landslide on the Mattole Road between Petrolia and Ferndale caused tree to fall on overhead lines
