THE EARTHQUAKE OF 23 NOVEMBER 1977
IN CAUCETE, SAN JUAN, ARGENTINA

(Preliminary Report of the Working Group of the
Institute of Antiseismic Investigations:
Ing. Aldo Bruschi)

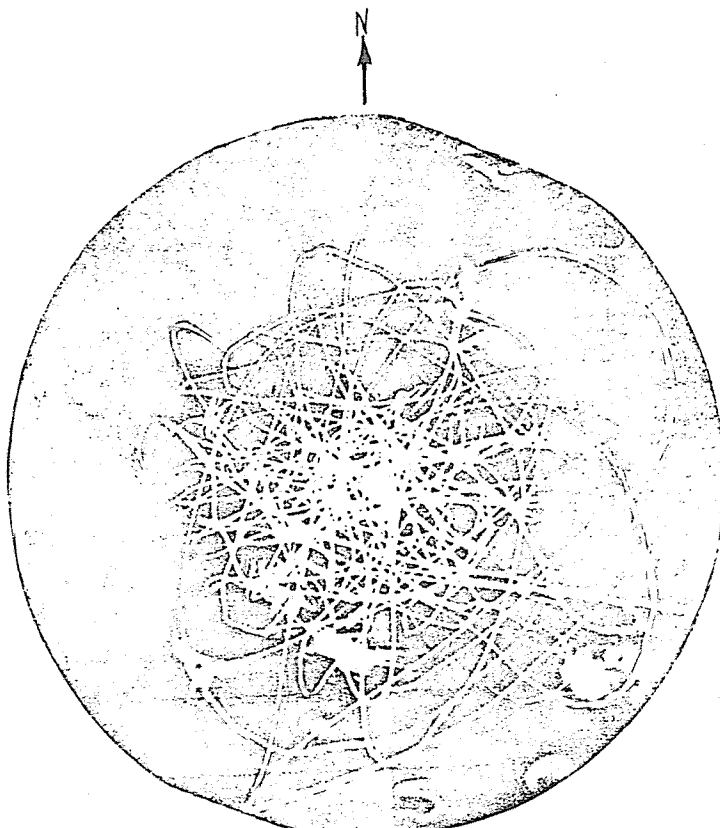
Figure 1.

The November 1977 earthquake operated a group of seismoscopes and accelerographs that were installed in the Provinces of San Juan and Mendoza. The seismoscopes located in the city of Caucete (Figure 1) went slightly off scale, thus reaching a displacement slightly greater than 0.5 radians. This instrument was installed near the Vieytes School by the Institute of Antiseismic Investigations. One room of this school collapsed even though it had been designed to be earthquake resistant. These seismoscope records have the largest amplitudes recorded in South America up to now. Other seismoscopes installed by the Institute of Antiseismic Investigations recorded amplitudes of 0.26 in San Juan and 0.30 in La Rinconada, approximately 20 km away to the south. The seismoscope located at the Center for Engineers, Architects and Surveyors in Mendoza, located 150 km south of Caucete, reached an amplitude of 0.10.

Seismoscope record from the town of Cauçete.

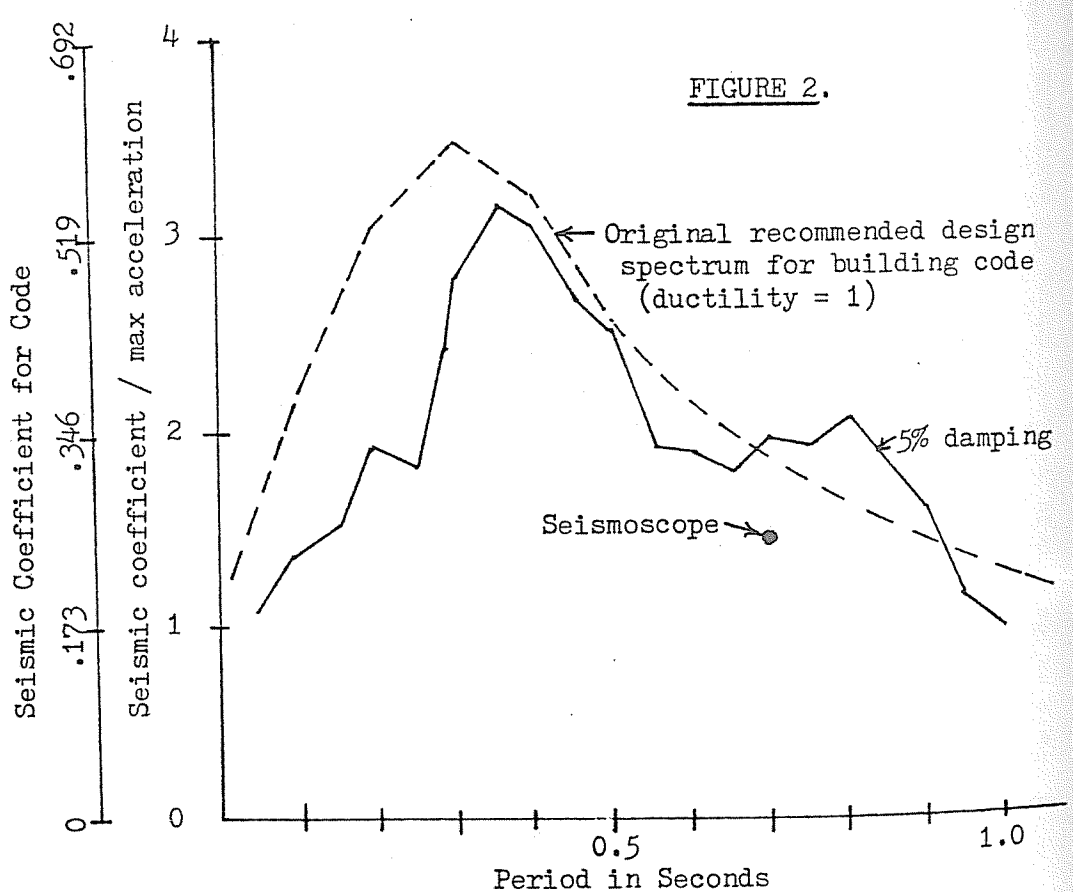
FIGURE 2.

In Figure 2 there is shown the response spectrum calculated from the east-west component for 5% damping. The corresponding maximum response of the seismoscope located adjacent to the accelerograph is also shown.

Figure 2 also shows a design spectrum that had been recommended by the Working Group of the Institute of Antiseismic Investigations to the subcommittee of Seismic Forces of the Committee of Structures of the Argentine Institute of Rationalization of Materials (IRAM). This spectrum corresponds to a ductility of 1, and it is the pseudo-acceleration response curve for 5% damping and a confidence of 84%.

Response Spectrum Calculated From San Juan Accelerogram
November 23, 1977
