THE YUNNAN, CHINA EARTHQUAKE OF NOVEMBER 6, 1988

Hu Qingchang, Beijing Institute of Architectural Design and Chung Yicun, Earthquake Engineering Research Institute, Academy of Building Science Research

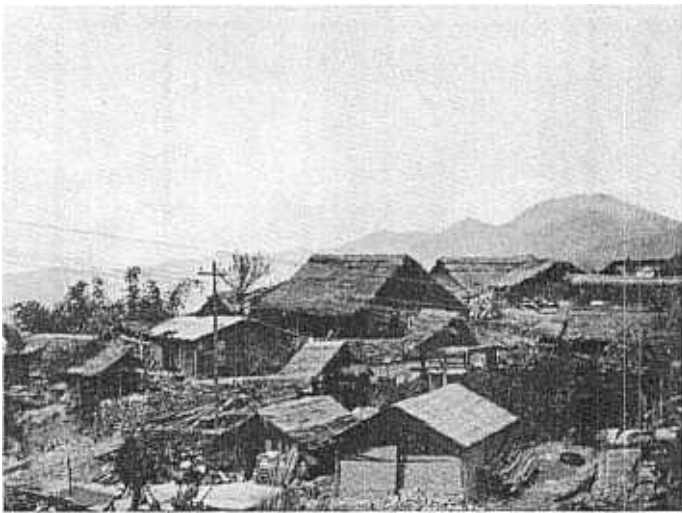
Photo 1. Yansoi Village houses, after earthquake shaking of intensity 9.

Most village houses were constructed with adobe-filled wooden framing and bundled straw roofing (photo 1). Many office buildings and warehouses were constructed with brick

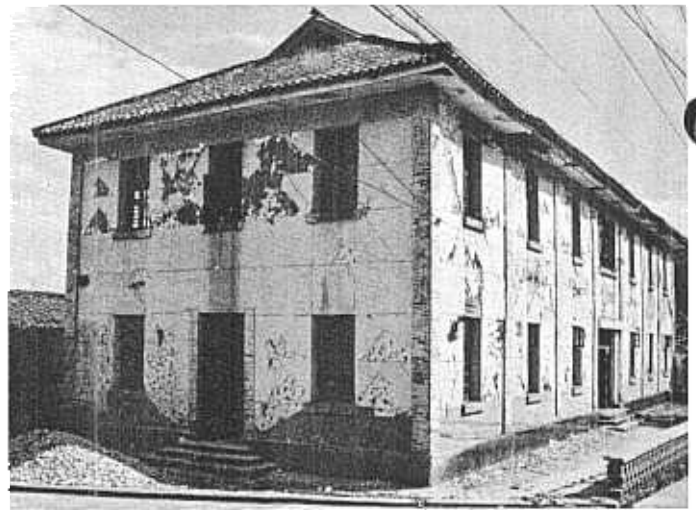
Photo 2. Administrative building of Gengma County. Adobe walls with brick piers. Intensity 8.

piers, adobe walls and reinforced concrete floors (photo 2). Brick walls laid with lime-mud or lime-sand mortar were badly damaged (photos 3, 4). Collapse and serious damage of 3- to 5-storied reinforced concrete frame buildings

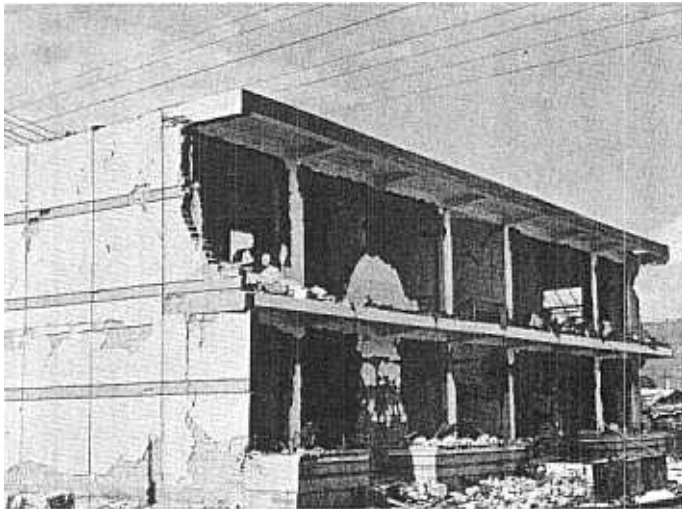
Photo 3. Mengerseng tea factory, after earthquake shaking of intensity 9. Masonry structure with hollow block walls and cast-in-situ reinforced concrete floors.

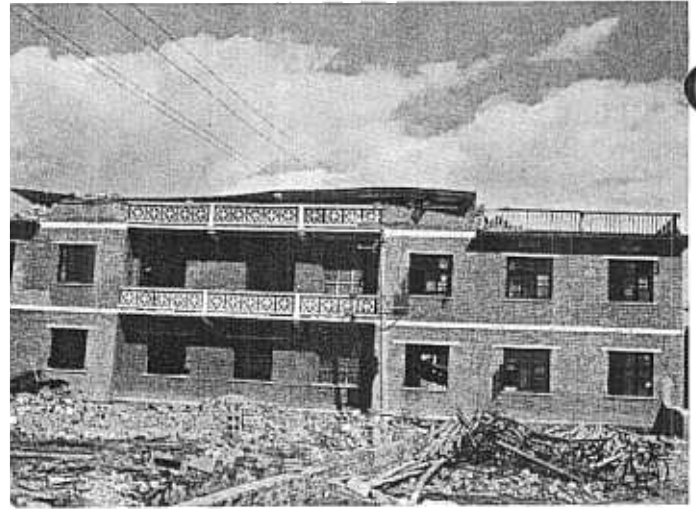
Photo 4. Office building, Gengma County, intensity 8. Three-storied brick masonry structure with monolithic reinforced concrete floors.

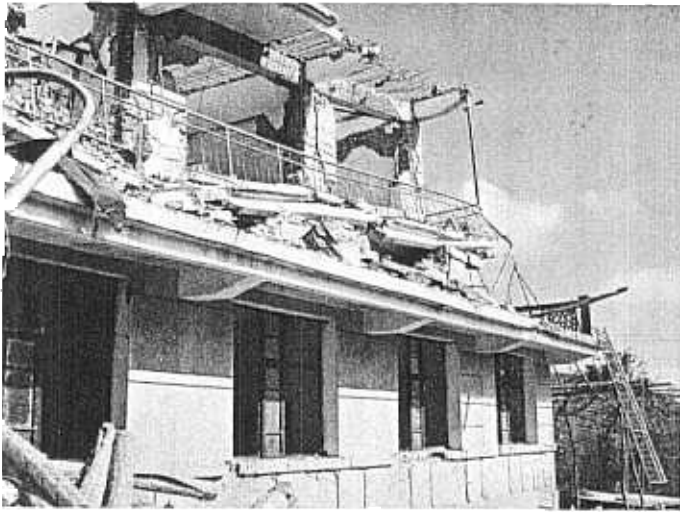
which were poorly designed and constructed with low strength concrete and incorrect detailing of reinforcement were observed (photos 5-8).

Photo 5. Administrative building, Yansoi Village, intensity 9. Two-storied reinforced concrete structure.

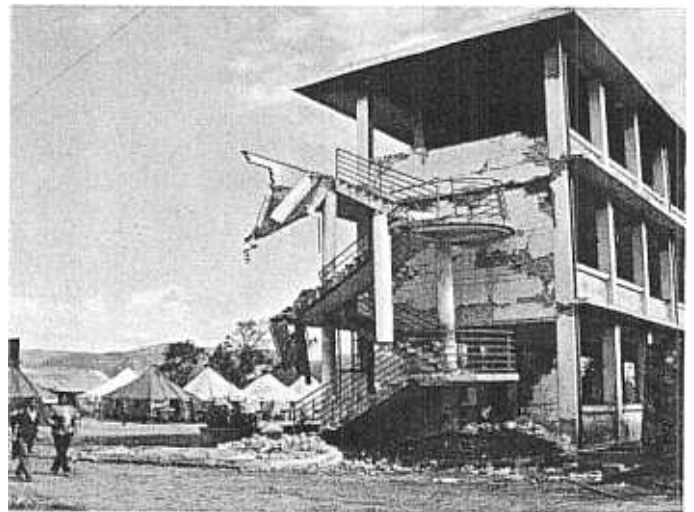
Photo 6. Yansoi Village middle school, after earthquake shaking intensity 9. Three-storied reinforced concrete frame structure.

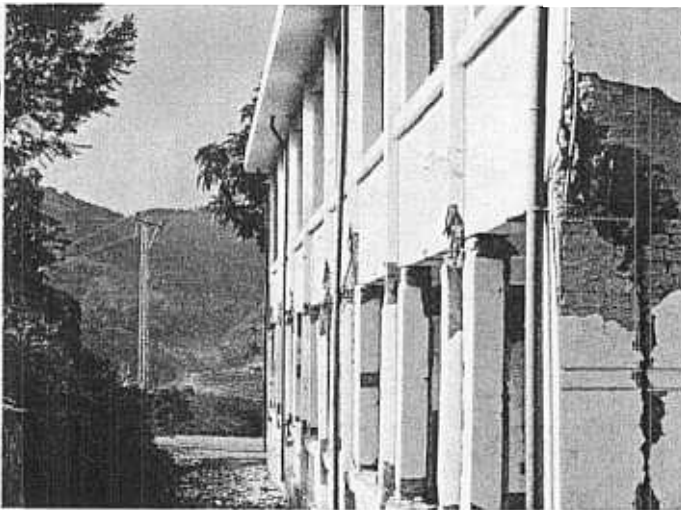
Photo 7. Yansoi Village primary school, intensity 9. Two-storied reinforced concrete frame structure.

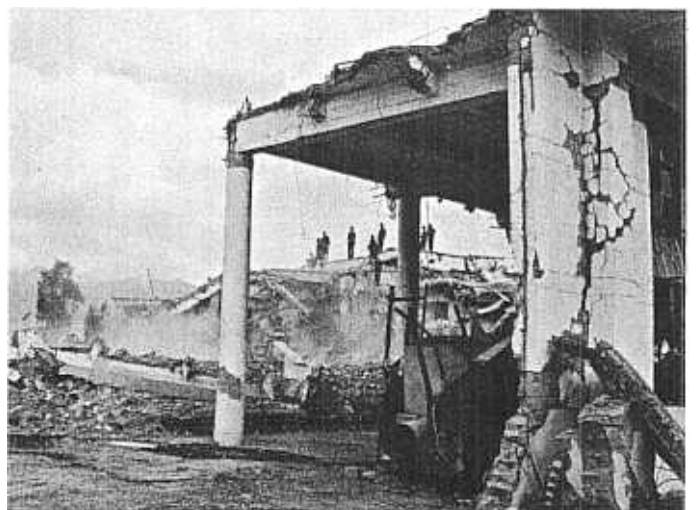
Photo 8. Mingseng tea factory, after earthquake intensity 8. Two-storied reinforced concrete frame structure; top story collapsed.

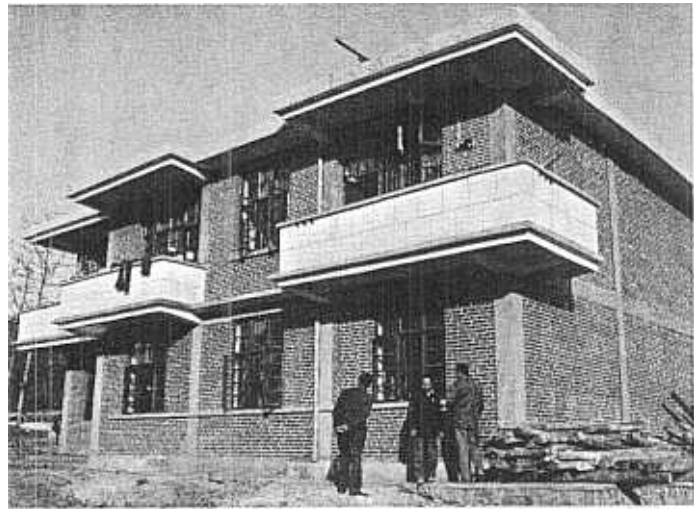
building strengthened by reinforced concrete tied columns and tied beams was completed just before earthquake. It sustained shaking of intensity 9 without any damage (photo 9).

Photo 9. Residential building, Yansoi Village, after earthquake intensity 8. Two-storied brick masonry structure, cast-in-situ reinforced concrete floor with tied columns and tied beams.
