## Learning from Earthquakes

# Preliminary Observations on the August 14, 2003, Lefkada Island (Western Greece) Earthquake

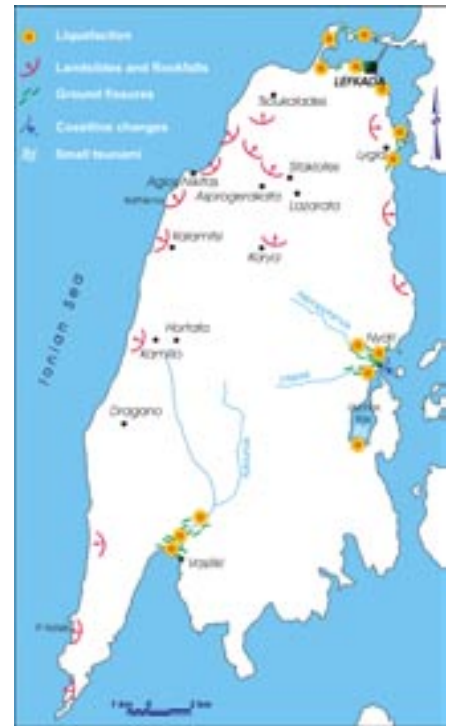
**Figure 8.** Geological and geotechnical effects of the Lefkada earthquake.

Damage surveys in the areas of Asprogerakata, Spanohori, Lazarata, Kavallos, Pinakohori, and Karya villages reveal building damage concentration that may be related to specific surface and subsurface topographic features. The rough

alignment of the damage coincides almost with the fault strike, a factor that may also influence the damage pattern (figure 8).

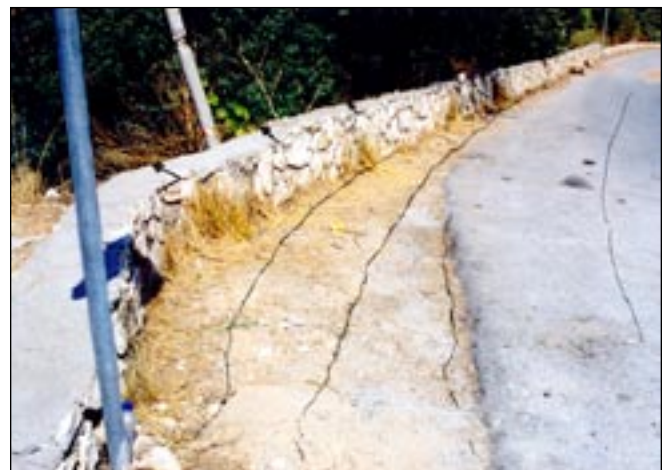
**Figure 9.** Many retaining walls leaned towards the external side; the adjacent parts of the roads subsided, and cracks appeared on the pavement (NTUA-UoA team).

The length of the fissures varied from a few tens of cm to tens of m, their width was from a few mm to 10 cm, and their visible depth reached 30 cm. A systematic study of the trends of the fissures showed that there were two prevailing sets, one parallel to the coast and one normal to it. In addition, the pattern was similar at the cracks located in the river deposits; however, the primary set ran parallel to the riverbed and the secondary ran normal to it. The fissures and cracks had no genetic relationship with the fault deformation, but they were a by-product of the seismic movement. Their occurrence is exclusively controlled by the differential compaction of the loose formations, the lateral instability of the ground masses at the coastal or riverside area, and the

differential seismic response of the various unconsolidated phases of the formations (figures 9 and 10). Most of them are also connected to liquefaction phenomena and represent lateral spreads and extensional failures.

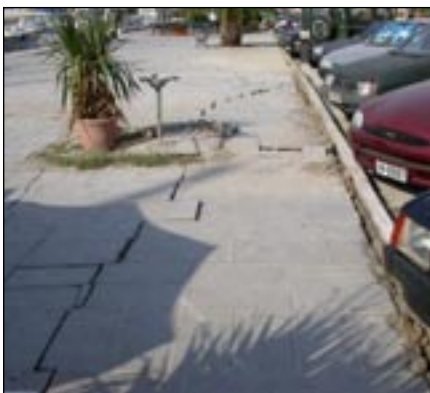
In the town of Lefkada, damage included uplifted, sunken or cracked concrete slabs, and distorted pavement and sidewalks (figure 11). Shallow subsurface materials at these sites probably consisted of uncompacted, miscellaneous fill. Local residents reported that muddy water was ejected from cracks in pavement surfaces. Observed ground cracking with lateral spreading, as well as silty-sandy boils along the waterfront in the town of Lefkada and in Nydri village, were the primary surface evidences of liquefaction, indicating high excess pore pressure generation during earthquake shaking.

**Figure 11.** In the town of Lefkada, distorted pavement and sidewalks due to ground settlement and lateral spread (ITSAK team).

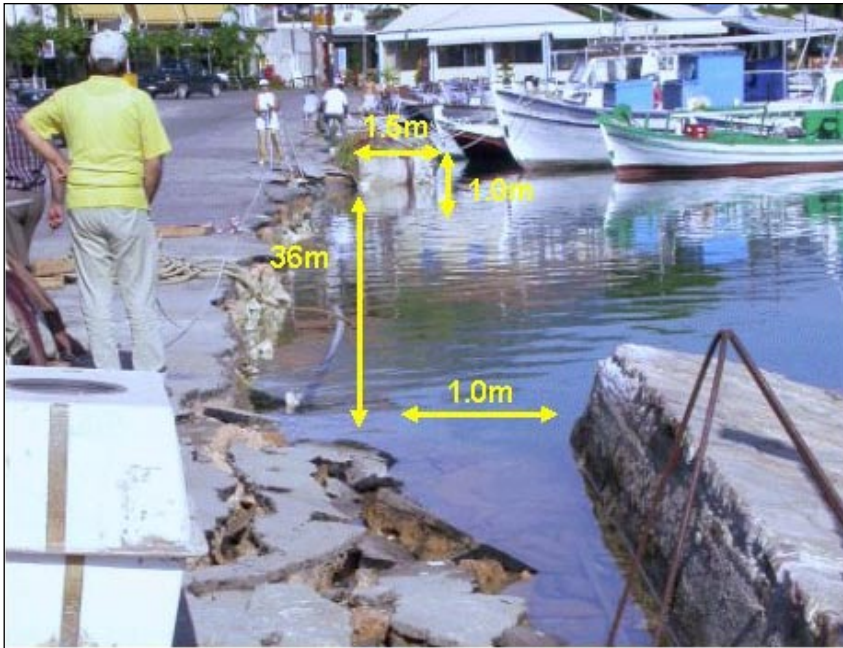
Densification of loose surface soil layers and of poorly compacted fills behind seawall facilities caused settlements and lateral spreading towards the free face. The horizontal and vertical displacements varied between sites, but they were in the range of 10-25 cm. Figure 13 shows ground settlement near the coastline. Lateral spreading was prevented due to the seawall, but an up-lift of the ground just behind the seawall tilted the lampposts.

**Figure 13.** Part of the seawall has been laterally shifted and overturned (ITSAK team).

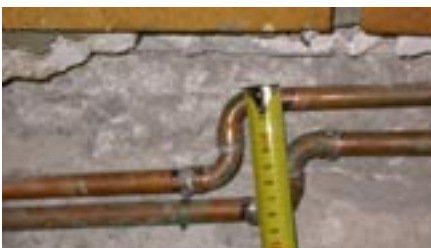
area, observed damage indicates a differential settlement between adjacent buildings of 5-10 cm. However, those buildings did not suffer any severe damage due to their relatively small mass, their “flexible” wooden frame, and, in cases of RC structures, their foundation type (mat foundation, tie or foundation beams). Figure 14 shows a plan view of two adjacent buildings with a common pipeline system that had a differential settlement of about 5 cm.

**Figure 14.** Plan view of two adjacent buildings with a common pipeline system that had a differential settlement of about 5 cm (ITSAK team). (Photo taken after repairing.)

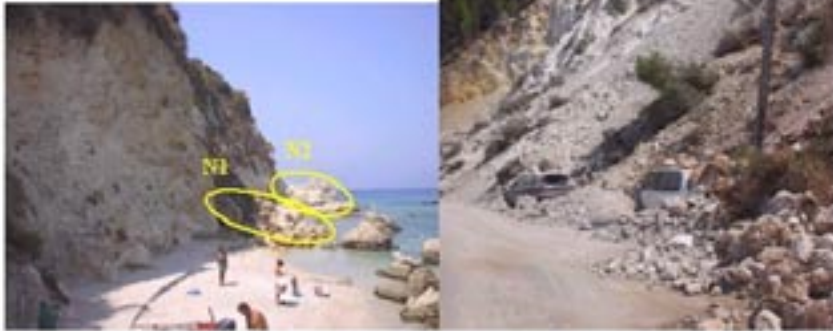
**Figure 16.** Rockfalls due to detachment and possible overturn at the Agios Nikitas (left); Cars were buried under landslides near the same beach (right) (ITSAK team).

schists) located on steep cut slopes (horizontal:vertical = 2:1 to 3:1) and with heights ranging from 20 to 50 m, without any trench or other preventive countermeasures. There were also a considerable number of failures of embankment slopes, especially when lack of compaction was obvious.

swimming and sunbathing, but they did not cause any casualties, thanks to the early morning hour of the main shock. Figure 16 shows rockfalls and scree deposits due to overturn, detachment, and sliding at Agios Nikitas Beach.

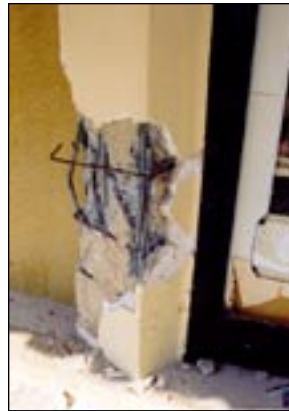
20a

In a building with a market and mezzanine on the ground floor: insufficient stirrups with poor detailing (a).

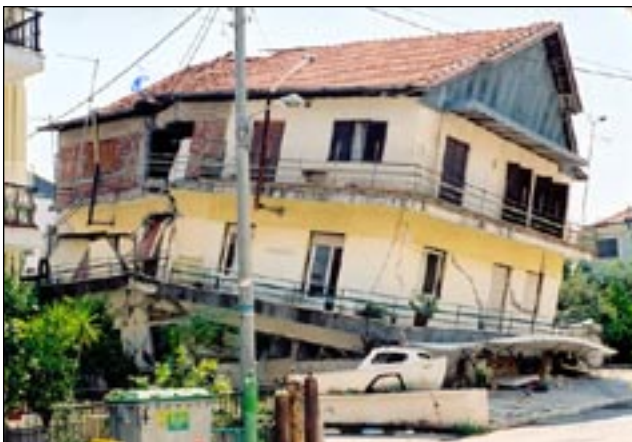
**Figure 19.** Collapse of R/C building in the town of Lefkada. On the right side, there are no brickwalls on the ground floor, where the building collapsed. The remaining part on the left side has partitions down to the foundation (NTUA-UoA team).

A total collapse occurred in a three-story R/C building (category C) with short columns on the ground floor at the front and thick brick infill walls at the back. The building was poorly designed with inadequate stirrups at the columns (figure 19).

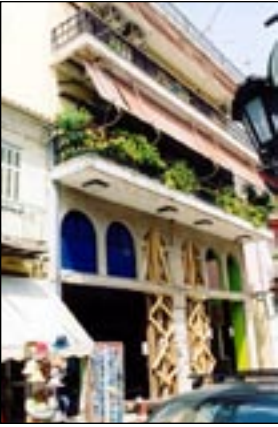
**Figures 21a and b.** A four-story building with a mezzanine was heavily damaged in the ground floor columns. The columns seem to have swollen in the center due to insufficient transverse reinforcement (NTUA-UoA team).

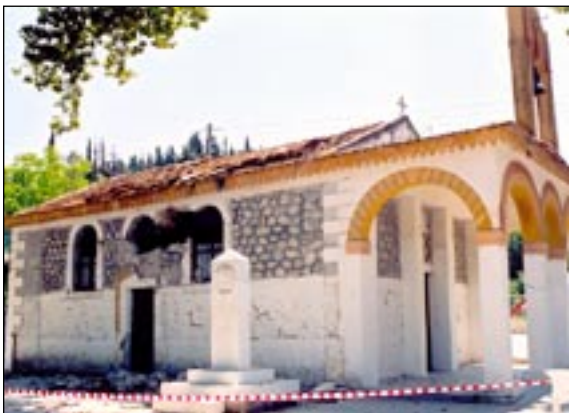
**Figure 22.** Churches built of stone masonry suffered heavy damage. In various parts of Lefkada, the tiles at the center of roofs moved. This might be explained by the vertical flexibility of the roof at its center (NTUA-UoA team).
