GUATEMALA EARTHQUAKE OF FEBRUARY 4, 1976

PRELIMINARY NOTES OF DON MORAN

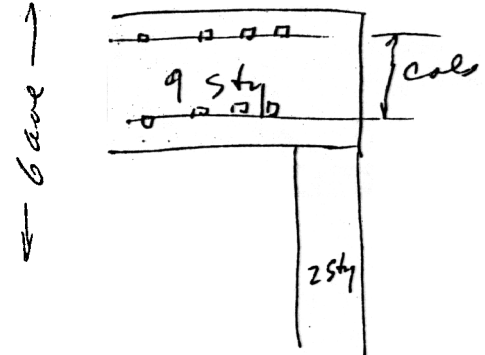
TIVOLI PLAZA

General Brick wall piers have heavy cracks below each floor. X cracks in interior brick partitions

Why? No evidence of structural damage.
