Reconnaissance Trip Report

GUATEMALAN EARTHQUAKE OF FEBRUARY 4, 1976

by
Karl V. Steinbrugge

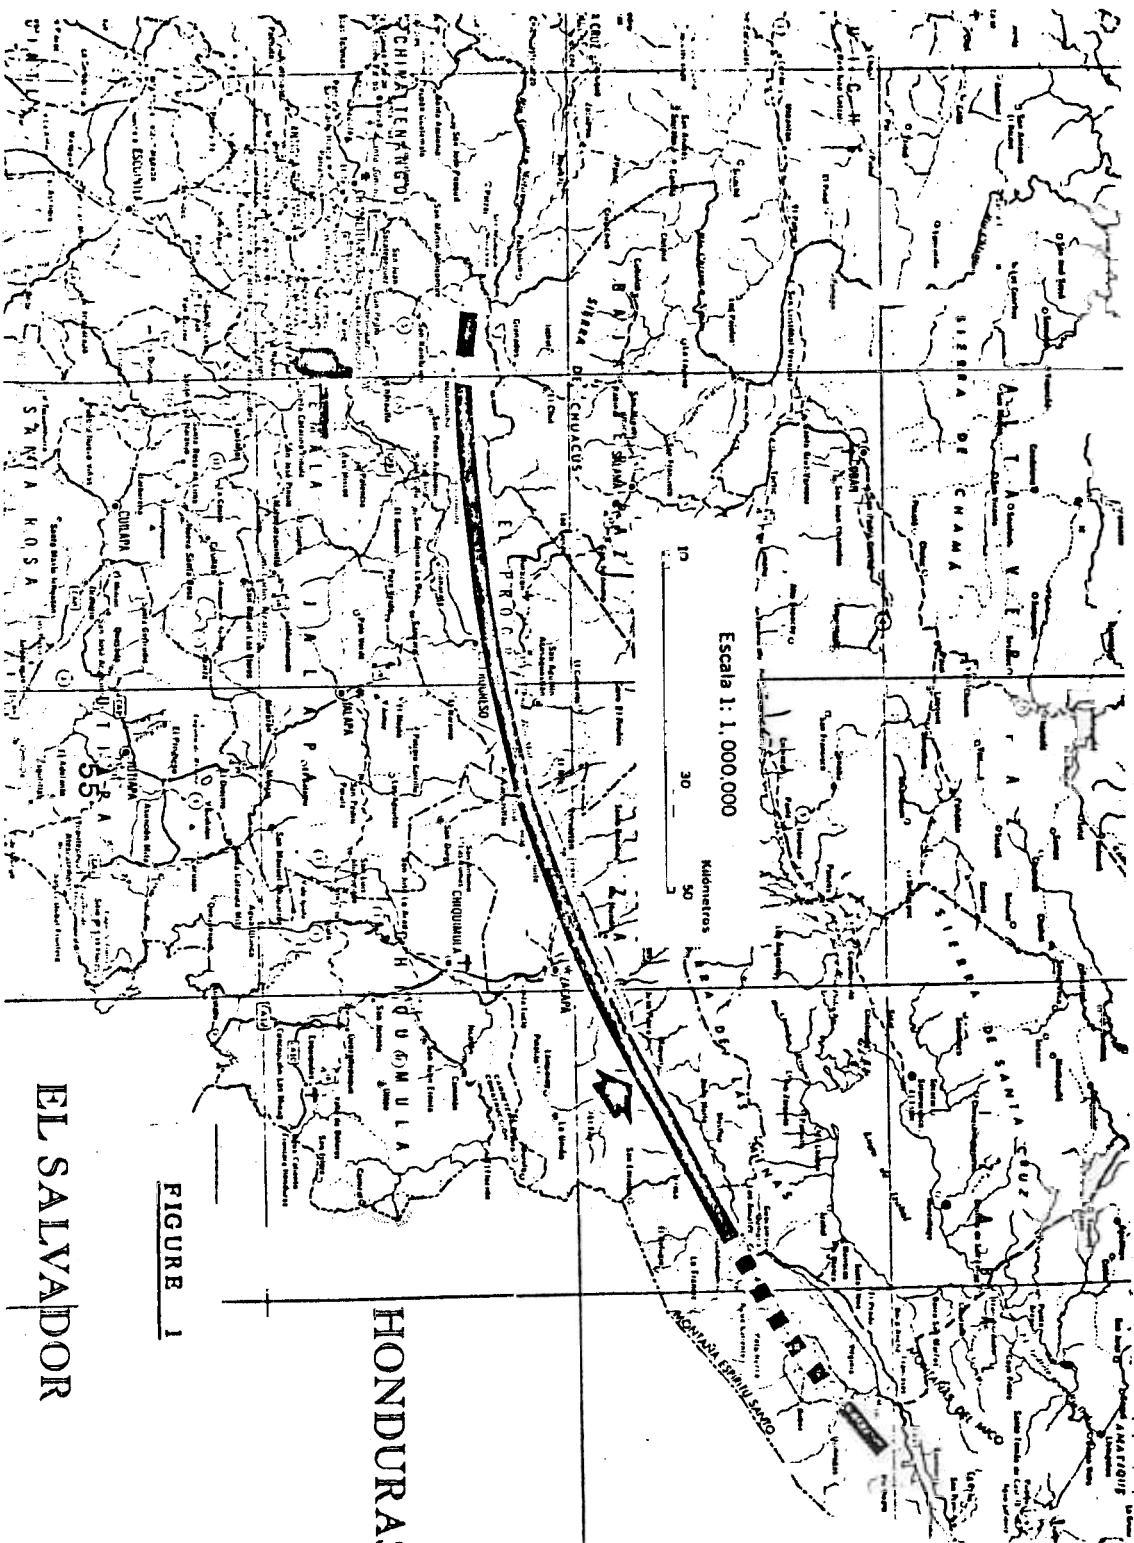
FIGURE 1

Figure 1 is the author's interpretation of the fault location with the arrow pointing to the epicenter (Fault location is by David Schwartz of Woodward-Clyde Consultants). On the basis that the energy release is distributed within a volume along each side of the rupture, the centroid of the energy release is closer to Guatemala City than is the focus. Indeed, with the westerly end of the rupture being perhaps 20 miles north of Guatemala City, some significant amounts of energy were released quite close to the city.
