Garhwal Earthquake of Oct. 20, 1991

A four-member team from Civil Engineering Department of the Indian Institute of Technology, Kanpur conducted a survey of the significantly affected areas during October 27 to November 4. The team members were Dr. Sudhir K. Jain, Dr. R. P. Singh, Dr. V. K. Gupta, and Mr. Amit Nagar.

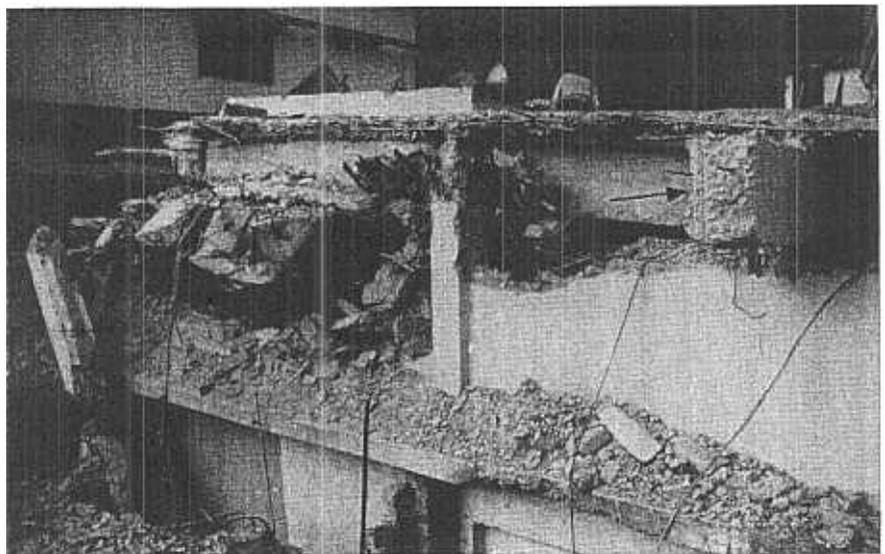
Figure 2 shows the State Bank Building in Uttarkashi. During the earthquake, the upper two stories collapsed on the first story. Information from local residents revealed that the building was first constructed as one story only; the upper two stories were added subsequently. The beams had only two nominal rebars on the top face near the column joint and those were incorrectly placed.

FIGURE 2 - State Bank Building at Uttarkashi

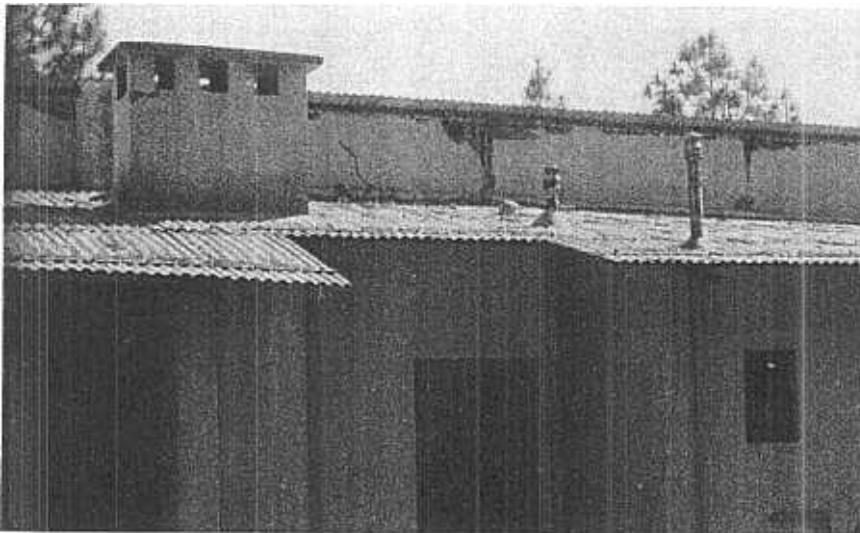
The ITBP Paramilitary Campus at Mahidanda consists of a large number of two story residential buildings with load bearing walls of concrete block masonry. All have RC lintel bands, but no roof bands or gable bands. The construction is about 10 years old. The damage to buildings consisted of (i) diagonal cracks

below window sills, (ii) damage at the connection between masonry walls and RC roof slabs, (iii) in buildings with corrugated iron sheet roofs, damage at the seat of purlins on the gable end walls, and (iv) damage to walls supporting roofs of different height at either end (Fig. 3). Roof and gable bands would have prevented damage of types (ii), (iii), and (iv) above.

FIGURE 3 - Damage to Wall Supporting Split Level Roof - ITBP Campus, Mahidanda

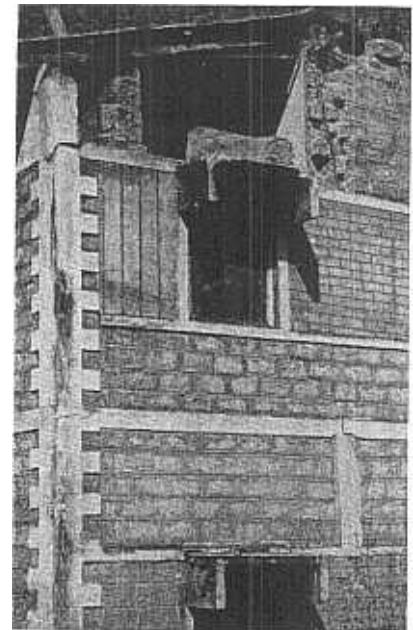
The Maneri Hydel power project colony campus has two-story buildings with concrete block masonry bearing walls, of poorer quality construction than that seen on the ITBP campus. Many buildings were damaged beyond repair. Damage consisted of (i) severe damage to gable walls (Fig. 4), and (ii) diagonal cracks in ground story walls.

FIGURE 4 - Damage to Gable Wall - Maneri Hydel Project Colony

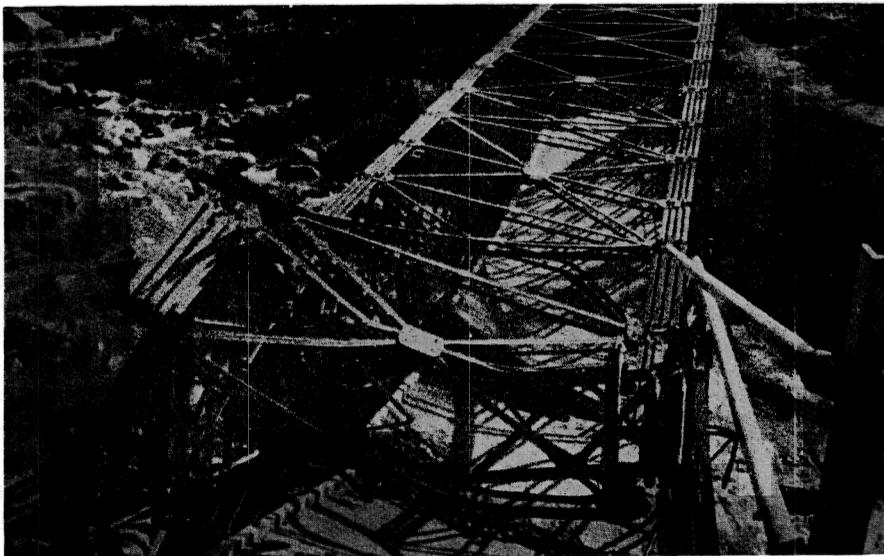
The Gawana Bridge is a 56.0 m span steel truss bridge built in 1974. It is located at 6 km from Uttarkashi towards Maneri. The entire bridge came off the abutments and fell into the river (Fig. 5), causing the entire area beyond Uttarkashi to be cut off from the rest of the country. Inadequate design of bearings and anchor bolts as well as absence of any suitable means of preventing the span from falling

off the supports were responsible for the damage.

FIGURE 5 - Collapsed Gawana Bridge

The peak horizontal ground acceleration in the region was about 0.30 g. The Indian code specifies the design seismic force for bridges in the range of 0.05 to 0.075 g for zone IV. This is obviously inadequate. It is hoped that the bridge failures caused by this earthquake will provide the necessary impetus to revise the code.
