Learning from Earthquakes

The Great Sumatra Earthquake and Indian Ocean Tsunami of December 26, 2004

Report #3

The Effects in Mainland India and in the Andaman-Nicobar Islands

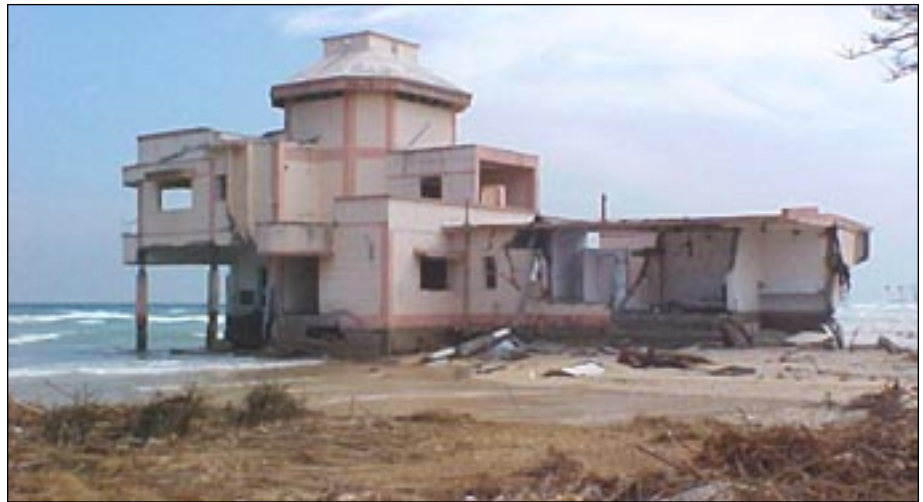
Figure 3. RC frame building (MES Inspection Bungalow) now stands in water on the eastern coast of Car Nicobar Island (photo: C.V.R. Murty).

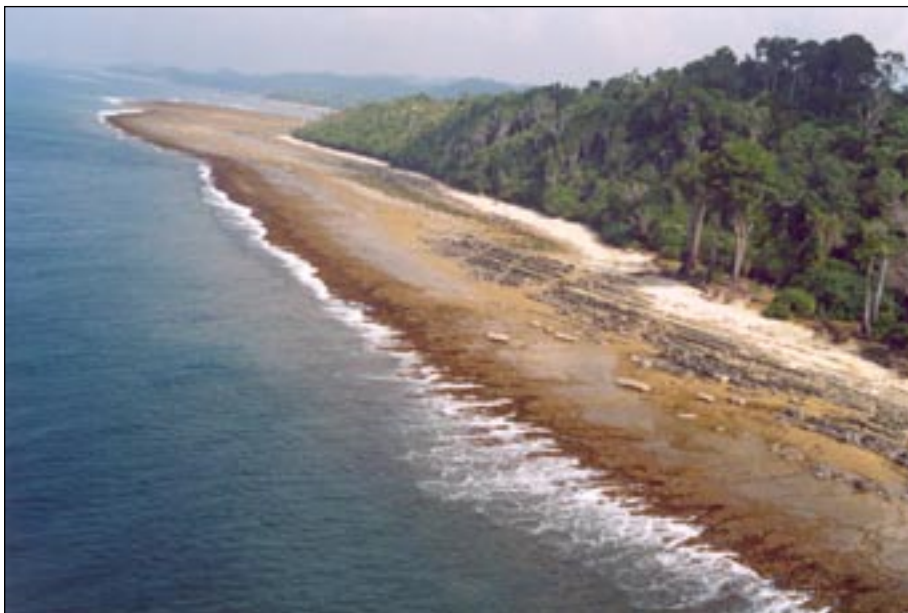
Island, suggesting an uplift of up to 0.3 m (Figure 4). The increased exposure of the RC piles at the jetty structure at Diglipur Harbor at the northern region of North Andaman Island (the northernmost of the A&N Islands) indicates an uplift of about 1.2 m.

Figure 4. Up-throw of coral beds and rock strata due to uplift on the western coast of Middle Andaman Island near Flat Island (photo: Javed N. Malik).

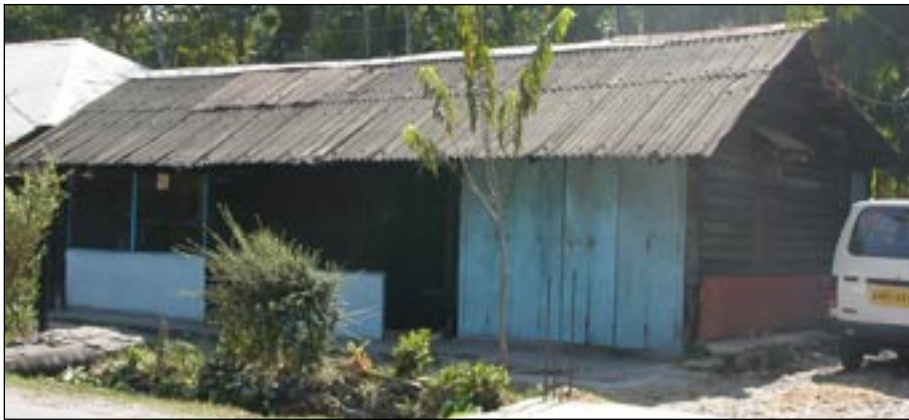
Figure 5a.
Single-story wood house in Port Blair with light roof had no damage (photo: C.V.R. Murty).

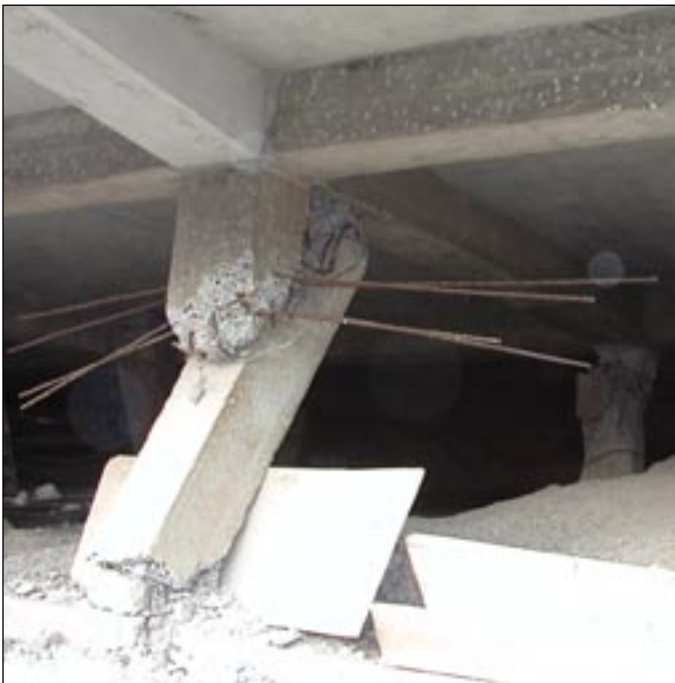
Figure 5b.
A three-story RC frame building in the same town collapsed in a brittle manner (photo: Sudhir Jain).

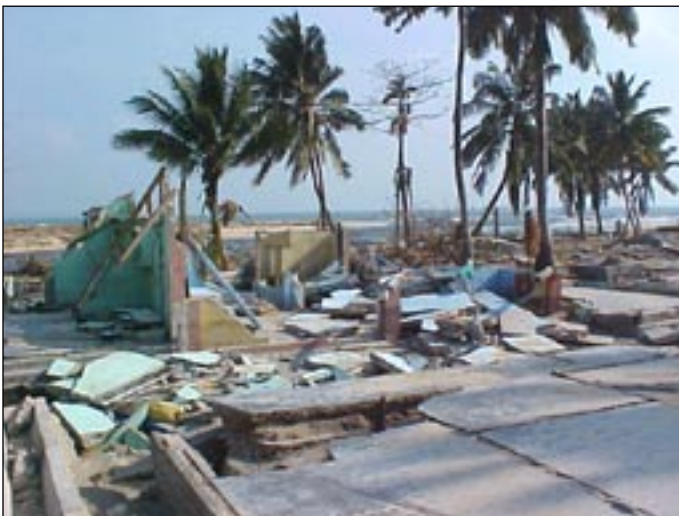
The tsunami waves caused severe destruction in the coastal areas of the southern islands (Figure 6). Structures near the water were subjected to (1) a positive water pressure when the waves arrived, and (2) a suction pressure when the waves receded. A large number of buildings right on the water in Little Andaman and Car Nicobar islands were washed away, regardless of how they were constructed.

Figure 6. *General destruction of built environment at Hut Bay in Little Andaman Island (photo: C.V.R. Murty).*

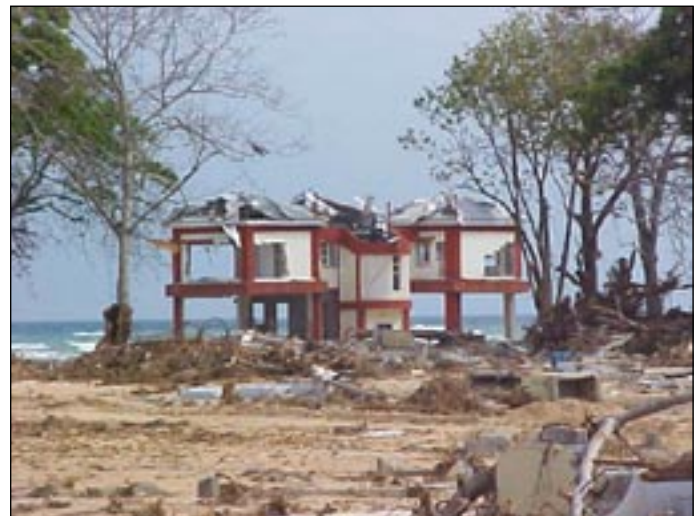
Figure 7. *Shore-front building on Car Nicobar Island was inundated by the waves, but the frame resisted the wave effects (photo: C.V.R. Murty).*

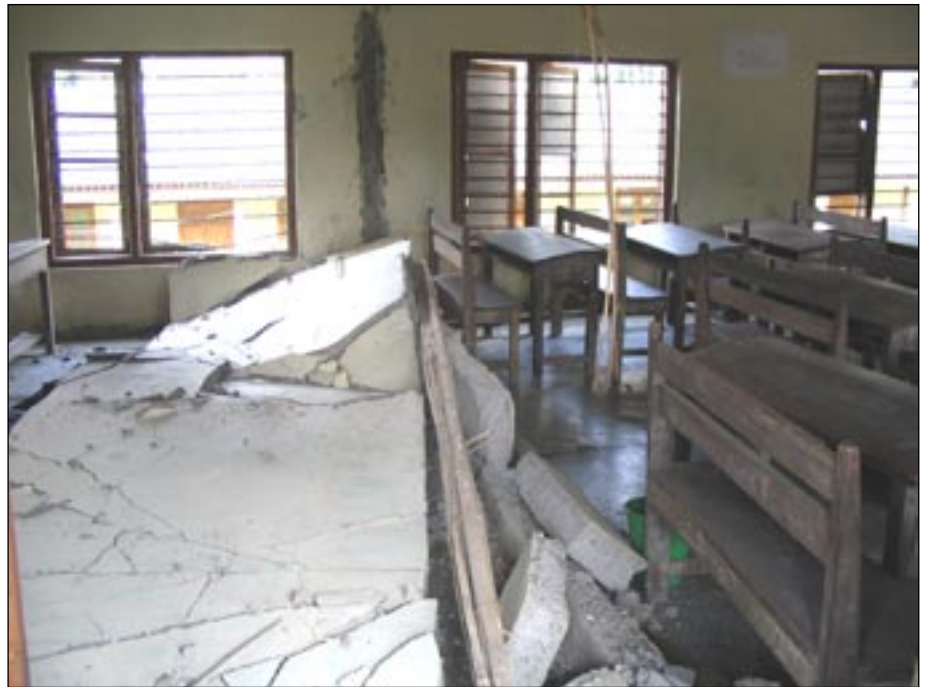
movement of the flexible roofs from earthquake forces caused out-of-plane masonry wall collapse. Similar damage was observed at a much larger scale in many school buildings, where the long partition walls separating two classrooms were either badly damaged or had fallen due to out-of-plane instability (Figure 8).

Figure 8. Slender masonry walls dislodged due to out-of-plane instability and poor or no connection to the surrounding structural elements (photo: Durgesh C. Rai).

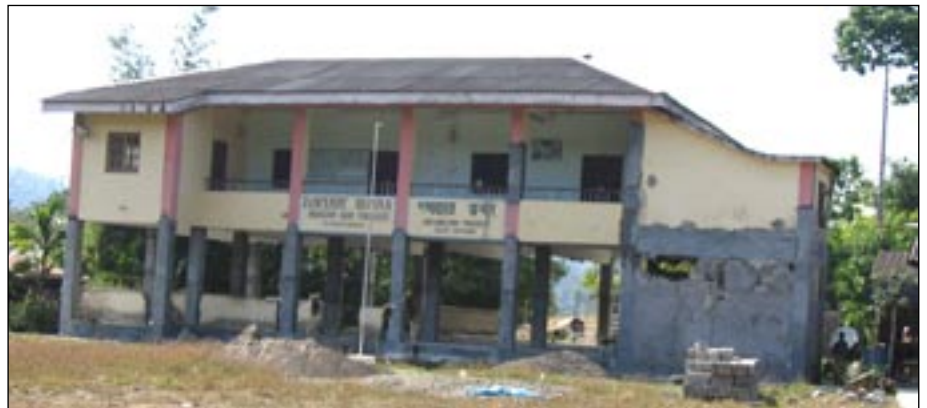
Figure 9a. The Panchayat Bhavan building showed severe cracking and damage to the soft first-story columns and infill walls (photo: Durgesh C. Rai).

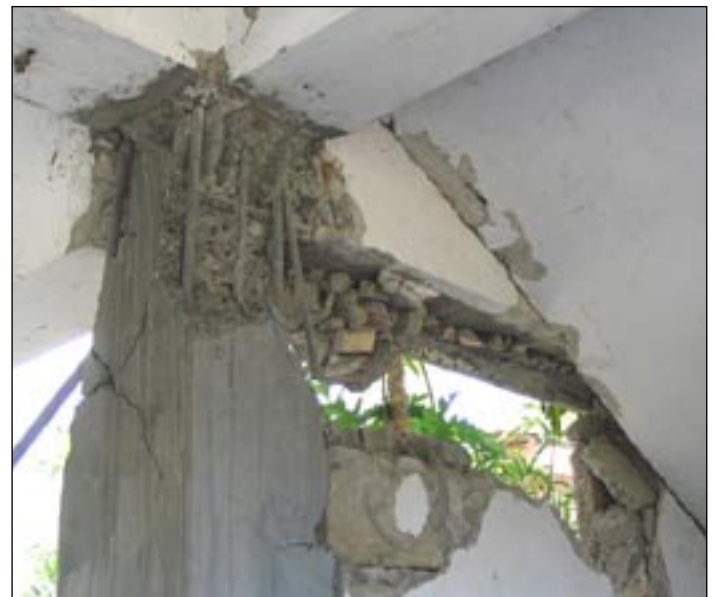
Figure 9b. Detail of column failure in the ground story (photo: Durgesh C. Rai).

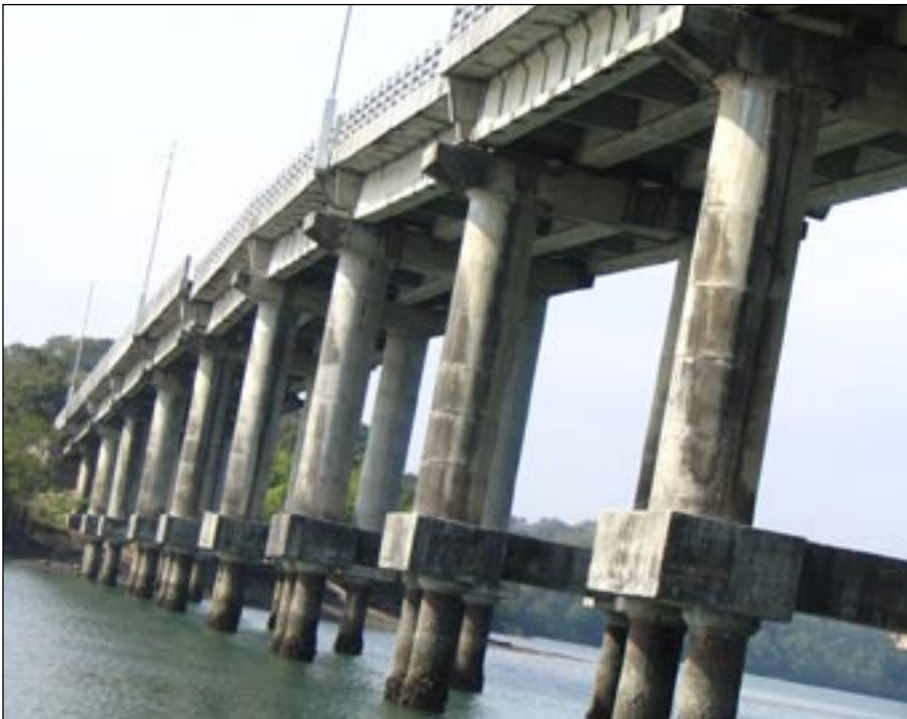
Damage to Infrastructure: A newly constructed 268 m-long RC bridge over the Austen Strait, connecting the North and Middle Andaman Islands on the Andaman Trunk Road, had to be closed to even light vehicles. Three middle spans of the superstructure were displaced laterally by about 70 cm and vertically by about 22 cm and fell off the bearing (Figure 10). Some other spans were also

moved laterally by about 2 cm to 15 cm. Two of the authors of this report visited this region two years ago after the moderate 2002 Diglipur earthquake. Their published reconnaissance report (Rai and Murty 2003) expressed the following concerns about this bridge:

“Inadequate seating of bridge deck over piers and abutments is a serious concern for its safety during a stronger earthquake in the future. The bearings are simple neoprene pads which are far from satisfactory for a bridge located in seismic

zone V. Bridge deck restrainers are the minimum that need to be provided to ensure that the spans are not dislodged from the piers in future earthquakes.”

Figure 10a. Chengappa Bridge over Austen Strait was rendered dysfunctional by displacement of the middle spans (photo: Durgesh C. Rai).

- d) Bridges in the coastal areas need to have lateral restraints to prevent the loss of spans during the buoyant conditions developed under high-tide levels.

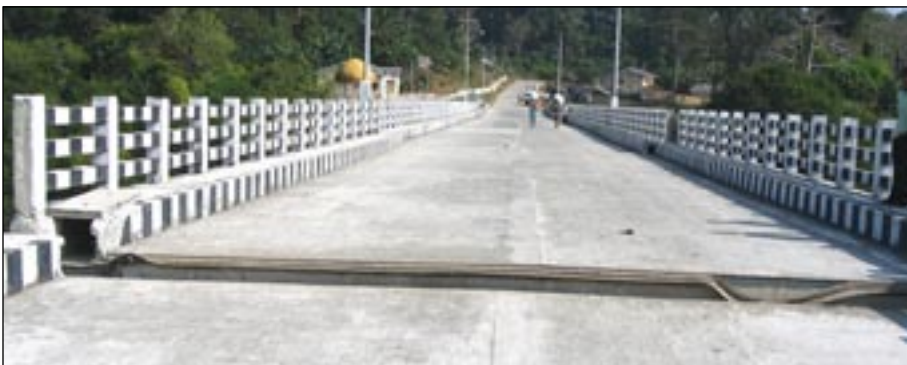
Figure 10b. Detail of the bridge deck showing lateral and vertical displacement due to shifting of the decks on their neoprene bearings (photo: Durgesh C. Rai).

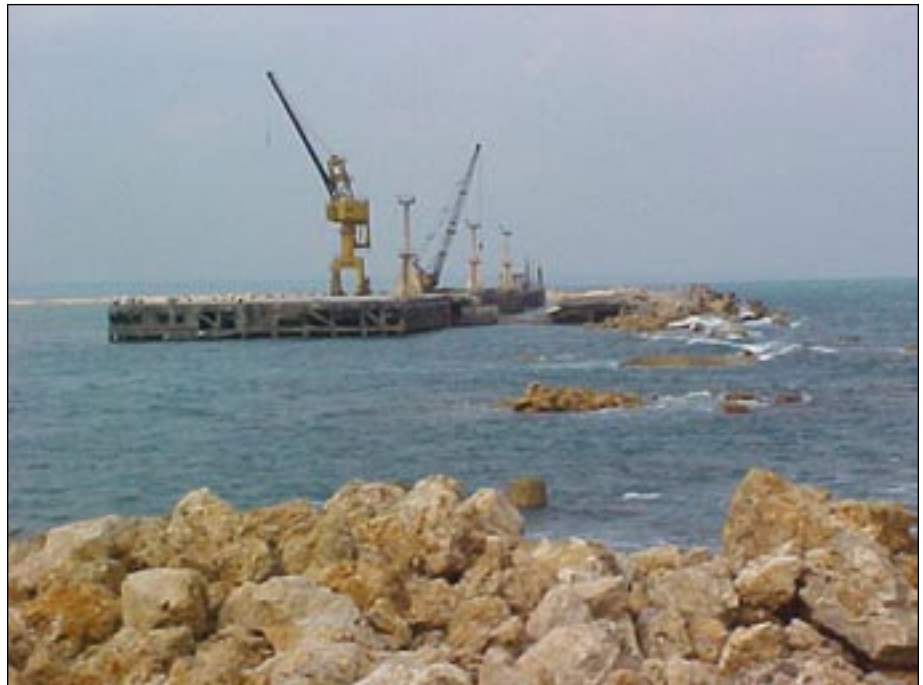
Figure 11. Shortage of appropriate construction material forced the use of porous coral stones from local quarries for building the breakwaters. The stones were easily uplifted during the tsunami and breached a large segment of the approach to the RC jetty at Hut Bay (photo: C.V.R Murty).

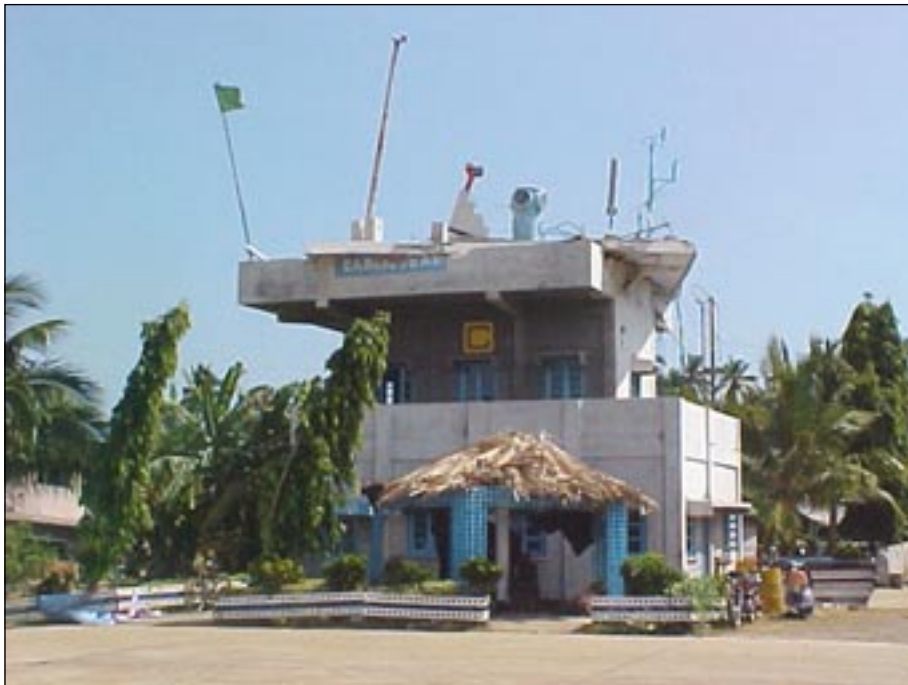
Figure 12a. Partial-collapse of the upper storey of the air traffic control tower at airport on Car Nicobar Island (photo: C.V.R. Murty).

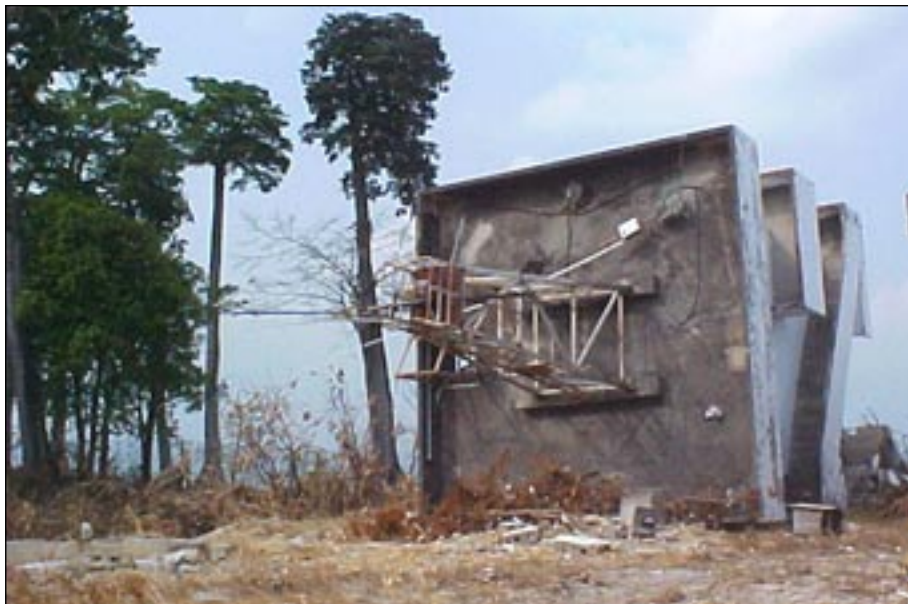
Figure 12b. Laterally toppled three-storey seaport traffic control tower at Hut Bay in Little Andaman Island (photo: Suresh R. Dash).

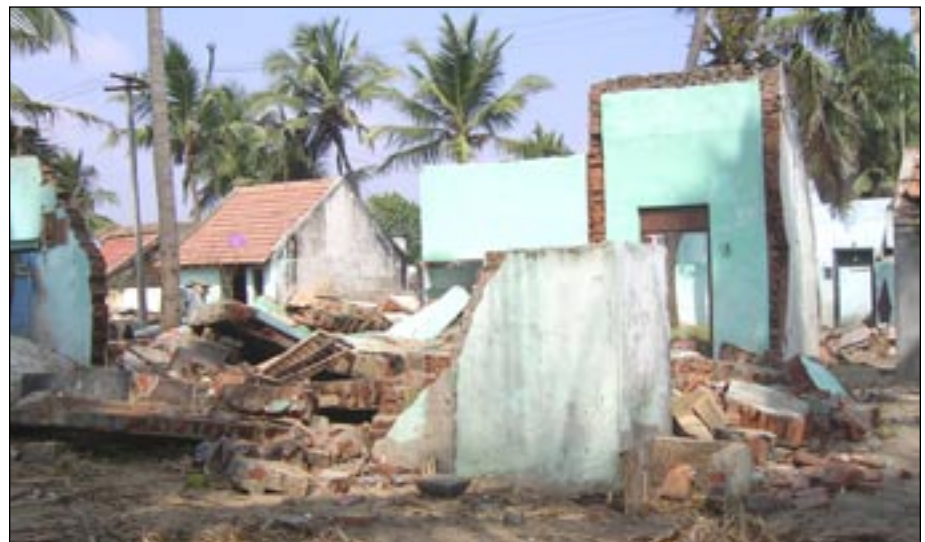
Figure 14. Houses destroyed by the waves at Nagapattinam in Tamil Nadu (photo: Alpa R. Sheth).

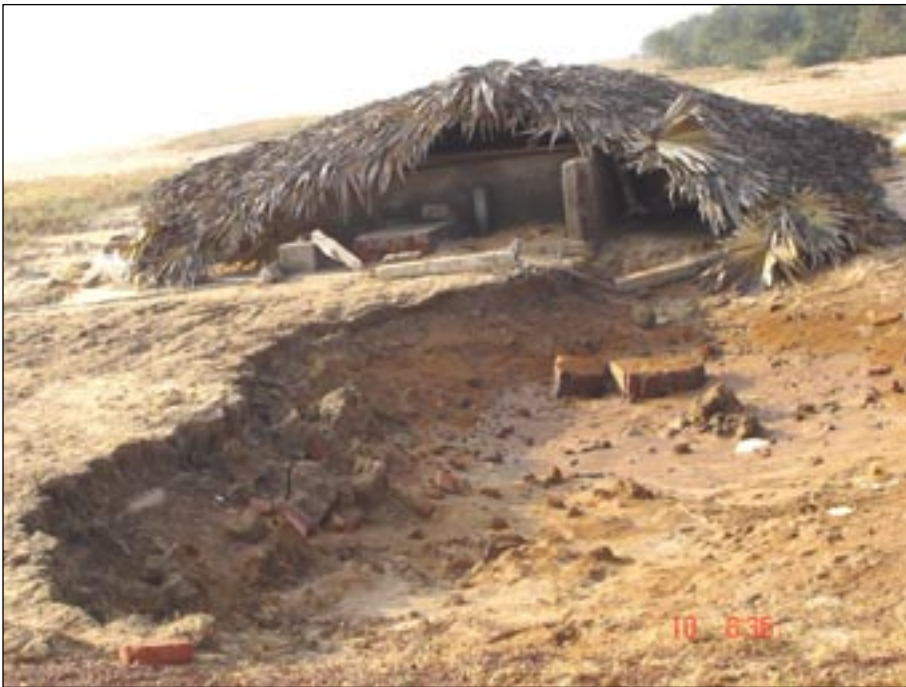
Figure 15. Mud house with thatch roof built within 100 meters of the sea at Pakala Beach in Andhra Pradesh (photo: Arvind Jaiswal).

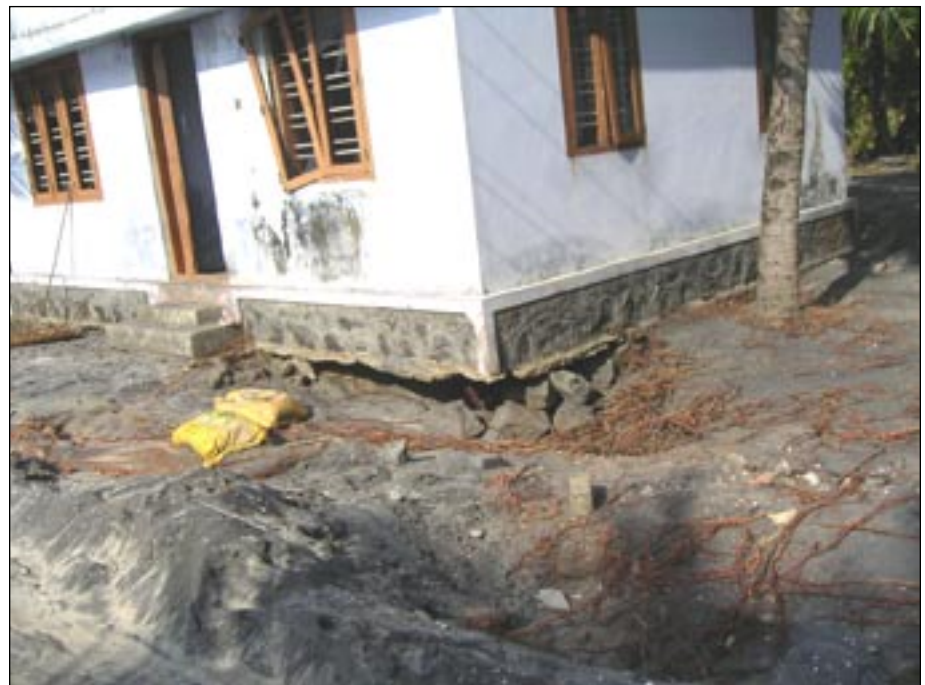
Figure 16. Scouring action at the base of houses due to returning wave of the tsunami in Kollam district in Kerala (photo: Alpa R. Sheth).

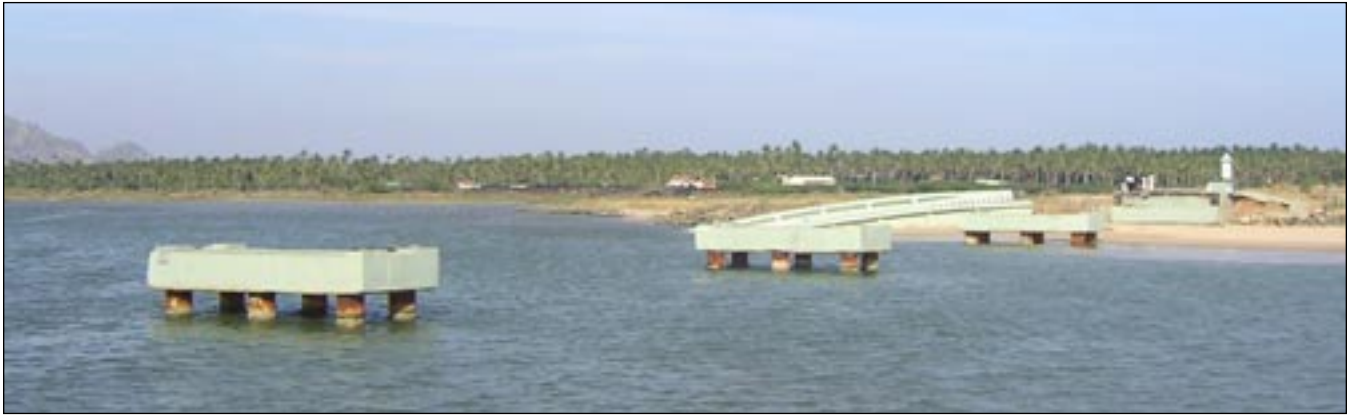
Bridges and culverts were affected. At least three bridges were damaged, with one of them losing all four spans (Figure 17). Roads suffered significant scouring at numerous places along the coast, as did railway lines. Road embankments were eroded. Compound walls

Figure 17. Complete loss of spans of the four span RC bridge at Melmannakudi in Tamil Nadu (photo: Alpa R. Sheth).
