### Damage to Housing

### Damage to Reinforced Concrete Buildings

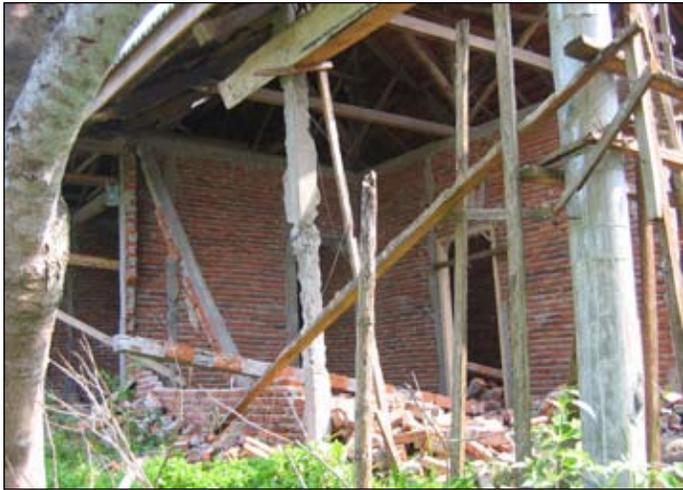
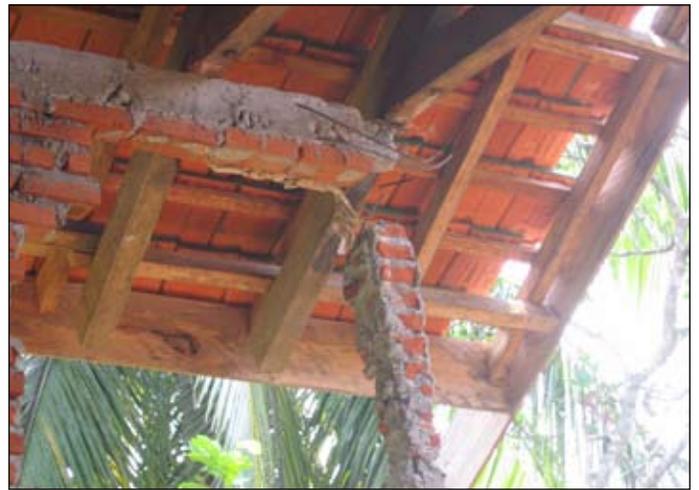
**Figure 3.** Confined masonry houses with failure in masonry walls and connections between tie columns and bond beams, Kec. Airnapal (North Bengkulu).

Figure 3 illustrates the importance of connections between confining elements. Note that the reinforced concrete columns and beams, despite their insufficient and inconsistent section and use of small diameter bars and stirrups or ties at large spacing, remain largely intact, with failure occurring in the masonry wall and at the connection between tie column and bond beam.

- (2) Poor quality workmanship in the masonry wall. Figure 3 also illustrates the importance of good quality masonry; in this case, partial collapse was initiated in the walls.
- (3) Lack of sufficient stiffness in the in-plane direction of the front wall. A common architectural preference in Indonesia is to have many large openings at the front of the house. This lack of stiffness in the in-plane direction contributed to several partial collapses (Figures 4 and 5).
- (4) Insufficient connections between tie columns and masonry walls.
- (5) Tall, slender wall prone to out-of-plane failure. With plaster, the common wall is only 13 cm thick, and walls tend to be 3 m in height. In the case shown in Figure 6, the wall was over 3.5 m tall with a

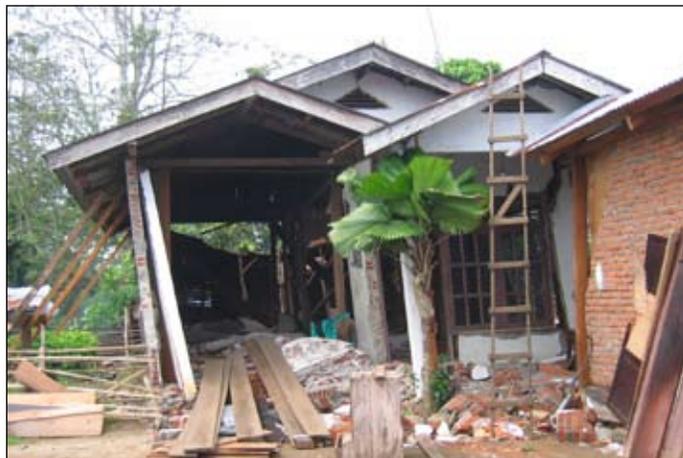
**Figure 4.** Partially collapsed unreinforced masonry house with timber bond beam (North Bengkulu).

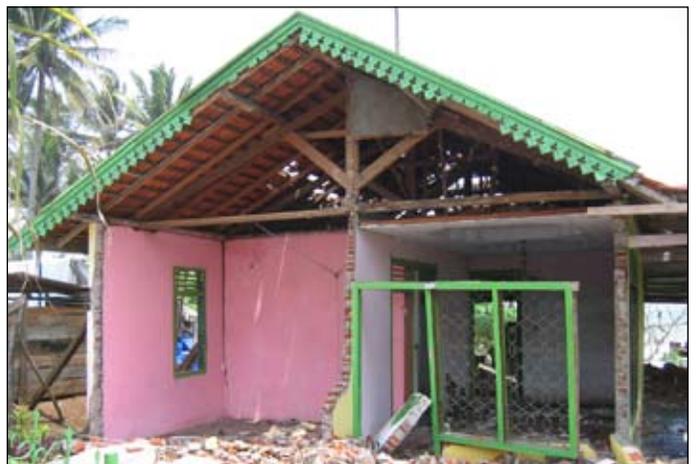
**Figure 5.** Partially collapsed brick masonry house with RC tie columns and timber bond beams. Note partial collapse of masonry gable wall and lack of inplane stiffness in front wall, Kec. Lais (North Bengkulu), S3.53217° E102.03771°.

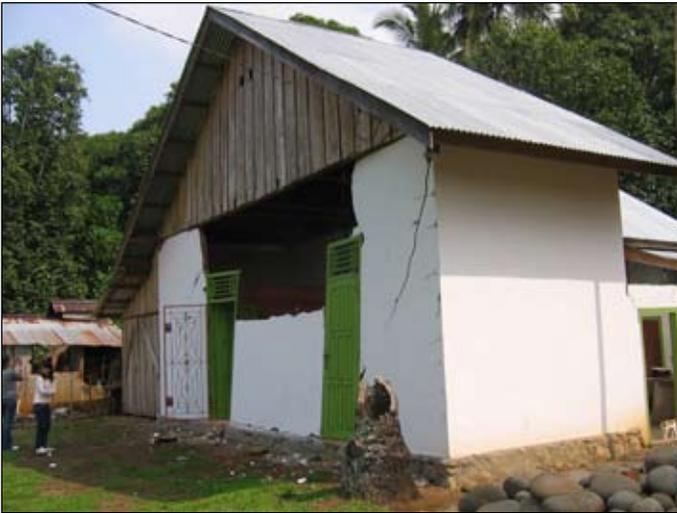
**Figure 6.** Confined masonry house with failure in masonry walls and connections between tie columns and bond beams, Kec. Airnapal (North Bengkulu).

span over 5 m without interior crosswalls or bracing.

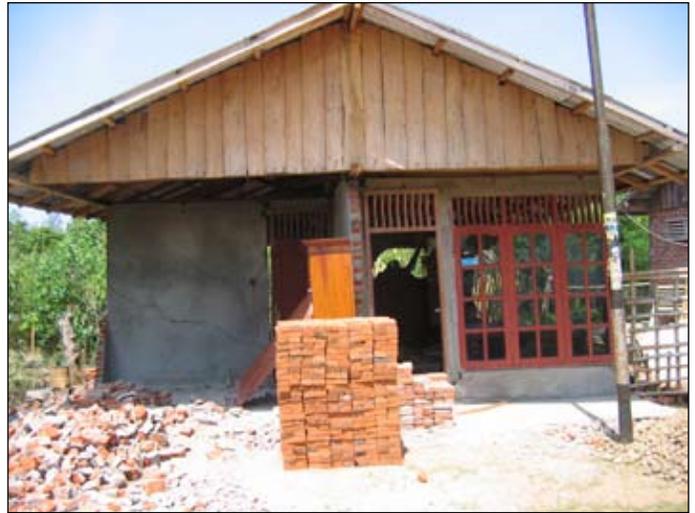
**Figure 7.** Partially collapsed unreinforced masonry house with timber bond beam, Lempuing (Bengkulu), S3.82799° E102.28473°.

- (6) Use of timber for bond beams. Common practice is to use reinforced concrete for tie columns and timber for the bond beams. This construction practice was not sufficient to prevent collapse of walls of some houses (Figure 7).

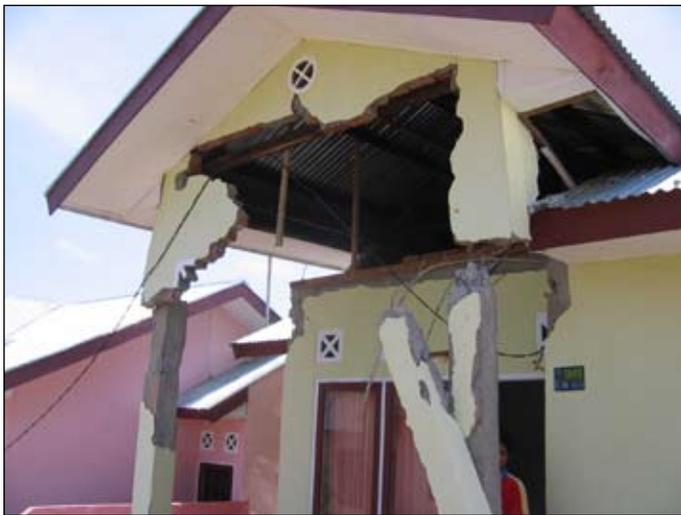
Damage was common at the upper column-beam connection in the open frame supporting the gable wall above the covered terrace (Figure 8). The gable wall and the side walls collapsed completely in several cases. The most significantly damaged structure was the only one that was not yet plastered (Figure 9); in Indonesia, cement-based plaster adds significant strength to the masonry wall. It is

**Figure 8.** Subdivision of confined masonry houses, damage to covered terrace, Bengkulu, S3.83218° E102.29287°.

likely that some houses were more damaged than others because of 1) variations in construction quality and workmanship, and 2) location on the hillslope. These failures should be studied for the purpose of improving guidelines for new confined masonry construction. The causes of these failures, particularly workmanship and poor connections, should be emphasized in the guidelines.

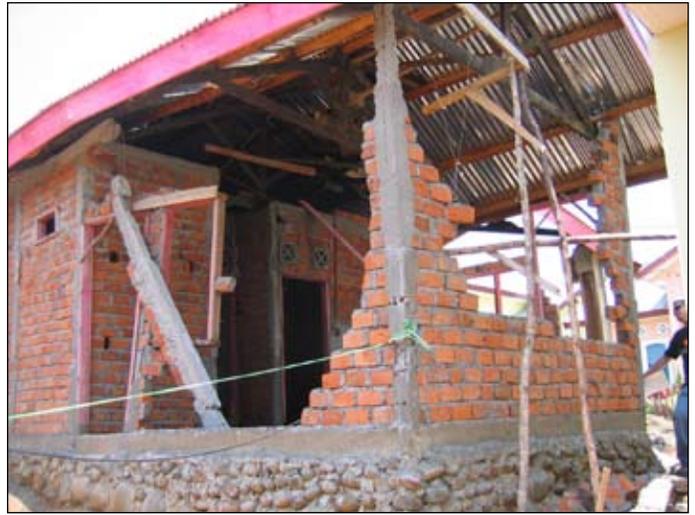
**Figure 9.** Subdivision of confined masonry houses, collapse of masonry wall exacerbated by insufficient connections, Bengkulu, S3.83218° E102.29287°.

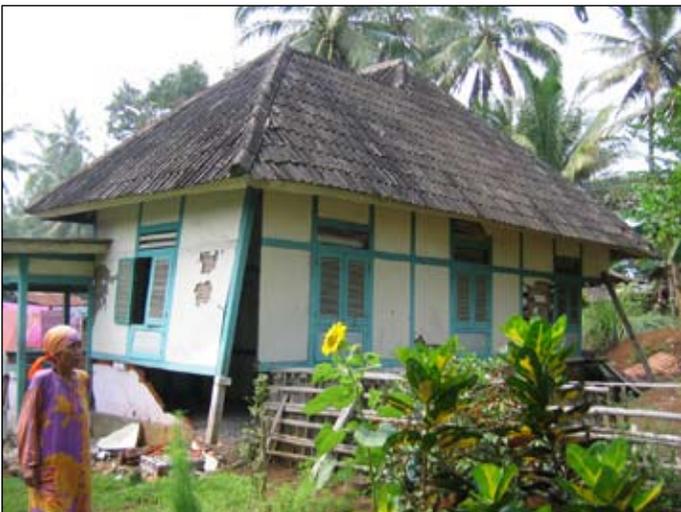
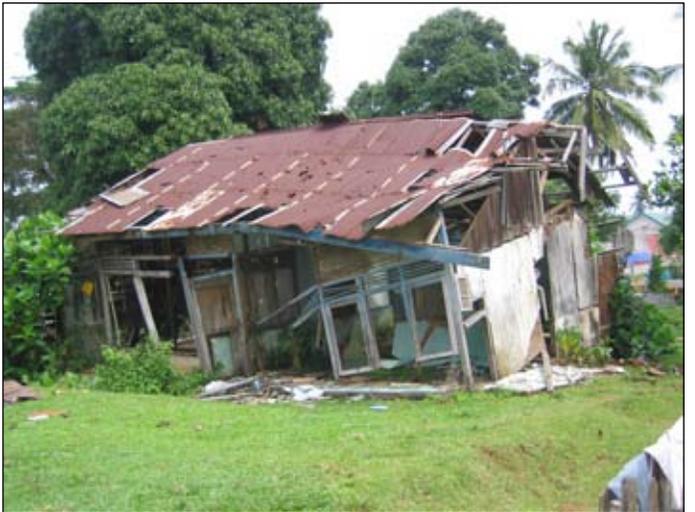
base of the wall performed well in the earthquake. Like confined masonry, this type of house is supported by a shallow stone masonry strip footing; however, there is rarely any connection between the timber posts and the footing, or the timber posts and the masonry panel. The damage to these structures, considered “semi-permanent” in Indonesia, consisted of cracking of the masonry panel, failure of the masonry panel as a rigid block, and shifting and damage to the timber frame (Figure 10).

**Figure 10.** Timber frames with masonry skirt, Kec. Lais (North Bengkulu). Left: Superstructure has shifted off, although the relatively heavy roof structure remains largely intact, and the masonry panel is partially collapsed, Kota Agung, S3.55841° E102.08951°.

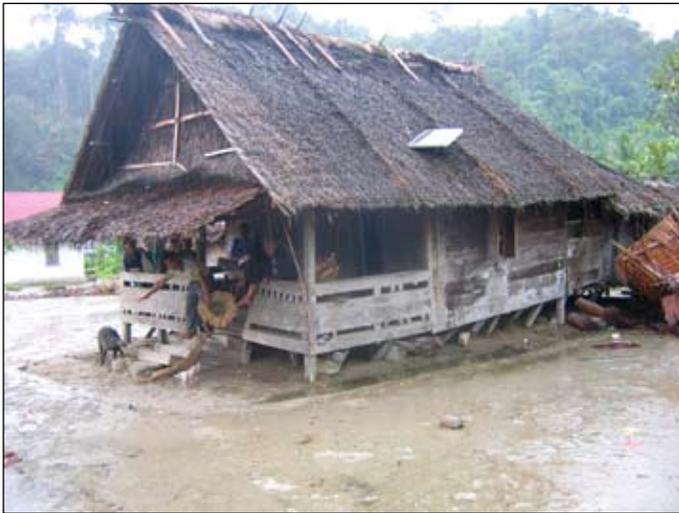
**Figure 11.** Timber frame with posts resting directly on soft ground, Barimanua, Pulau Sipora, Mentawai Islands.

Damage to the timber houses resulted from a few causes. First, timber posts rest directly on the ground, which caused the posts to sink in the ground at soft soil sites

and sites inundated by tsunami; this foundation system is vulnerable to weathering of the timber due to the lack of isolation from water uptake from the ground (Figure 11). Some houses with a stone or concrete stub foundation slid off the foundation. Superstructures lack bracing in the in-plane direction, and members are connected with nails only. Timber is not maintained or treated; newer houses with treated or painted timber performed better than those with older, weathered timber.

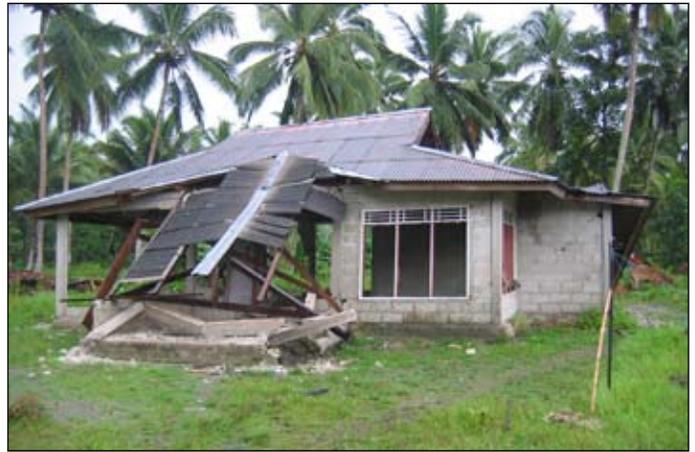
**Figure 12.** Confined concrete block masonry, partial collapse due to lack of sufficient connections between confining elements, Barimanua, Pulau Sipora, Mentawai Islands.

mainland, including lack of sufficient connections between confining elements, and poor quality block masonry (Figure 12). Most concrete blocks are cellular. There was a wide variation in the strength of the blocks used, some of them crushing easily under hand pressure. This lack of strength results from low cement content, use of beach sand, and production by hand (without mechanical vibration).

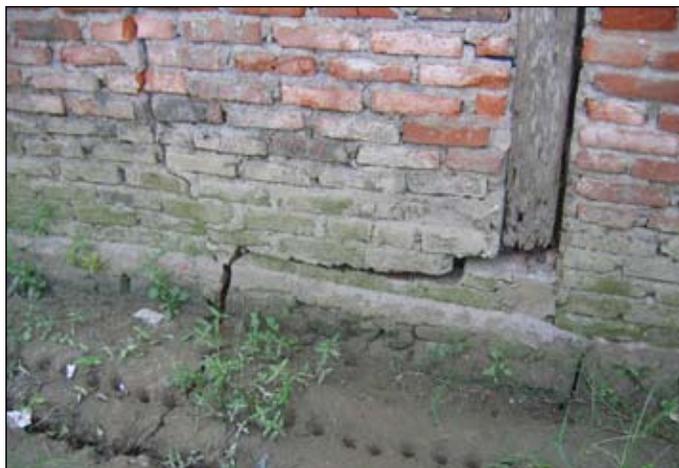
**Liquefaction effects on houses:** Effects of liquefaction, in the form of differential settlement and foundation cracking (Figure 13), vertical cracks in masonry walls, heave and cracking of interior floors, and reports of water and sand coming up

**Figure 13.** Cracks in foundation and walls associated with settlement and tilt on liquefiable soils, Lempuing (Bengkulu), S3.82799° E102.28473°

through the cracks in the floors, were found in at least six houses in Lempuing, a village on the edge of Bengkulu city. This low-elevation site consists of clean, fine to medium sand near the surface, on top of high groundwater. Floor slabs generally consist of thin (5-10 cm) unreinforced concrete.

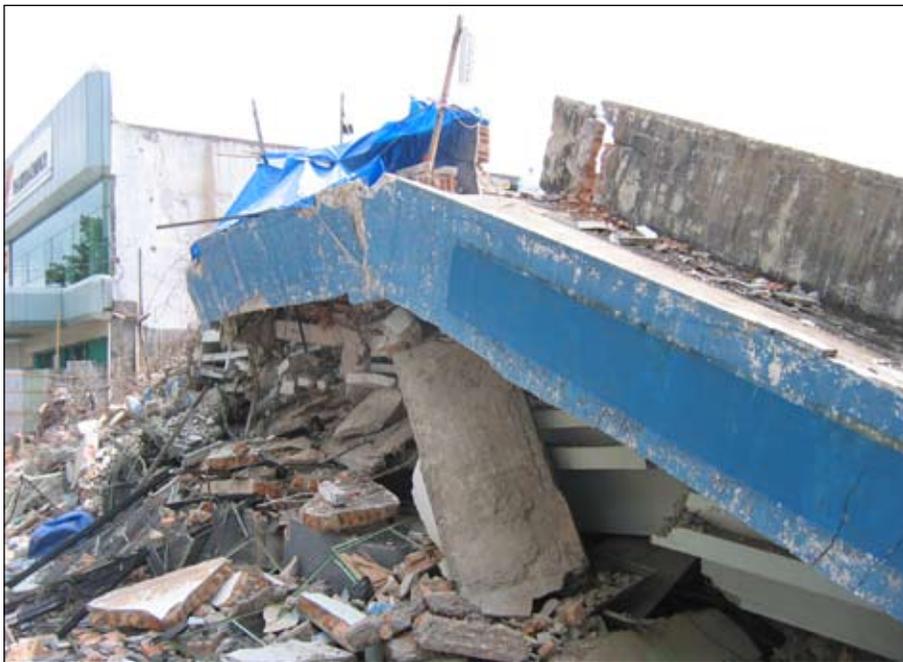
**Figure 15.** Hyundai Shop, Padang.

steel frame structures are under construction in Padang. In the cities, many multistory RC frame with masonry infill buildings had cracks; however, little structural damage was observed. In Padang, two buildings collapsed completely, both RC frame buildings with RC slab roof and floors. One of them, the Hyundai shop, is shown in Figure 15.

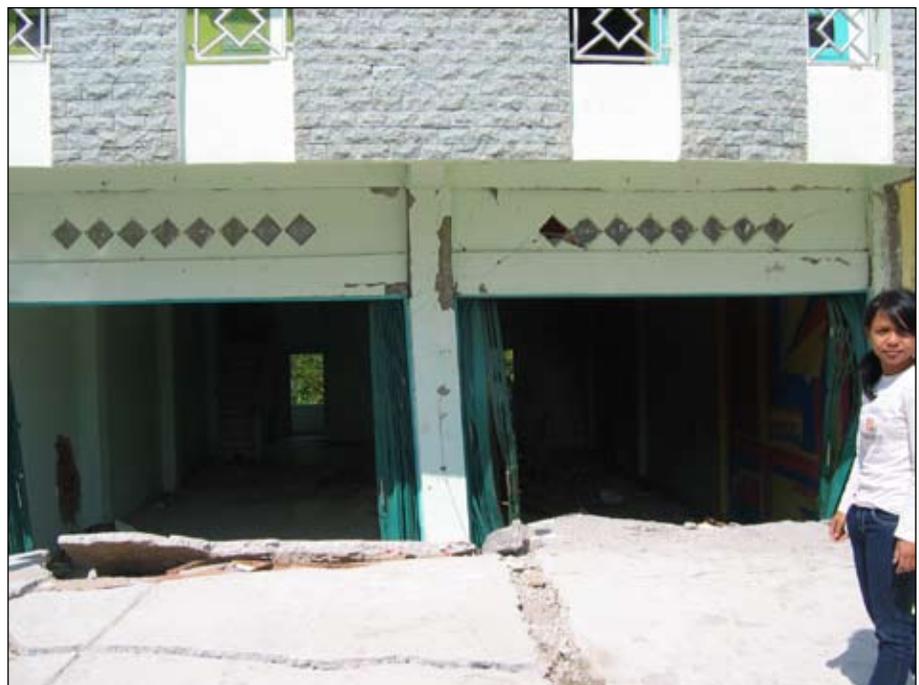
**Figure 16.** Two-story ruko, 3° tilt in first floor column, Bengkulu, S3.80362° E102.27617°.

The ground floor of the five-bay, two-story ruko shown in Figure 16 dropped by approximately 1 m due to failure at the column-slab interface. The structure is tilting back by approximately 4°, and the first floor columns are leaning to the left at 3°. Ribbed, 14 mm diameter steel was used in the columns and beams, with ties of 6 mm diameter spaced at 4 cm near the joint. Similar failure at the column-ground floor-beam interface occurred at a three-story, two-bay ruko (Figure 17). In this case, the failure was clearly exacerbated by slope failure towards the building. The columns were 32 cm x 32 cm and used up to eight smooth 15 mm diameter longitudinal bars.

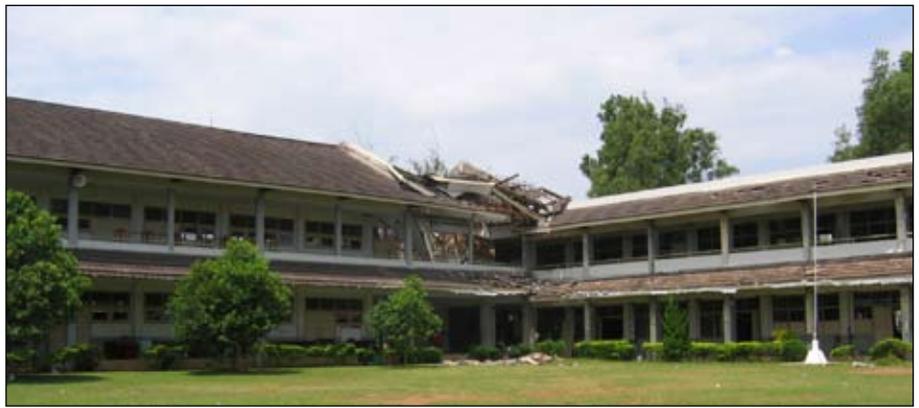
**Figure 18.** SMAK SNT Carolus School, pre-2000 earthquake building on right, post-2000 earthquake building on left, Bengkulu, S3.82846° E102.29587°.

ings, one of which was a new building constructed after the previous building collapsed in an earthquake in 2000. The other building was repaired after the 2000 earthquake. Only hairline cracks were found at the edges of masonry infill walls in the new building; however, the timber truss roof collapsed where it was joined to or battered by the older building (Figure 18). The repaired building had new, hairline cracks in the same pattern as those that were plastered and painted after the last earthquake. The tops of the first floor columns were

also cracked. It appeared that they had been previously repaired by a sealant or adhesive. Some masonry interior walls were partially collapsed.

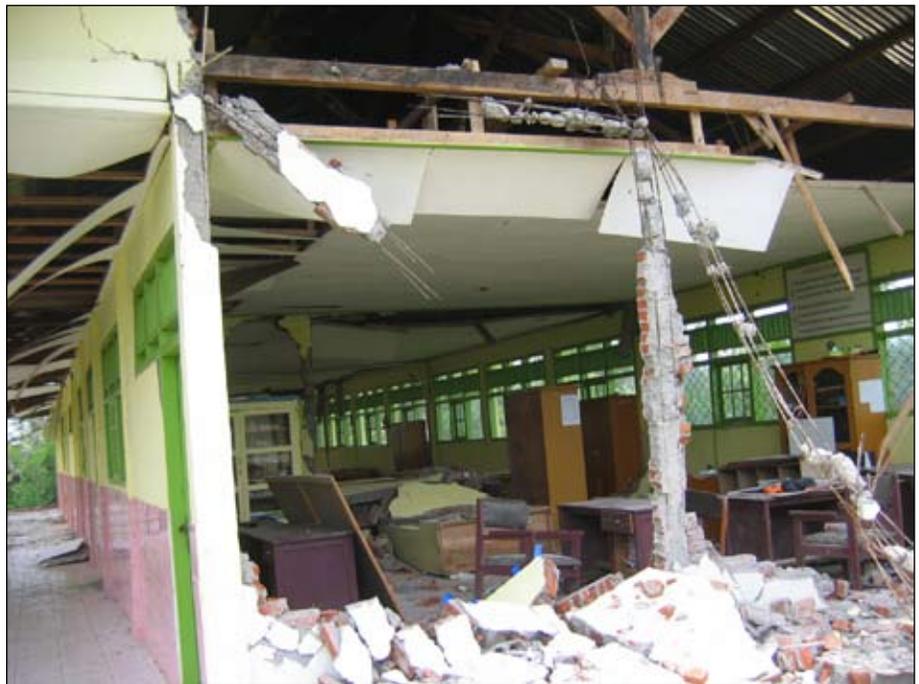
Confined masonry interior and end walls collapsed at a rural single-story school complex in Lais Sub-district (Figure 19), leaving the long walls standing and supported against out-of-plane failure primarily through column steel tied around the roof trusses. Without strong-motion recordings, it is difficult to

**Figure 19.** Sekolah Dasar Negeri No. 04, note steel splice location, use of rounded cobbles in concrete, Kec. Lais (Bengkulu), S3.52958° E102.04525°.

say how much directionality contributed to the end and interior wall collapses. The ring beams were not capable of spanning these wide classrooms. Ring beams were approximately 15 cm x 11 cm in section and used four 8 mm diameter longitudinal bars, with 4-5 mm diameter stirrups spaced at distances of 20-30 cm. Similar to the problems observed for confined masonry houses, connections between tie columns and bond beams were insufficient. Coarse gravel to cobble-size aggregate was used

in the concrete, which was broken easily by hand pressure.

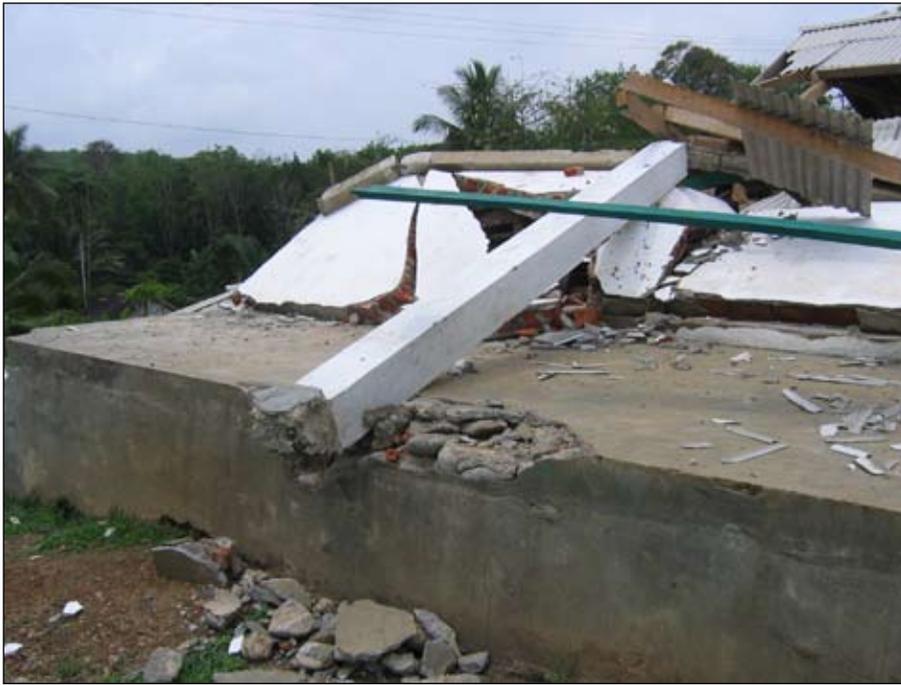
**Figure 20.** Collapsed confined masonry building, note lack of plinth beam and connection between column and plinth, Pal 30, Kec. Lais, (North Bengkulu), S3.53490° E102.05996°.

A second school compound with significant damage in Lais Subdistrict consisted of two buildings. A single-story confined masonry building collapsed (Figure 20). The plinth was built of rounded river stone masonry, without a plinth beam for the columns to tie into. Failure at these and the upper column-beam joints likely led to collapse. The columns themselves appeared to be largely intact. A newer single-story building, rectangular in

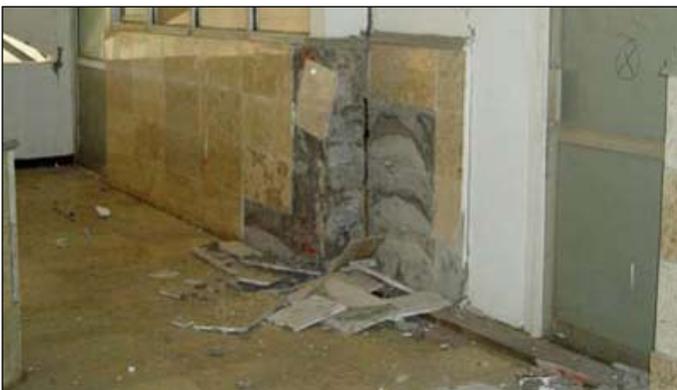
**Hospitals:** Nonstructural damage to hospital buildings in Bengkulu and Padang resulted in cracked masonry in fill walls, chipped plaster, and dust (Figure 21); patients were evacuated to tents (Figure 22). The M. Yunus hospital in Bengkulu was not operational right after the earthquake due to repair work needed. The building code considers masonry infill walls to be nonstructural elements, which has important implications for critical facilities that need to remain operational after earthquakes.

**Figure 21.** Nonstructural damage at M. Yunus hospital in Bengkulu (photo: Boen).
