Learning from Earthquakes

Preliminary Observations on the Bam, Iran, Earthquake of December 26, 2003

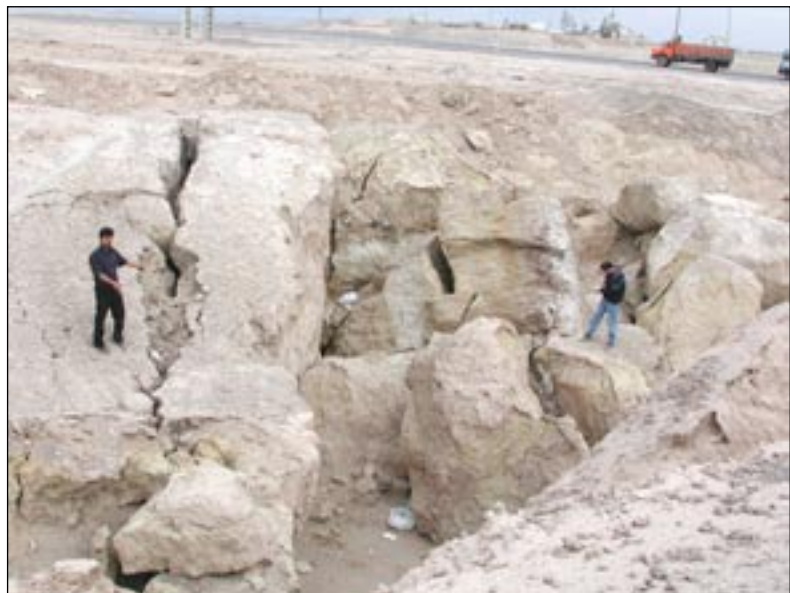
Landslides: The area is generally flat, and there are no major man-made earth structures, but there were landslides along riverbanks and man-made channels. A typical riverbank landslide is shown in Figure 6. Large blocks of soils moved and tumbled. Most soil blocks already had tension cracks due to the dry environment. There was no direct damage caused by the landslides, but the soil blocks need to be removed to clear the riverbed for the next seasonal flooding.

Figure 6 A typical landslide along a riverbank.

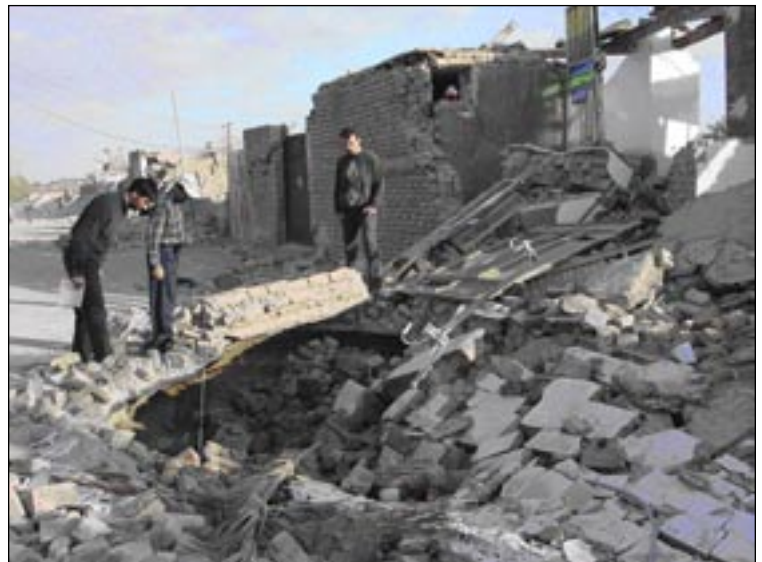
It is estimated that 50% of the water for irrigation around Bam was delivered by 120 qanat systems. About 40% of the qanats were damaged in the earthquake. Visible in the form of sinkholes, the failures were caused by the collapse of the shafts near the ground surface or the tunnel. There are also numerous old qanats in the general area with locations that were unknown at the time of city development. Some of the old qanats failed and caused foundation damage in buildings located close by (see Figure 8). The shafts and qanats need to be repaired and reinforced to prevent extinction of the palm farms, the very livelihood of the city.

Figure 8 Qanat sink-hole that damaged a nearby structure (IIEES 2003).

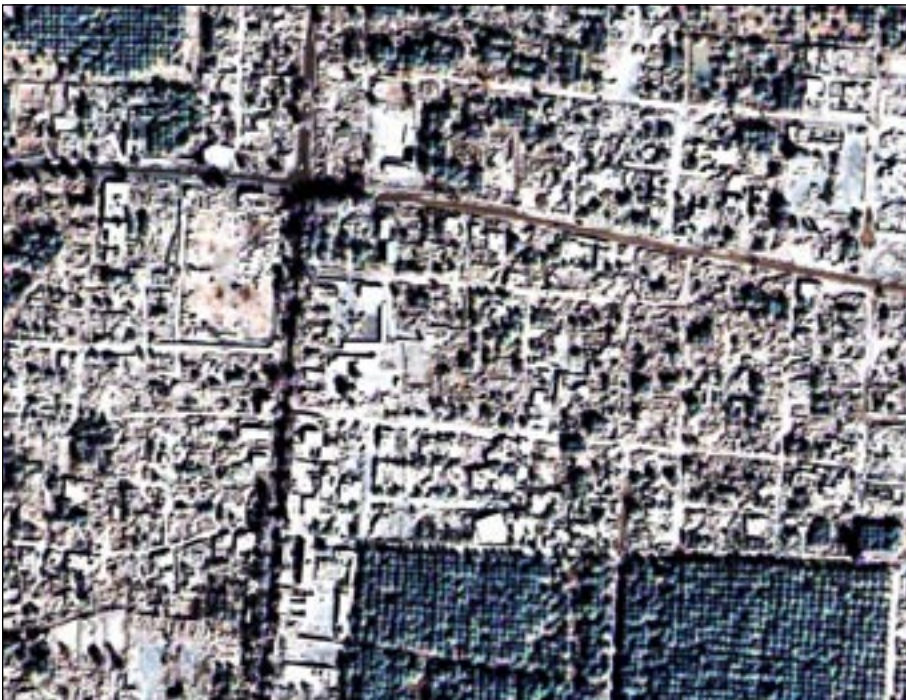
Bam. Satellite photos of a neighborhood in Bam with 80%-100% damage are illustrative. Figure 9 was taken on 9/30/2003 before the earthquake, and Figure 10 was taken on 1/3/2004 after the earthquake.

Figure 10 After-earthquake satellite image of the same neighborhood shown in Figure 9 (imagery courtesy of DigitalGlobe, www.digitalglobe.com).

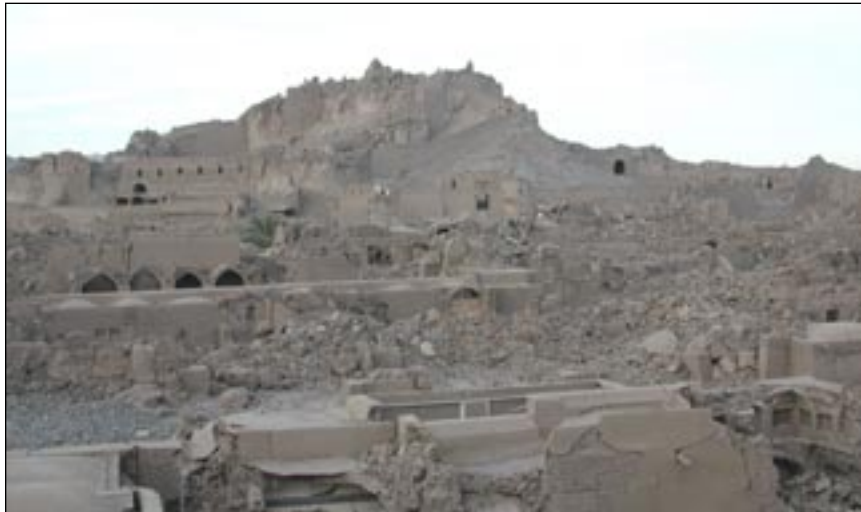
Historic buildings: The historic Arge-Bam Citadel is a complex of one- and two-story buildings surrounded by several tall free-standing walls. Figure 12 shows how it looked before the earthquake. The building's adobe is approximately three feet thick with a layer of straw-reinforced mud cover for rain protection. The free-standing walls are thicker, but have the same construction as the building walls. The roofs consist of domes and cylindrical arches constructed of adobe. These structures have little resistance to earthquake motion so the quake caused widespread and significant collapse of the citadel (Figure 13).

Figure 13 View of damage to the Arge-Bam historical citadel.

Because of the historical significance of the citadel, the repair of the structures is under study. The extensive damage suggests that repair decisions should consider

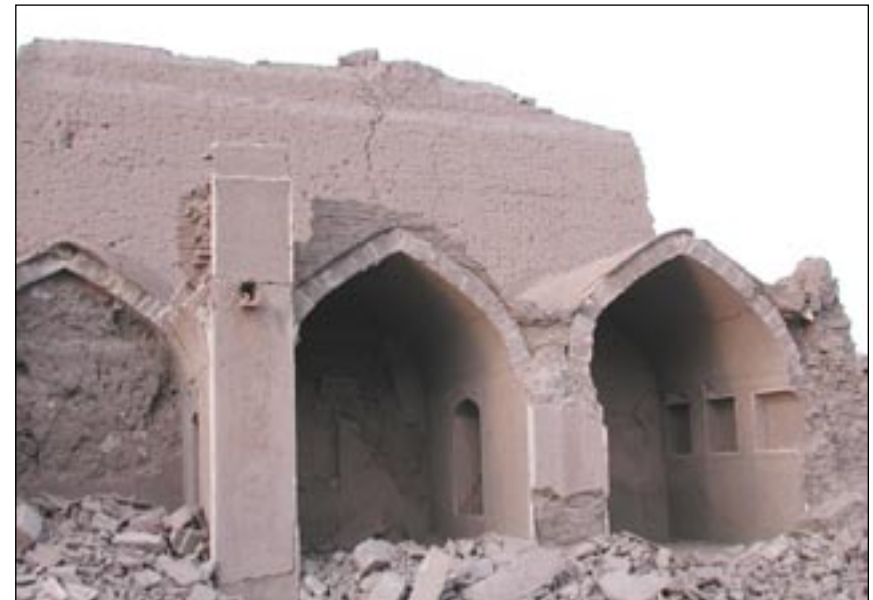
Approximately 80% of the buildings experienced total collapse. The collapse pattern in various buildings indicates that the failure initiated in load-bearing walls was followed by roof collapse (Figure 14). There appeared to be no difference in per-

Figure 14 Out-of-plane collapse of adobe walls in Arge-Bam.

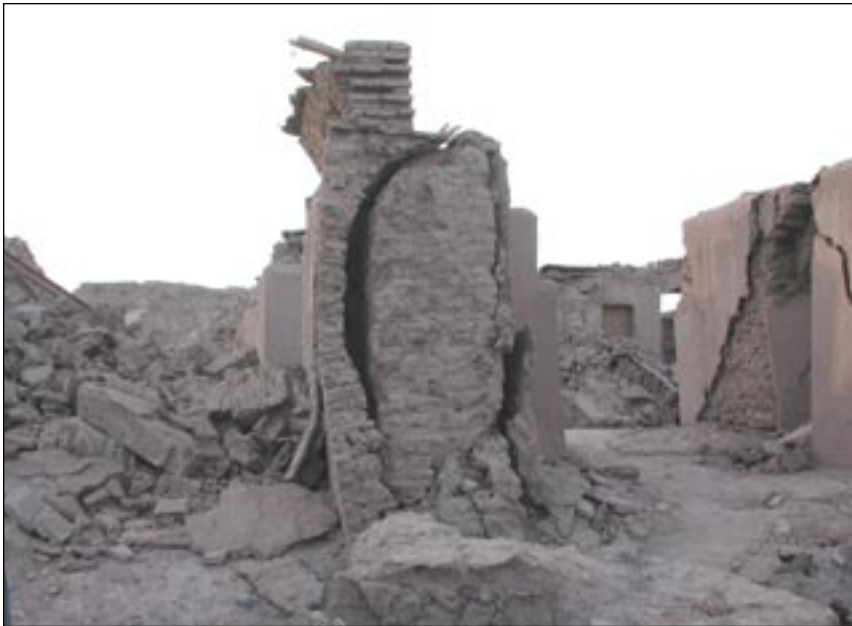
formance of domes as compared to cylindrical roofs. Some collapsed walls revealed repairs that may have been made after previous earthquakes (Figure 15).

Figure 15 Addition of exterior layers to the core adobe walls suggests earlier repair of earthquake damage.

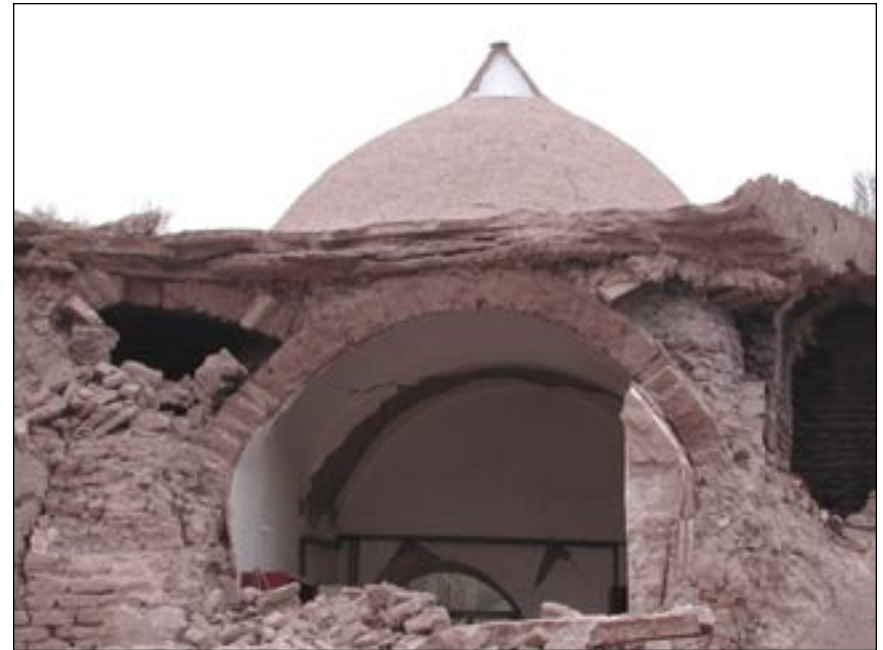
Collapse of these structures was widespread (Figures 16 and 17). Most of the 43,000 lives lost were due to their collapse. The mode of collapse appeared to be out-of-plane failure of walls, resulting in loss of support for the roof.

Figure 16 Failure of large adobe house.

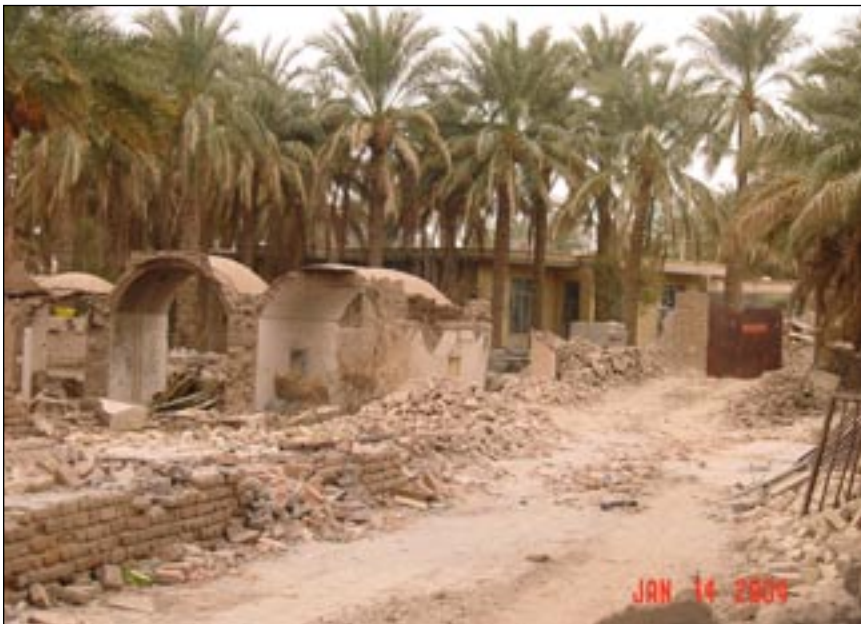
Figure 17 Collapse of smaller adobe house.

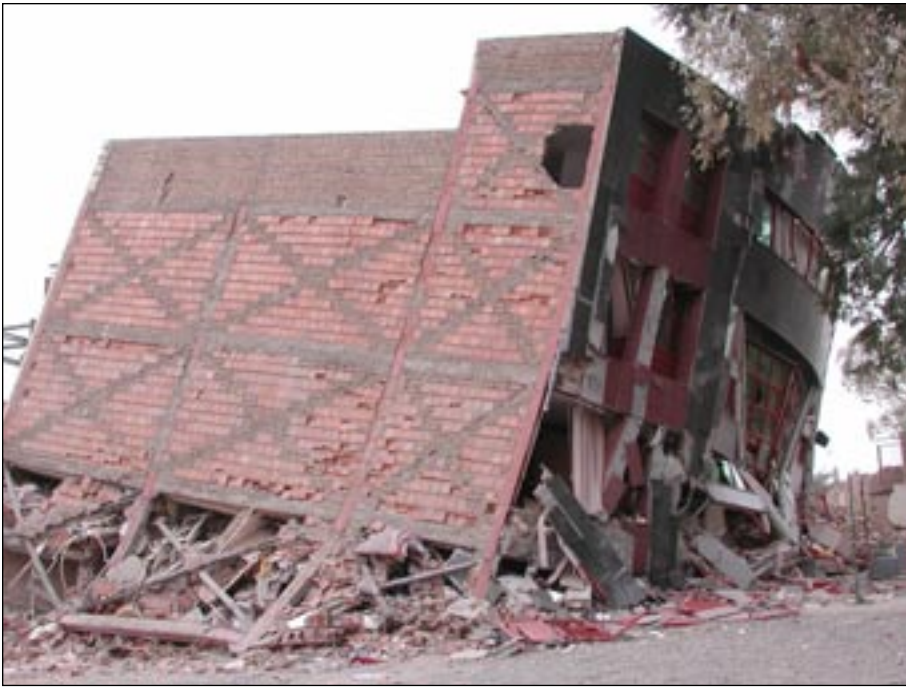
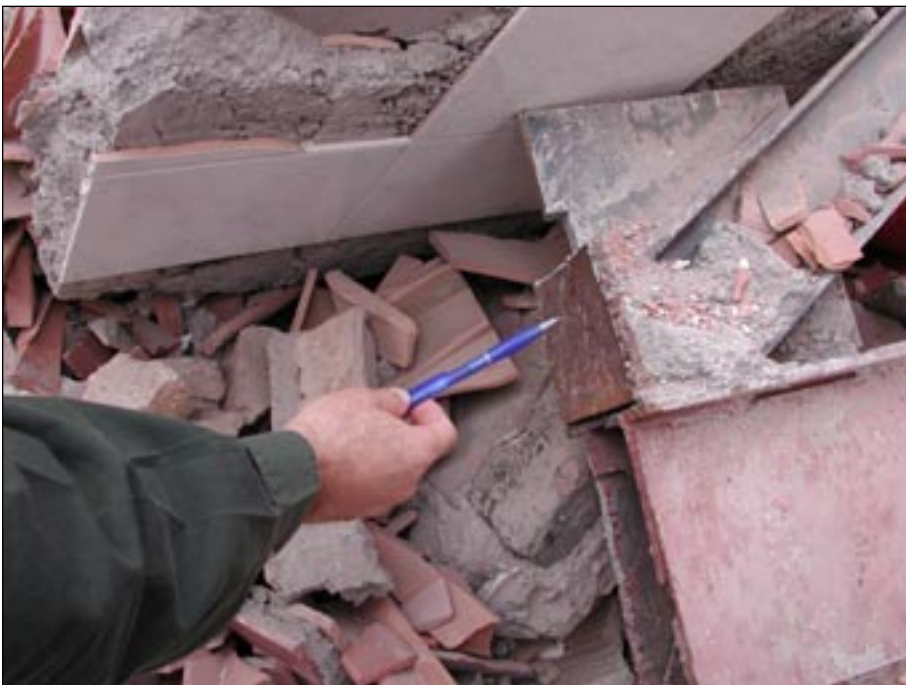
Figure 19 Collapse of steel-framed dual-system building at least partially due to deficient welding practice.

The collapses of low-rise contemporary buildings were primarily due to out-of-plane wall failure leading to floor collapse. In mid-rise construction with braced frames, collapses resulted from bad construction practices or lack of quality control, including improper welding (Figure 19) or nonengineered bracing schemes.

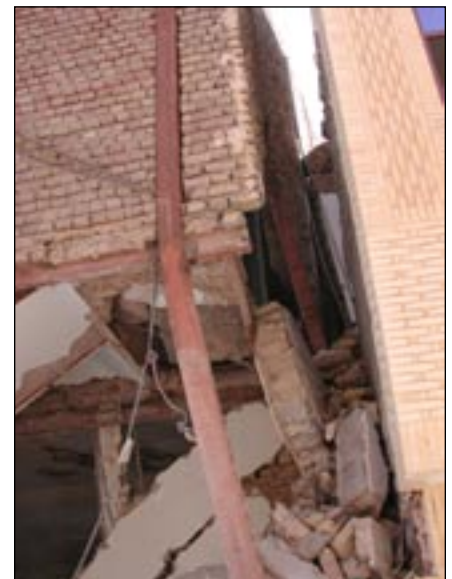
Weak-story collapse mechanism was also observed repeatedly (Figure 20). Infill walls reinforced with steel angles framing around windows seemed to perform well.

Figure 20 Typical weak-story collapse.

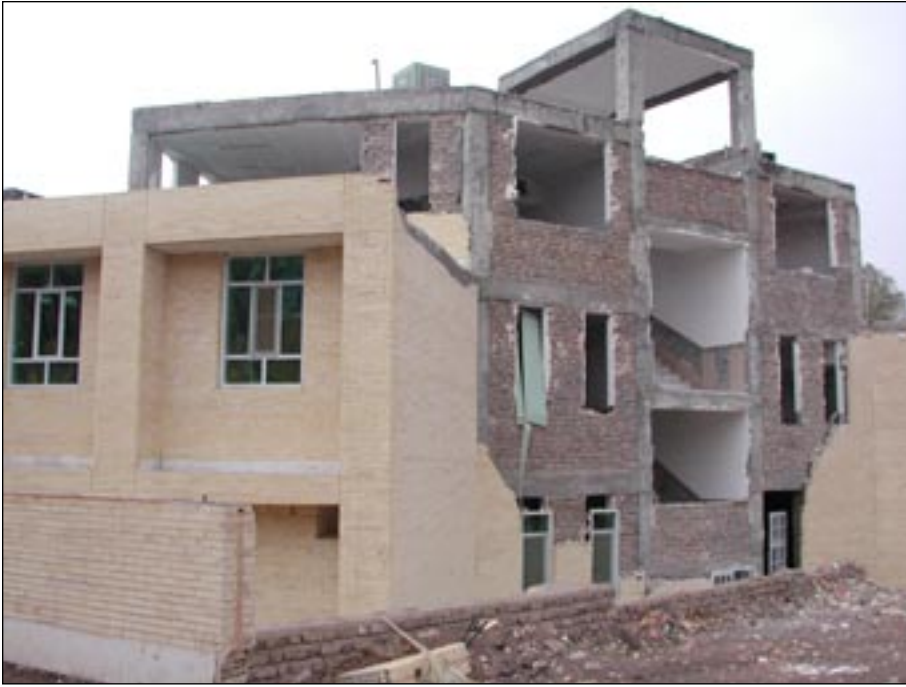
Essential buildings: The two major hospitals in the city experienced significant structural damage and/or partial collapse (Figure 21). The construction of these facilities is similar to the contemporary buildings discussed above, although some quality control may have been observed. Again, out-of-plane failure of unreinforced brick walls was a predominant behavior.

Figure 21 Substantial damage to a hospital building.

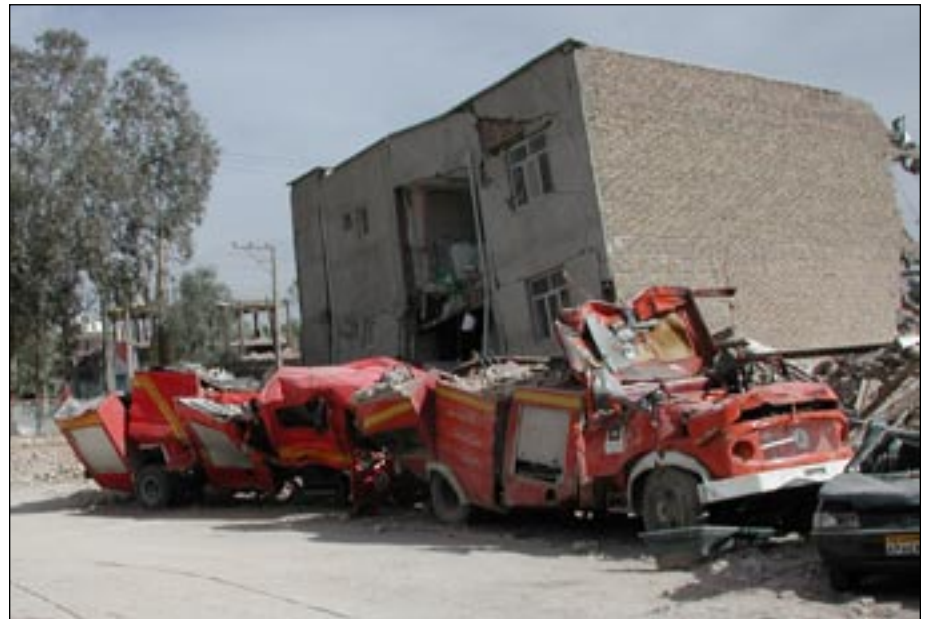
The city fire station had a weak-story collapse that rendered the fire engines useless (Figure 22). Collapse of the one-story bus depot structure crushed city buses (Figure 23).

Figure 22 Fire engines were crushed under the collapsed fire station.

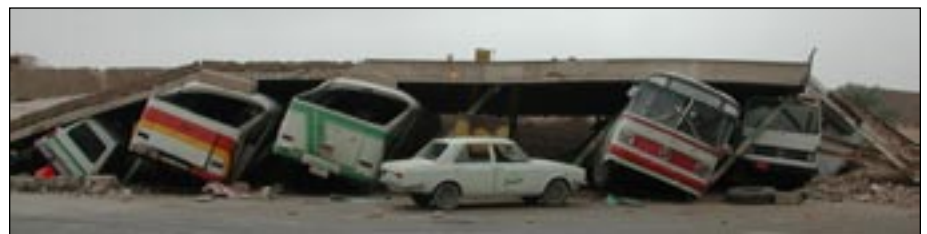
Figure 23 Collapse of the bus terminal roof trapped city buses.
