Learning from Earthquakes

Preliminary Observations on the Niigata-Chuetsu Oki, Japan, Earthquake of July 16, 2007

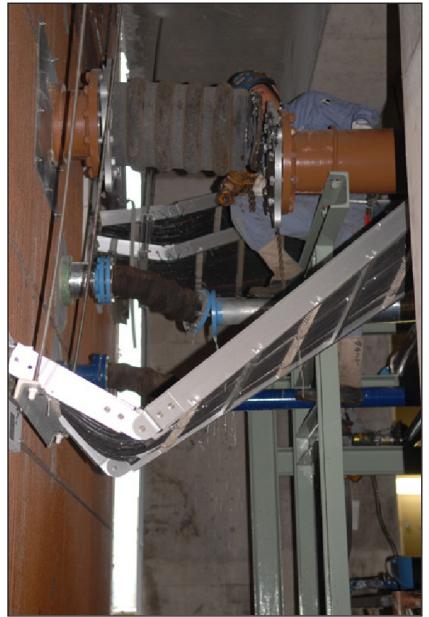
Figure 4: Pipe breaks due to separation of two halves of Kashiwazaki Wastewater Treatment Plant.

Sandy fill deposits used for backfill for the wastewater and stormwater drain network performed poorly throughout the epicentral region, causing hundreds of separated and uplifted manholes that incapacitated the drains and impeded traffic. Ports and harbors suffered only moderate levels of settlement and liquefaction-related lateral spreading.

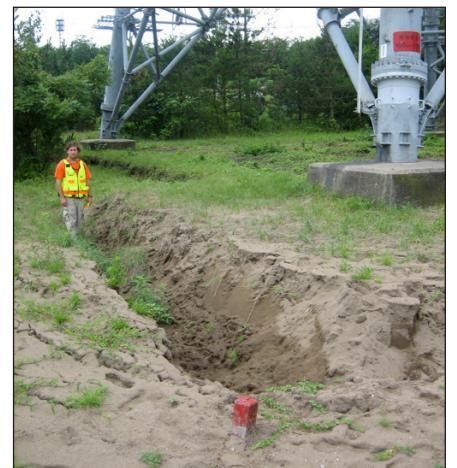
Figure 6: Settlement of ground adjacent to the grade beam between footings of a high voltage transmission line tower (site RK40).

induced settlement was observed around the foundation pile cap of a large high-voltage power transmission tower leading from the nuclear power plant. Though the soil pulled away from the cap, the pile cap and tower had no indication of deformation (Figure 6).

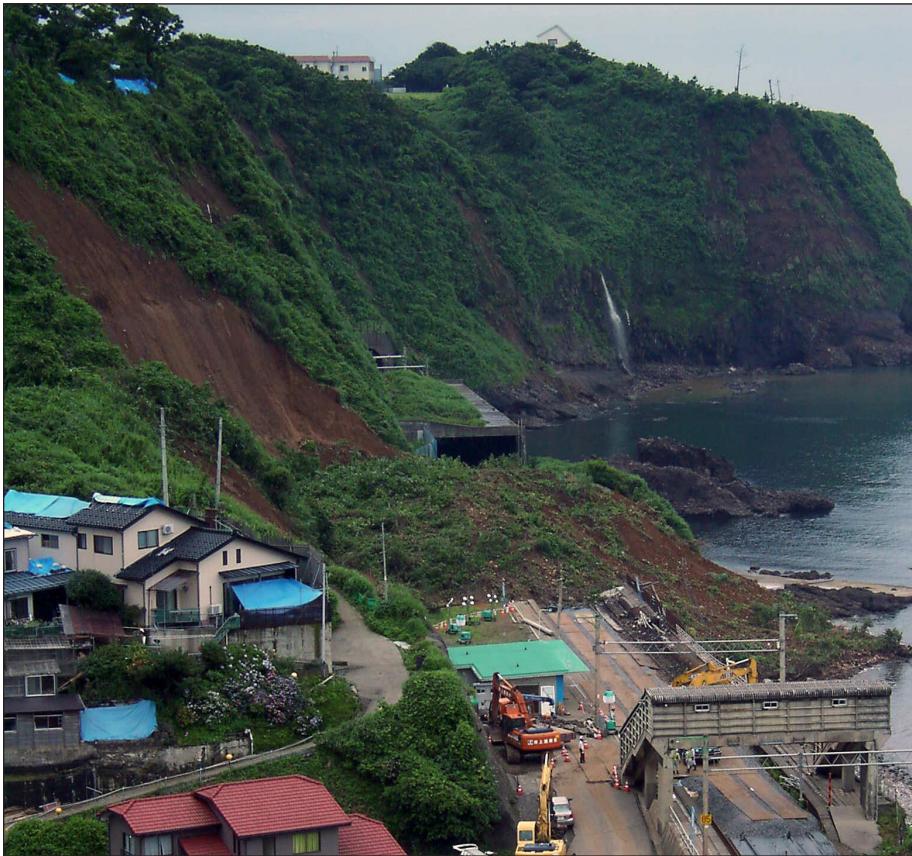
Figure 7: Landslide at the Oumigawa Train Station on the Shin-etsu Line (sites RK20, YT16/SA9).

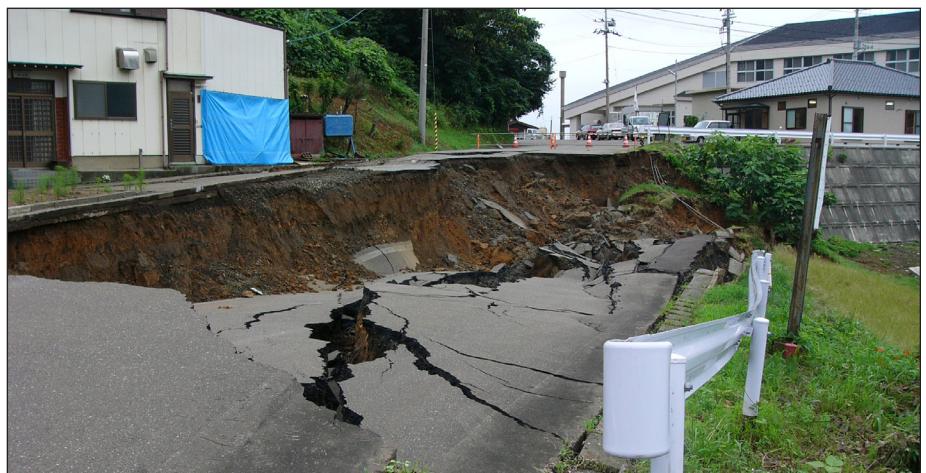
Figure 8: Road embankment failure off Route 8 on the way to Kasashima (site YT18).

Embankment failures were typical in road fills both along the coast, and were also observed at three sites located further inland (Figure 8). Embankments underwent from 10 cm to 1 m of vertical displacement, extending 10-60 m in length. Three embankment failures required full closures of roads or protection with tarps to reduce rainfall infiltration and the associated potential for additional movement. Among these was a 15-m-high, 97.5-m-wide earth-fill dam located to the east of the region, where cracking through the midpoint of the crest was observed. The water level at the time was well below the crest.

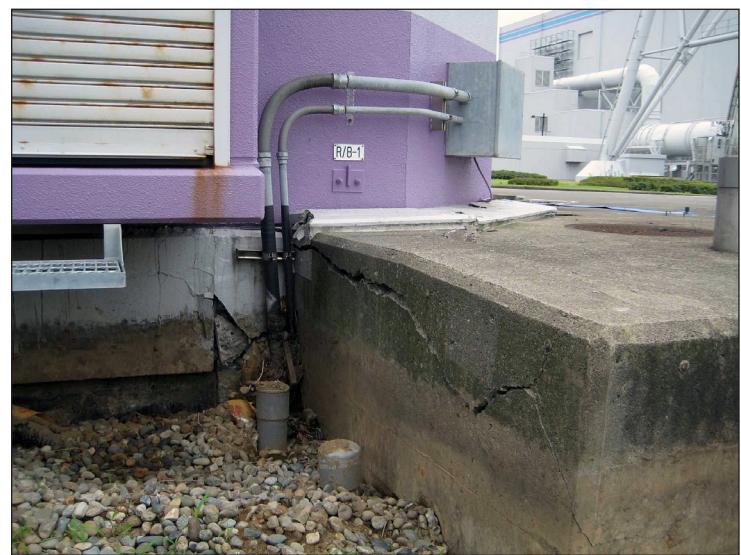
Figure 10: Ground settlement around buildings at the nuclear power plant was a major cause of damage to foundations and footings.

Observed damage was related to problems with foundation soils (Figure 10). Joints of piping resting on isolated footings and expansion joints in covered pathways failed, and underground pipes supplying fire retardant to reactors broke because of the relative movement be-

tween soils and the foundations. In a two-story steel building used for plant administration, drop ceilings fell and windows broke. Access through doors was impaired by ground settlements of up to 40 cm. The plant was closed after the earthquake and is expected to remain closed for months.

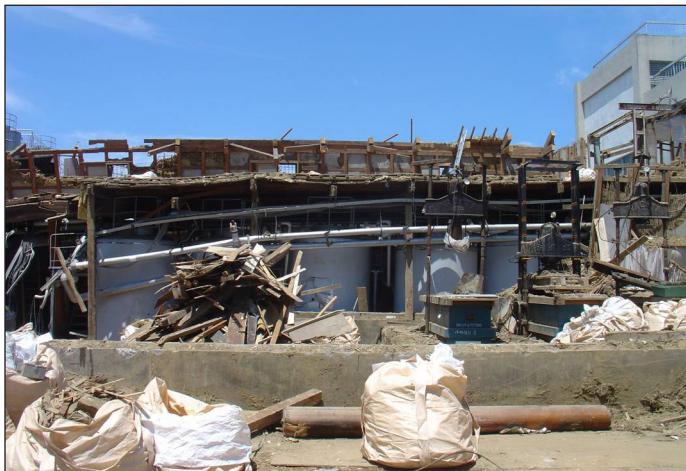
Hara Sake Plant: The Hara Sake Plant, located near the Kashiwazaki Station, consisted of both new structures and older ones (50+ years). Five buildings belonging to the sake plant collapsed, all in the southward direction. All of the collapsed structures were two-story timber structures. Two were used for storage and the other three for manufacturing and operations (Figure 11).

Figure 11. Hara Sake Plant tank storage area. Two-story timber structure collapsed around storage tanks, Kashiwazaki City, Niigata.

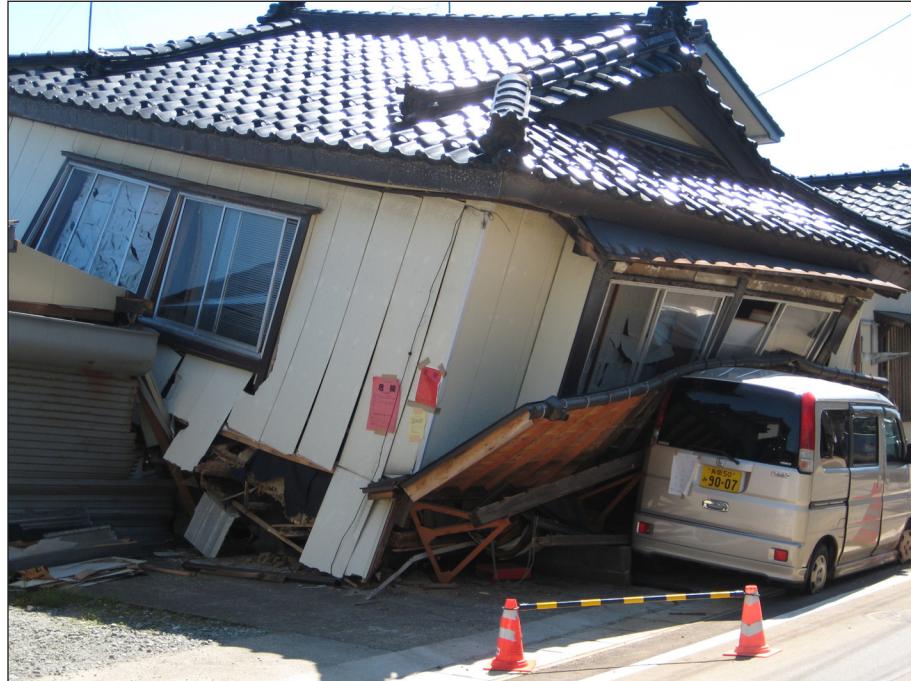
Figure 12: Collapse of house with heavy tile roof.

shaking had at least one of three features: a soft story; heavy clay-tile roofs (Figure 12); or walls constructed from a combination of wood and clay (Figure 13). This traditional Japanese construction technique is commonly known as *tsuchi-kabe* or “soil wall” and consists of tied bamboo framework filled with clay. Many of the houses that had damage associated with ground failure (soil liquefaction, vertical settlement, and dynamic displacements of structures) were built on either reclaimed alluvial sandy deposits or sand dune slopes.

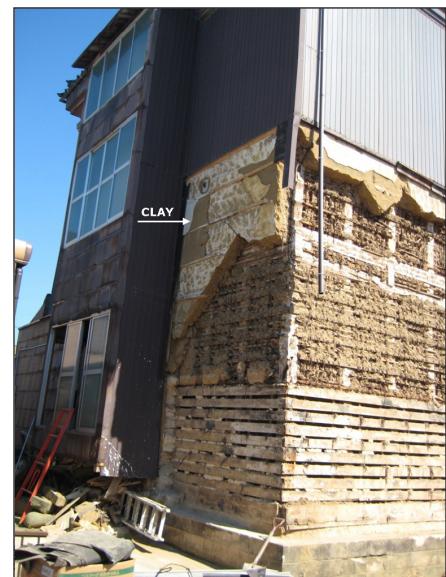
Figure 13: Traditional Japanese tsuchi-kabe ("soil wall") construction technique (site SP13).

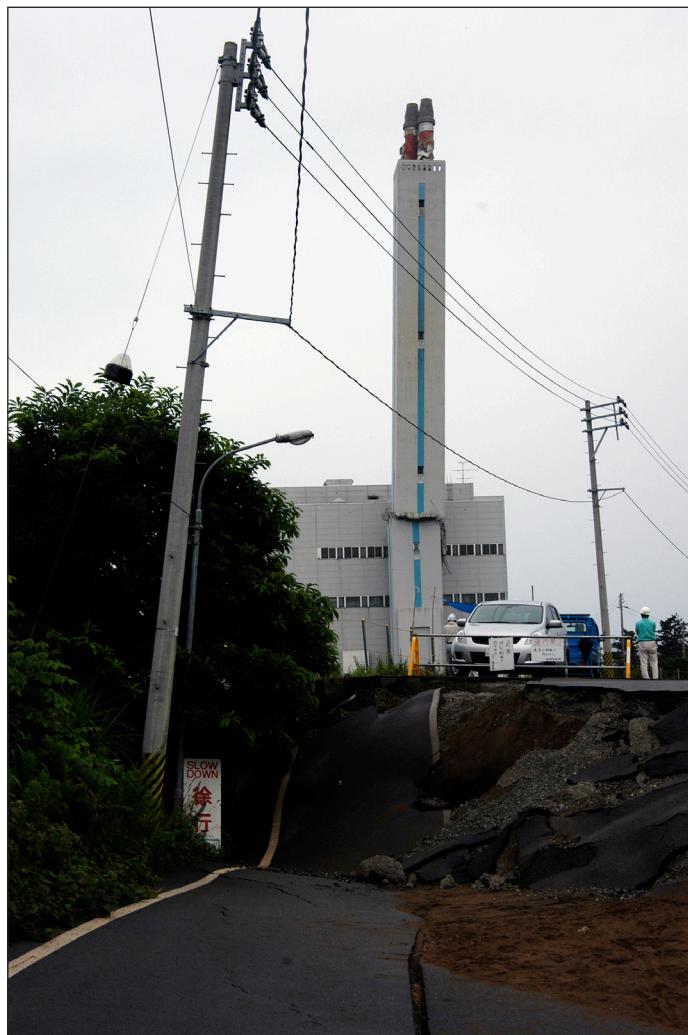
Figure 14: Failure of reinforced concrete stack (site SP31).

Reinforced Concrete Structures: The reinforced concrete stack at the Kashiwazaki Municipal Recycling Plant failed (see Figure 14). The 59-m-tall stack was one of the tallest

reinforced concrete structures in the area. It had a square cross section with 4.6 m sides and walls that varied in thickness from 18 cm at the top to 36.6 cm at the bottom. The failure took place at a height of approximately 17 m, where the longitudinal reinforcing bars were lap spliced (Figure 15). According to the plant manager, this was also the location where rebar quantity was reduced. The failure caused the upper part of the stack to fall 6-7 m. Some transverse reinforcing bars, which also had lap splices, were observed to have ruptured. It has been reported that the stack was designed in accordance with modern design standards, which require lap splices to have a length

equal to 40 times the diameter of the largest bar spliced. Splice failures in similar conditions have been reported to have caused the collapse of a stack during the 1999 Kocaeli, Turkey earthquake (Kilic and Sozen, 2003).

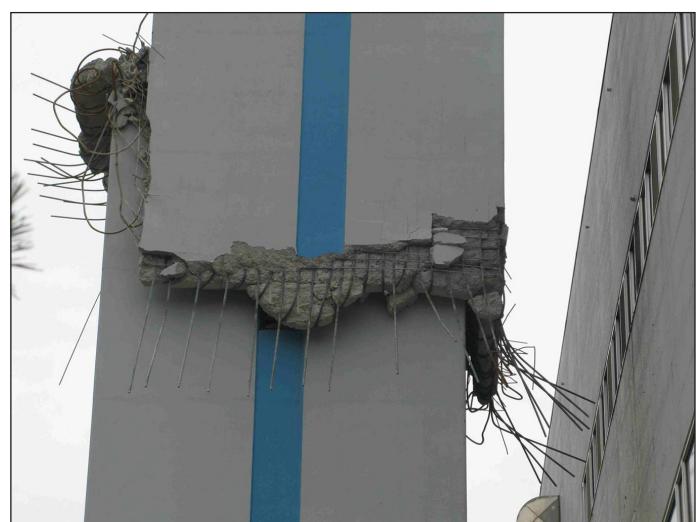
Figure 15: Details of failure of reinforced concrete stack (site SP31).

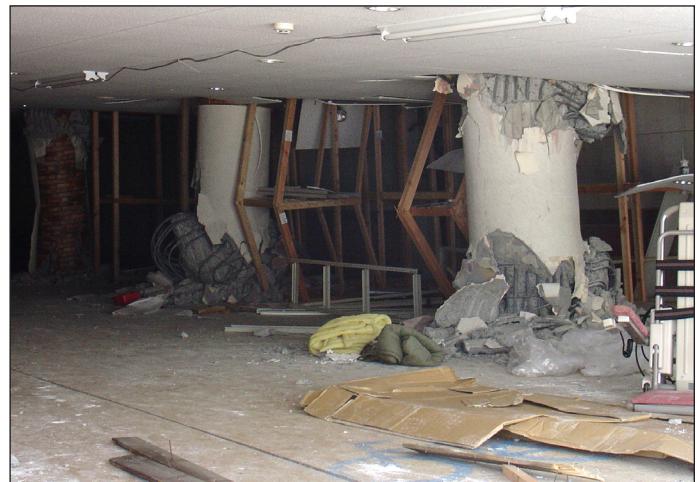
Figure 16: Shear failures of reinforced concrete columns (site NIT-81).

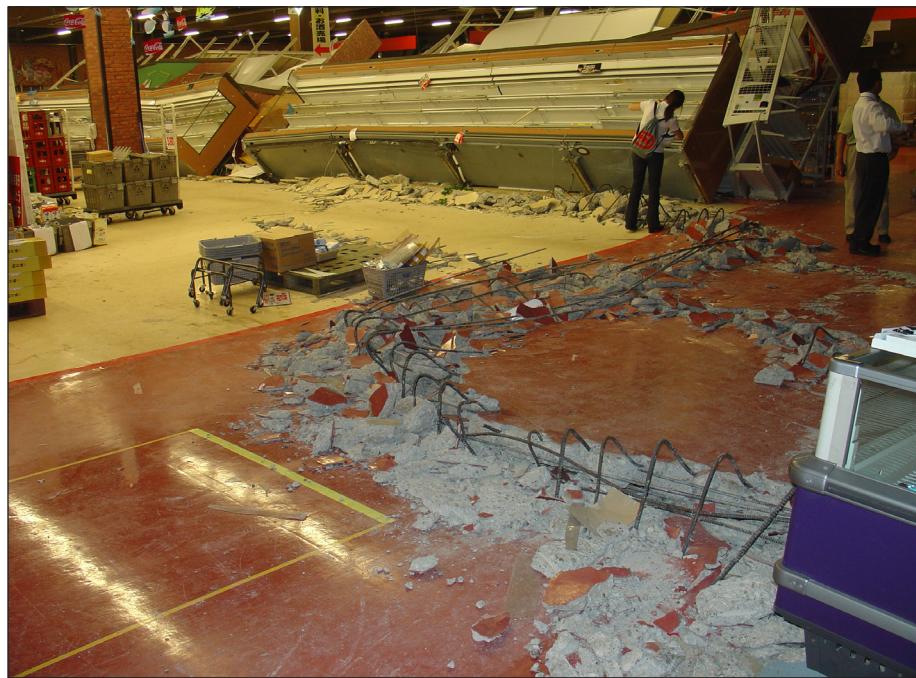
Figure 19: Damaged slab in Super Center Plant 5 (site RK 41).

The steel framing of the one-story Super Center Plant 5 building was damaged because of failure of the foundation. This is by far the largest building in the entire affected area. A fault-like mole track was observed across the entire width of the flat slab of the building (Figure 19). The slab and its reinforcing steel failed in tension. A gap of probably more than a foot opened up and then closed

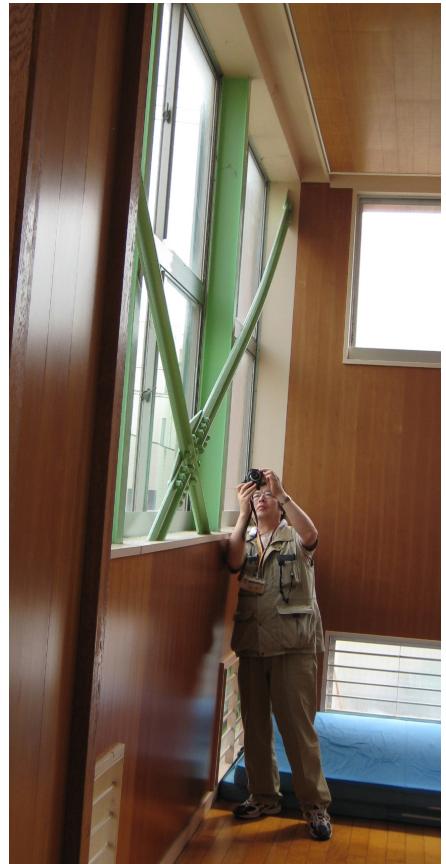
Figure 18: Buckling of steel braces (site SP7).

a gymnasium located 430 m from a K-NET station, buckling of steel braces in the lower of the two stories in the structure was observed. The braces had T-shape cross sections with a thickness of 12 mm. The flange measured 150 mm and the stem 45 mm. The braces had a slope of 2/3 with respect to the horizontal. Four pairs of braces reinforced each story in the NS direction. The floor plan was approximately 20 m in the EW direction and 33 m in the NS direction (Figure 18).

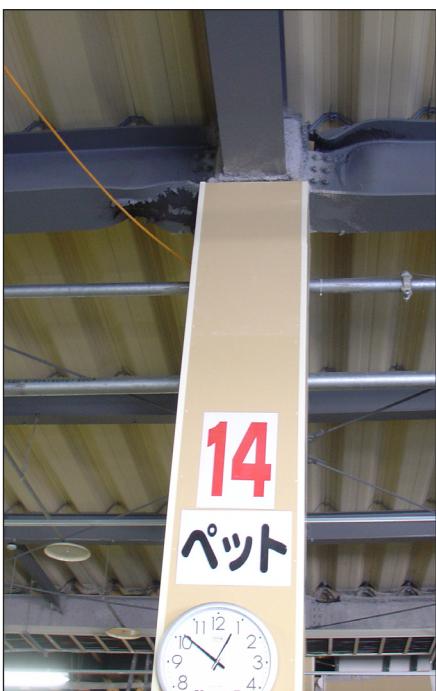
Figure 20: Buckling of beam flanges (site RK41).

during the motion (this may have happened several times), as evidenced by buckled rebar. This distortion of the foundation buckled many of the connections of the columns to roof beams (Figure 20).

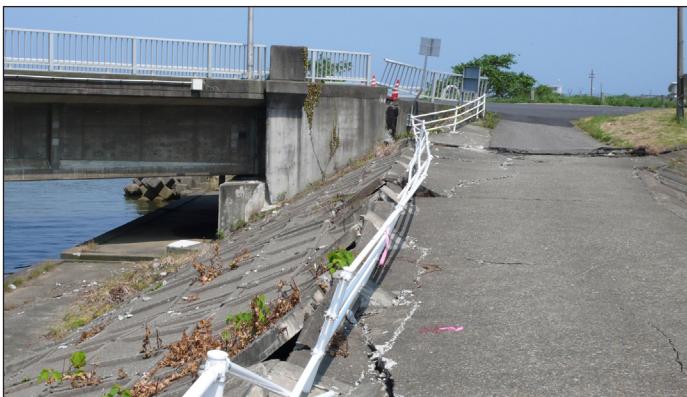
Figure 21: Embankment cracking near river crossing.

Bridges and Highways: Damage to bridges crossing the Sabaishi River (north of Kashiwazaki) and the U River (south of Kashiwazaki) was caused by permanent deformation of embankments that run parallel to the rivers. Lateral and vertical deformations of embankments ranging from a few centimeters to about a meter were observed. Embankments cracked at their crests and, in some instances, sand boils flowed upward through these cracks, indicating liquefaction (Figure 21).

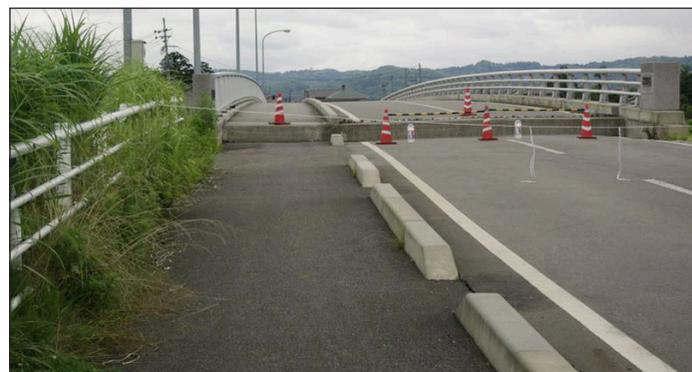
Vertical offsets at bridge approaches caused by soil settlement ranged from 5 cm to 1 m (Figure 22). Asphalt or gravel fill was placed to permit cars to cross bridges. Utility lines attached to bridges where approaches settled were damaged. Settlement of approaches was observed at bridges crossing the Sabaishi and U rivers, and at bridges along the Hokuriku Expressway.

Figure 22: Abutment settlement at a bridge crossing the Sabaishi River.

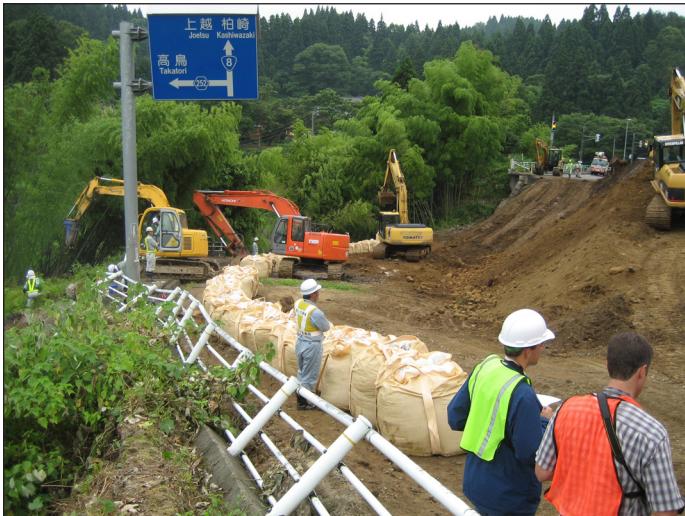
Figure 23: The Ozumi Senbon Landslide, located along Highway 8 just north of the intersection with Route 252, closed both lanes of traffic (site RK1).

In one location, located inland from the coast, both lanes of a busy regional highway were moved down slope by about 10 m as a result of a deep-seated slope movement (Figure 23). The road was reopened less than seven days after the earthquake. A large lateral spread affected a road near the Kashiwazaki municipal waste incinerator, forming a headscarp with a vertical offset of 2.5 meters that transected the road. The pavement was heavily damaged for a length of over 200 m in the lateral spread region.

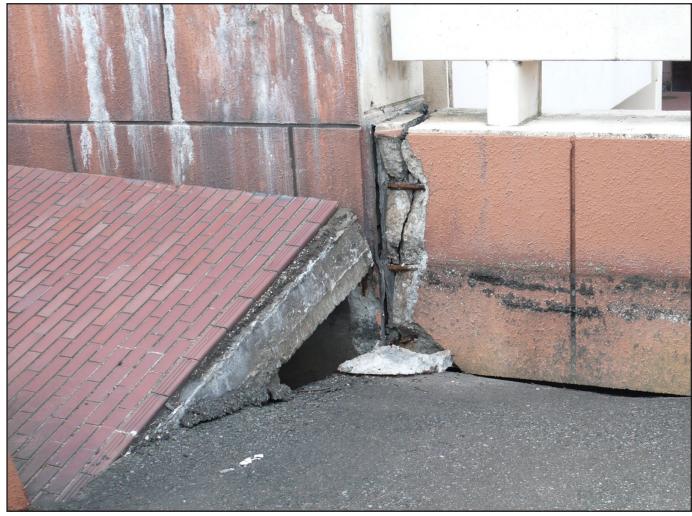
Figure 24: Wastewater treatment plant damaged due to ground settlement and shaking.

The Kashiwazaki City water treatment plant suffered minor damage during the earthquake, but the wastewater treatment plant had major damage. Although wastewater continues to be treated, it is no longer possible to remove sludge from the system, which will become critical at some point. Pipes, clarifiers, sludge digesters, and other essential equipment were damaged due to the ground shaking, soil displacement, and differential settlement at the plant (Figure 24).

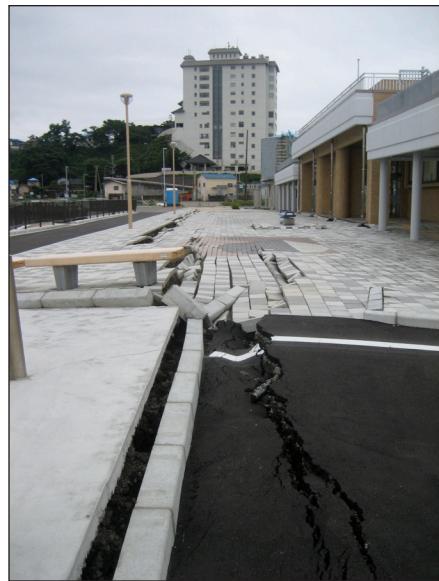
The westernmost section of the Port of Kashiwazaki was subjected to the effects of widespread liquefaction, lateral spreading, and settlement exceeding 30 cm in many areas (Figure 25), and a pronounced graben formed between a port building and the waterfront quay wall. A pile-supported structure performed very well, but two pedestrian-accessible roof areas on either side of the main structure were distressed by ground settlement and lateral spreading. Fortunately, the damage did not keep the port from being a major staging area for relief supplies following the earthquake.

Figure 25: Kashiwazaki Harbor — Liquefaction induced lateral spreading and settlement of soil beneath a harbor-front caisson resulted in rotation toward the harbor and lateral displacement of the soil behind it.
