The October 9, 1995 Magnitude 7.6 Manzanillo, Mexico Earthquake

This report was compiled from information submitted by Julio Ramirez of Purdue University and Raymond Pugliesi of Degenkolb Engineers.

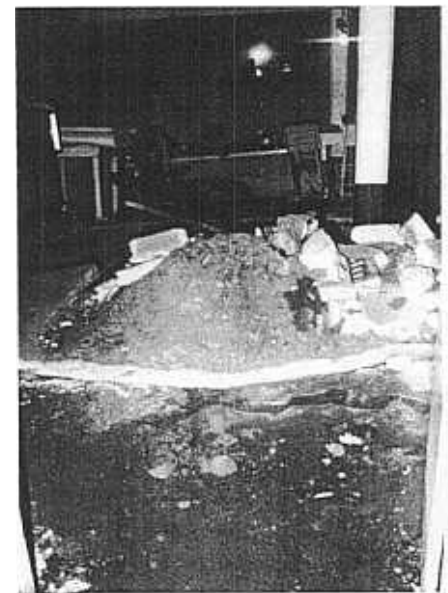
Houses constructed on landfill along the bank of the Laguna De Cuyutlan in Manzanillo suffered substantial damage due to liquefaction. In some cases buildings sank up to two feet in the loose soil, sometimes twisting and sliding several inches. Sidewalks were often highly distorted and uplifted. Sand boils, unable to rise through the paved street, were forced through the thin unreinforced concrete floors of the homes and literally filled them with sand or soil (Figure 1). The heavier two-story buildings were most susceptible to this problem. The houses did not collapse, but were a total loss. Damage associated with soil failure was also observed along the sea wall.

Figure 1 - Liquefaction caused a sand boil that forced its way through the weak concrete foundation of this home.

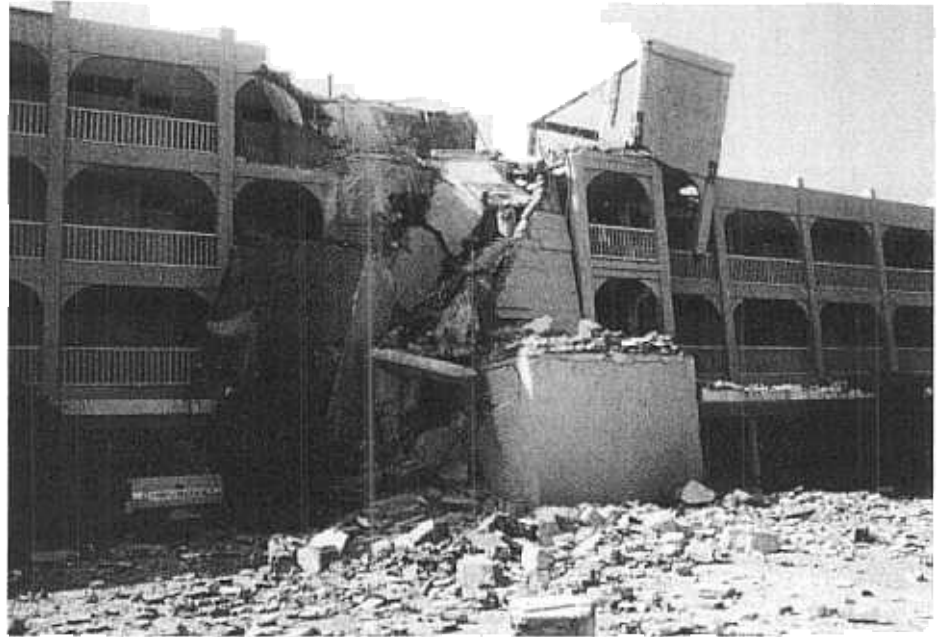
Figure 2 - A collapsed stair tower at the Casa Grande Resort in Melaque. A 45-ton water tank constructed on top of the stair tower probably contributed to its failure.

concentrated at the interface of the brick infill and the beams of the concrete frame and in interior brick partitions. In Melaque, the Casa Grande Resort consisted of multiple five-story buildings constructed within the last 20 years. All three stair towers on the oldest structure collapsed. Each stair tower supported a 45-ton water reservoir (Figure 2). These masses undoubtedly contributed to the collapses.

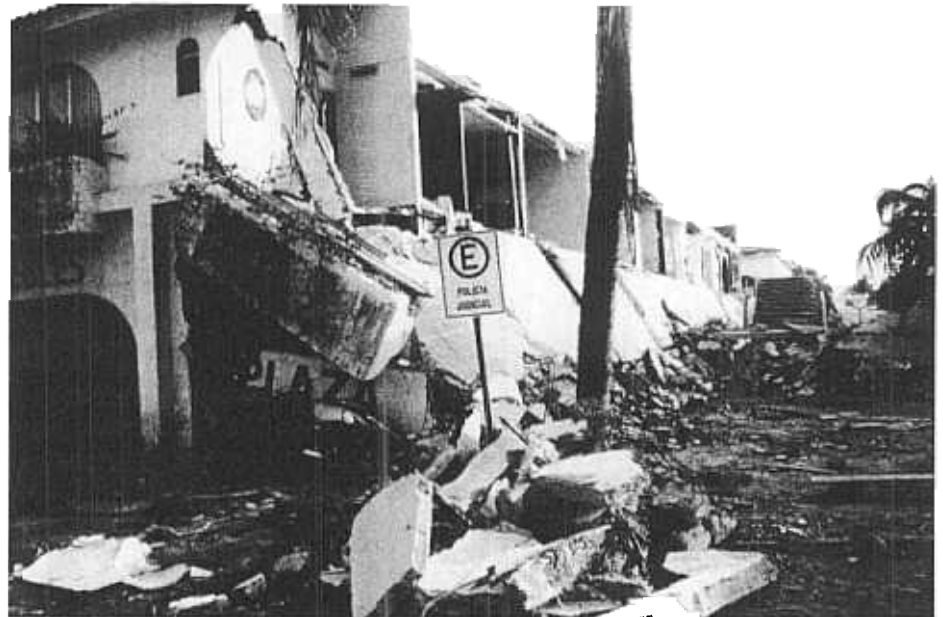
Figure 3 - The partial collapse of a two-story office building in a Santiago shopping center was due to inadequate exterior columns.

One of the most widely affected areas was a large shopping area in Santiago. The complex included a large open warehouse, three one-story shopping centers, a two-story federal office building (containing a jail), and a bank. The buildings used steel columns with masonry walls, an unusual form of construction for the area. Many of the shopping center buildings had very high (3 m) masonry parapets. One of these collapsed and fell into the building. Several other parapets were damaged. The exterior walls of the federal office collapsed on three sides (Figure 3). These brick walls had many openings and no exterior steel columns. The one-story bank building had a steel frame which was apparently undamaged, but the masonry infill was considerably distressed. Loose clay roof tiles littered the complex. The fact that other buildings around this particular shopping area were relatively undamaged casts suspicion on the construction methods used.

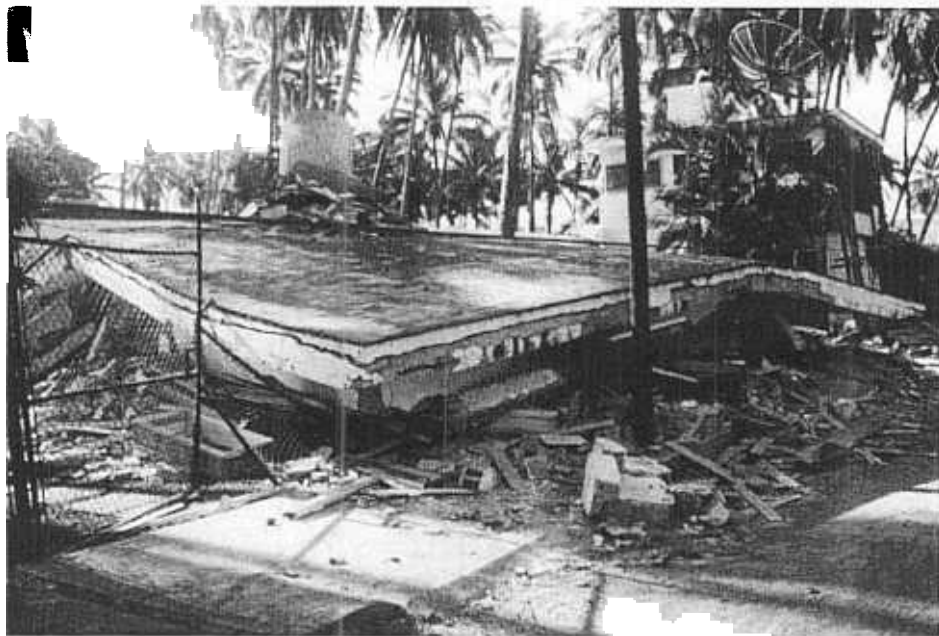
Figure 4 - This two-story home in Manzanillo collapsed due to a heavy roof and inadequate walls.

Complete collapses occurred in many of the simple masonry buildings that did not make use of supplementary horizontal and vertical concrete elements (Figure 4). Much of this type of construction has clay tile roofs; the tiles were often shaken loose.

Most of the damage occurred in non-engineered masonry construction. The damage observed after the quake indicated that the use of concrete columns and beams can greatly enhance the performance of these buildings.
