## Learning from Earthquakes

# Preliminary Observations on the Southern Peru Earthquake of June 23, 2001

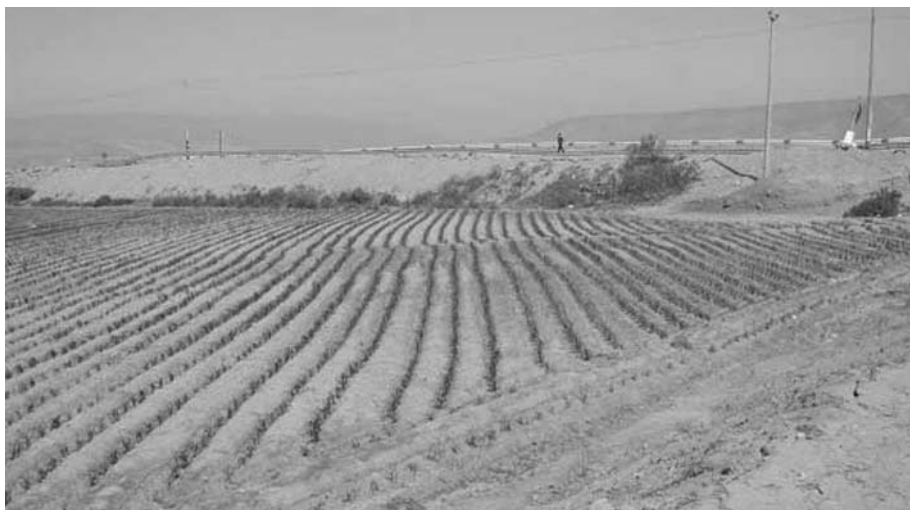
Liquefaction was observed at three bridge sites located in alluvial valleys. In one instance, liquefaction-induced lateral spread severely damaged a concrete bridge and several residences located along the banks of a river (Figure 4). At another site, liquefaction caused a

**Figure 4** The offset in the corn rows (left to right near middle of photo) is due to localized displacement induced by lateral spread. (photo: geotechnical reconnaissance team)

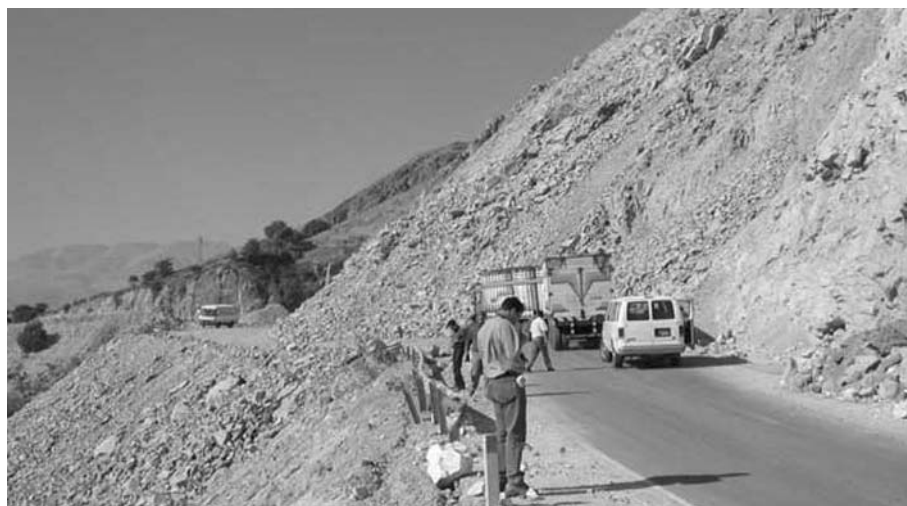
Landslides and slope stability failures occurred at localized cut and fill sections along highways (Figure 5). In most cases, slope movements in the fill section were due to fill densification. Rockfalls were observed along many of the steep road cuts in the region. Observed rockfalls ranged from single-block failures to raveling of both bedrock and the exposed colluvial material. Some planar and wedge failures within the bedrock were also observed. Natural slopes composed of bedrock or colluvium had very little observed failure, with the exception of displacements of a shallow veneer of soil in sandy slopes.

**Figure 5** Slope failure along highway between Cuajone and Moquegua. (photo: geotechnical reconnaissance team)

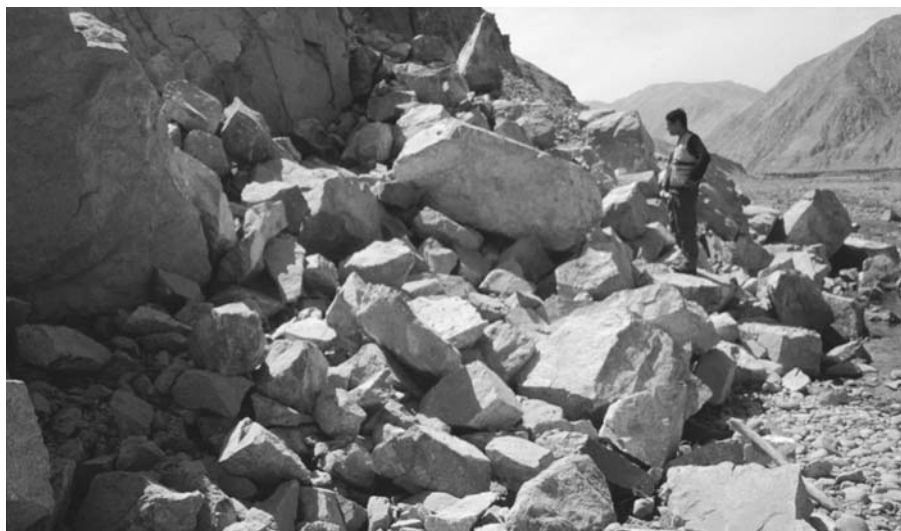
**Figure 6** Typical rock fall from wall of lower Ilo Valley near Algarrobal. (photo: David K. Keefer)

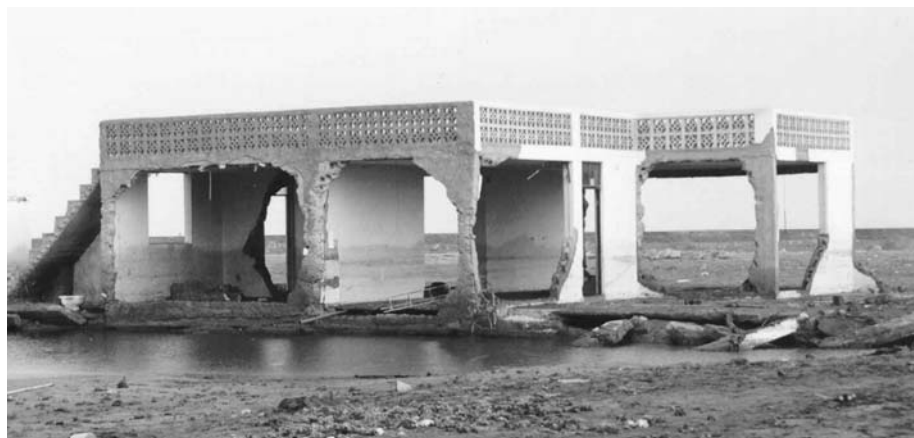
**Figure 8** Reinforced column/infilled brick wall structure in the La Punta area. Brick walls perpendicular to wave impact were typically blown out. (photo: Sebastian Araya)

formed very poorly. No signs of adobe structures remained. Infilled walls were typically blown out on walls perpendicular to the wave direction (Figure 8). Significant scour occurred to structures at the corners, often undermining the slab foundations. Reinforced concrete structures with thicker foundations were most likely to survive.

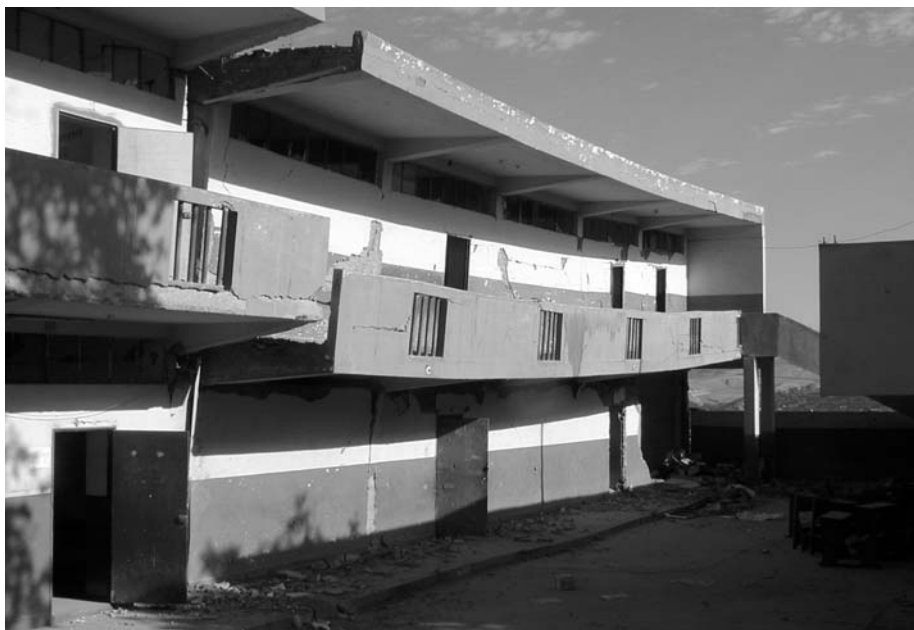
**Figure 9** School building in Moquegua. Partial collapse due to failure of short columns. (Photo: E. Fierro)

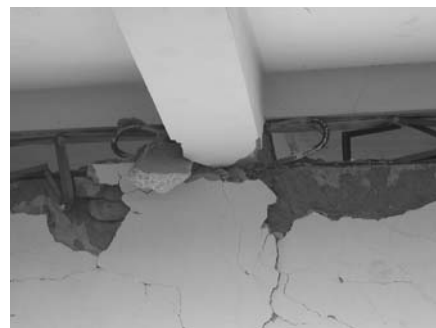
**Figure 10** View of the collapse of one of the short columns in the school building shown in Figure 9. (Photo: E. Fierro)

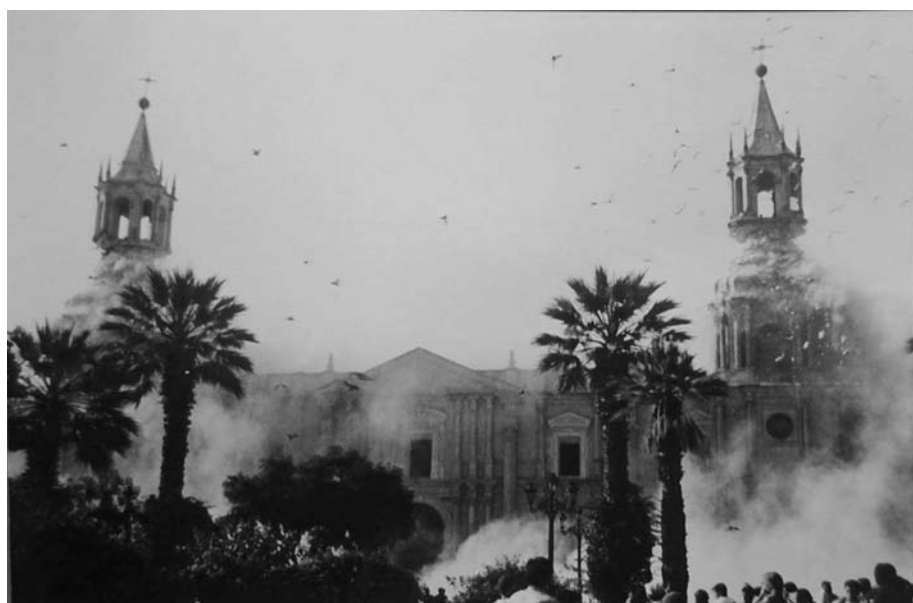
The city's historic cathedral, built in 1612, sustained heavy damage, mainly due to the collapse of one of its towers. The cathedral is situated on the Plaza de Armas in Arequipa's historic center, a UNESCO World Heritage site. It was damaged by previous earthquakes and fire, and was substantially rebuilt in the 19th century. Both towers were apparently rebuilt most recently in about 1940. A photo extracted from a video taken during the earthquake shows part of the collapse sequence of the tower (Figure 11). The tower on the left collapsed and fell through the vaulted dome above the main altar of the cathedral.

**Figure 11** Cathedral of Arequipa, still photo from sequence taken during main event. (photo purchased by E. Fierro)

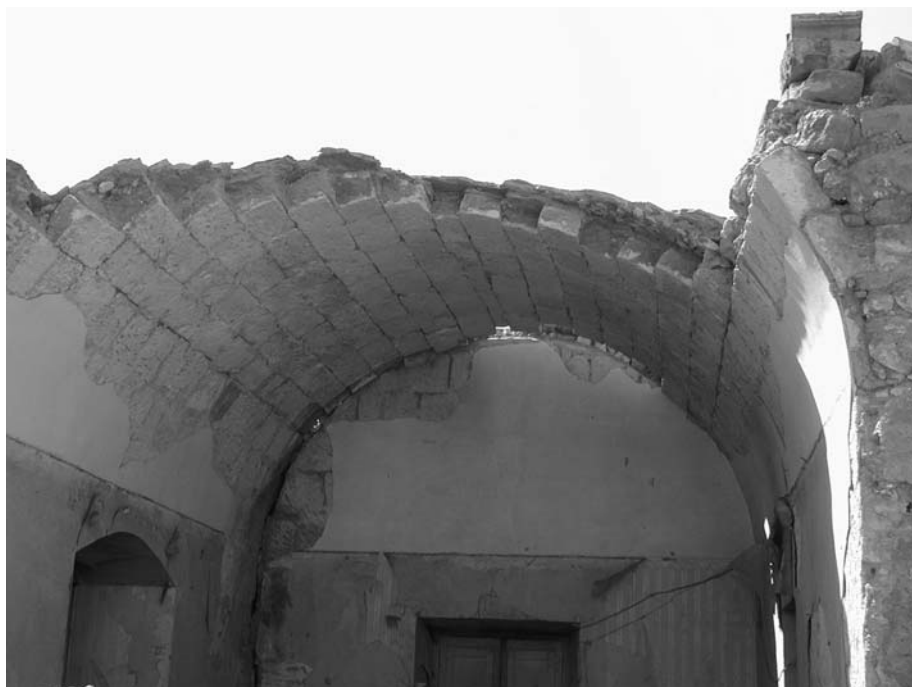
founded in 1579. Many traditional domed and vaulted structures were extensively damaged. Most of the historical monuments are made with blocks of sillar (consolidated volcanic ash) laid with lime or cement mortar. Sillar is also used for housing. A damaged vaulted ceiling in an older home is shown in Figure 12. Many of the older roofs were made

with heavy blocks of low strength sillar supported by steel rails.

**Figure 12** Damage to typical historic dwelling with vaulted roof constructed of "sillar" blocks. (Photo: E. Fierro)

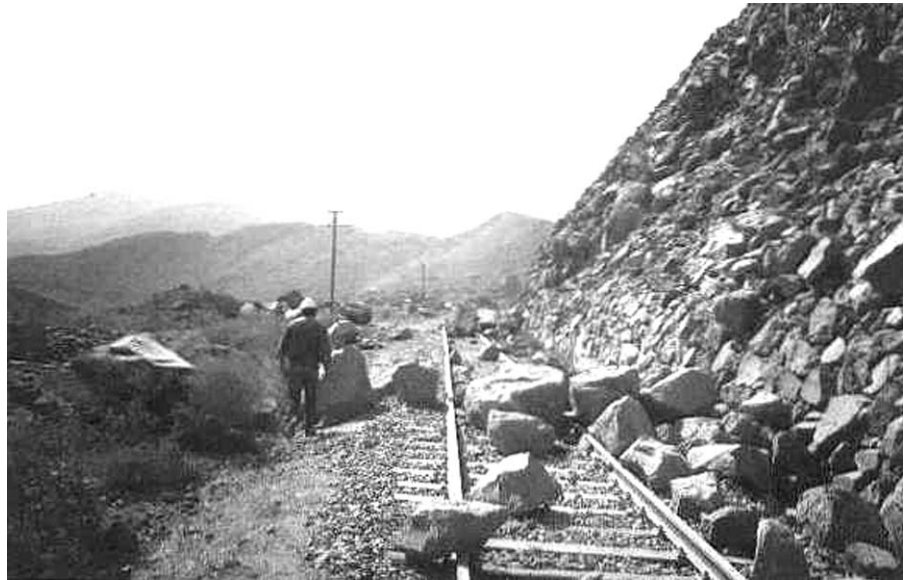
**Railroads:** The railroads of Peru do not constitute a network, but include separate entities not physically connected. Two of these sustained extensive damage: PeruRail, a common carrier providing freight and passenger service; and the industrial railroad of the Southern Peru Copper Corporation, which transports copper concentrate from inland mines to a smelter and refinery on the coast, and supplies and equipment to the mines. Major line segments, with a combined length on the order of 700 km, were out of service for three to seven days. The most severe damage involved material sliding or falling onto the track, or embankment failures. In some cuts, track was buried under as much as 5 meters of material (Figure 13).

**Figure 13** Rock Fall Blocking PeruRail Line. (photo: PeruRail)

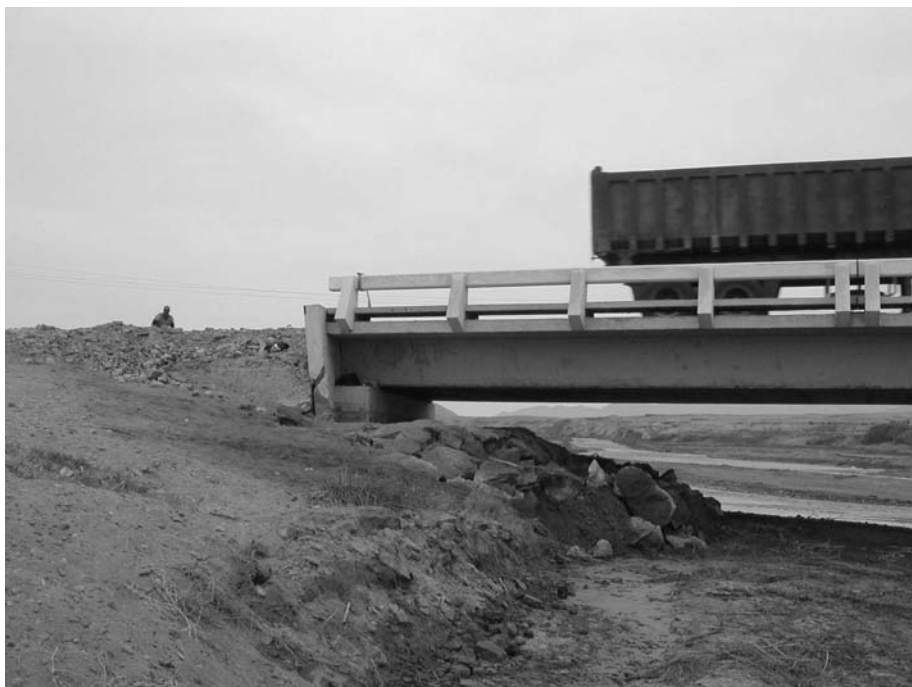
Highway structures such as bridges and culverts were also damaged due to the use of poorly compacted material around abutments and wingwalls. This resulted in subsidence of the bridge approaches. In addition, liquefaction caused failure of some wingwalls and approaches. Most bridges were in use 30 days later, but one older steel truss bridge was closed due to failure of bearing supports (Figure 14). Box culverts also performed poorly due to loosely compacted material. An 18'-by-40'-tall single-box culvert remained undamaged on the Pan-American Highway, but the roadway over the culvert settled several feet, and the wingwalls were shattered due to active pressure from the surrounding soil.

**Figure 14** *Damaged bridge abutment.* (photo: Yashinsky)

The severity of damage to the highway system can be reduced in the future by replacing weak fills along roads and highway structures with 90% compacted material. Slopes

above roads should be carefully inspected for loose material, which should be removed or draped to prevent future movement. Catchment walls should be constructed between slopes and roads to prevent falling rocks from impeding traffic.
