# BEHAVIOR OF EARTHEN BUILDINGS DURING THE PISCO EARTHQUAKE OF AUGUST 15, 2007

Marcial Blondet  
*Catholic University of Peru (PUCP)*

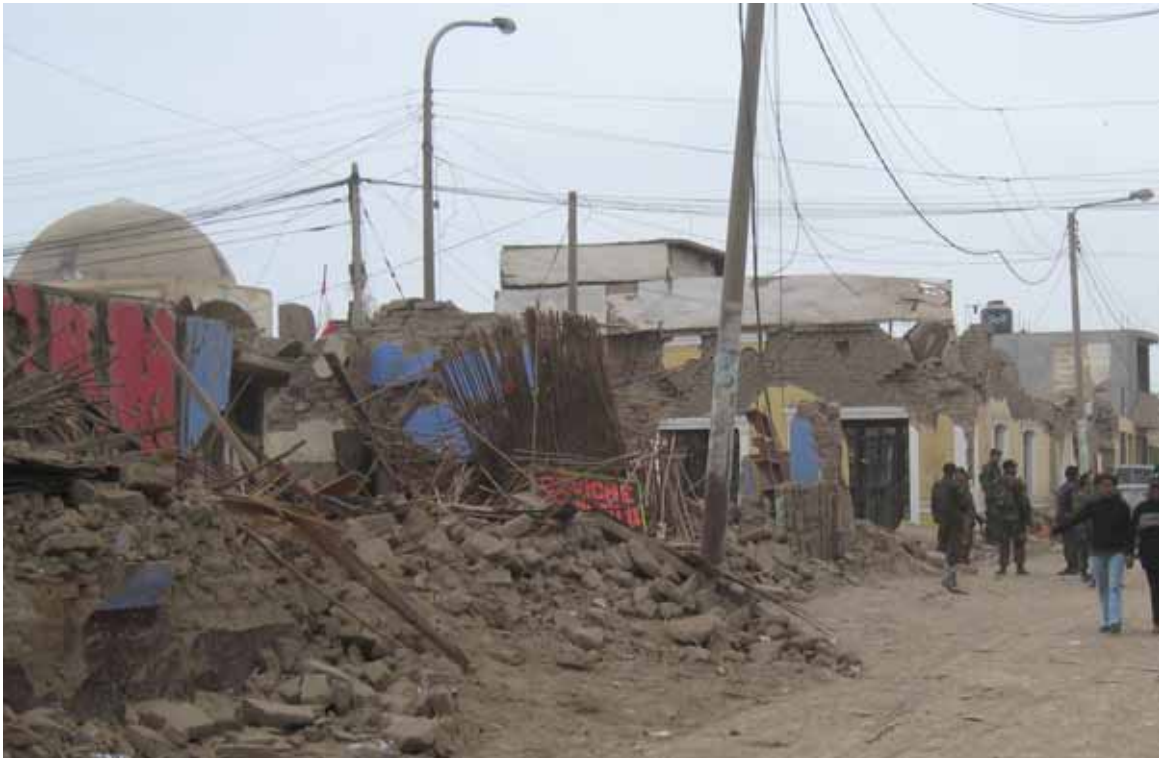
In Pisco, more than 80% of the adobe houses collapsed or sustained heavy damage. This was due to the perverse combination of mechanical characteristics of adobe walls: they are massive, weak and brittle. Since they are massive, they attract large inertia forces during seismic shaking, which they are unable to resist because the masonry is weak, and brittle failure occurs without warning. Furthermore, it seems that the adobe blocks and mortar in the Pisco and surrounding areas were made with sandy soil, which did not have sufficient clay to provide good adhesion between mortar and adobe blocks. Figure 1 shows a view of a street in Pisco, full of debris from collapsed adobe houses.

Fig.1 Street in Pisco three days after the earthquake. Most of the adobe houses suffered total collapse. The light blue house at the far right, undamaged, was made of confined masonry.

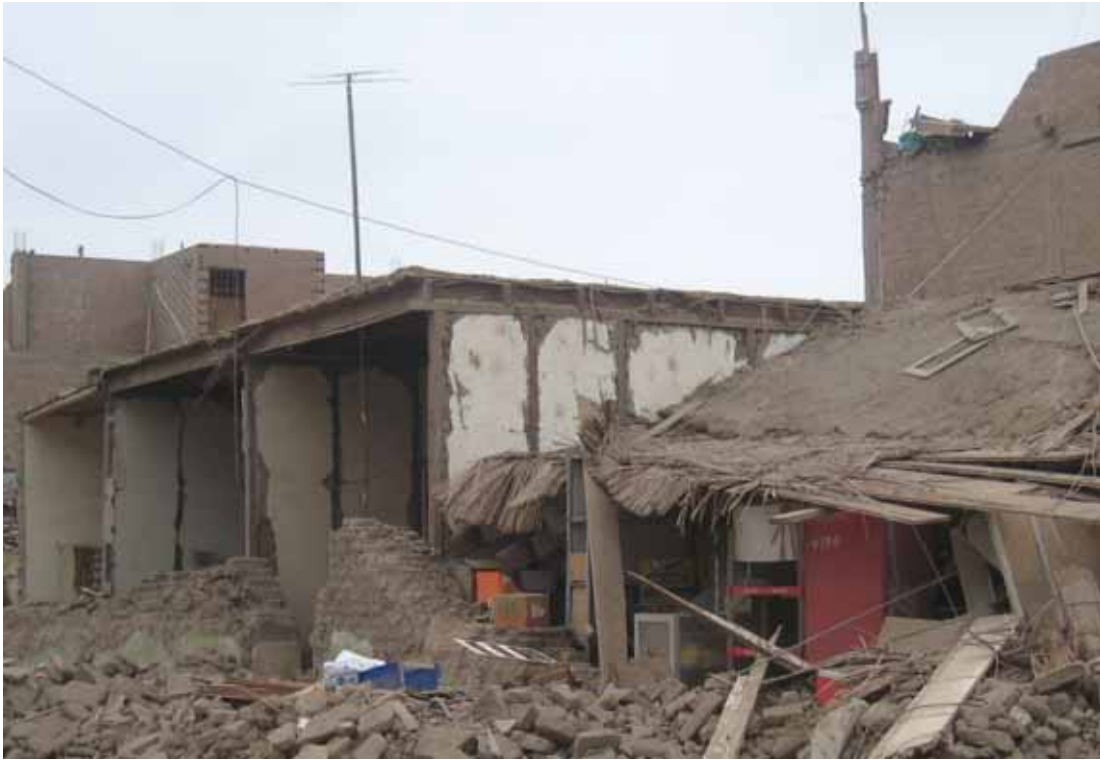
The most common type of failure observed in adobe houses was due to the formation of vertical cracks at the corners of the façade walls as a result of out-of-plane shaking, followed by the collapse of the walls onto the street and sometimes the collapse of the roof (especially if the roof joists were supported on the façade wall). A top collar beam joining all walls probably would have been helpful to prevent this type of damage. See Fig. 2 below.

Fig. 2. Two collapsed adobe houses in Pisco. The roof joist of the house on the left are supported on the *quincha* partitions. The roof joists of the house on the right were supported on the façade wall, and thus collapsed with the façade. Notice the undamaged confined masonry house at left, and the collapsed masonry parapet on the house at the back right.

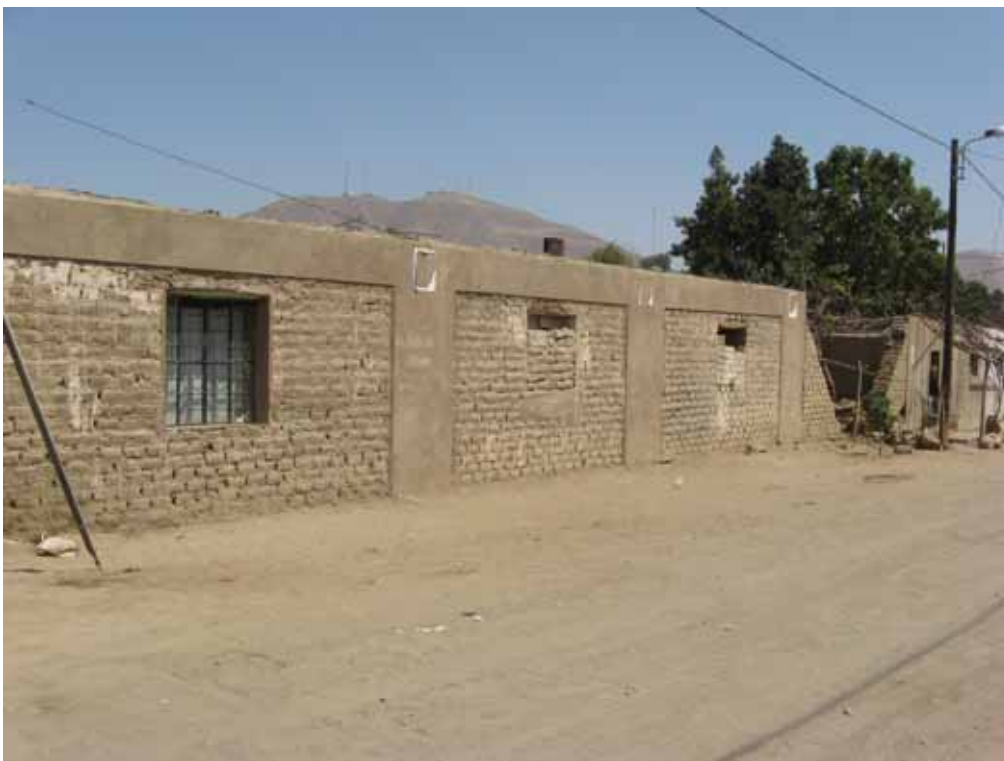
In 1999 the Catholic University of Peru (PUCP) reinforced 19 adobe houses in different locations of the country. The reinforcement consisted of bands of welded wire mesh nailed to the walls and covered with a cement-sand mortar. Figure 3 shows the house that was built in Guadalupe, a small town near Ica. It did not suffer any damage during the Pisco earthquake, whereas neighboring unreinforced houses suffered significant damage or collapsed. This reinforcing system should be used with caution because although shaking table tests have shown that the strength of the adobe walls is significantly increased, the mode of failure is brittle.

Fig. 3. This undamaged adobe house was reinforced with bands of wire mesh covered with sand-cement mortar. Vertical bands were placed at each wall intersection, and horizontal bands at roof level. Notice the collapsed unreinforced wall at the right.

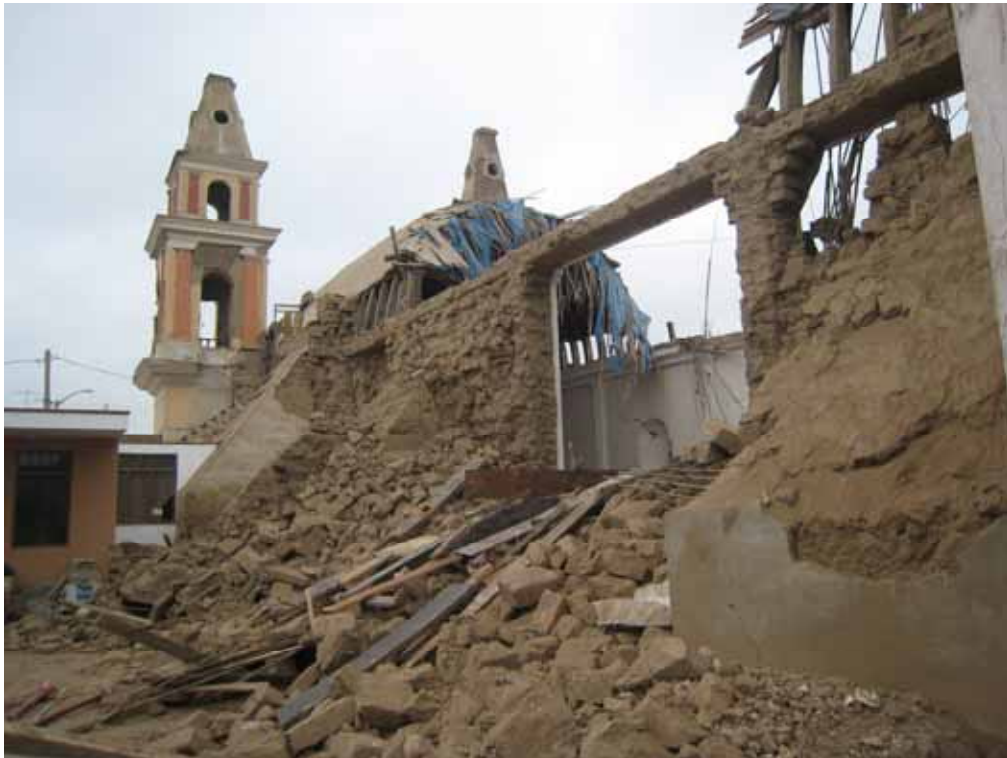
There are many beautiful ancient churches in Peru. Many of them are built with adobe walls and a *quincha* vault covering the nave. Most churches suffered tremendous damage during the earthquake. The most dramatic case was that of the San Clemente church in Pisco, where the vault collapsed suddenly and killed around 160 people who were attending a funeral service. The priest was saved because he was under the dome, which had been repaired with reinforced concrete after a previous earthquake. Figure 4 shows a side view of the church of San Luis, a small town just South of Cañete. It seems that the lateral thrust of the vault pushed the supporting lateral wall, weakened by a door opening.

Fig. 4. San Luis Church. The lateral wall and its heavy abutments were practically torn down, presumably by the dynamic thrust of the collapsing vault. The towers are made of *quincha* and suffered little damage.
