World Housing Encyclopedia Report

Country: Taiwan

Housing Type: Street front building with arcade at the first floor (contemporary construction)

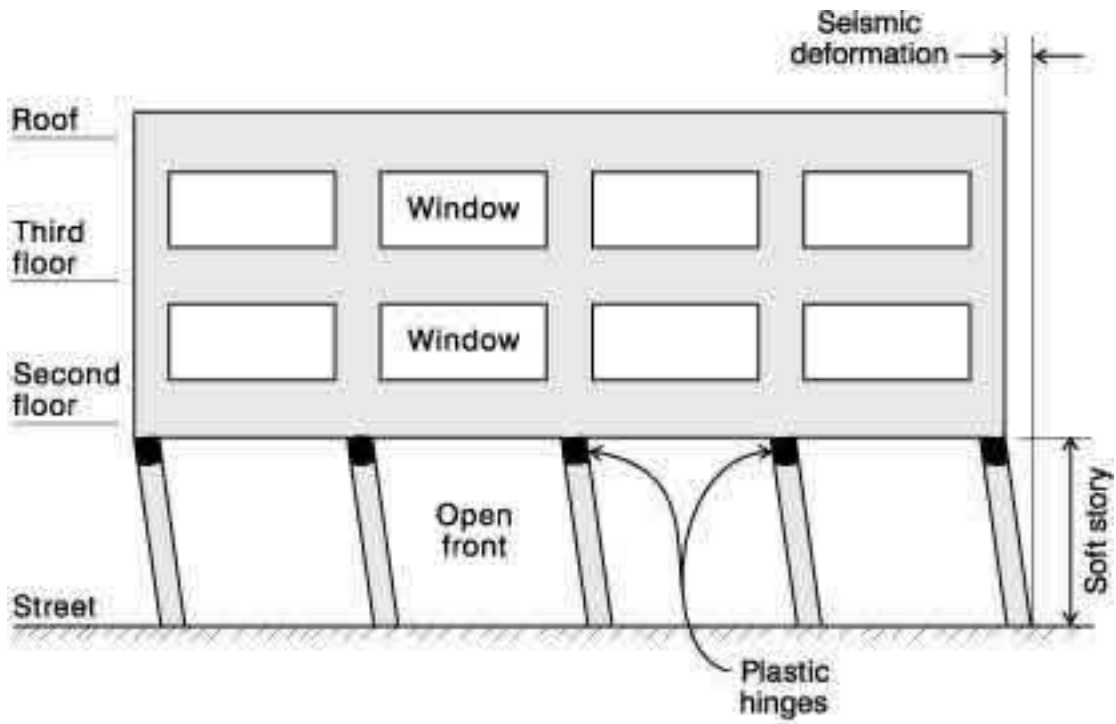
Roof and floors	No major deficiencies		
Building Configuration	The open front at the bottom story is the most obvious configuration irregularity characteristic for this construction type. This feature creates undesirable soft-story and torsional effects, as illustrated in Figure 5A. (Source: EERI 2001)		Extensive damages and building collapses due to the large demands on the bottom story columns caused by soft story and torsional effects (see Figures 6A, 6B, 6C, 6D, 6E, 6F)

FIGURE 5A: Seismic Deficiency: Soft-story deformation of open front at the street level

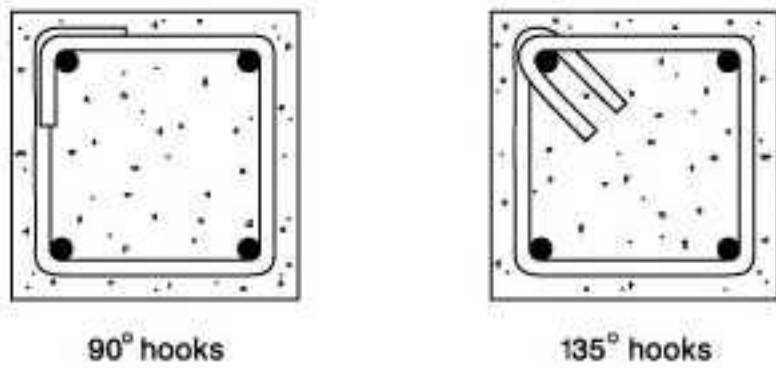
FIGURE 5C: Seismic Deficiency : Column ties -90 degree hooks were used instead of 135 degree hooks
(Source: EERI 2001)

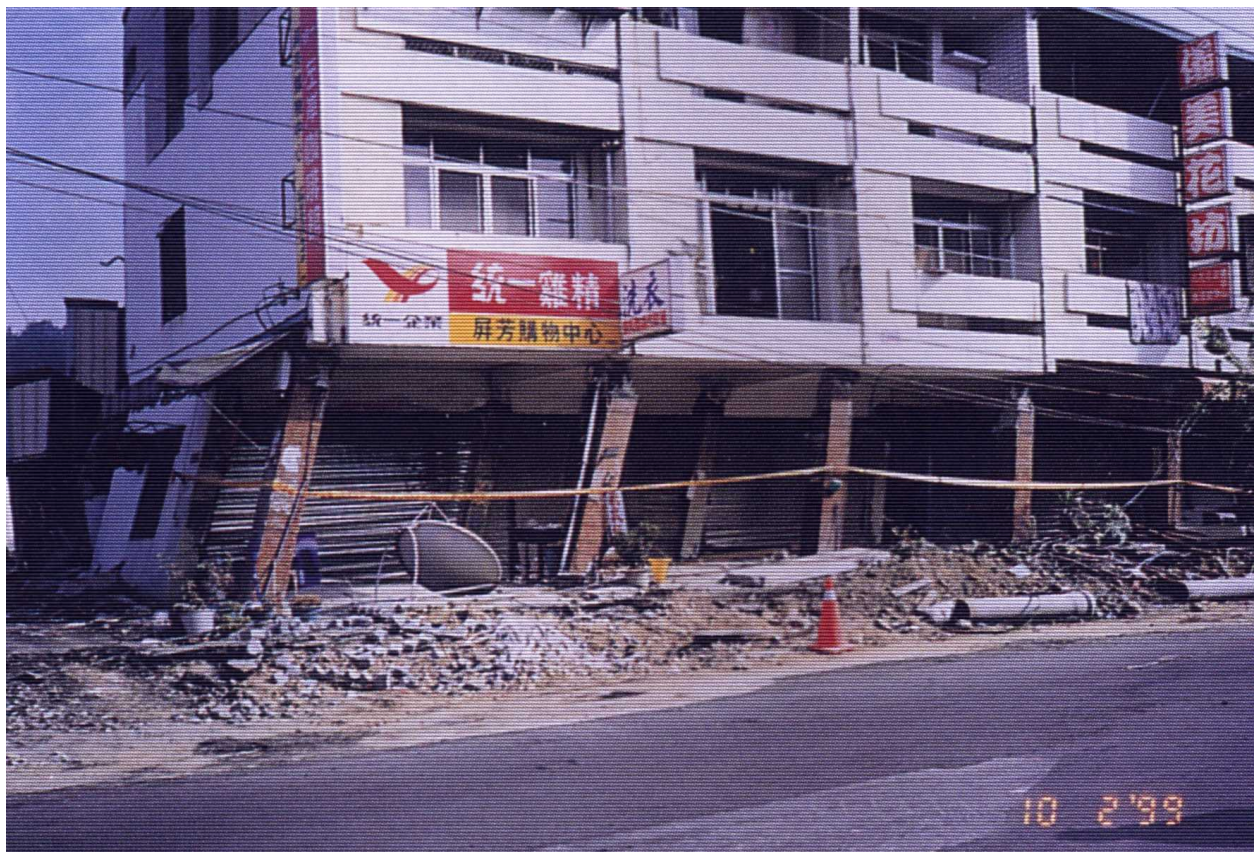
Additional Comments: Although many buildings of this construction type sustained significant damage in the 1999 Chi Chi earthquake, most of them performed satisfactorily. Earthquake damages are illustrated in Figures 6A, 6B, 6C, 6D, 6E, and 6F. The main causes for damage observed after the earthquake are (EERI, 2001): 1) Poor configuration attributable to the open front combined with inadequate column lateral reinforcement (ties). The large displacement demands from the soft-story and torsional effects often damaged the plastic hinge regions of the columns at the open front. All damaged columns were observed to have non-ductile confinement reinforcement details consisting of widely spaced horizontal hoops, more than 300 mm apart, and 90 degree hooks. Usually, the lack of confinement reinforcement in the plastic hinge regions resulted in brittle failure. In some cases, hinge rotation caused buildings to permanently lean out of plumb. In other cases, buildings with no signs of earthquake damage remained standing next to the seemingly identical buildings that sustained the total collapse of entire bottom stories. 2) There was also widespread damage to the unreinforced brick partitions and perimeter walls. Although partitions are usually considered nonstructural elements, the collapse of or damage to unreinforced brick partitions represents a significant falling hazards, and it forced many people out of their homes. 3) Performance of this construction type in the earthquake was significantly influenced by the infill wall layout. Because brick infills significantly influence the structural characteristics and yet are not considered in the design, the seismic performance of this building type is highly unpredictable.

FIGURE 6A: A Photograph Illustrating Typical Earthquake Damage

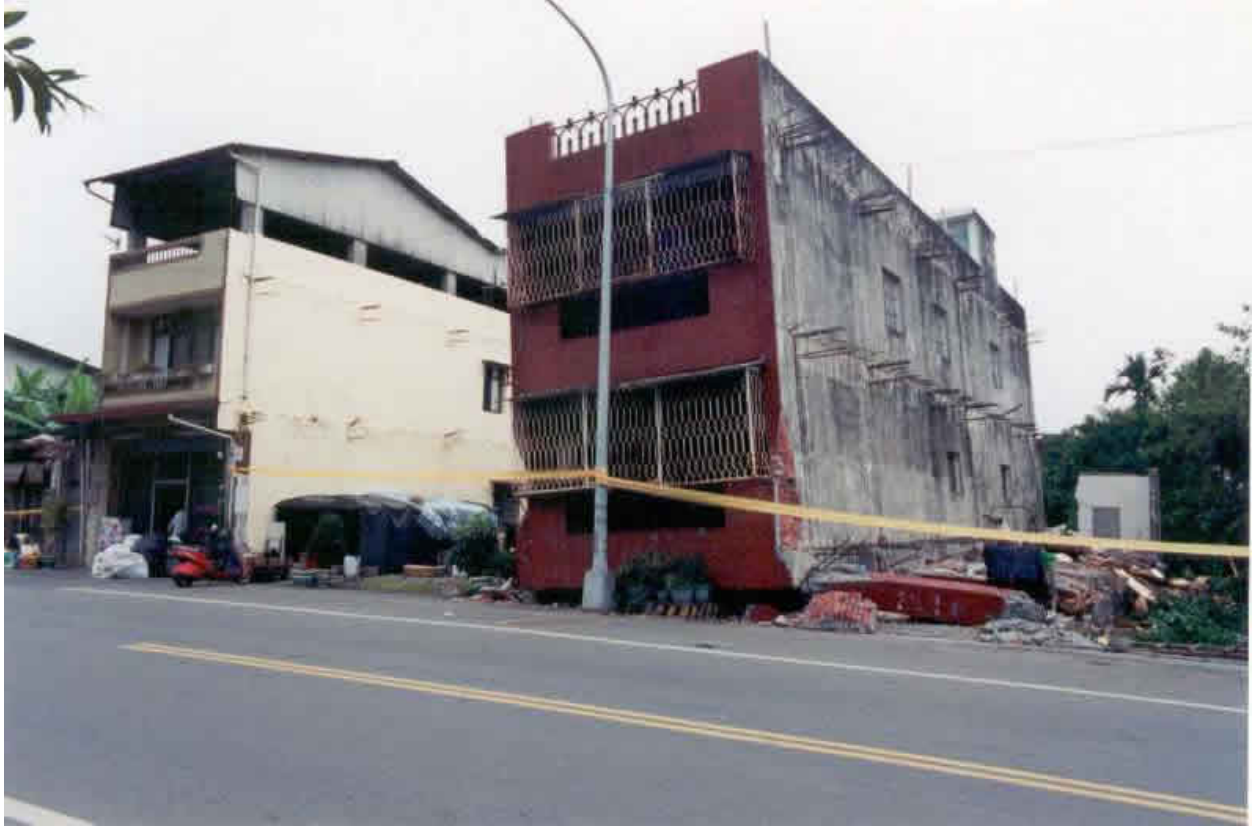
*FIGURE 6B: Earthquake damage-Collapsed Three-story building in the 1999 Chi Chi earthquake
(Source: EERI 2001)*

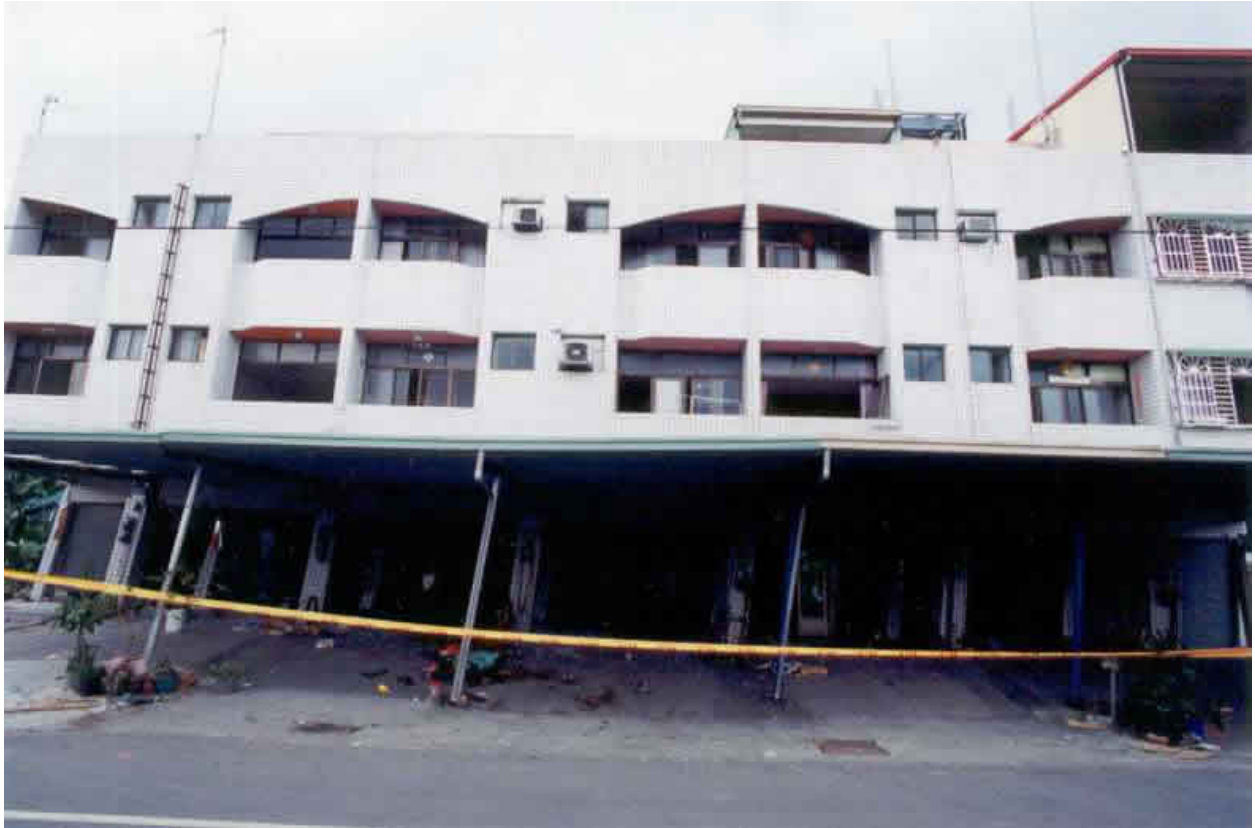
FIGURE 6C: Earthquake Damage - Partial Collapse of a Three-story building in the 1999 Chi Chi Earthquake (Source: EERI 2001)

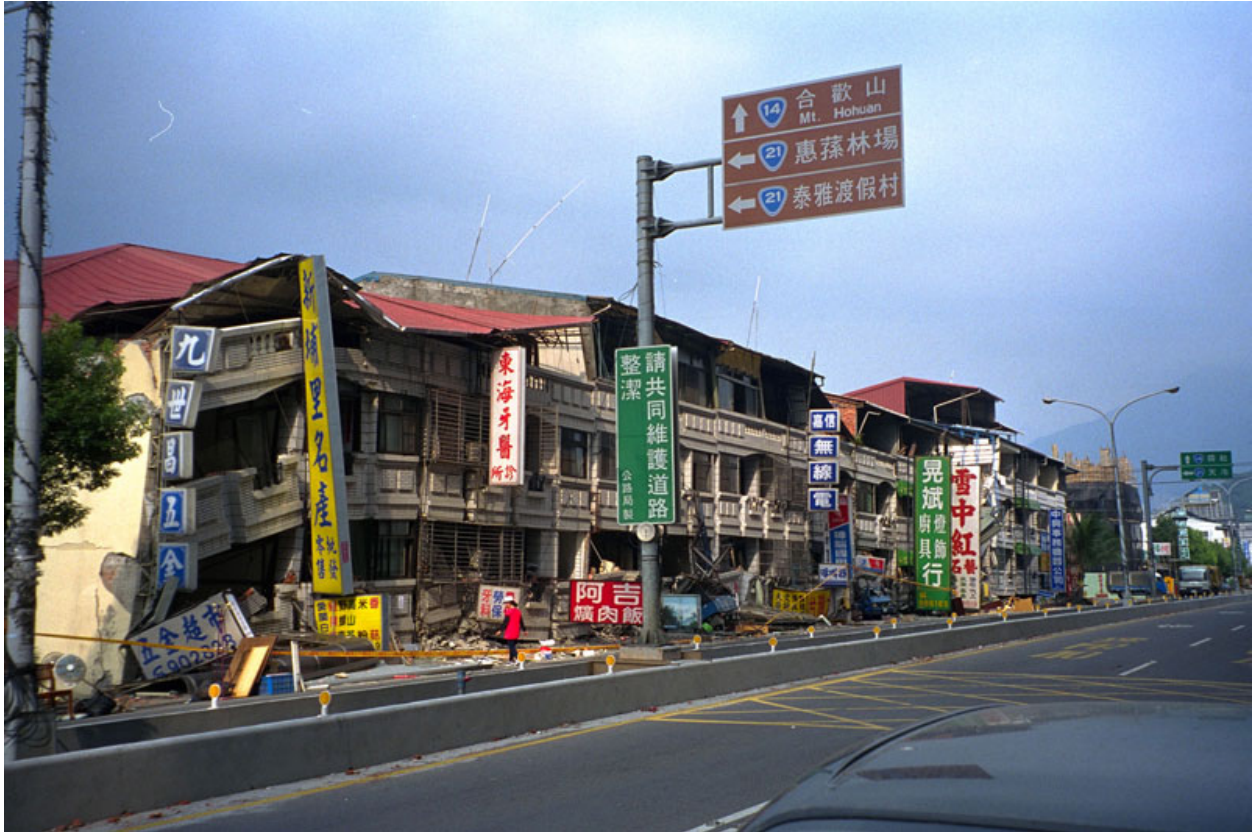
FIGURE 6D: Earthquake Damage - Pancake Collapse of an Entire City Block in the 1999 Chi Chi earthquake (Source: EERI 2001)

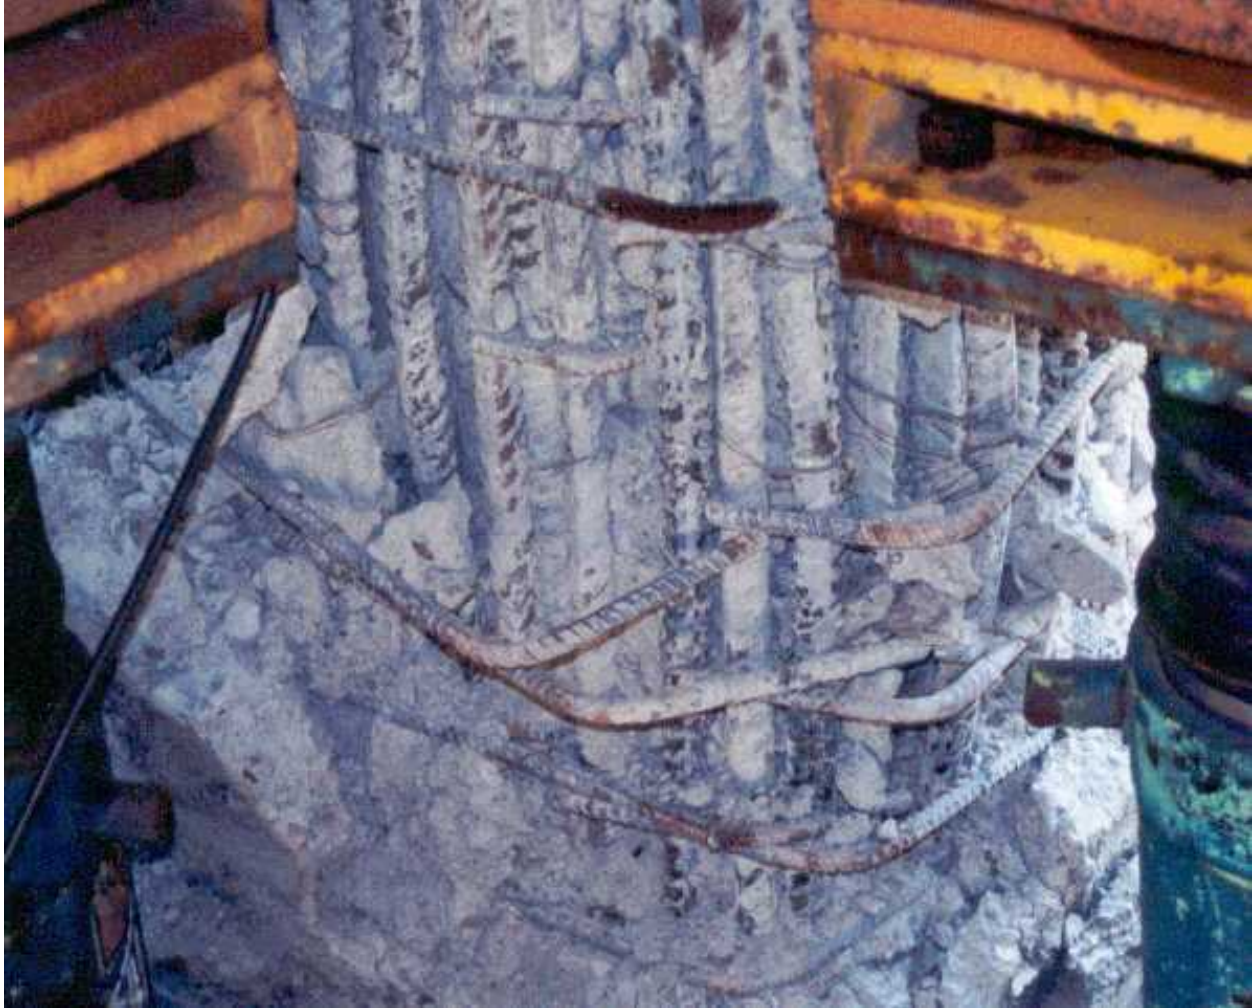
*FIGURE 6E: Earthquake Damage - Opening of 90 degree column hooks in the 1999 Chi Chi earthquake
(Source: EERI 2001)*

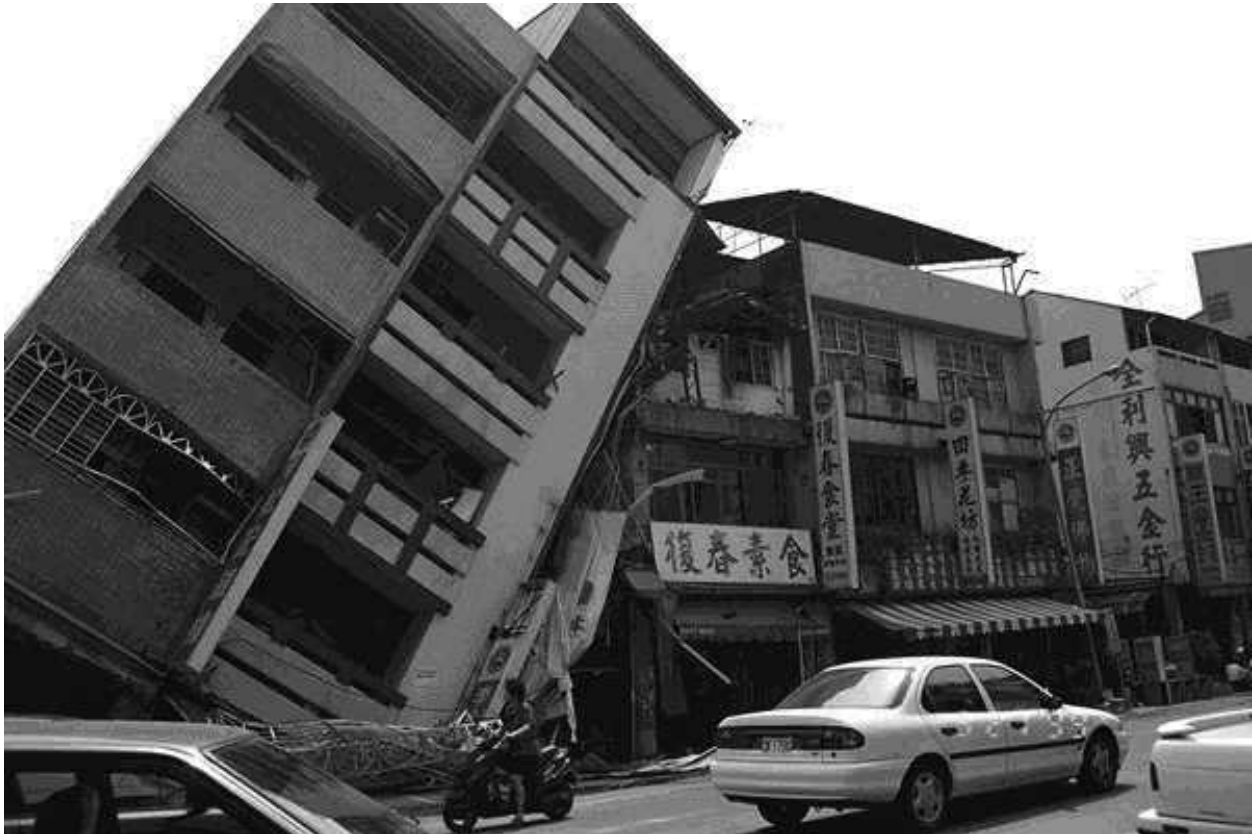
FIGURE 6F: Collapse of a Concrete Frame Building in the 1999 Chi Chi Earthquake (Source: EERI 2001)

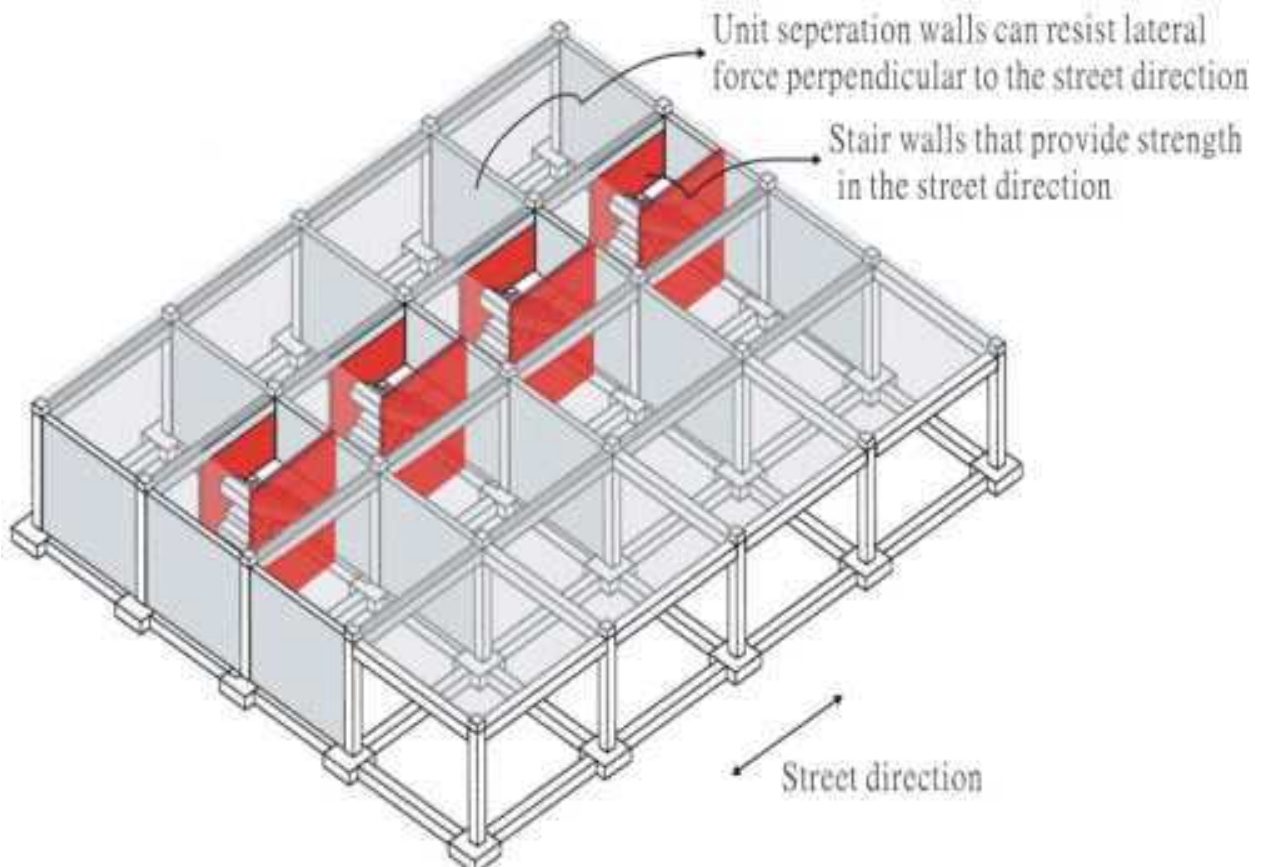
In some buildings, walls are laid out parallel to the street direction due to the layout of stairways (which is also parallel to the street), as illustrated in Figure 7B. These buildings have demonstrated better seismic performance as compared to the buildings with different wall layout, as observed in the 1999 Chi-Chi earthquake.

FIGURE 7B: Seismic Strengthening (New Construction) - Wall Layout in the Street Direction

Type of intervention	Structural Deficiency	Description of seismic strengthening provision used
Retrofit (Strengthening)	Lack of walls at the ground floor level in the direction parallel to the street	- Installation of new walls near the rear door or staircase to increase seismic strength in the direction parallel to the street, as illustrated in Figure 7A. - Installation of new steel braces.
	Weak columns	-Steel jacketing or fiberwrap
New Construction	Planning of stairways and walls parallel to the street direction	Walls laid out parallel to the street direction due to the layout of stairways, as illustrated in Figure 7B.
