Performance of Roads and Bridges During the December 22, 2003 San Simeon Earthquake

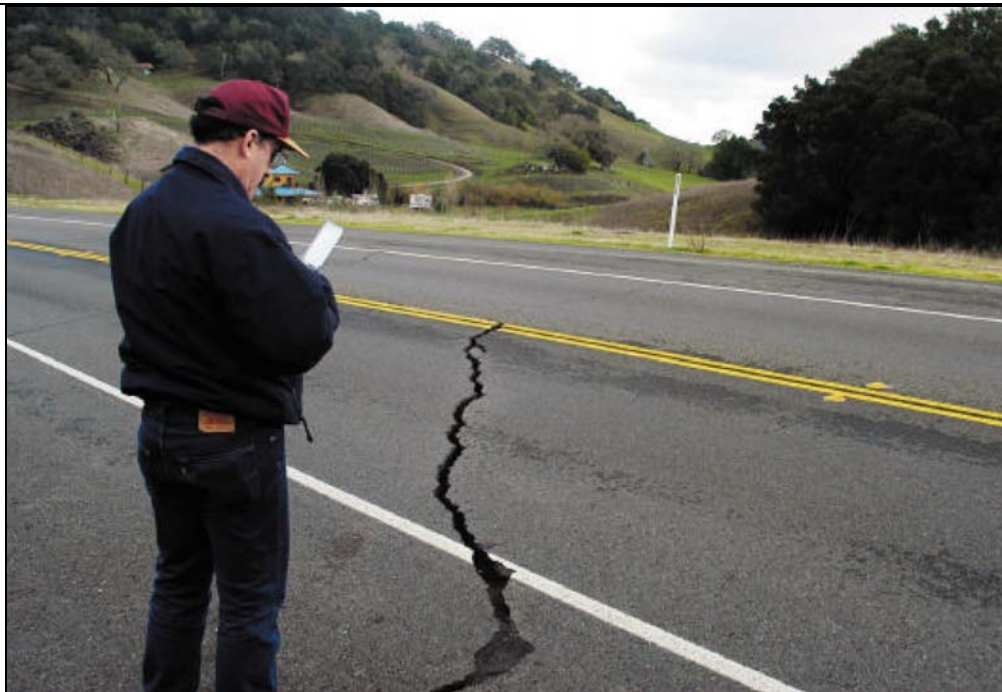
Lou Rosenberg (San Luis Obispo County Geologist) standing in front of damage to Highway 46.

The most significant road damage was to State Routes 41 and 46 between I-101 and I-1. Ron Richman, the District 5 Geotechnical engineer writes, *“We observed rock falls originating from cut slopes on Route 41. The Route 46 damage included surging of landslides, spreading of tall embankments and fissuring at the contacts between the original ground and tall embankments. We did not observe significant effects on the bridges in the region. We looked for indications of liquefaction, but found none.”* This damage was sufficient to keep Caltrans busy with repairs.

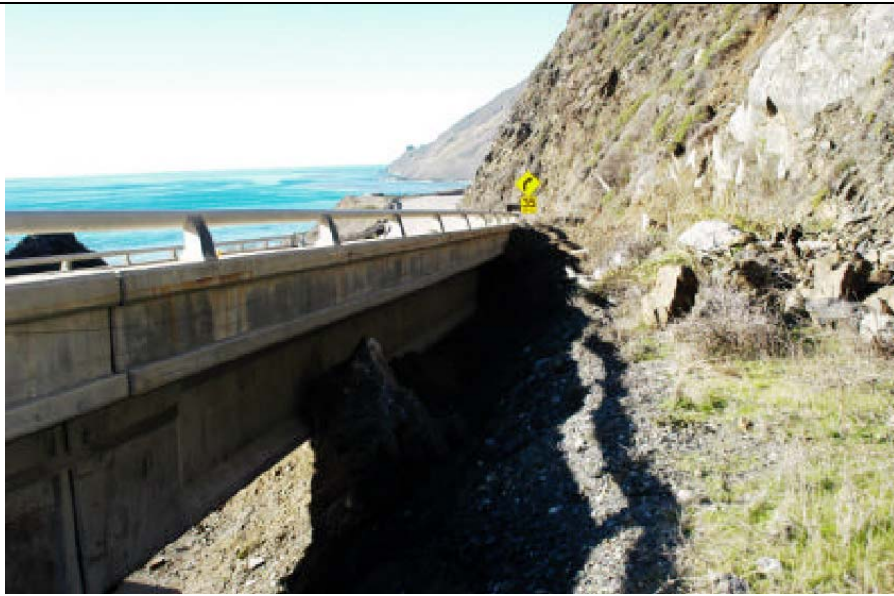
Villa Creek (State) Bridge (44 0028) in Monterey County.

Villa Creek Bridge, seven miles north of San Luis Obispo County, was the only Caltrans structure that was damaged during the earthquake. This is a five simple-span, precast girder structure on Highway 1, along the Pacific coast. The deck is supported on tall single column bents. The bridge was recently retrofit, which didn't protect it from a rockslide that put a hole in the northeast girder web. However, this damage did not reduce the girder's ability to carry traffic and the bridge remained open following the earthquake.

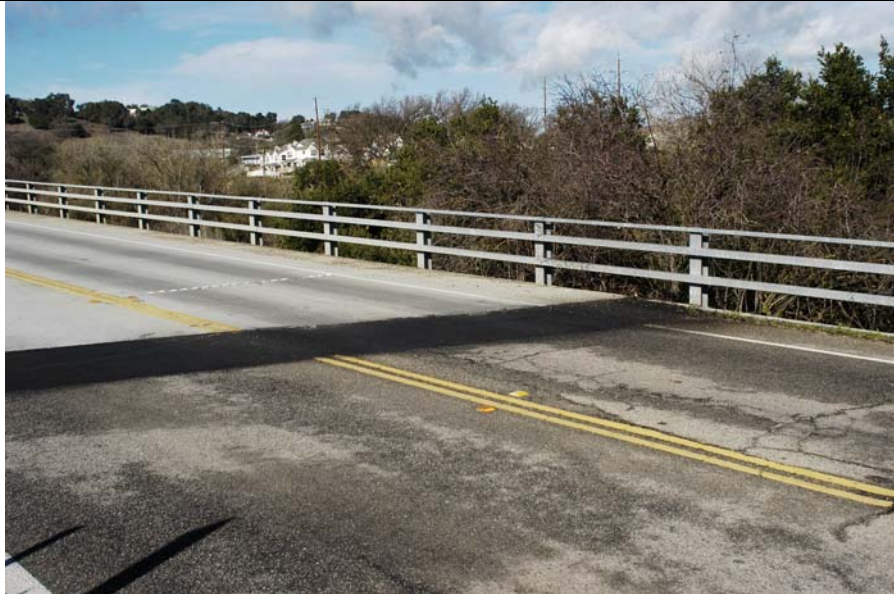
Templeton Road (County) Bridge (49C 0177) less than a mile east of I-101 in San Luis Obispo County.

The Templeton Road Bridge spans over the Union Pacific RR and the Salinas River. The west two spans are CIP girders and the east five spans are RC box girders. The superstructure is on flared, single column bents with piles and on seat and end diaphragm abutments on spread footings. The bridge was not retrofit. Most of the damage was due to liquefaction, settlement, and shaking of the superstructure. The approaches settled about 5 inches. The barrier rail and utility lines were also damaged. Soil borings were taken before a chip seal was placed at the approaches.

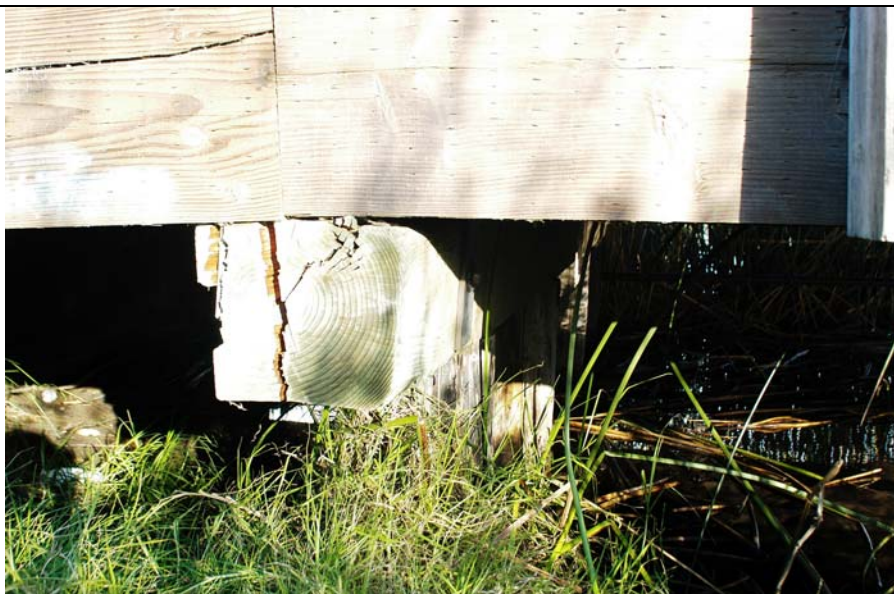
Lakeside Ave (County) Bridge (49C 0126) in Oceano.

A lagoon in Oceano frequently floods its banks. The town was built on the loose, saturated alluvium carried by these floods. This soil liquefied during the earthquake causing considerable damage. There are three timber trestle bridges that cross over the lagoon and they were all damaged due to lateral spreading. The seat-type abutments moved toward the lagoon cracking the timber stringers and splitting the timber bent caps. These bridges look fairly new and the lumber appears to have been recently purchased.
