Learning from Earthquakes

Preliminary Observations on the December 22, 2003, San Simeon Earthquake

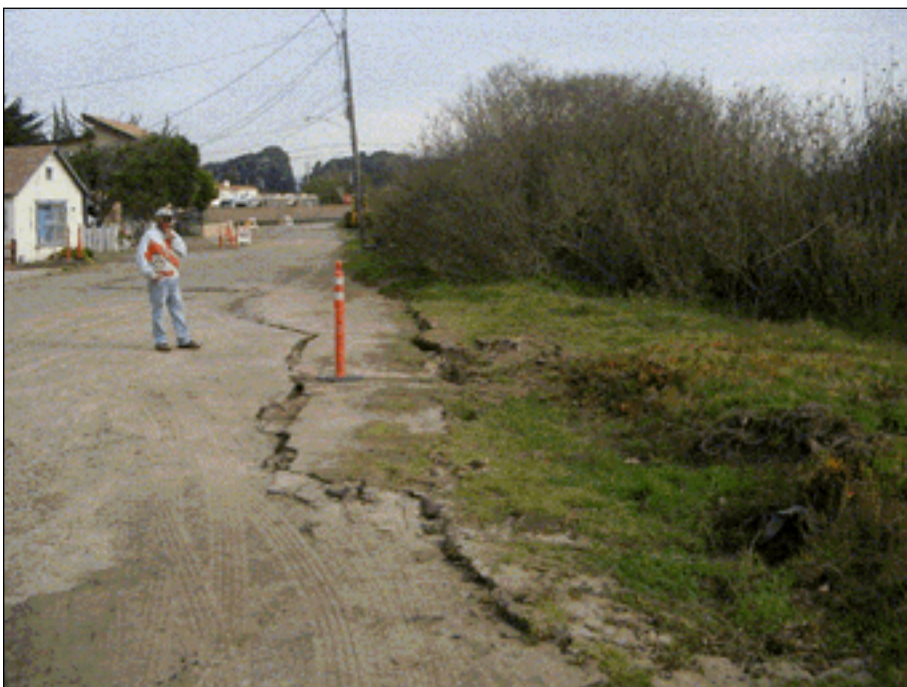
Several lateral spreads were observed near Oceano. A group from the reconnaissance team found substantial damage to homes, lifelines, roadways, and a sewage treatment plant there (Knudsen 2004). Spreads up to 180 m wide were observed, with maximum horizontal displacements on the order of 10-20 cm (Figure 4). It is thought that most of the liquefaction and lateral spreading at these Oceano locations is associated with artificial fills. There was also liquefaction and related settlement of the levee along Arroyo Grande Creek.

Figure 4. Lateral spread in Oceano (photo Knudsen).

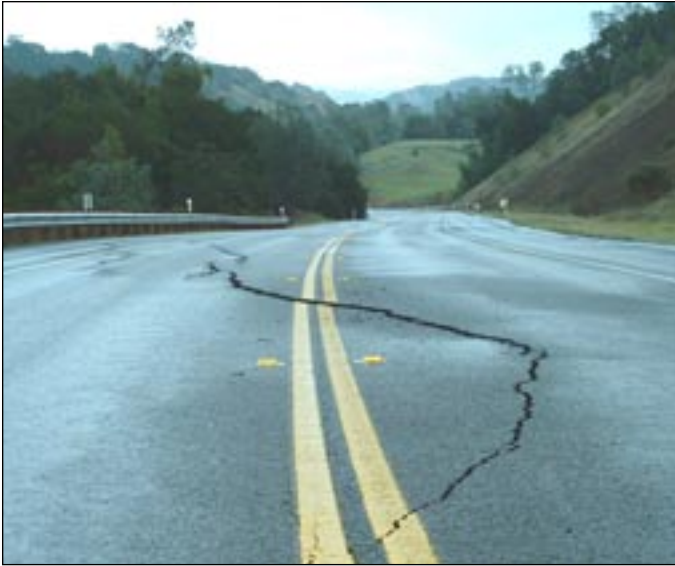
Seismic compression was prevalent along SR 46 and, to a lesser extent, along SR 41. Disruption of the asphalt produced large cracks with both horizontal and vertical offsets over significant lengths of these two highways. The strong ground shaking caused settlement of the road fills, resulting in sway-backed roads and large cracks in the asphalt pavement with vertical offsets on the order of 10 cm. Deep rotational slope instabilities in the road fills caused the scallop-shaped asphalt cracks shown in Figure 5. Settlement of bridge approaches and embankments also resulted in disruption of the pavement. Overall, the road damage occurred close to the southeast projection of the fault rupture.

Figure 5. Seismic compression and slope instability along SR 46 (photo Chadwell).

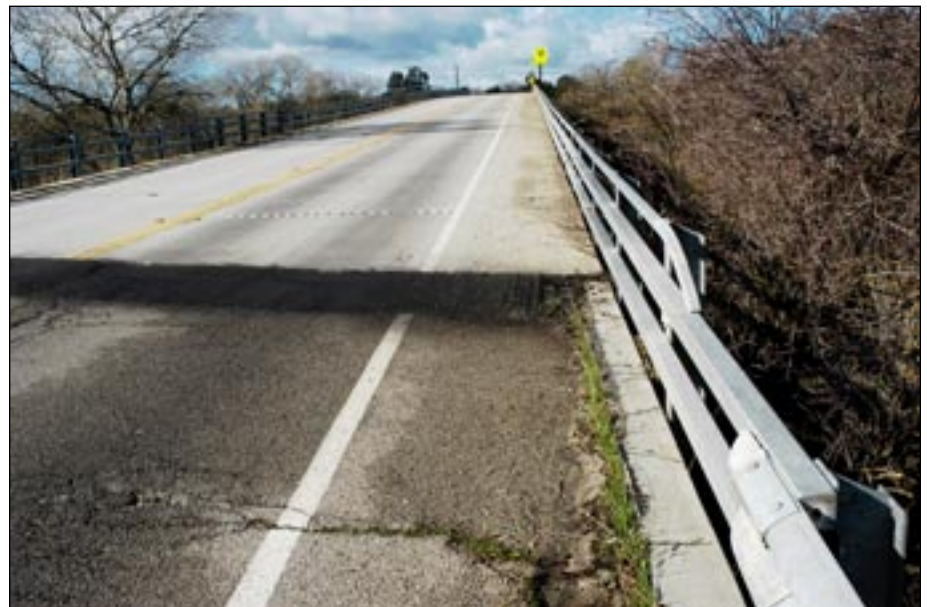
The Templeton Road Bridge, which spans over the Union Pacific Railroad and the Salinas River, had its approaches settle about 13 cm (see Figure 6). The barrier rail and utility

lines were damaged. The western two spans are cast-in-place girders and the eastern five spans are reinforced concrete box girders. The superstructure is on flared single-column bents with piles, and on seat and end diaphragm abutments on spread footings. Most of the damage was due to liquefaction, settlement, and shaking of the superstructure. The bridge was not retrofitted. Soil borings were taken before a chip seal was placed at the approaches.

Figure 6. Templeton Road Bridge approach settlement (photo Yashinsky)

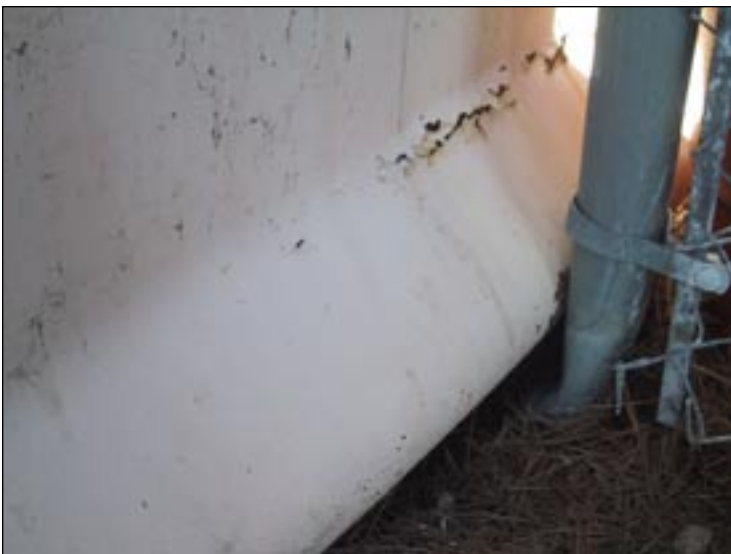
Water storage tanks in Paso Robles and Templeton had damage in the form of tank wall buckling (“elephant’s foot”), an example of which is shown in Figure 7. Additionally, pipe connection damage due to tank differential settlement occurred at several locations. There were few water repairs, except in the Oceano area where there was liquefaction.

Figure 7. Buckle and fence post (photo Eidinger).

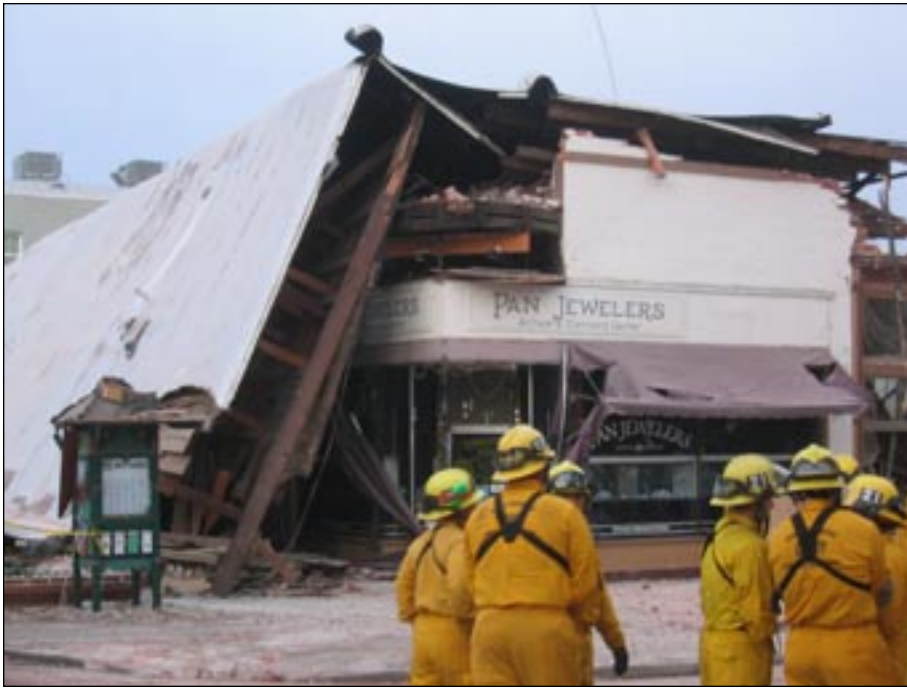
Figure 8. The collapsed Acorn building (photo Marrow).

The Acorn building, a historic, unreinforced masonry building dating to 1892, collapsed completely, causing the only two fatalities of the earthquake (Figure 8). The lateral-load-carrying system of this two-story building appears to have been unreinforced masonry walls supporting the timber floor and roof trusses. Neither the floor nor the roof seemed to have been even minimally tied to the walls. During the earthquake, the clock tower on the Park and 12th Street corner of the building collapsed and the second story wall on the Park Street side collapsed out-of-plane. The major shear resistance of this building was in the north-south direction, but, as

noted previously, the strong shaking was in the east-west direction.

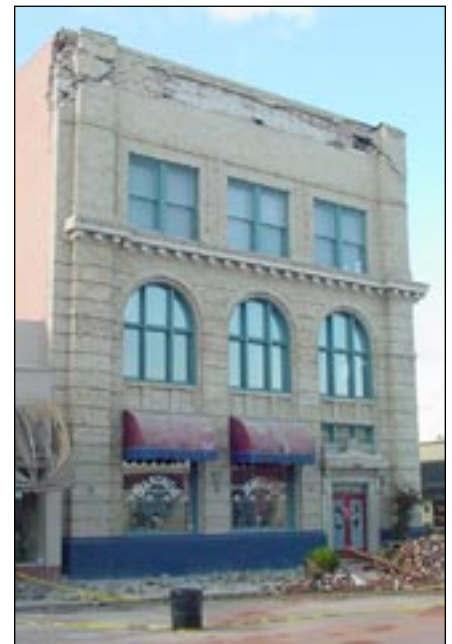
Other buildings suffered nonstructural damage to parapets and the external wythes of brick. The building in Figure 9 was reportedly partially retrofit prior to the earthquake. However, the veneer separated from the exterior URM bearing wall and fell to the sidewalk and street.

Figure 9. Nonstructural parapet and veneer brick damage (photo Lynn).

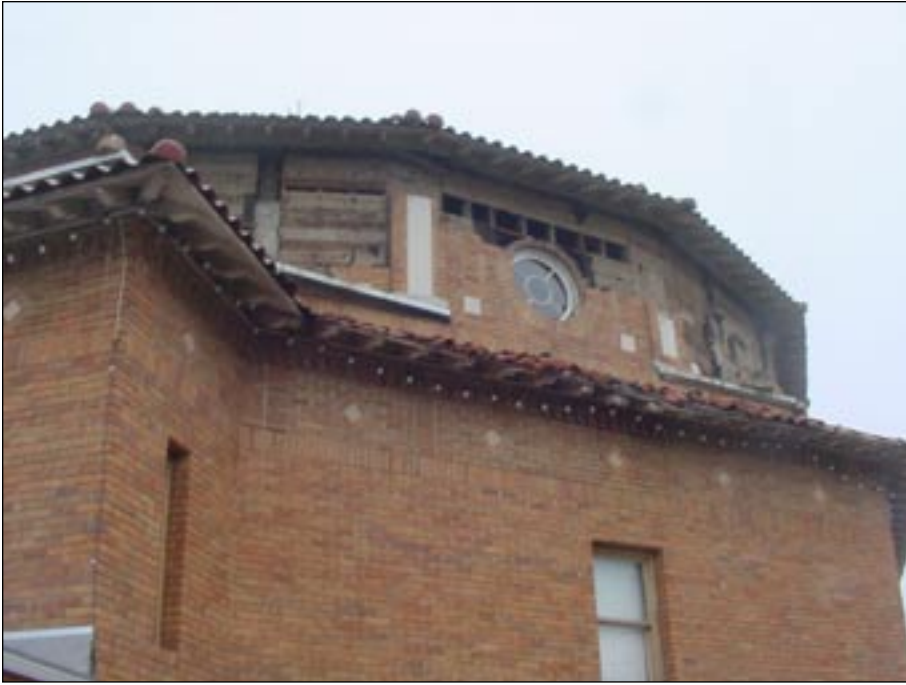
Atascadero: Built in 1918, the Atascadero City Hall consisted of a reinforced concrete space frame with brick façade. The exterior damage primarily consisted of cracks and severe spalling of the brick façade on the rotunda (Figure 10). Falling bricks from the façade took out a skylight and fell on the tables in a room located at the rotunda office level. The reinforced concrete space frame supporting the dome roof was

found to have suffered no damage. The parapet walls and interior dome structure — which were not damaged — had received a seismic retrofit in 1987.

Figure 10. Atascadero City Hall facade damage (photo Lynn).

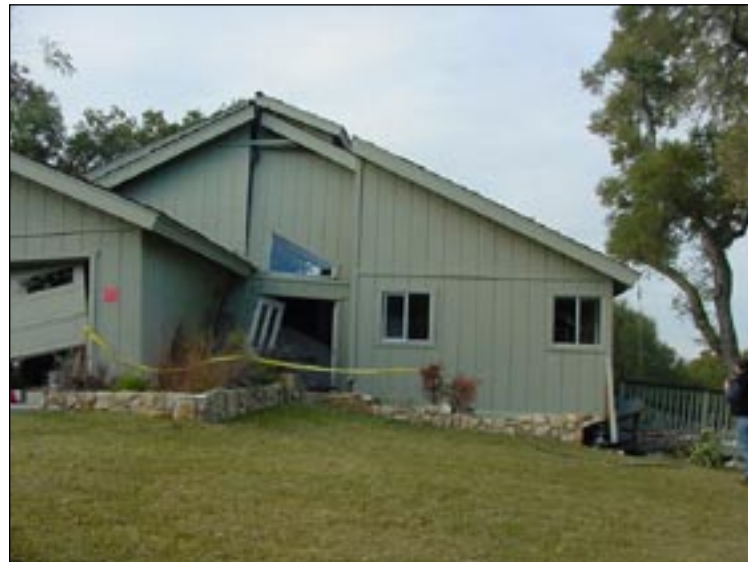
on San Gregorio Road moved off its foundation, suffered collapse of its cripple walls, loss of its chimney and porch, and separation into several sections (Figure 11). While the house had plywood siding and foundation bolts, in fact most of its damage appears to be caused by poor construction. Many of the nails fastening the plywood to the sill plate actually missed the sill plate, and there were fewer nails than required. There were also a number of severely damaged and collapsed residential structures in the region directly southeast of the epicenter. While there have been some suggestions that this damage is associated with ridge-top shattering, other houses along the same ridge did not appear to have suffered any significant damage.

Figure 11. Residential collapse in Atascadero (photo Lynn).

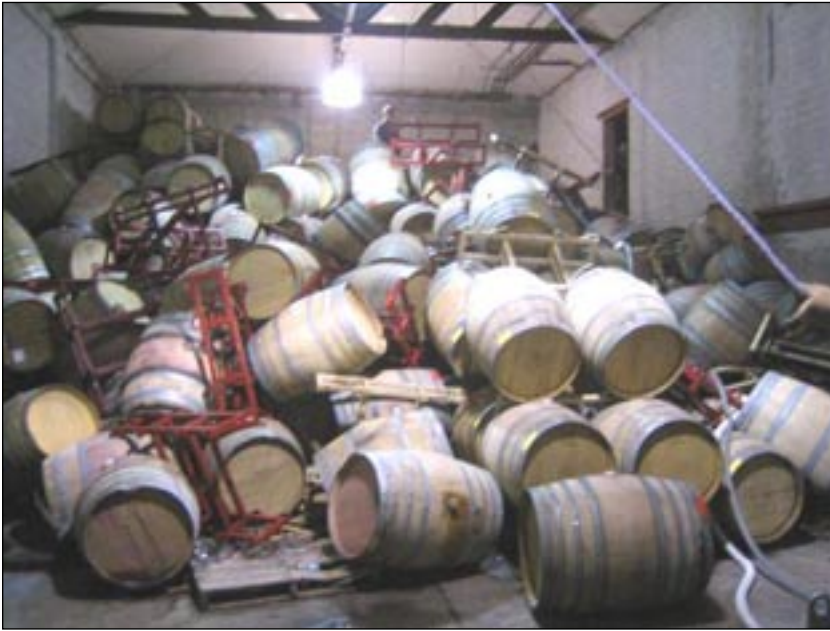
tles and glassware in the tasting rooms, to toppled wine barrel stacks (see Figure 12) and ruptured wine tanks. Generally, no major structural damage was reported or observed. The most heavy winery damage was centered along SR 46, south-east of the epicenter.

Wineries reported losses of millions of dollars where barrels toppled and burst. Wine barrels stacked three levels high on two-barrel portable steel wine barrel racks fell when the

Figure 12. Collapsed wine barrel stacks at Turley Wine Cellars, SR 46 near Paso Robles (photo Marrow).
