## PRELIMINARY REPORT ON DECEMBER 22, 2003 SAN SIMEON EARTHQUAKE

Rakesh K. Goel, M.EERI

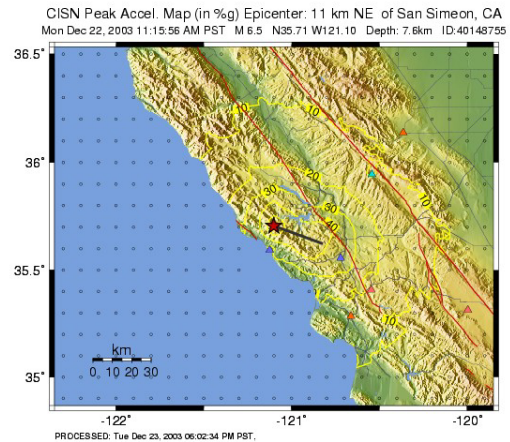
Figure 6. Peak ground acceleration map (CISN).

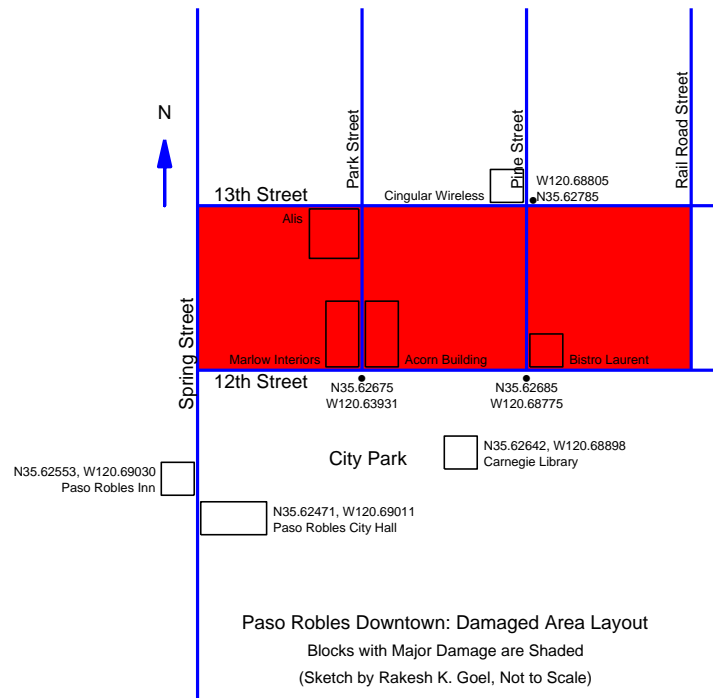
**Figure 7. Damaged area in downtown Paso Robles.**

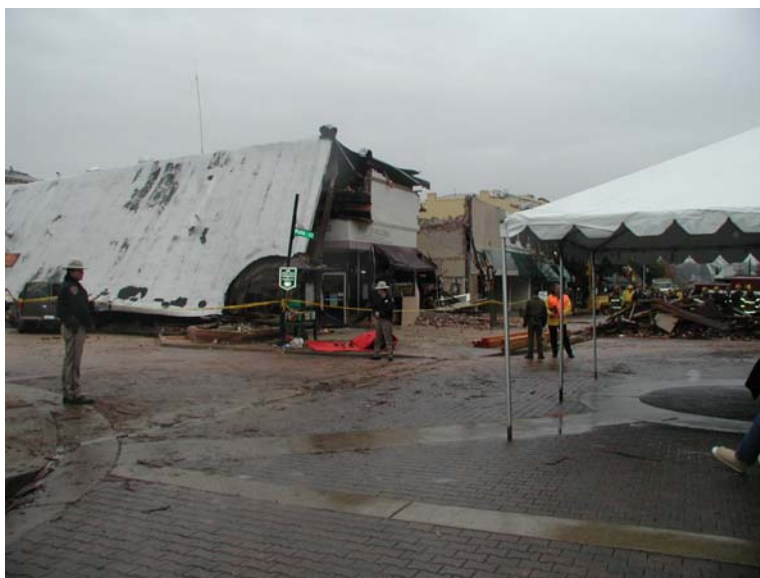
**Figure 8. Collapsed Acorn building on the corner of 12<sup>th</sup> and Park Streets in downtown Paso Robles (Picture by Rakesh Goel).**

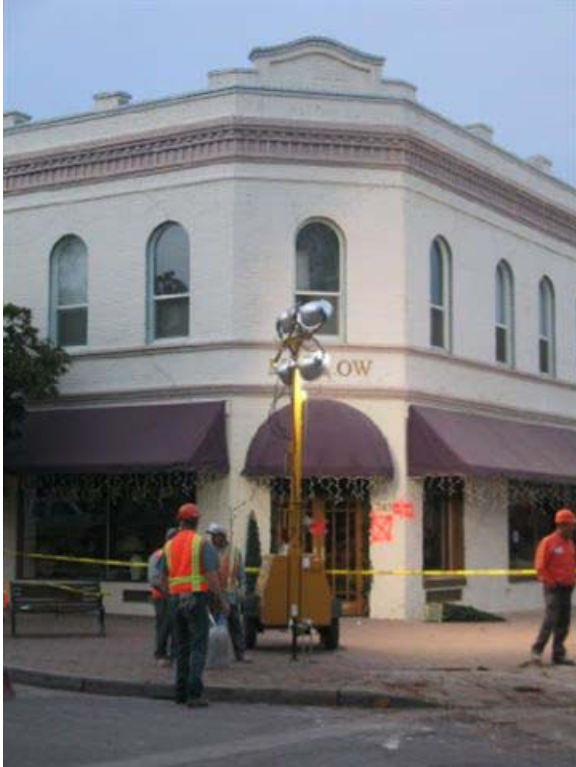
Figure 9. Marlow Interior building located at the corner of 12<sup>th</sup> and Park Streets in downtown Paso Robles (Picture by Josh Marrow).

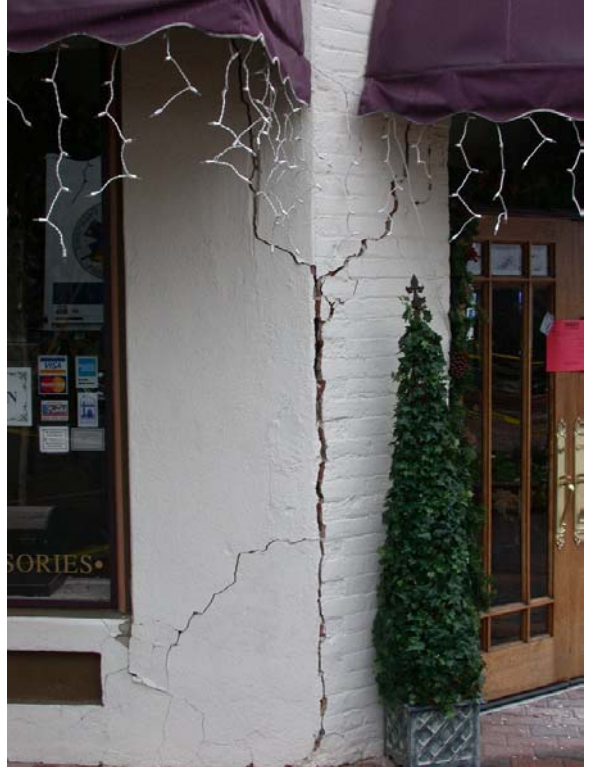
Figure 10. Large cracks at the corner of the Marlow Interior building (Picture by Sam Vigil).

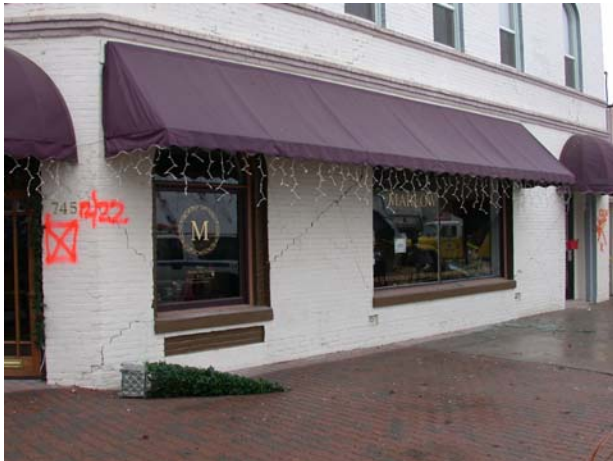
Figure 11. Crack pattern in the first story of the Marlow Interior building on the Park Street face (Picture by Sam Vigil).

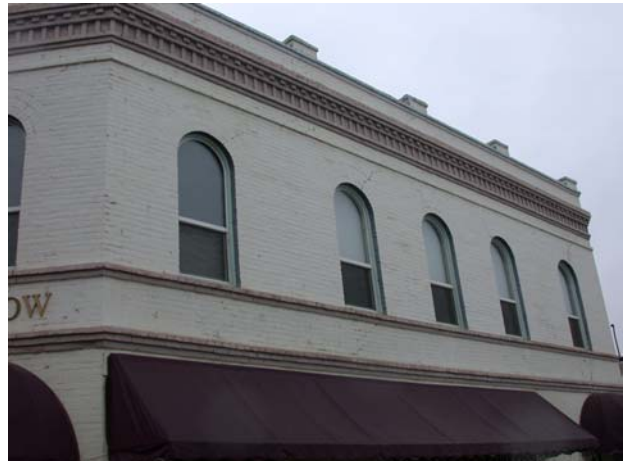
Figure 12. Crack pattern in the second story of the Marlow Interior building on the Park Street face (Picture by Sam Vigil).

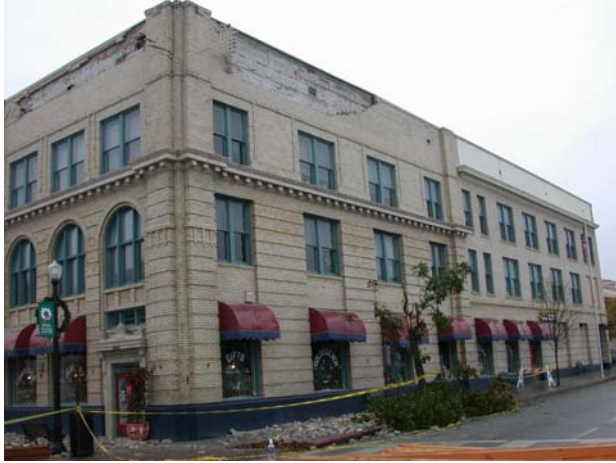
Figure 13. Peeling of the brick facade in the second story of the Ali's Persian Rug building on the corner of Park and 13<sup>th</sup> Streets in downtown Paso Robles (Picture by Sam Vigil).

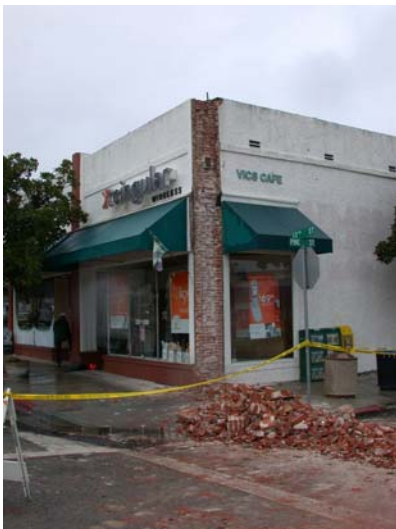
Figure 15. Damage to the Cingular Wireless building on the corner of Pine and 13<sup>th</sup> Streets in downtown Paso Robles (Picture by Sam Vigil).

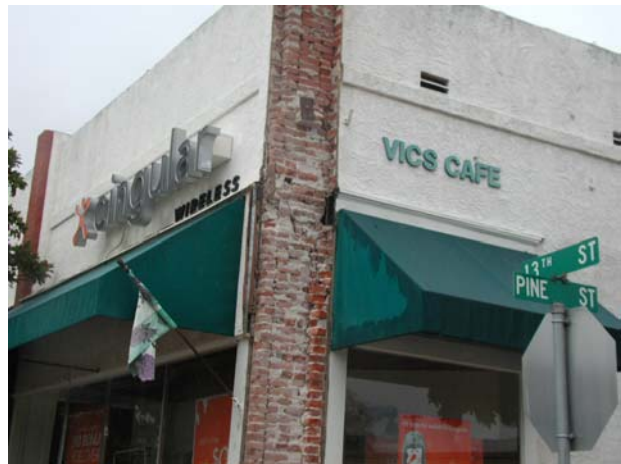
Figure 16. A close-up view of the seismic retrofit anchors in the Cingular Wireless building (Picture by Rakesh Goel).

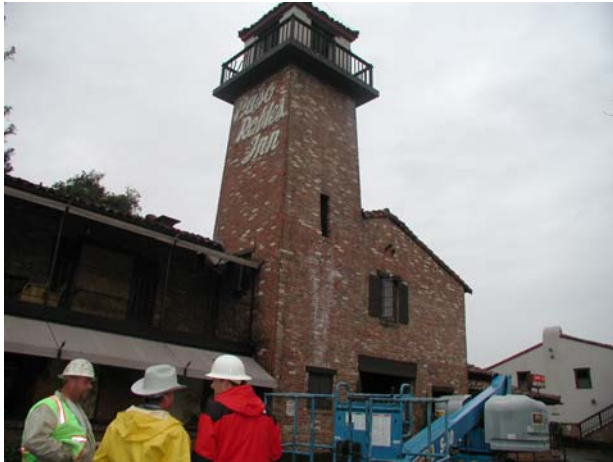
**Figure 17. Observation tower of the Paso Robles Inn on Spring Street in Paso Robles (Picture by Rakesh Goel).**

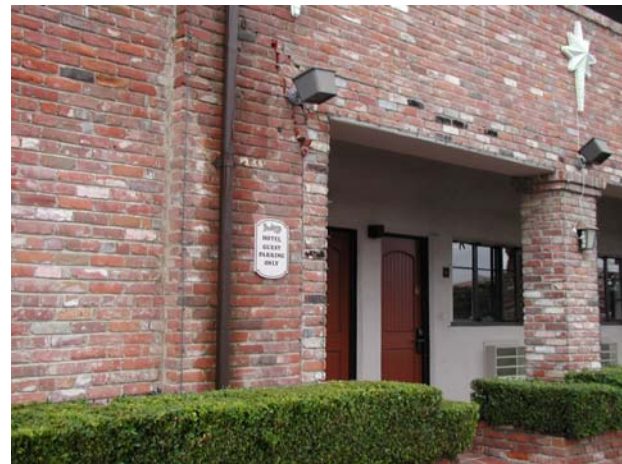
**Figure 20. Cracks in the brick walls of the guest quarter building at the Paso Robles Inn (Picture by Rakesh Goel).**

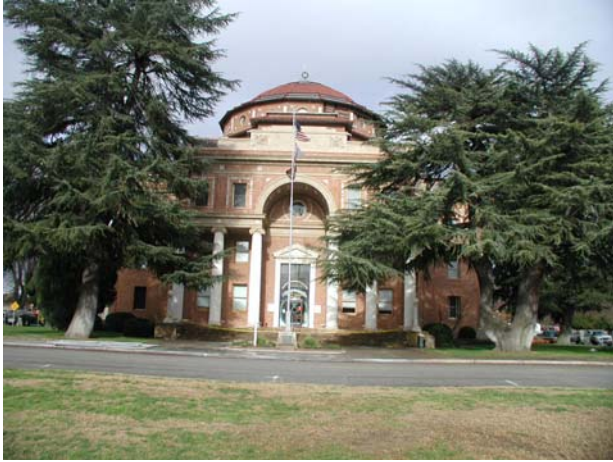
Figure 21. Atascadero City Hall (Picture by Rakesh Goel).

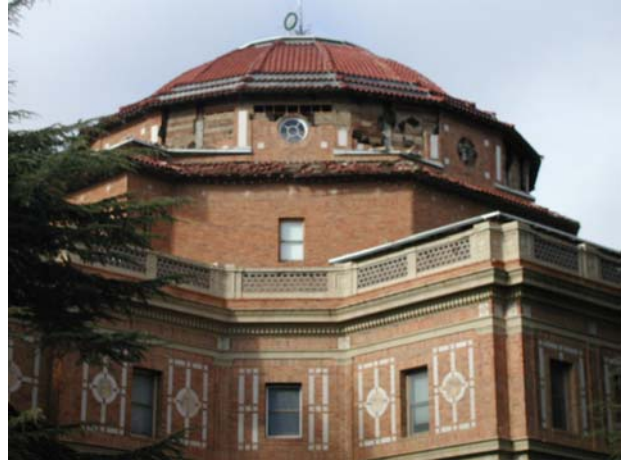
Figure 22. Peeling of brick façade from the rotunda of the Atascadero City Hall (Picture by Rakesh Goel).

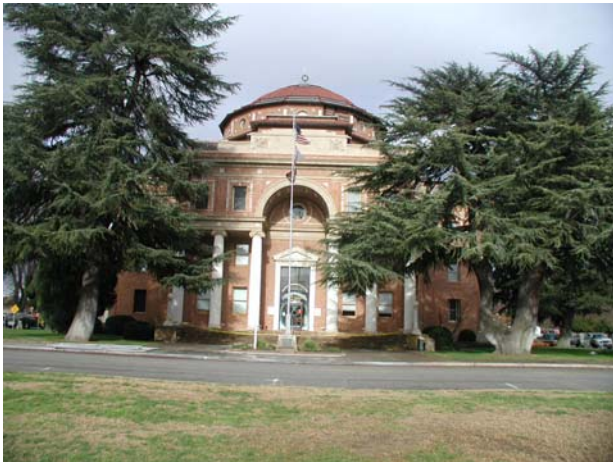
Figure 21. Atascadero City Hall (Picture by Rakesh Goel).

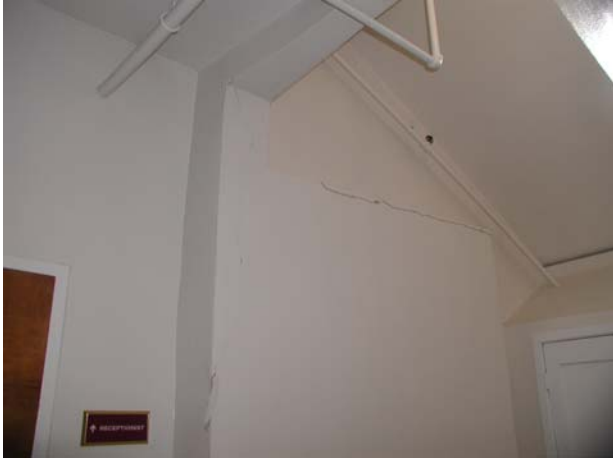
Figure 23. Typical cracks in the walls of Atascadero City Hall (Picture by Rakesh Goel).

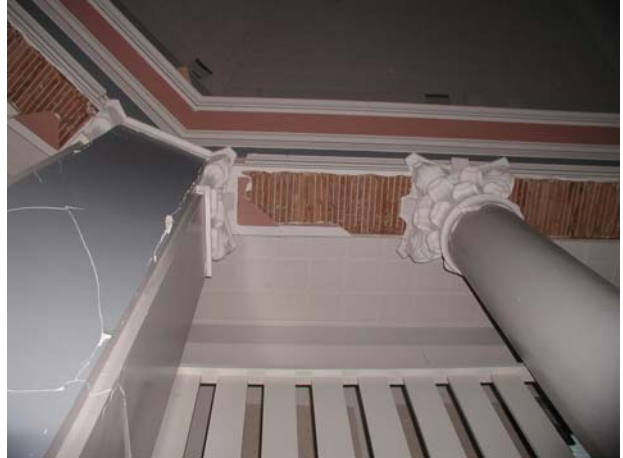
Figure 24. Peeling of plaster from ring beam of the rotunda of the Atascadero City Hall (Picture by Rakesh Goel).

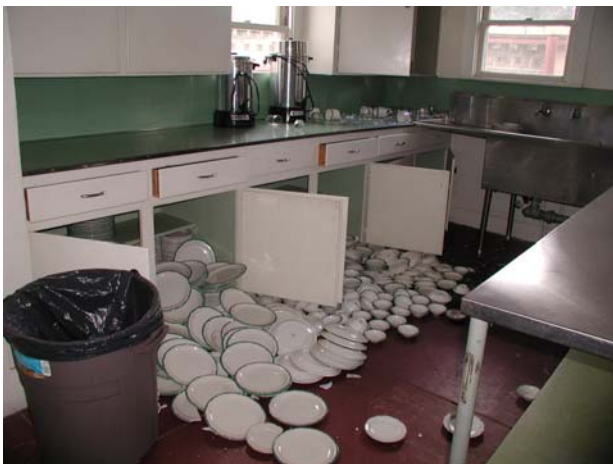
Figure 25. Damage in the kitchen of Atascadero City Hall (Picture by Rakesh Goel).

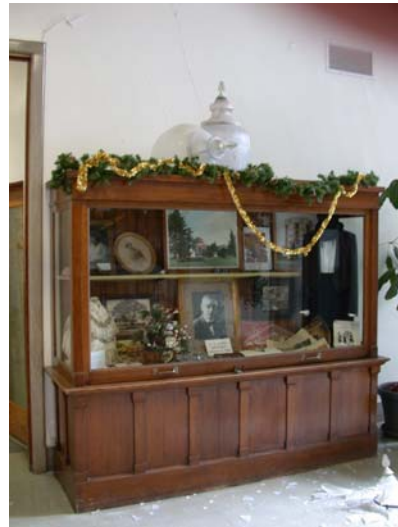
Figure 24. Damage in the lobby of the Atascadero City Hall (Picture by Sam Vigil).

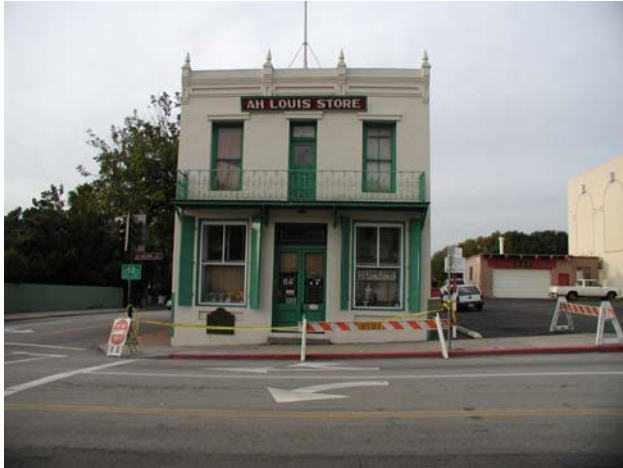
Figure 25. Ah Louis Store in downtown San Luis Obispo (Picture by Rakesh Goel).

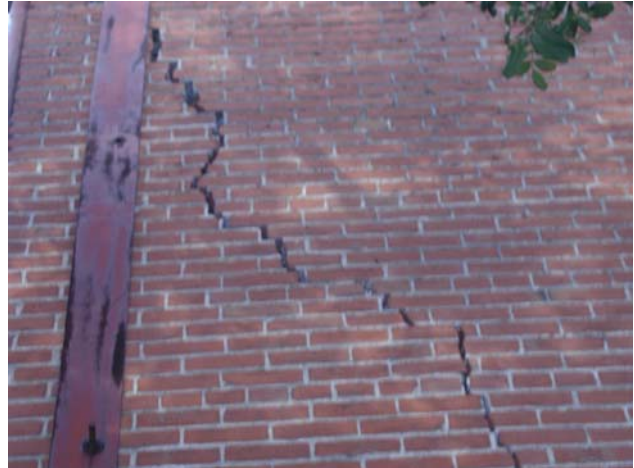
Figure 26. Cracks existing prior to the earthquake and attempt to retrofit on the south-west wall of the Ah Louis Store building (Picture by Rakesh Goel).

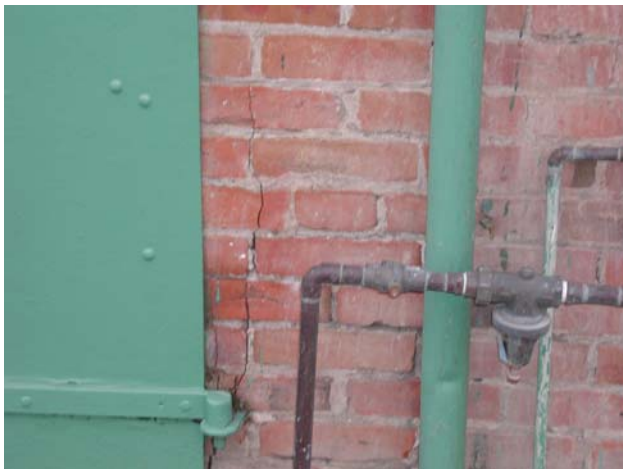
Figure 27. New cracks on north-east wall of the Ah Louis Store building (Picture by Rakesh Goel).

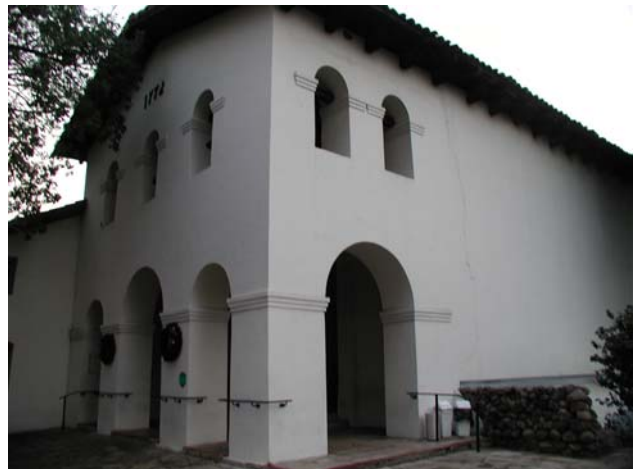
Figure 28. Widening of cracks at junction of the bell tower and adjacent building in the Mission San Luis Obispo de Tolosa in downtown San Luis Obispo (Picture by Rakesh Goel).

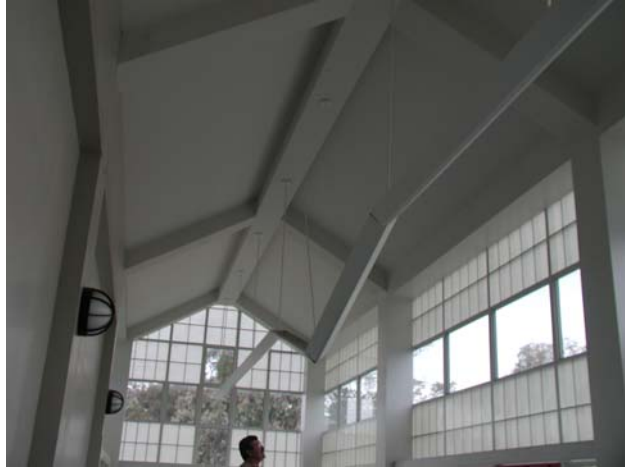
**Figure 29. Damage to a light fixture in Recreational building on the Campus of California Polytechnic State University, San Luis Obispo (Picture by Rakesh Goel).**
