Learning from Earthquakes

Preliminary Observations on the Tecomán, Colima, Mexico, Earthquake of January 21, 2003

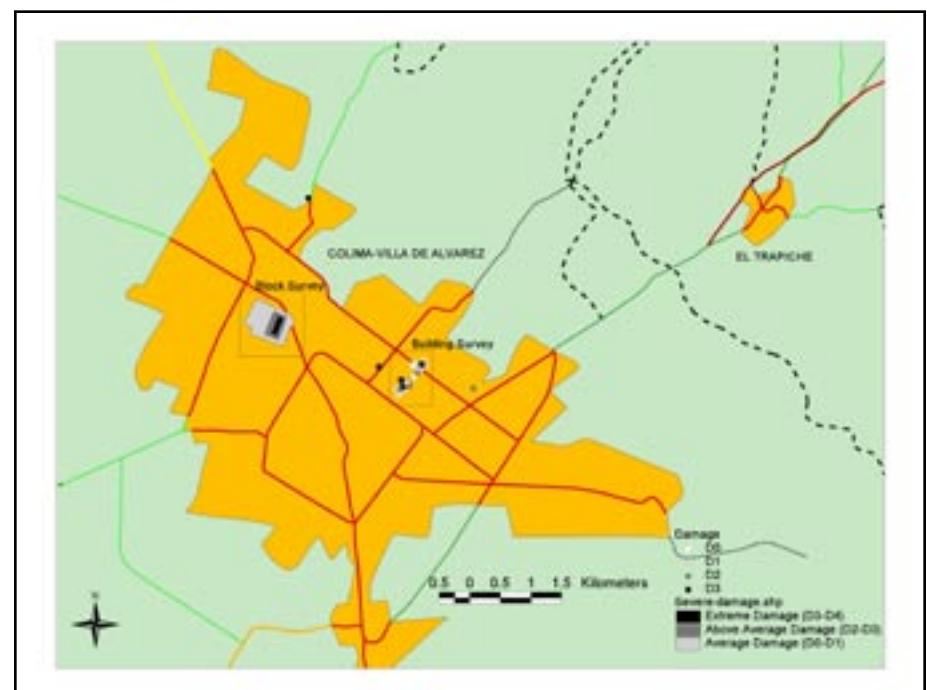
Damage surveys in the conjoined cities of Colima and Villa de Álvarez indicated locations of damage concentration around the neighborhoods of San Isidro (Villa de Álvarez) and Lomas de Circunvalación (Colima) (see Figure 4). In addition, damage to adobe housing in downtown Colima was extensive. Damage surveys were carried out using PQuake software (Georgia Institute of Technology), which directly integrates digital photography and handheld GPS technology to facilitate documenting, mapping, analyzing, and visualizing damage data. The use of PQuake permitted a digital data set of the earthquake effects to be created in a timely manner. Damage surveys were performed either by assigning an average damage index (D0 = no damage, D5 = collapse) to a whole block (Block Survey), or by assigning damage indices to individual buildings.

Figure 4 - Damage survey map of the city of Colima indicating areas of high damage concentration.

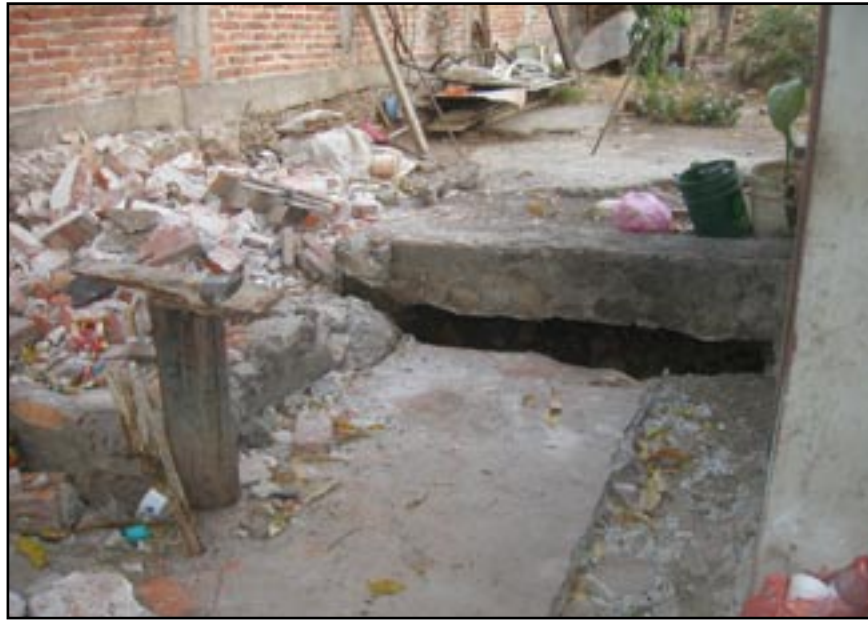
The San Isidro neighborhood is located near the Arroyo de Pereira, a small creek running north to south across Colima/Villa de Álvarez. Most of the damaged area overlies highly heterogeneous fill. Evidences of liquefaction were found in areas of high damage concentration. Significant ground settlement was observed at some locations, possibly due to collapse of poorly compacted fills (Figure 5). There were numerous reports of open-pit sand mining earlier in the 1900s at this location. Poor filling of these pits could explain localized zones of large surface settlement. Although construction quality in the San Isidro neighborhood is poor, other neighborhoods with similar construction did not suffer as much damage.

Figure 5 - Large settlements in a house in the San Isidro neighborhood, possibly due to collapse of poorly consolidated fills.

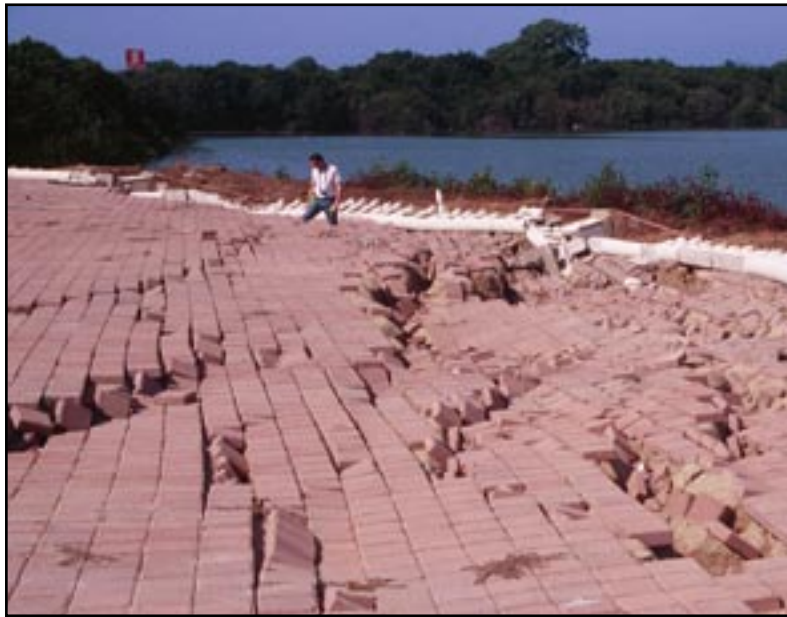
A majority of the waterfront liquefaction sites in Manzanillo were marked by lateral spreading of the ground toward the free face. The horizontal displacements varied between sites, but were often in the range of 1-3 m. Figure 6 shows lateral spread of a pedestrian promenade located off a major boulevard. The promenade surface consisted of paving blocks, whose positions after the earthquake clearly preserve the deformations caused by lateral spreading. Apparently, a 0.2-0.5 m thick crust of silty sand moved over an unknown thickness of liquefied ground. An overturned concrete railing is visible near the right portion of the photograph. The ground slope was about 3%, and maximum lateral spread displacements at the site were on the order of 2 m.

Figure 6 -
Liquefaction-induced lateral spread in Manzanillo (for scale, each paving block is 0.20 m square).

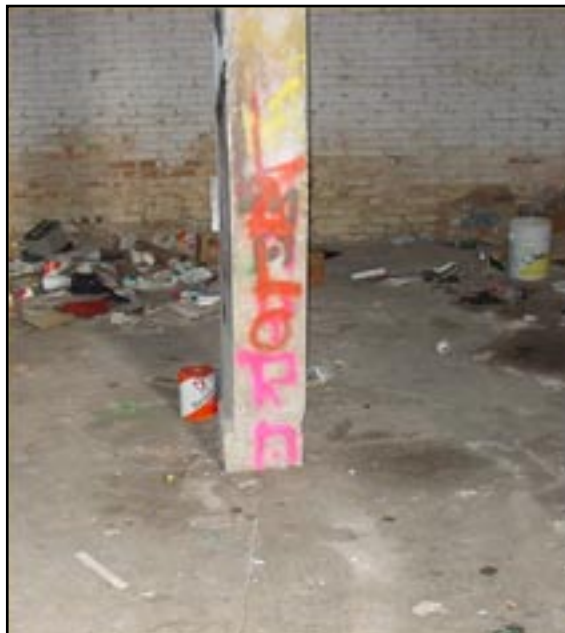
Figure 7 shows a concrete column supporting a modern three-story residential structure located in the Colima neighborhood damaged by liquefaction. It is typical construction practice in Colima to support columns and load-bearing walls on shallow foundations consisting of spread and wall footings. During the earthquake, the column experienced a loss of bearing capacity and dropped about 30 cm, causing significant structural damage to the building.

Figure 7 -
Bearing-capacity failure in Colima. The column dropped through the floor of the structure, ultimately settling about 0.3 m.

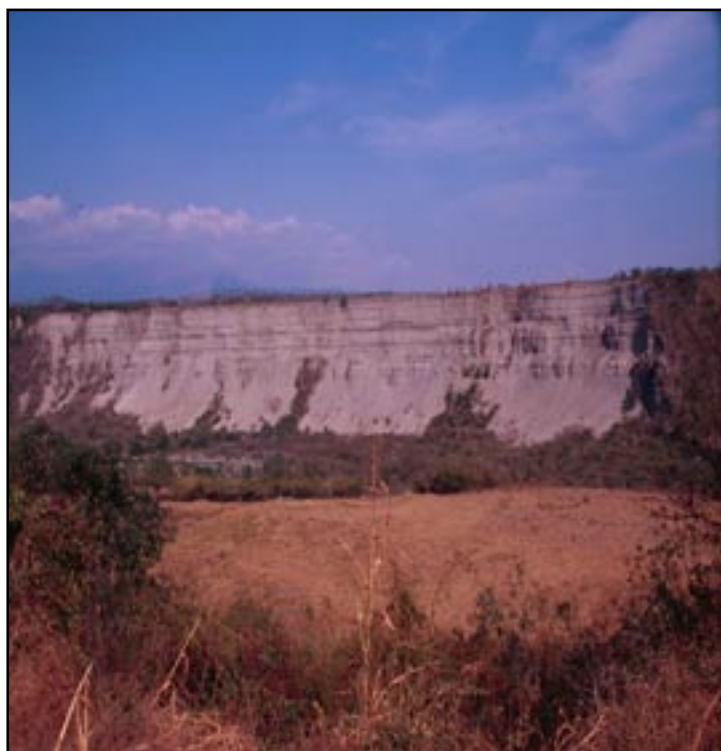
Figure 8 - Stretch of cliff along Rio Armería northwest of Colima denuded by landslides during the earthquake. Before the earthquake, this stretch of slope was reportedly vegetated in a manner similar to the intact stretch of slope at the extreme right of the photograph.

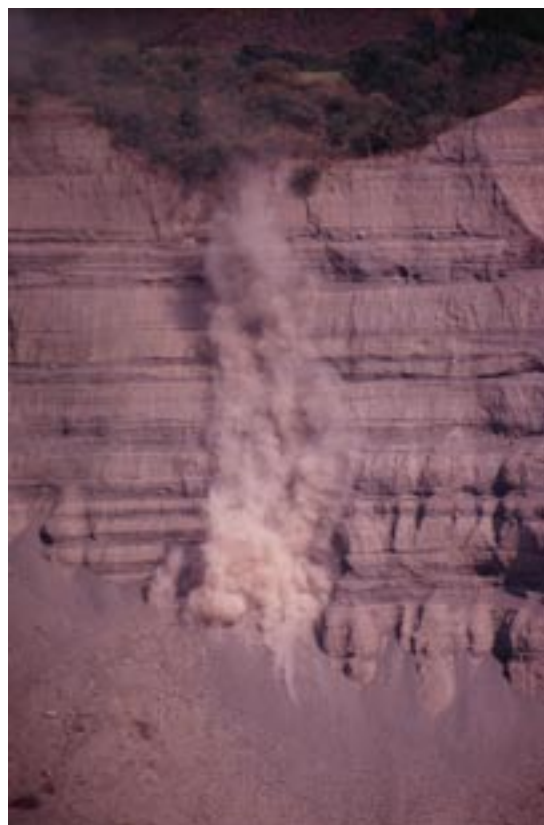
When this area was inspected on the ground on January 28 and again on January 31, the cliffs were so unstable that they were still producing several falls each minute (Figure 9). On January 31, in fact, 20 falls occurred in 15 minutes along a single section of cliff 1 km long, suggesting that approximately 2,000 falls were occurring there each day. These falls were typically small, ranging from a few cubic meters to perhaps 50 m³ of

material each. The continuing instability of these cliffs, exacerbated by the ongoing removal of material by falls, indicates a possible continuing hazard to villages, dwellings, and other infrastructure in the areas located close to the cliffs.

Figure 9 - One of the larger falls observed from the Rio Armería cliffs on the afternoon of January 28, 2003, which had an estimated volume of 20 m³.

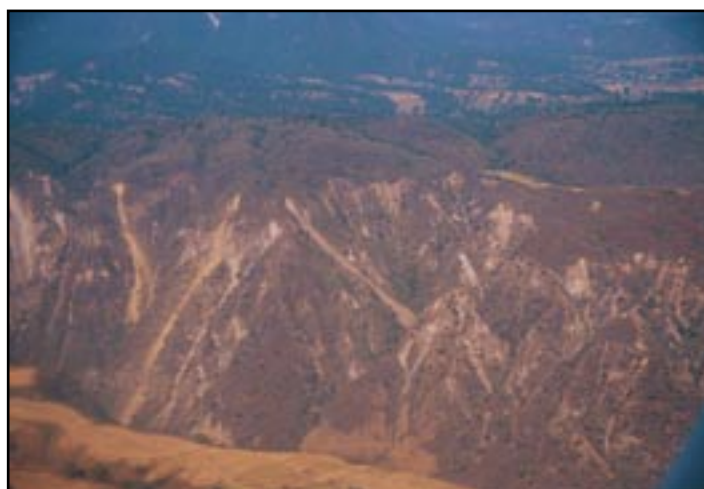
Figure 10 - Landslides along one stretch of canyon wall in the Barranca de Atenquique, on the east flank of Nevado de Colima volcano.

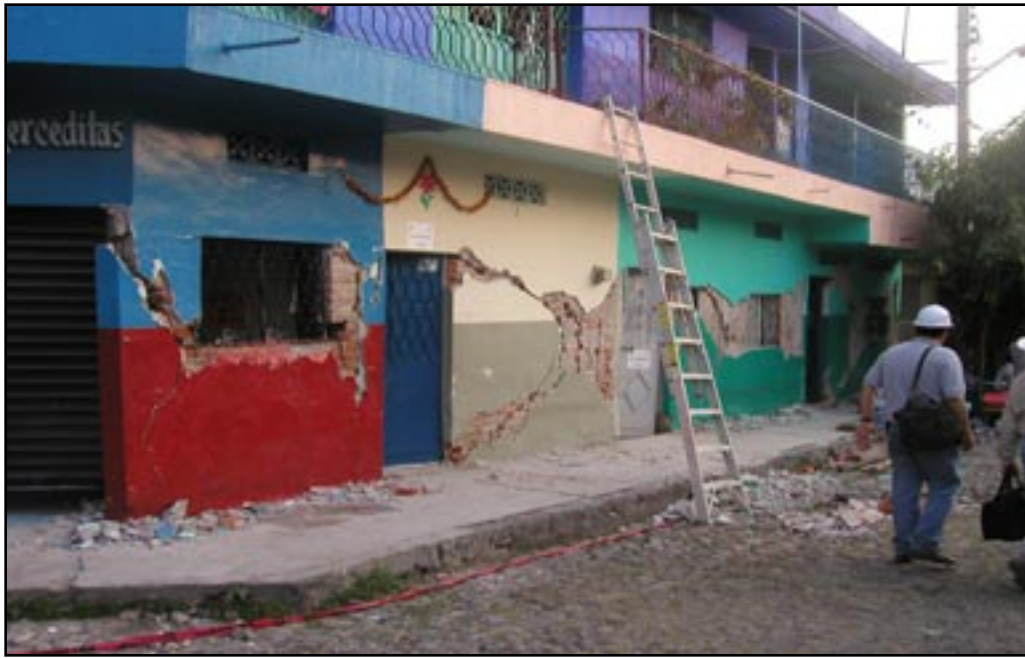
Figure 12 - Typical damage to unreinforced masonry structures.

bined with inadequate out-of-plane strength due to a lack of reinforcement; and in-plane shear failures occurred separately or in combination with out-of-plane failure. Increases in in-plane stiffness and strength due to stucco were lost as the stucco spalled off due to lack of mechanical anchorage. Due to the absence of reinforcement, combined in- and out-of-plane failure often led to collapse of walls and structures (Figure 12).

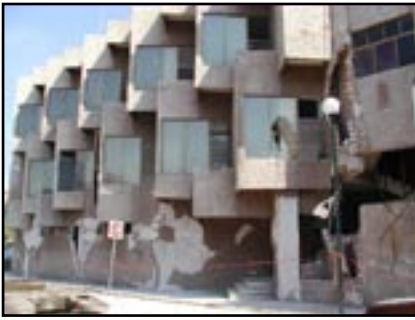
Figure 13 - Example of lack of structural continuity of vertical and horizontal elements.

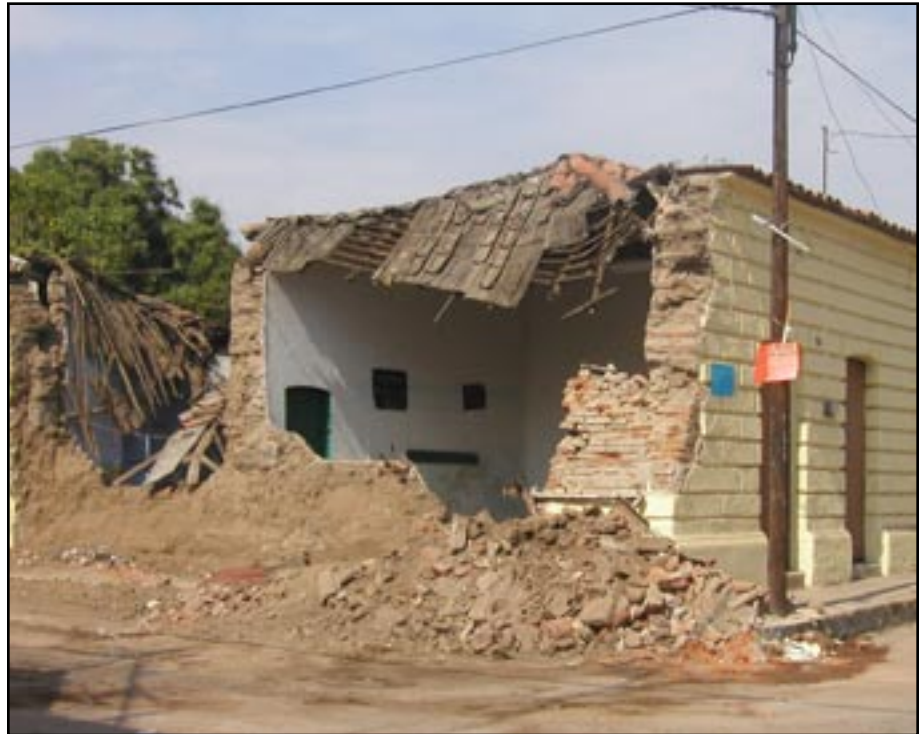
material, structural performance was clearly enhanced by aspects of building configuration: presence and symmetrical location of shear walls; absence of large openings in street level walls; and continuity of vertical and horizontal elements (figure 13). Location within a block was also important. Corner buildings appeared to suffer relatively heavy damage, due to a combination of the effects of openings in walls, and the plan eccentricity between the center of mass (generally located near the plan center of the building) and the center of rigidity (generally located near the interior corner of the building plan). This plan eccentricity led to heavy damage in the shear-resisting elements on the corner façade of the building, and sometimes to collapse of the exterior walls near the corner (Figure 14).

Figure 14 - Typical damage to adobe structure at the corner of a block.

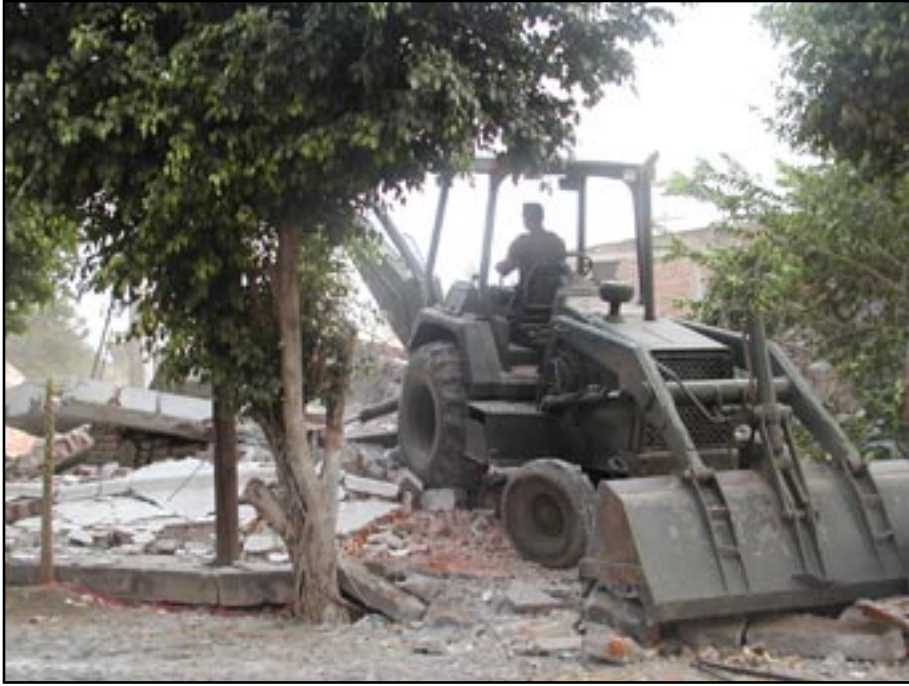
Figure 17 - Demolition by the Mexican military of adobe structures categorized as totally damaged.

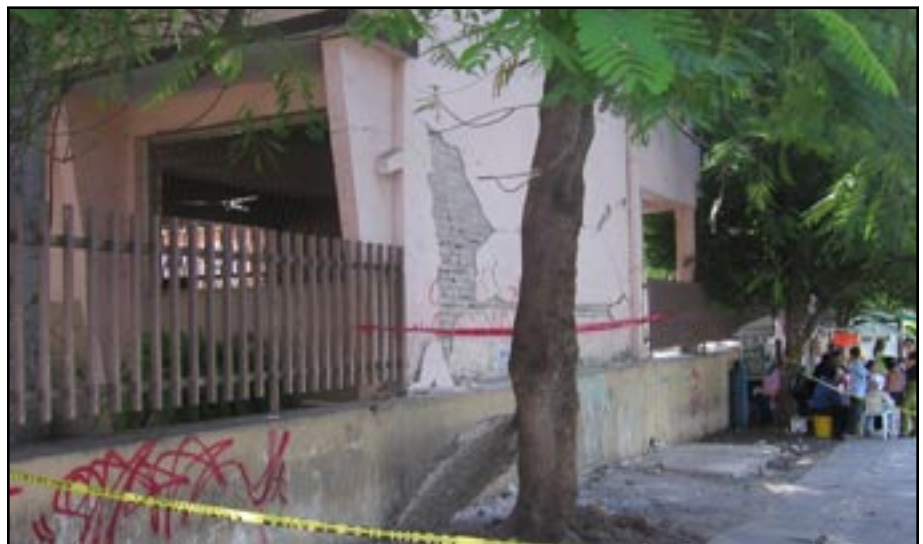
Figure 18 - Damage to a school building.

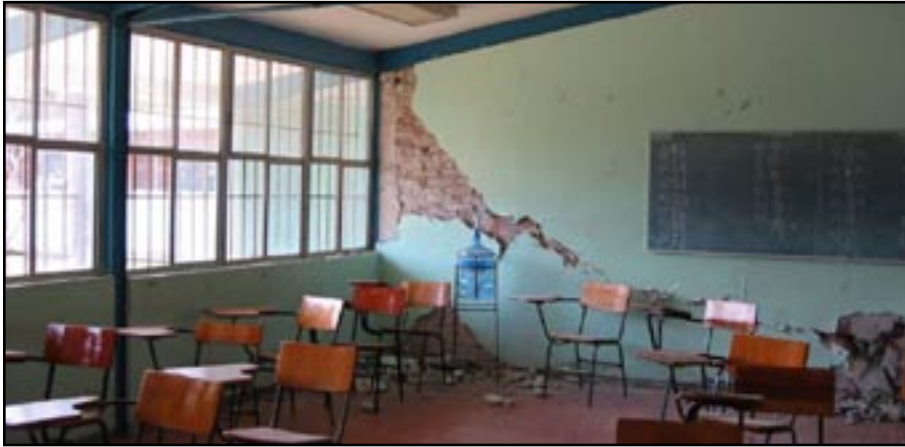
Figure 19 - Inclined cracking in an infill wall of a school building in the village of Ixtlahuacan. The structure of the school is made of light gage steel members.
