## Learning from Earthquakes

# The M<sub>w</sub> 7.1 Darfield (Canterbury), New Zealand Earthquake of September 4, 2010

From September 8th to 20th, 2010, a team organized by the Earthquake Engineering Research Institute (EERI) and the Pacific Earthquake Engineering Research (PEER) Center investigated the effects of the Darfield earthquake. The team was led by Mary Comerio, UC Berkeley, and included Lucy Arendt, University of Wisconsin, Green Bay; Michel Bruneau, University of Buffalo, New York; Peter Dusicka, Portland State University; Henri Gavin, Duke University; Charles Roeder, University of Washington; and Fred Turner, California Seismic Safety Commission. Additionally, individuals sponsored by their organizations, or already in New Zealand, joined the team: Tao Lai, AIR Worldwide Corporation; Rob Williams and Oliver Boyd, US Geological Survey; Myrto Anagnostopoulou, University of Buffalo; and William Holmes, Rutherford and Chekene, LFE Program Manager. Thomas O'Rourke of Cornell University visited Christchurch the week of October 11th.

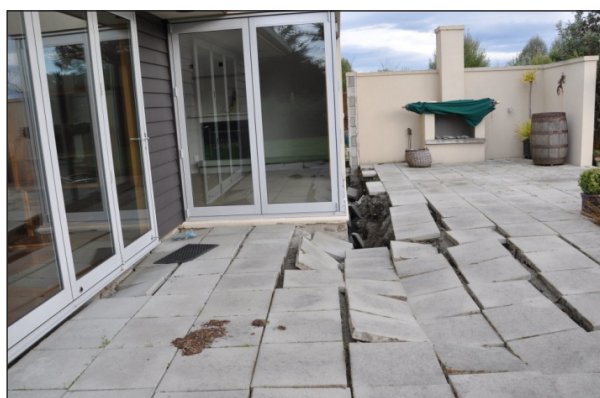
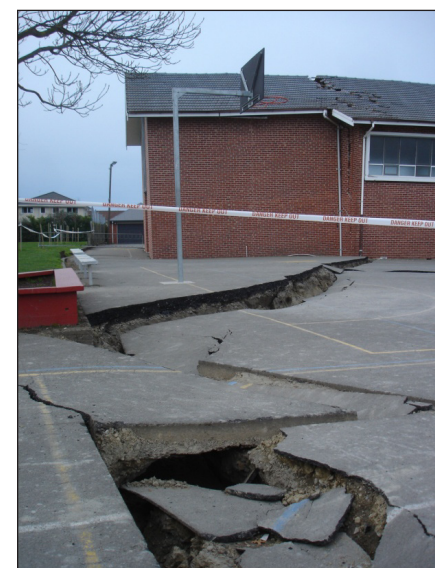
**Figure 3.** Structures damaged by lateral spreading and post-liquefaction differential settlement. (a) ▲ Residential structure in Spencerville; (b) ► St. Paul's Church in Dallington (photo: Green).

By far one of the greatest impacts of this earthquake on the residents in the Canterbury region was the lateral spreading and post-liquefaction differential settlement that damaged numerous residential and other structures (Figure 5). Particularly hard hit were the Christchurch neighborhoods of Dallington, Avonside, and Bexley, outlying neighborhood of Halswell (southwest of Christchurch), outlying neighborhoods of Spencerville and Brooklands (northeast of Christchurch), and Kaiapoi and Pines Beach (northeast of Christchurch, north of the Waimakariri River).

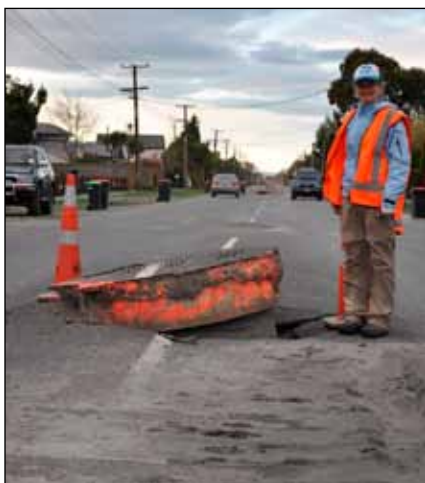
The hardest hit communities in Christchurch were perhaps Spencerville and Brooklands. Two weeks after the earthquake, neither community had functioning wastewater collection systems, and Brooklands was without potable water. Liquefaction along Lower Styx road, the primary connection between these two communities, caused ground subsidence, raised the water table, and uplifted 25 manholes. Separation between the manholes and the road surface was 28-46 cm (Figure 4).

**Figure 4.** Uplifted manholes along Lower Styx road. (photo: Green)

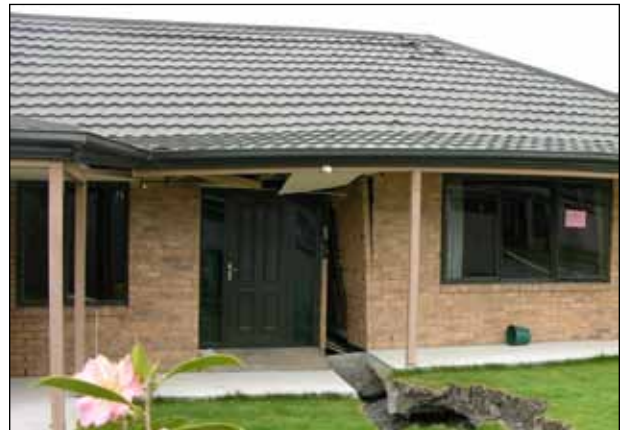
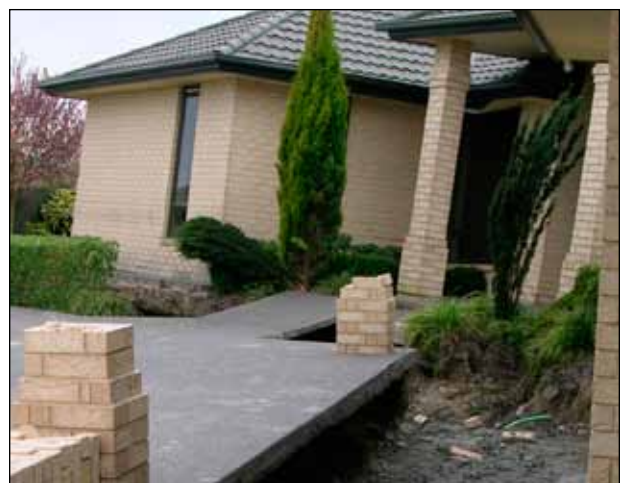
**Figure 5.** (a) ▲ Large lateral spreading like a rupture passed through the foundation near Courtenay Drive in Kaiapoi. (b) ▼ This house slid more than 1.2 m and tilted significantly (near Courtenay Drive in Kaiapoi) (photos: Lai).

As an example of the complications involved, Figure 5 shows two dwellings in Kaiapoi that were severely damaged due to large lateral spreading. In the first photo, the lateral spreading created a large ground rupture passing through the foundation and leaving this house uninhabitable. In the second case, the entire house moved, mostly with the surrounding soil about 1.2 meters to the rear, which overlooks a wetland. It is expected that both dwellings will have to be demolished; however, it will be difficult to determine financial responsibility since the large lateral spreading could be associated with the development's location adjacent to public wetlands. The role of the develop-

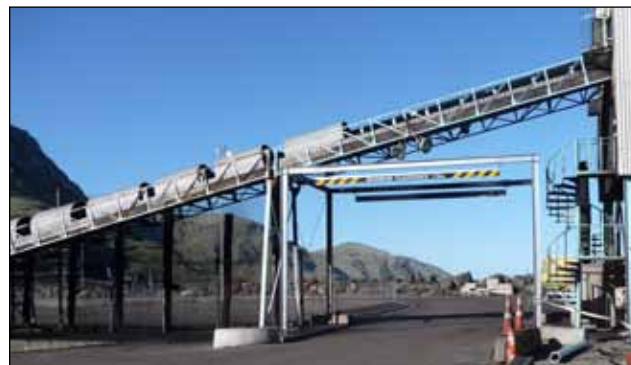
Indeed, significant liquefaction was observed in many areas around the port. Although the soil movements appeared somewhat less severe than in many other areas near Christchurch, the actual magnitude of vertical and transverse movement was not precisely known because geometric surveys were not complete by the date of the visit. However, there was clear differential deformation in Cashin Quay wharves 1 and 2. The landward piles had approximately 200 mm downward movement compared to the rest of the wharf, the timber cap beams for the piles were broken in many locations, and there was considerable deformation of the precast deck panels on the landward side of the wharf. Both crane rails rest on the seaward side of the wharf, and no relative displacement between the rails occurred so that crane operation resumed quickly. These movements caused separation and misalignment of the conveyors (Figure 7) used for loading coal at these wharves. These wharves returned to service shortly after of the earthquake, but they are not operating at full capacity and some parts of the wharves and coal-handling equipment must be replaced.

**Figure 7.** (a) ◀ (b) ▲ The coal loading machinery at the port (source: Roeder).

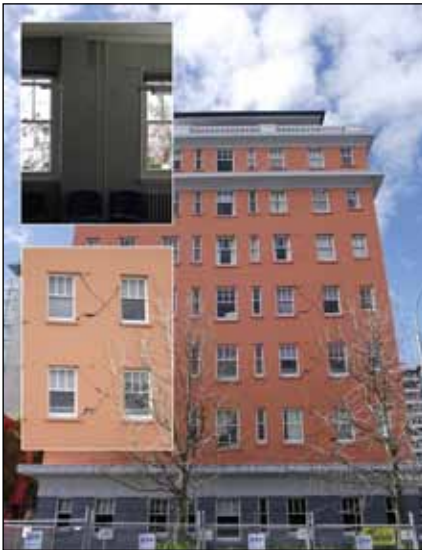
**Figure 8.** Shear cracks in perimeter masonry walls of an eight-story reinforced concrete frame building in downtown Christchurch (photo: Dusicka)

Newer engineered buildings generally performed well, but preliminary indications are that the ground shaking was below the design response spectra for shorter-period buildings (periods less than about 2 seconds). The majority of larger and multi-story buildings in the affected area are located in downtown Christchurch and on the University of Canterbury campus. Reinforced concrete construction is prevalent, with older buildings being typically reinforced concrete moment frames. A number of these older buildings also had masonry infill walls, but we observed very limited structural damage to these structures. This is likely attributable to the lower-than-design-level demands that are suspected to have been imposed on the shorter-period structures. One of the most visible exceptions was an eight-story building consisting of reinforced concrete frames with a double cavity wall of unreinforced masonry bricks around the building. Severe shear cracks were visible in the masonry on both the exterior and interior of the building (Figure 8).

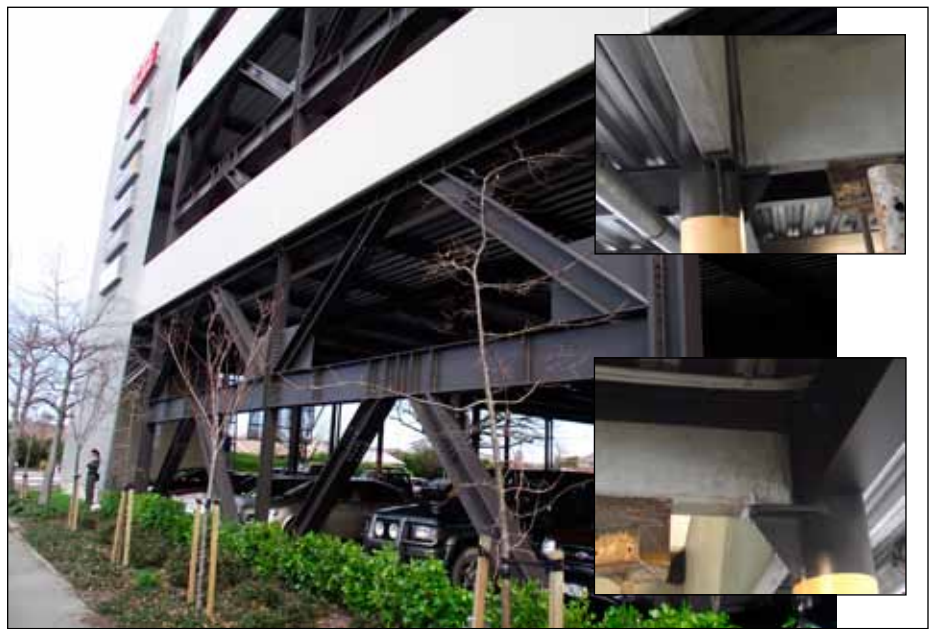
**Figure 9.** Cracks at beam seats of gravity load precast members used in parking garage, along with undamaged eccentrically braced frame lateral system in Christchurch area (photos: Dusicka).

More modern engineered buildings are also reinforced concrete, often utilizing precast structural components and sometimes mixed (concrete and steel) construction. One such example was the Westfield Riccarton Mall, a multi-story shopping complex where precast panels were combined with steel eccentrically braced frames (EBFs) on a multi-story garage. Relative movement of the precast panels of approximately 0.25 in was apparent from the steel connector brackets and cracking damage to a couple of the precast beam seats; however, the steel lateral system did not appear to be affected (Figure 9).

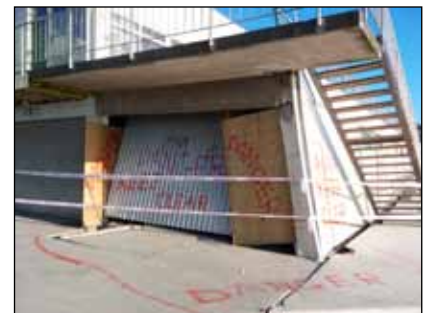
One reinforced concrete building constructed about 1960 was situated alongside the Avon River in an area with significant liquefaction and lateral spreading. This building sustained significant damage (Figure 10) because of lateral spreading under the foundations of the columns. The column line adjacent to the river shows soil movement. Most damage is concentrated in the beam-column connections since many bays of the building have masonry infill that provides a very stiff structure.

**Figure 10.** Damage to a reinforced concrete building from lateral spreading at a site near the Avon River (photo: Roeder)

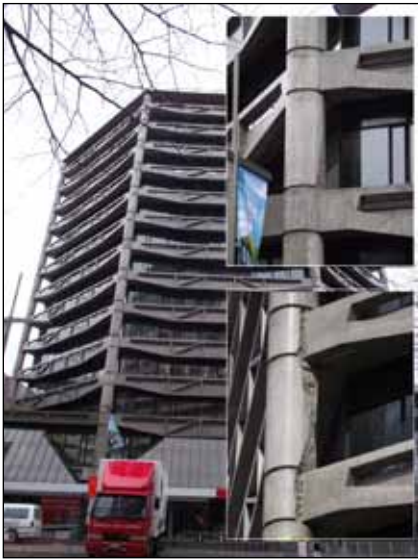
A number of modern buildings had broken windows, and a few showed signs of structural distress. The WestPac Trust Building is a 14-story reinforced concrete frame structure in central Christchurch with concrete core walls and diagonally reinforced coupling beams (Figure 11). The perimeter beams were precast concrete elements that form an apparent truss. A secondary shallow concrete beam appears to be located behind the truss, but does not connect to the centerline of the column. The columns are spalled at the beam-column connection for all connec-

**Figure 11.** Perimeter column spalling throughout the height of a reinforced concrete frame with perimeter precast trusses in West-Pac building in downtown Christchurch (photo: Dusicka)

tions at lower levels, and for many levels of the structure. The spalling was increasingly more severe and clearly distributed throughout the height when observed two days after the initial survey. The spalling was mitigated by manual removal of loose concrete and clearly exposed the main and transverse reinforcing at some locations.

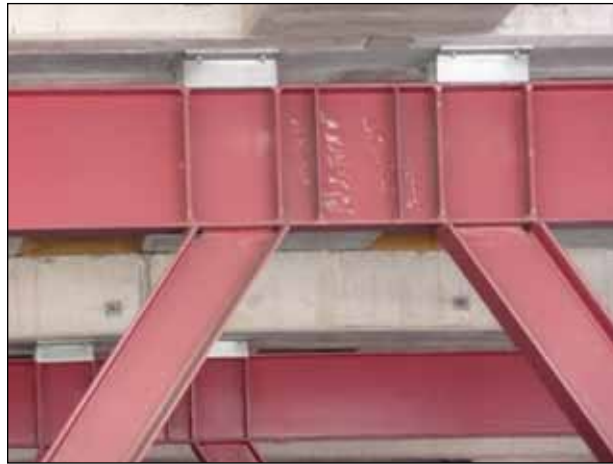
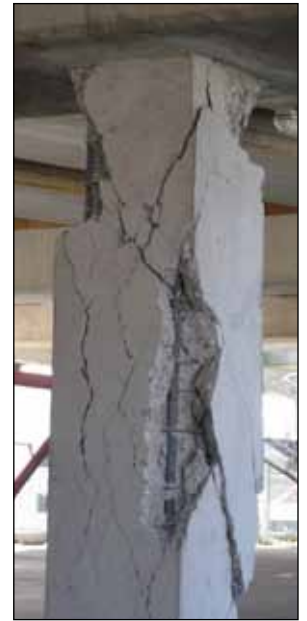
Steel structures are not common in Christchurch, and the relatively few performed quite well. However, steel eccentrically braced frames (EBFs) were used with concrete columns in several buildings, in some cases as a retrofit. One relatively new parking garage employed this concept to provide lateral resistance to other framing made of precast concrete, likely to enable rapid construction. Numerous EBFs indicated yielding in the link beam, illustrating the engagement of the lateral system and protecting most of the precast beam and column gravity structure (Figure 12a). The garage had long inclined concrete ramps along one edge of the building, which possibly caused torsional deformation that might explain the

**Figure 12.** (a) ▲ Yielding in the link beam of an eccentrically braced frame (b) ► and a severely damaged concrete column in a parking garage in downtown Christchurch (photos: Roeder).

non-uniform yielding in the steel frames. In addition, several concrete columns located on the upper ramp were severely damaged (Figure 12b).

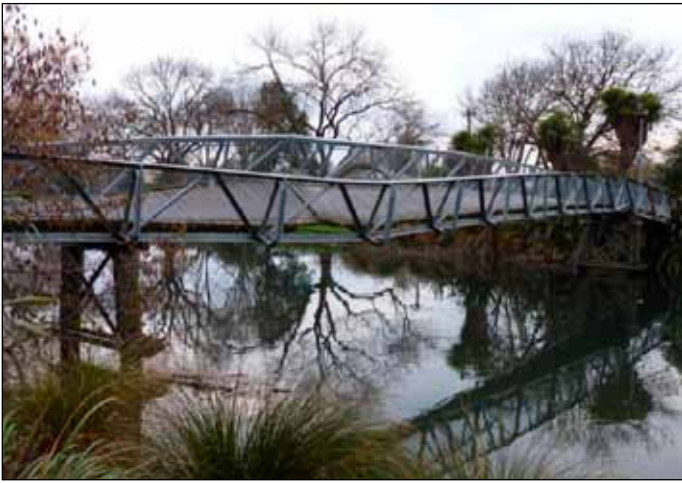
Six pedestrian bridges, not endowed with similar strengths and stiffness to resist the demands applied to them as a consequence of the liquefied soils, did not fare as well and will need replacement. One notable example is the pedestrian steel truss bridge over the Avon River in Christchurch that buckled axially under thrust imposed by the movements of its abutments due to the lateral spreading action of soils on top of liquefied layers (Figure 13). This introduced compressive forces in the bridge truss chord, forces unanticipated in the original design that led to local buckling of some chord members, twisting of the superstructure, and uplifting at a support location above one of the braced pier in the river.

**Figure 13.** Pedestrian bridge, River Road–Avonside Drive, Christchurch (photo: Bruneau).

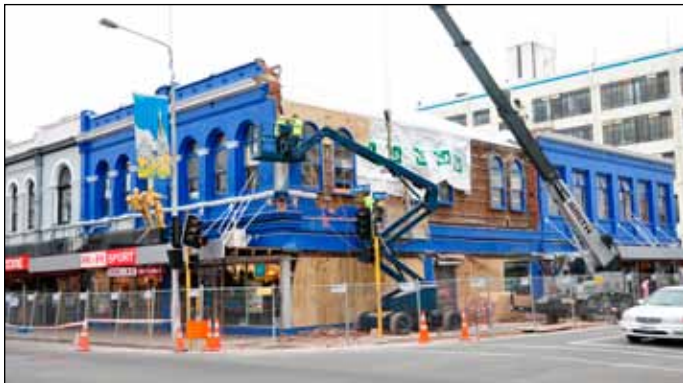
Throughout the city, loose masonry fell from unbraced parapets and gable walls (Figures 15 and 16). In a large number of cases, entire parapets and upper walls not adequately attached to roofs fell onto streets, sidewalks, and adjacent smaller buildings.

**Figure 15.** This corner building had braced parapets only fronting on the main street, left. The secondary street wall separated from the roof, falling onto the street and sidewalk below (photo: Turner).

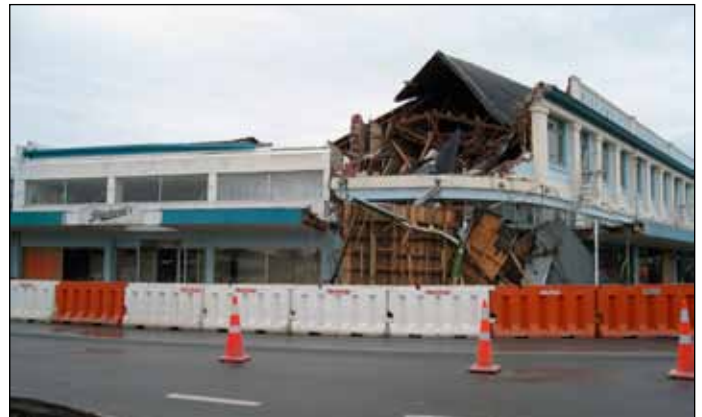
**Figure 16.** Blackwell's Department Store on William Street in Kaiapoi suffered extensive structural damage (photo: Arendt)

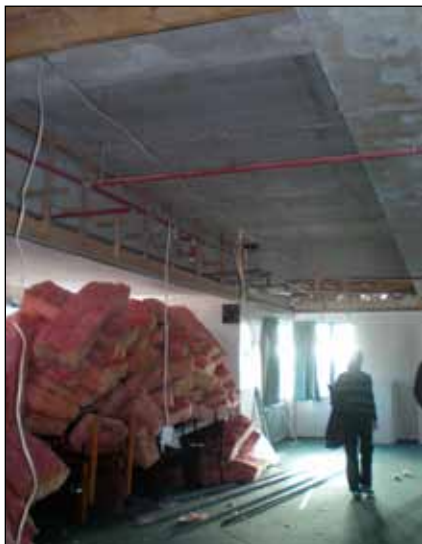
**Figure 17.** Nonstructural damage at the University of Canterbury: fallen ceiling tiles and hangers (photo: Comerio)

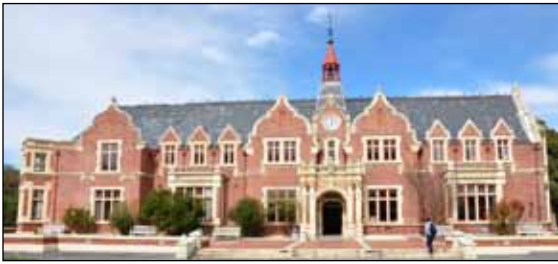
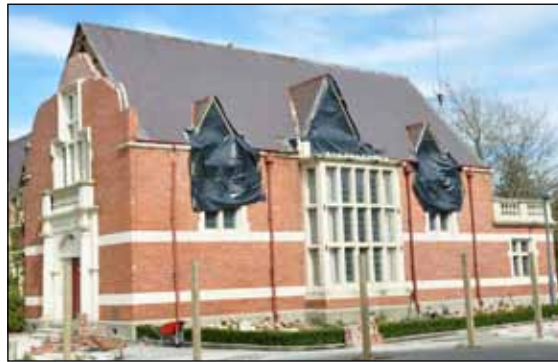
**Figure 19.** Ivey Hall (a) ▲ at the Lincoln University campus was partially retrofitted prior to the earthquake and performed remarkably well, whereas (b) ► the adjacent unretrofitted Memorial Hall had severe damage at its gable walls (photos: Turner).

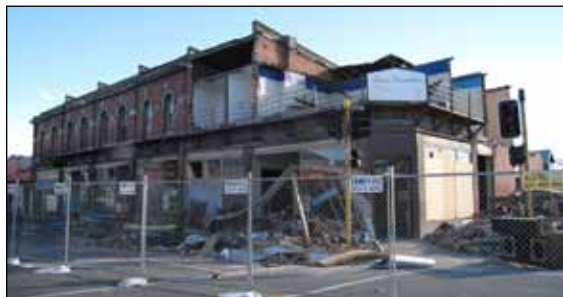
**Figure 20.** The building housing Angus Donaldson, and other businesses on Colombo St. in Sydenham, is cordoned off two weeks after the quake (photo: Arendt).

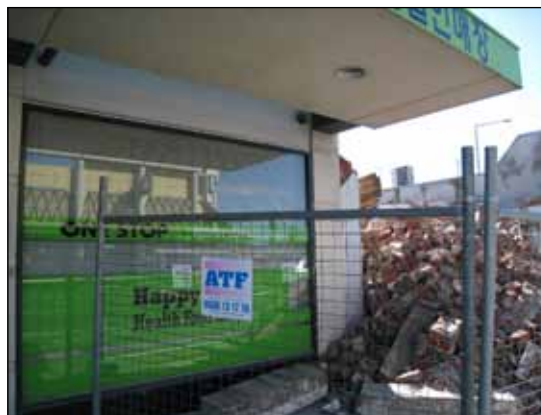
**Figure 21.** This Asian Supermarket on Riccarton Rd, Christchurch, reopened two weeks after the quake despite damage suffered when the adjacent URM collapsed (photo: Arendt).
