# Intensity and Damage Assessment of the 2007 Tocopilla Earthquake, Chile.

*This report presents the findings of the reconnaissance team from three Chilean universities that conducted site visits to approximately 20 towns in the earthquake zone shortly after the event. The focus was primarily on damage to dwellings and lifelines, geotechnical effects and the calculation of intensities.*

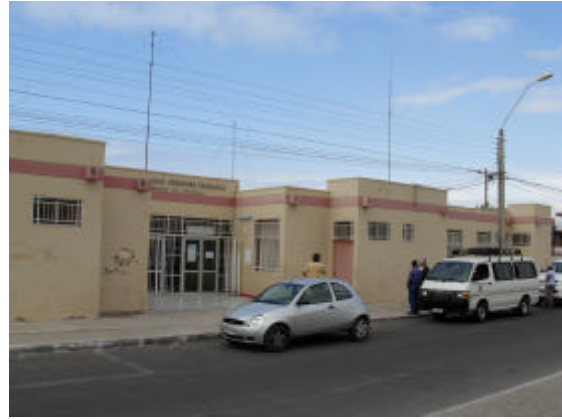
**View of undamaged health center in Mejillones where the accelerograph is located.**

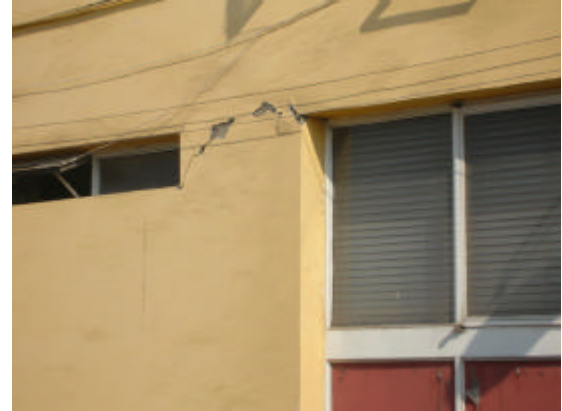
**Moderate damage in short columns of the Gobernacion building.**

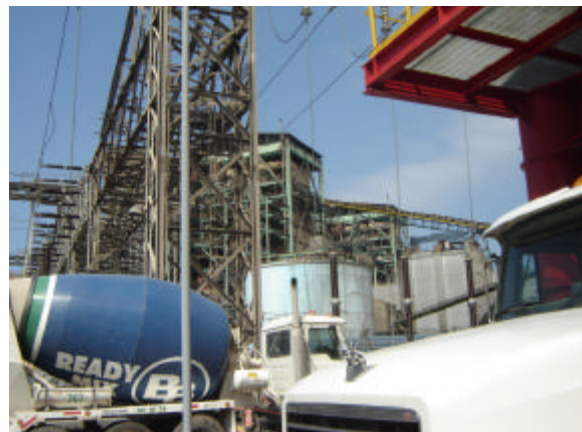
**View of undamaged thermoelectrical plant near the station located on rock in Tocopilla.**

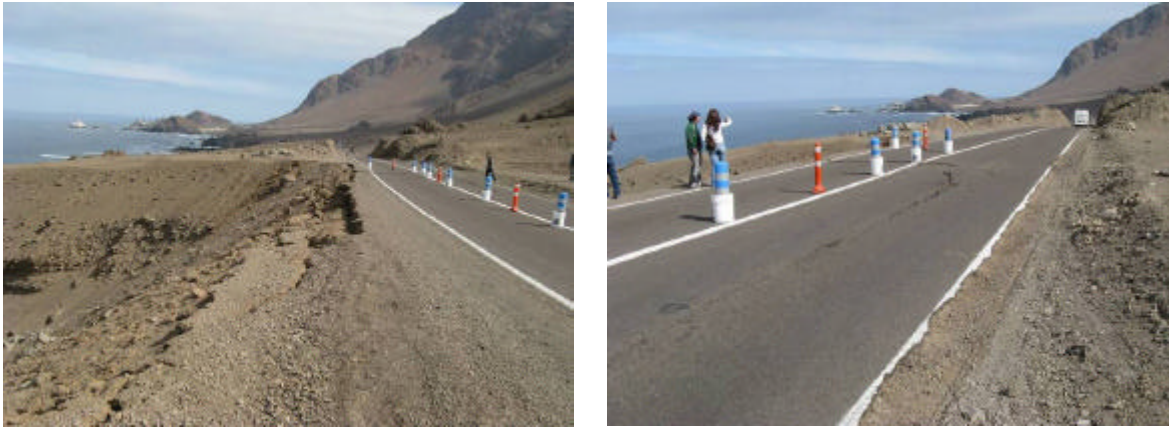
Serious geotechnical hazards were not found although some landslides and pavement cracking were observed (see Figures 6 and 7). The landslides occurred in road cuttings and natural slopes and caused the closure of Highway 1 between Tocopilla and Iquique (see Figure 8). No sand boils or other signs of soil liquefaction were observed near the coast.

**Figure 6 – Landslide and pavement cracking on Highway 1.**

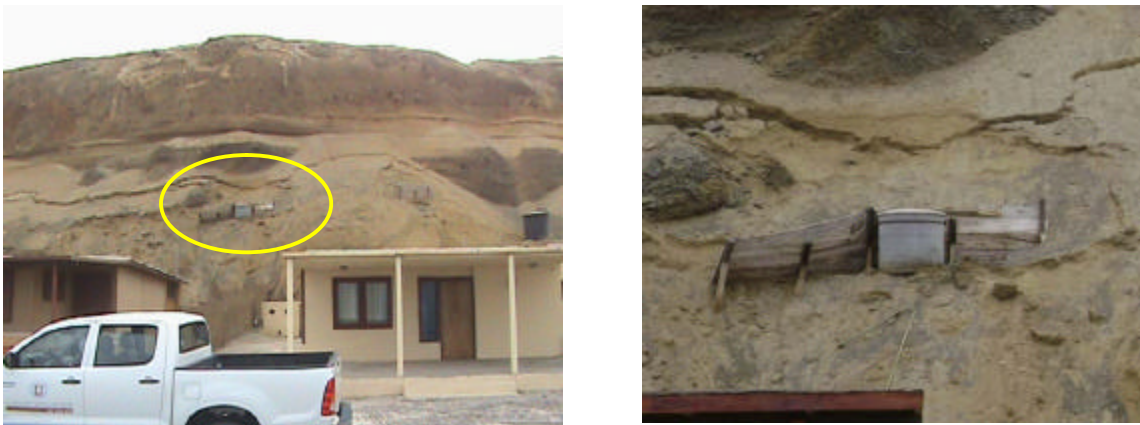
**Figure 7 – Landslide at Hornitos beach**

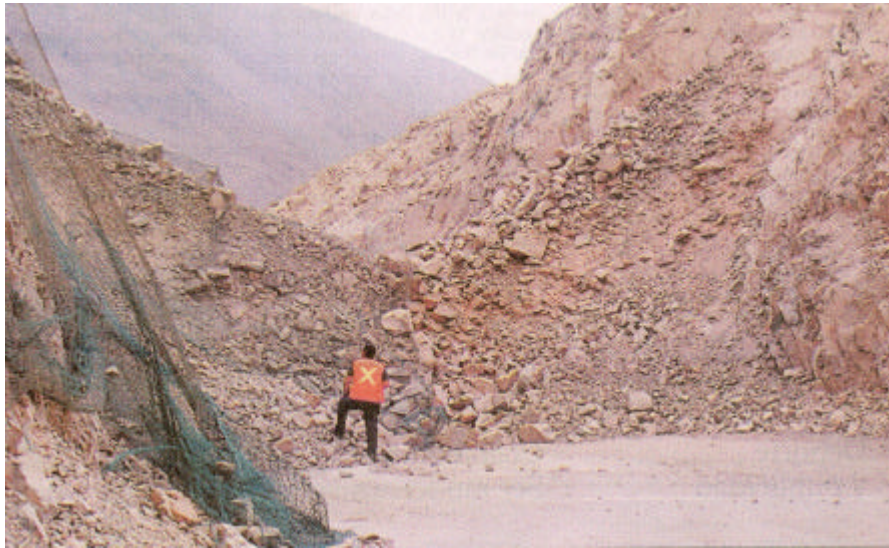
**Figure 8 – Landslide at La Paragua, Highway 1 between Tocopilla and Iquique (20 km from Tocopilla).**

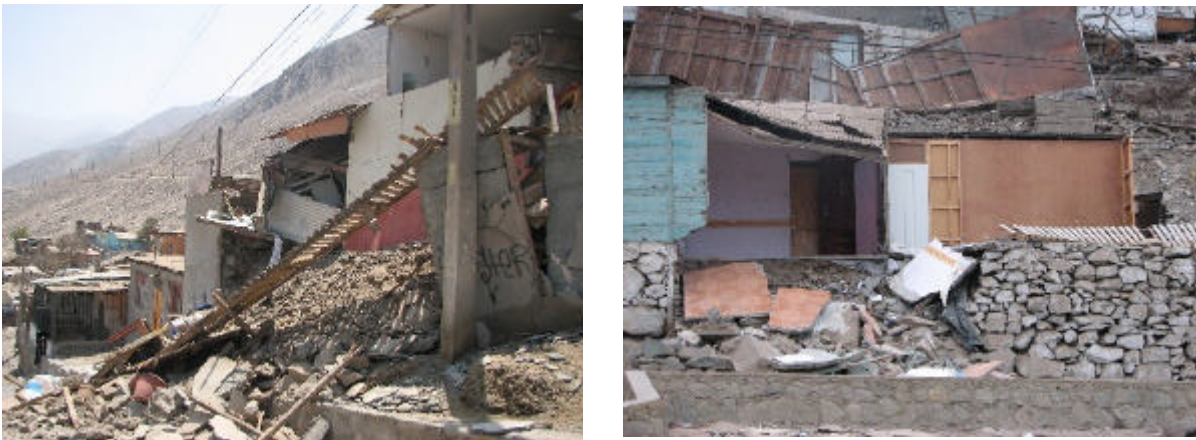
The hillside residential area of Tocopilla, located on the eastern side of the city, experienced some slope failures during the earthquake. Construction and retaining wall in the area have been carried out by homeowners cutting into the hillside and using the resulting material as fill. In some places the retaining wall had failed with the soil mass sliding downwards a short distance. Significant damage to structures due to slope and retaining wall deformations was observed along the hillside. Figure 9 shows some of these failures.

**Figure 9 - Damage to the hillside residential area of Tocopilla.**

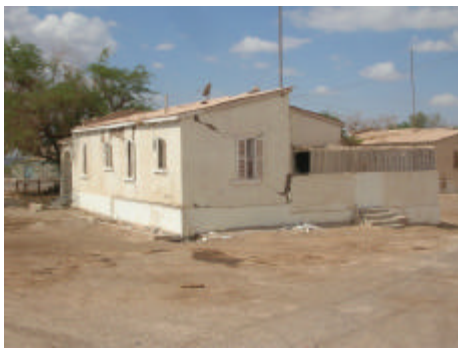
**Adobe:** Adobe units are made with low plasticity fine silts. Although no reinforcement is included, few buildings made of adobe collapsed in the epicentral zone. This type of construction is more common in central Chile.

**Figure 12. Observed damage: (a) Adobe house in Maria Elena, (b) Wooden frame with adobe infill in Baquedano, (c) Self-construction wooden frame with low quality concrete infill in Tocopilla and (d) Masonry in Maria Elena.**

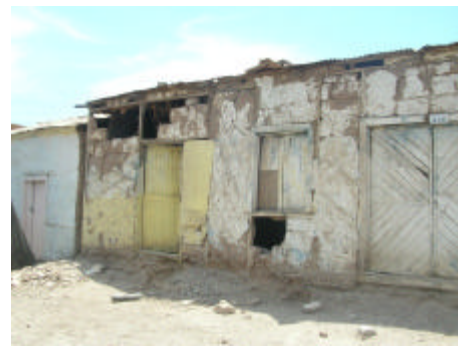
(b)

**Wood frame with adobe infill:** In this type of construction void spaces between wooden frames are filled with vertically aligned adobe units covered with mud plaster. Moderate damage to stucco or fallen adobe units was observed. Most of this construction is found in towns near Highway 5.

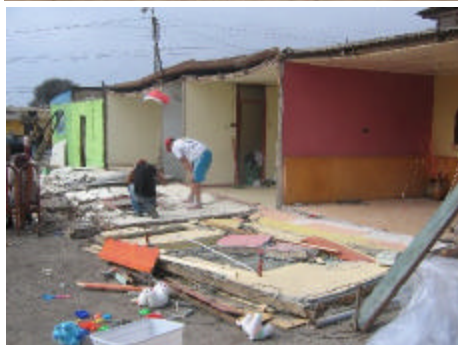
(c)

The seismic performance of this type of self-construction dwellings is poor because the resisting elements (vertical and horizontal) are not assembled adequately.

- Self-construction dwellings must be avoided in regions where this type of earthquake occurs since the assembly of the resisting elements (vertical and horizontal) is generally inadequate and they suffer severe damage, increasing the risk of injury.
- Well constructed confined concrete block masonry for low-cost dwellings is an efficient construction system to reduce earthquake damage.
- Damage increases dramatically when dwellings are located on recent alluvial deposits and uncontrolled fills in hillside residential areas.

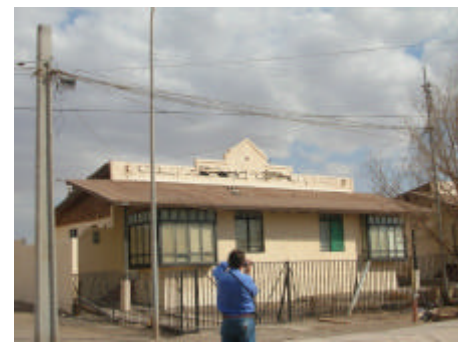
(d)

**Masonry:** When properly designed and built, masonry walls of concrete block resisted the earthquake with little or no damage. However, the observed behavior was less satisfactory when the quality of the construction procedure and materials was poor, or the reinforcement detailing inadequate.

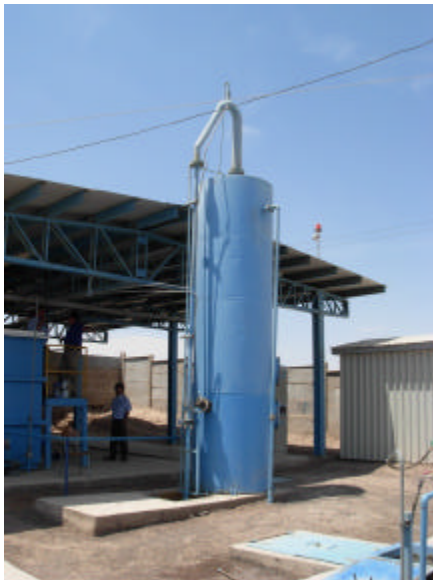
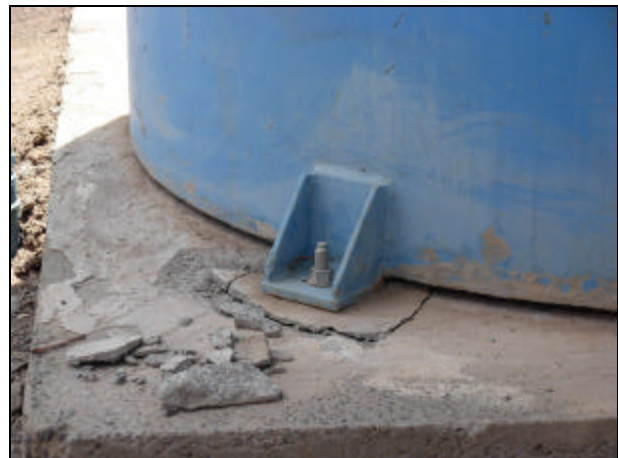
The Baquedano water treatment plant suffered minor damage to the filter tank anchor bolts (see Figure 13). There was no interruption of the water supply for this town.

**Figure 13 - Damage to filter tank at Baquedano**

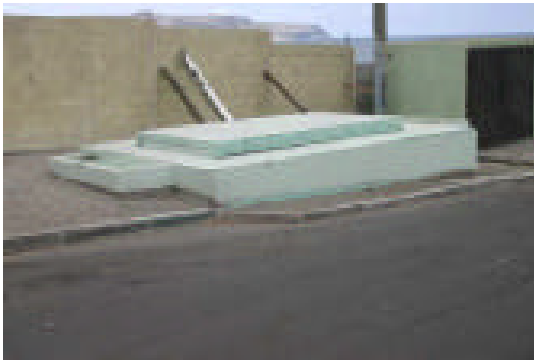
The sewerage system of Mejillones suffered minor damage to the main sewer, the treatment plant and the surge chamber of the submarine outfall sewer. The damage was concentrated near the coast and it was caused by settlement in the saturated sand filling (see Figure 14).

Treatment plant and surge chamber of outfall sewer.

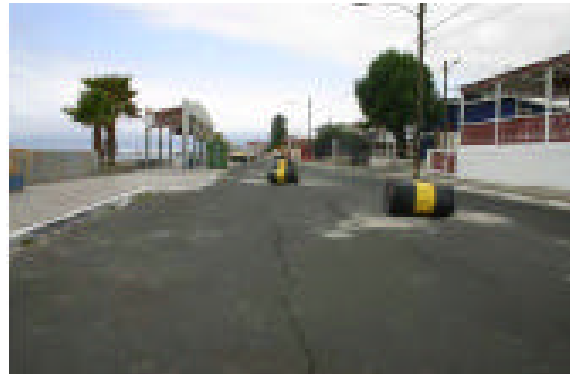
Settlements of main sewer sections.
