Learning from Earthquakes

The M_w 6.3 Abruzzo, Italy, Earthquake of April 6, 2009

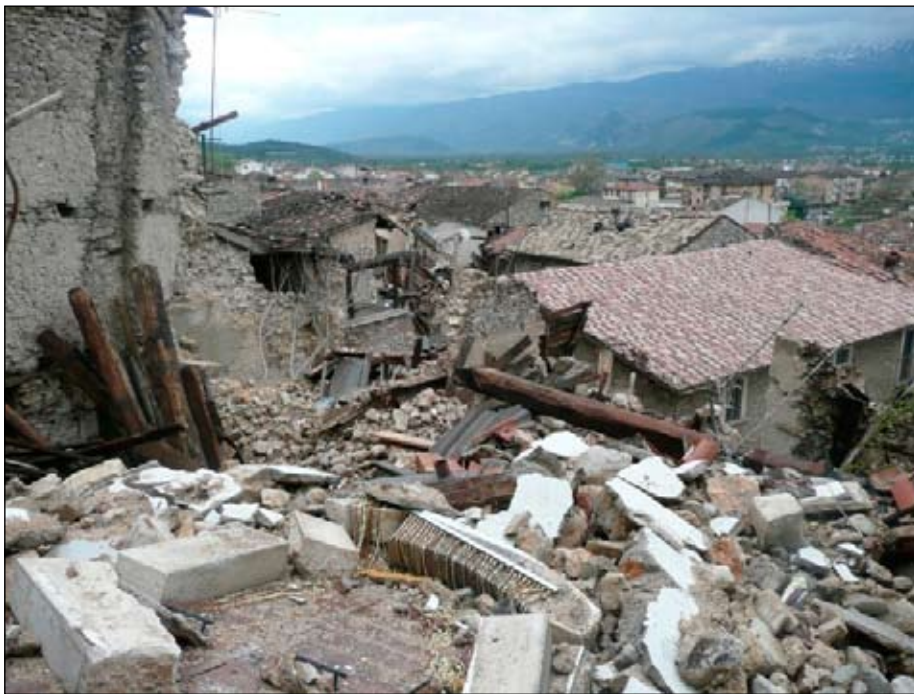
Figure 6. Devastation of poor-quality buildings in Paganica.

The team surveyed buildings in L'Aquila and approximately 20 surrounding towns (of the 49 cities and towns included in the ministerial damage decree). While L'Aquila had dramatic damage to late medieval, Romanesque, and Renaissance buildings and artwork, more widespread extensive damage was seen in smaller towns such as Onna, Paganica, and Castelnuovo, where more than 50% of the historic centers were damaged

beyond repair (see Figure 6). In other towns, such as Barisciano, Santo Stefano, and Monticchio, approximately 20-25% of the buildings in the center suffered extensive damage. The difference between the damage levels observed at locations that are very close to one another, such as Onna and Monticchio, and that have URM buildings of the same quality and characteristics, is most likely due to site amplification effects (see the GEER report for details).

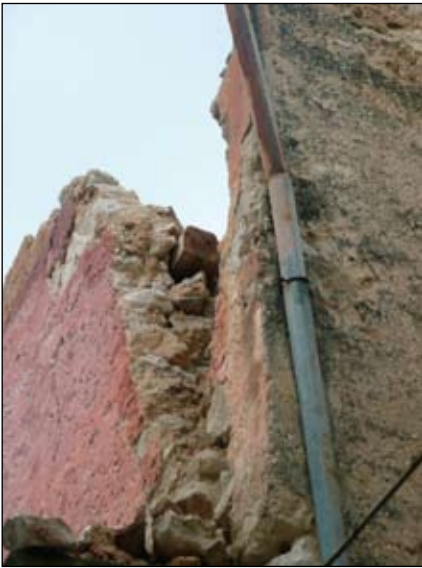
Figure 7. Detail of 18th century wall-strengthening system, where no ties connect the beam to the wall.

After the last major earthquake in the region in 1703, attempts were made to strengthen masonry walls by inserting a large (approximately 20 cm

diameter) timber into the wall with wood or iron ties through the perpendicular wall. In Paganica, we saw numerous examples of this approach, where the first story was built after the 1703 earthquake using the timber-and-ties technique, but 2nd and 3rd floors were added in the 19th century without ties, as the technique was forgotten (Figure 7).

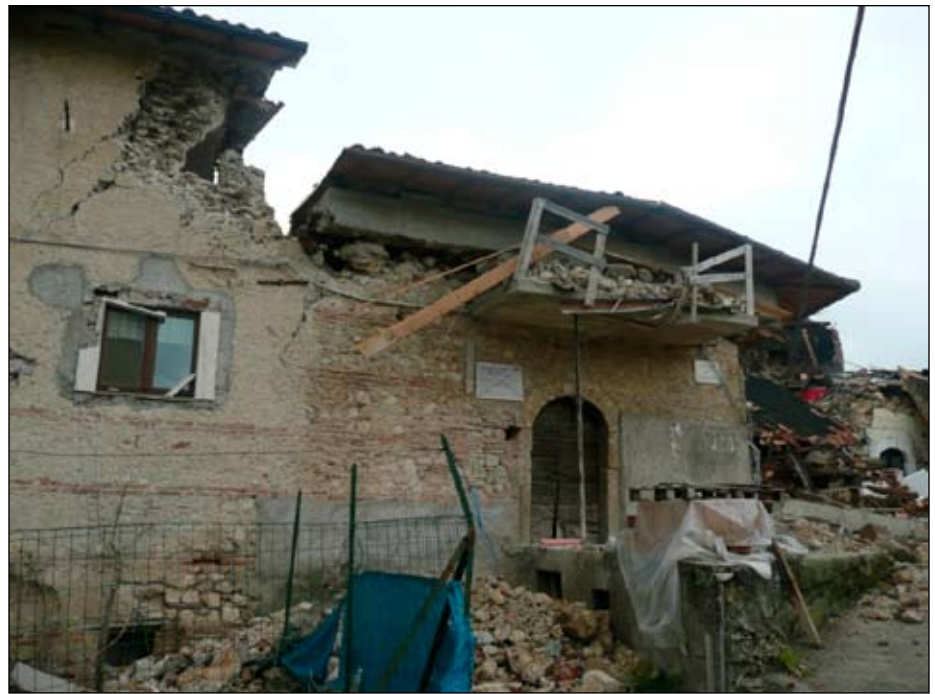
Figure 8. Collapse of a masonry building in Temperra with concrete ring beam retrofit.

on a number of churches (Figure 10). Unfortunately, this system proved to be ineffective, and many structures, such as the building in Figure 8, collapsed. The additional mass of the beam, the inconsistency between the deformation of the beam and that of the walls, and the lack of positive connection between the beam and the masonry walls above and below are reasons that were brought up to explain the generally poor results of this retrofit technique.

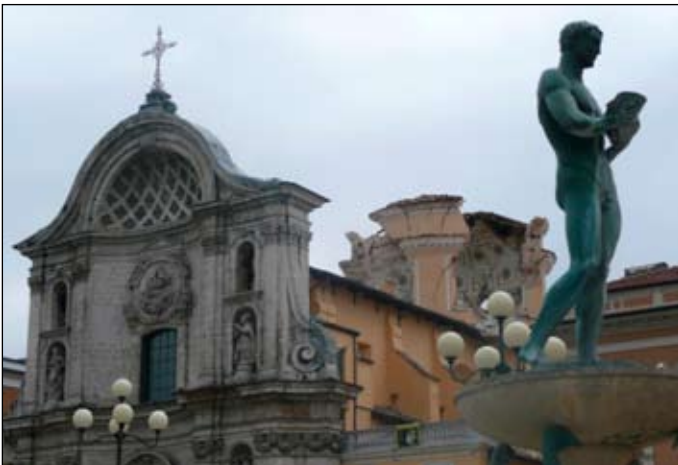
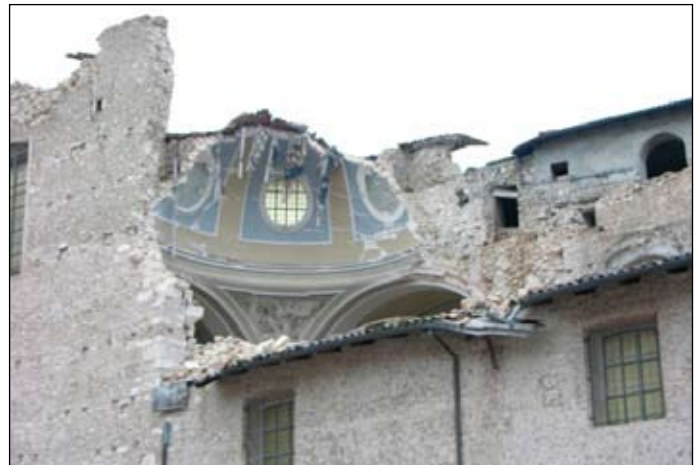
Figure 9. (a) Santa Maria del Suffragio, built after 1703, and (b) Santa Maria di Paganica, both in L'Aquila, lost the roof and cupola.

Many churches in the region experienced partial failures of their walls and domes, fall of architectural elements, out-of-plane wall failures, and cracking of bell towers and corners (Figures 9 and 10). Some particular cases of interest were the Chiesa di Santa Maria del Presepe in Paganica that suffered very little damage in contrast with the rest of the town, probably due to the reinforcing corner plates and the proper anchorage of roof trusses into the walls. The Palazzo Dragonetti, built at the end of the 18th century and recently restored as a high-end hotel, had its corners heavily rein-

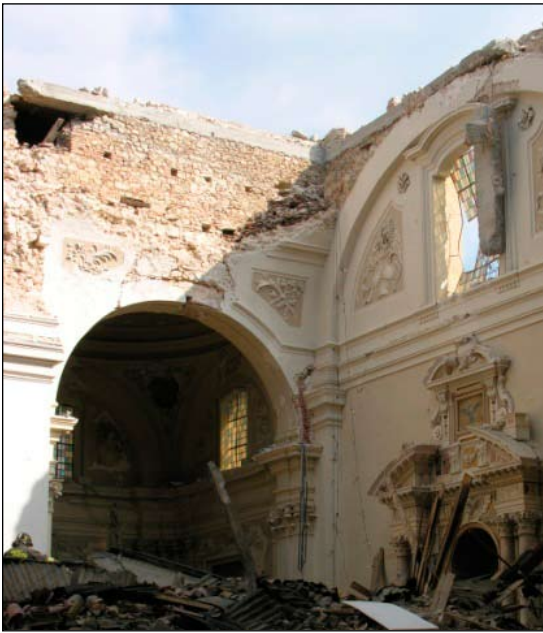
Figure 10. Roof and cupola collapse in the Santa Maria di Collemaggio Abbey in L'Aquila. The reinforced concrete ring beam did not prevent the collapse of the cupola.

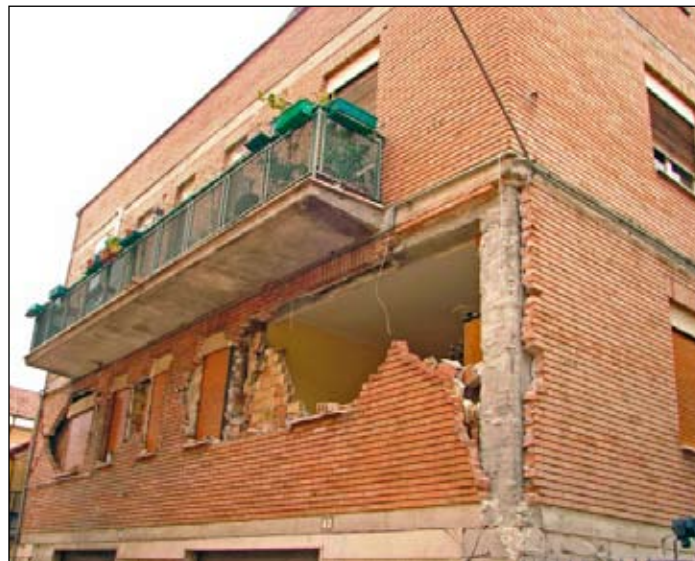
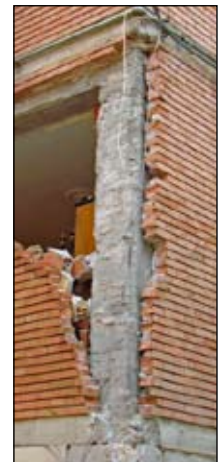
We found widespread damage to exterior infill walls and interior partitions, varying from small cracks to collapse along with minor or no damage to structural elements. Several buildings completely lost their masonry infill walls at lower stories (Figure 11). This kind of damage extended to newer build-

Figure 11a/b. Typical damage to infill walls.

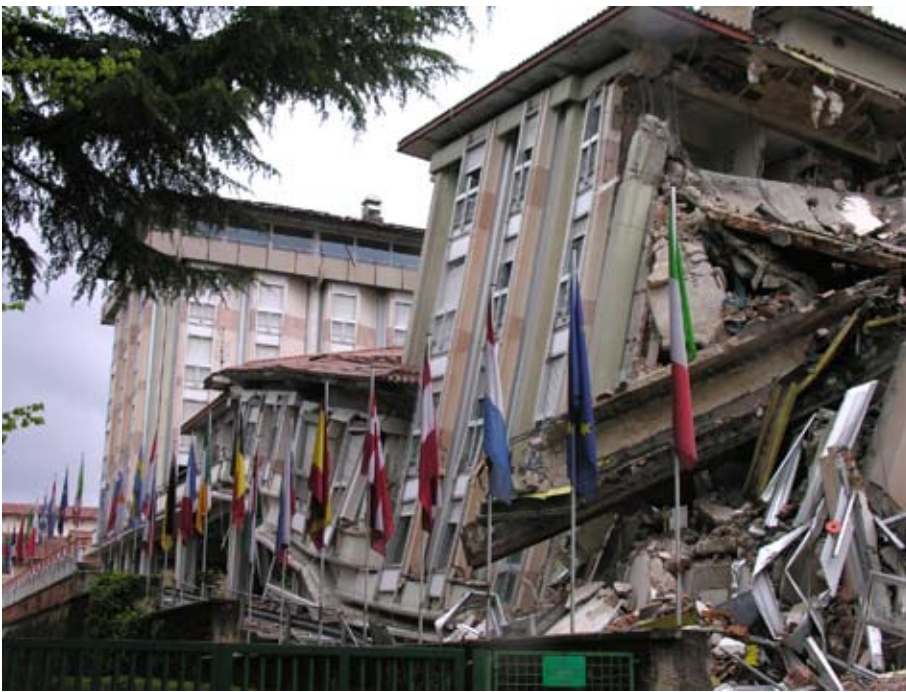
Figure 12. Collapse of part of the Duca D'Abruzzi Hotel caused by a soft-story mechanism. The far part of the building was saved by a seismic separation joint.

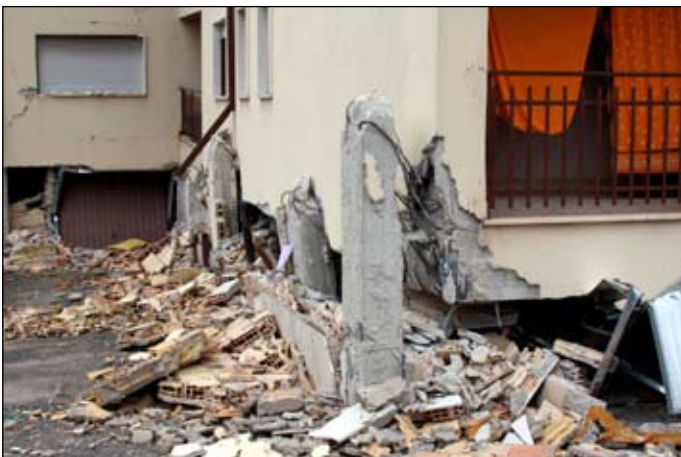
In Pettino, northwest of L'Aquila, there were several pockets of reinforced concrete structures that suffered significant damage. Among them were two soft-story collapses (Figure 13) and a large modern concrete structure with shear failure in several columns of its moment-resisting frame and the shear wall of its elevator core at the lower story (Figure 14). Since several columns remained intact, it is possible that torsional effects contributed to the unusual shear failure distribution, as the building is "L"-shaped in plan. Detail deficiencies included insufficient column ties (i.e., excessive spacing and small section, which results in inadequate confinement), lack of cross ties, and splices with inadequate length.

Figure 13. Soft-story collapse in Pettino. Two of four almost identical structures collapsed.

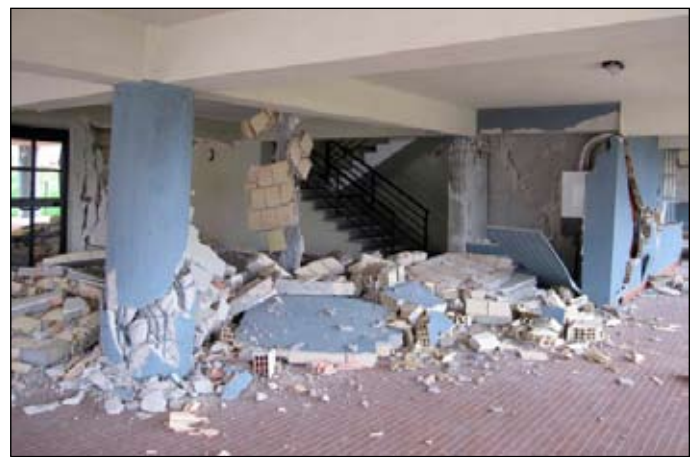
Figure 14. Core shear wall with extensive structural damage and failure in a modern RC building in Pettino.

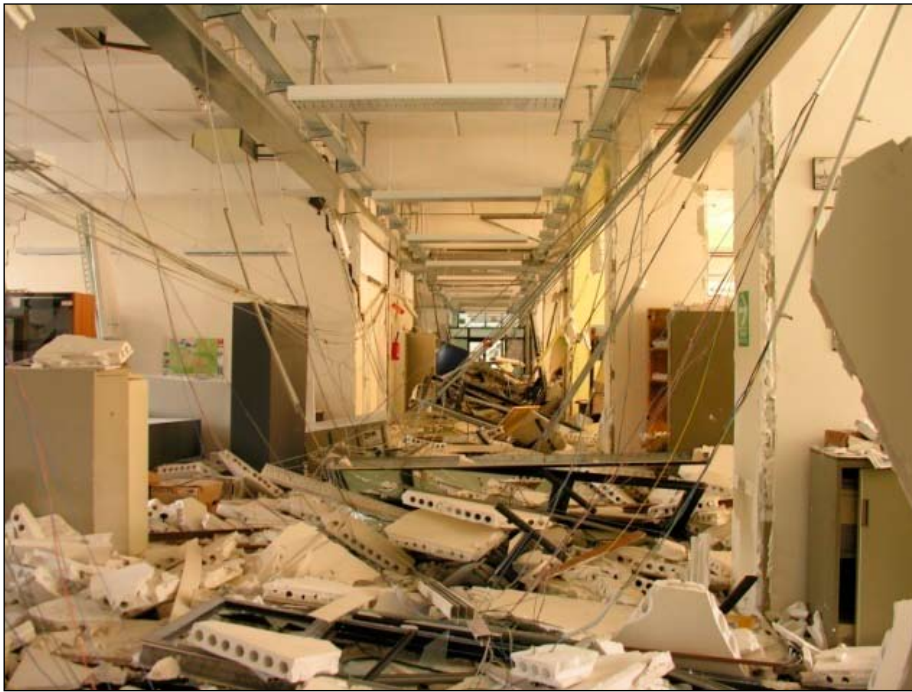
In summary, reinforced concrete buildings in the L'Aquila region behaved, on average, fairly well, considering the limited seismic design requirements and the severe ground shaking, often in exceedance of the design level. From the perspective of the repair cost, however, reinforced concrete buildings showed higher losses due to widespread extensive damage to masonry infill walls and internal partition walls (Figure 15).

Figure 15. The interior of the City Planning Offices in L'Aquila. Note that the building exterior has very minor detectable damage.

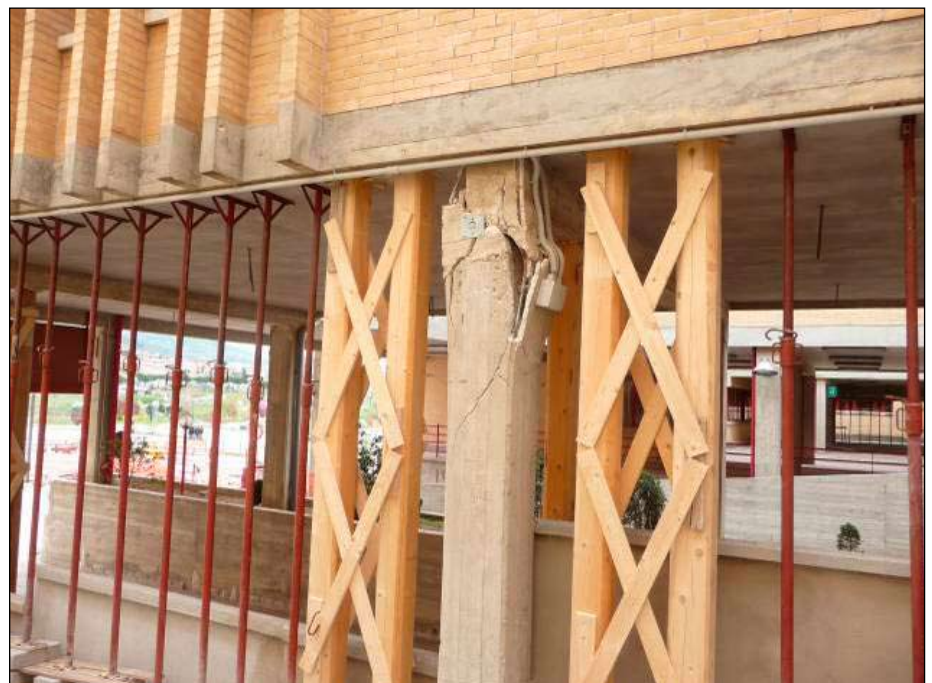
Figure 16. Column damage at hospital entry structure; no tie reinforcement is evident.

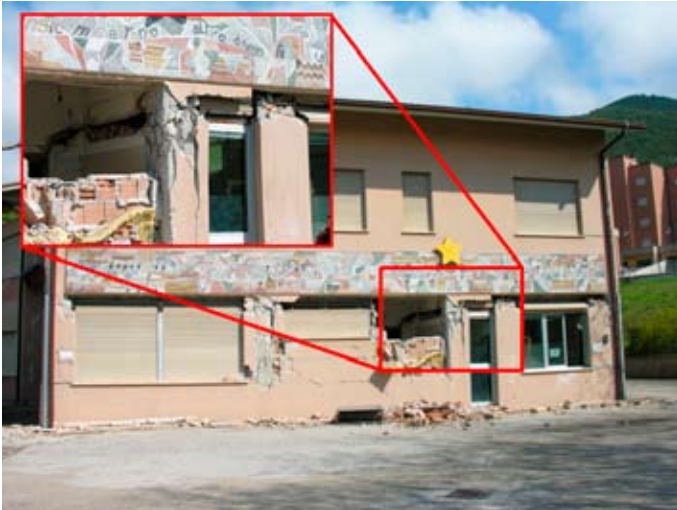
was able to inspect the exterior and the interior of six schools in the area. The Pettino Elementary School, a two-story reinforced concrete frame with infill brick walls completed in 1994, was seriously damaged and reached the verge of partial collapse (Figure 17). The damaged pillars on

the ground floor showed nonductile detailing in the beam-column joints, the minimal confining reinforcement, and smooth rebars. A separation in the concrete between the top of the pillars and the upper beams was also evident.

Figure 17. Extensive damage to the elementary school in Pettino.

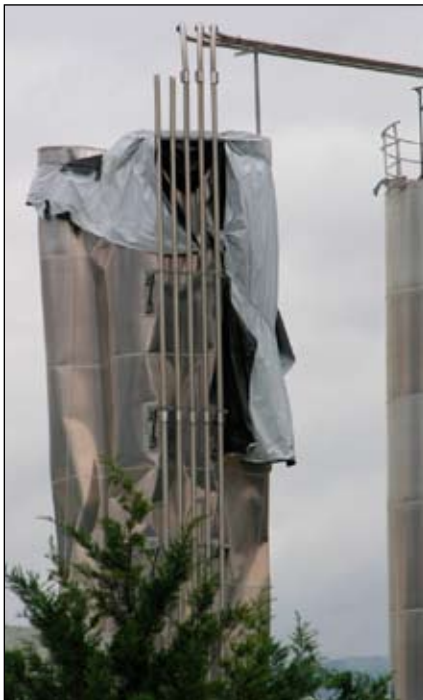
Figure 19. Extensive damage at one silo.

At a manufacturing plant in the same facility we observed three tall steel silos storing polypropylene beads that suffered damage. The three silos that were full during the earthquake either collapsed or suffered extensive dam-

age (Figure 19). The silos pounded on the adjacent precast warehouse, partially crushing the concrete wall and leaving an imprint of impact. The silos also crumpled at their bases. The undamaged sections are being salvaged and reused.

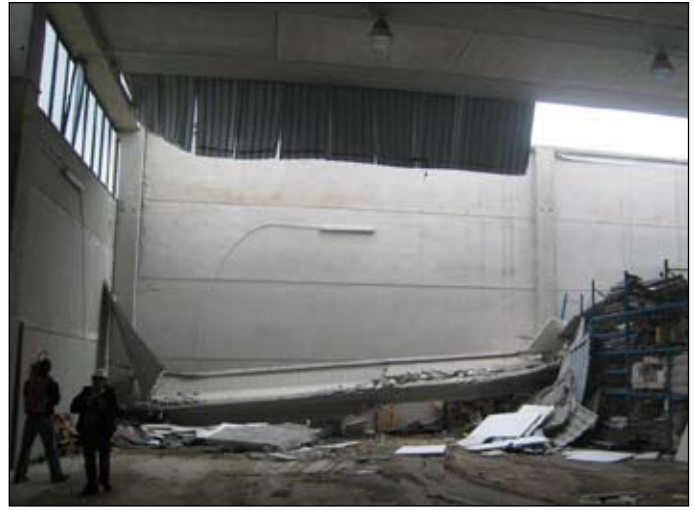
In the warehouse, a precast girder collapsed along with one span of roof slab (Figure 18). There did not appear to be any positive connection of the precast girders to the exterior precast frame, and the exterior wall appeared bowed, allowing the girder to unseat.

Figure 18. Partial collapse of the roof.

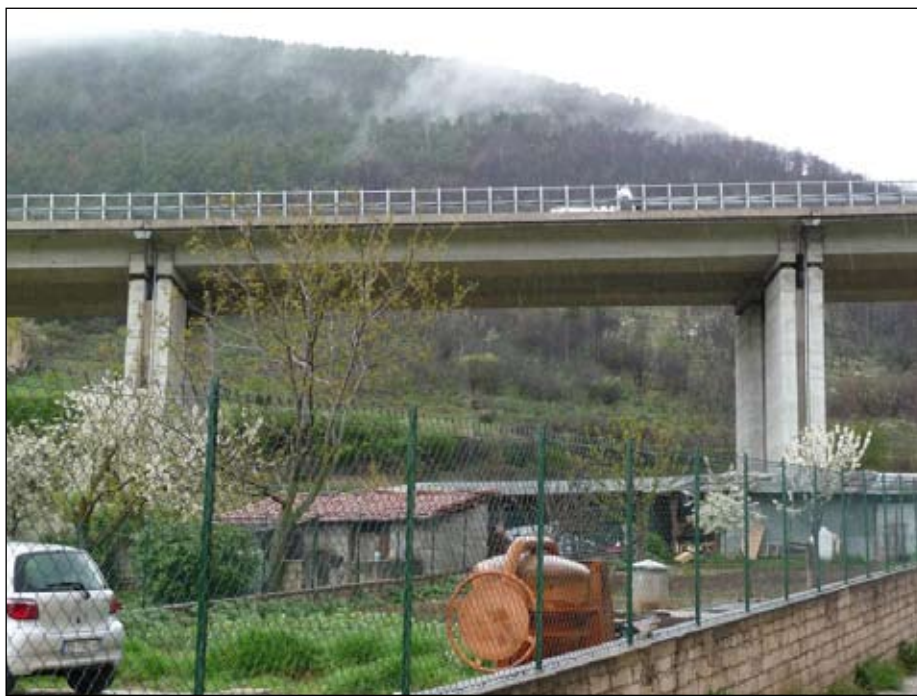
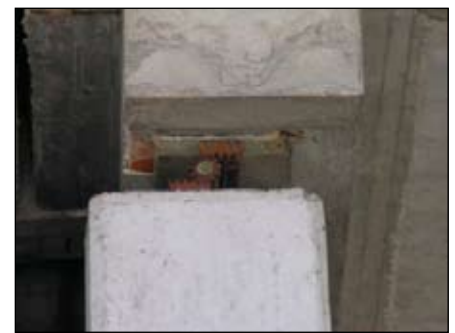
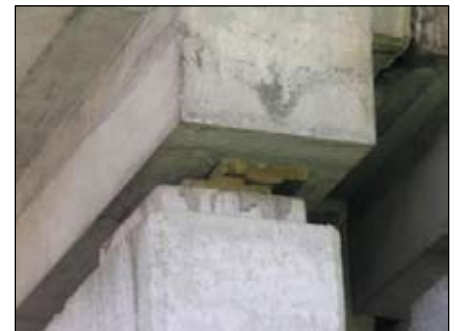
Figure 20. (a) Reinforced concrete highway viaduct that suffered movement of (b, c) bearings and misalignment of columns.
