## Learning from Earthquakes

# Performance of Engineered Structures in the $M_w$ 9.0 Tohoku, Japan, Earthquake of March 11, 2011

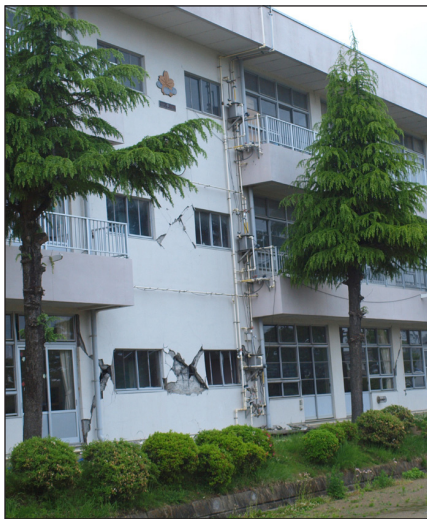
**Figure 3.** Elementary school in Sukagaya. Column damage at classrooms depended on presence or absence of cast-in-place infill at the base. Infill creating captive column with integrated wing walls caused shear failures.

The reinforced infill panels restrained column deformations, creating a “captive column” and typically inducing column shear failures. Columns with longer clear heights (free of infill restraint) fared better (Figure 3). Columns restrained by infill supporting windows developed shear cracks, while those extending to the floor were undamaged. The most severe damage was seen in columns with reinforced wing walls that were cast integrally with the columns (Figure 4). In addition to reducing column clear height, the infill wing walls increased the effective width of the column, thereby affecting the aspect ratio.

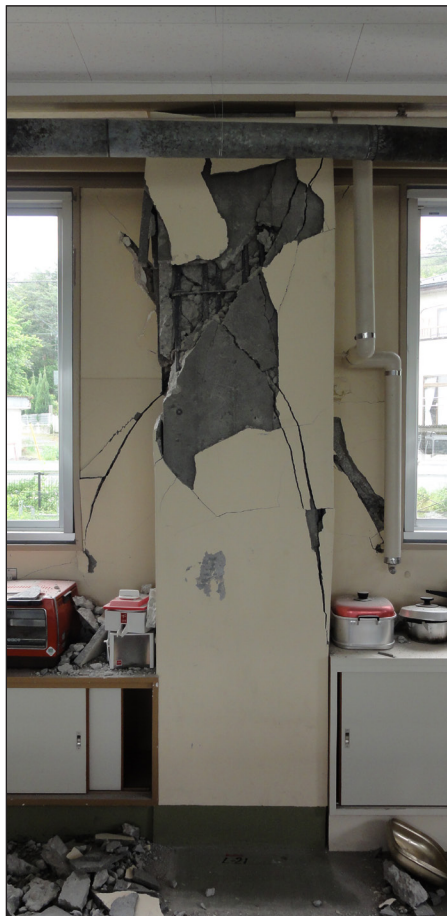
**Figure 4.** Junior high school built in 1966, located 10 km N. of Kuriyama. Wing walls along the exterior, nominally reinforced and cast eccentrically with columns, induced shear failures that penetrated through the columns.

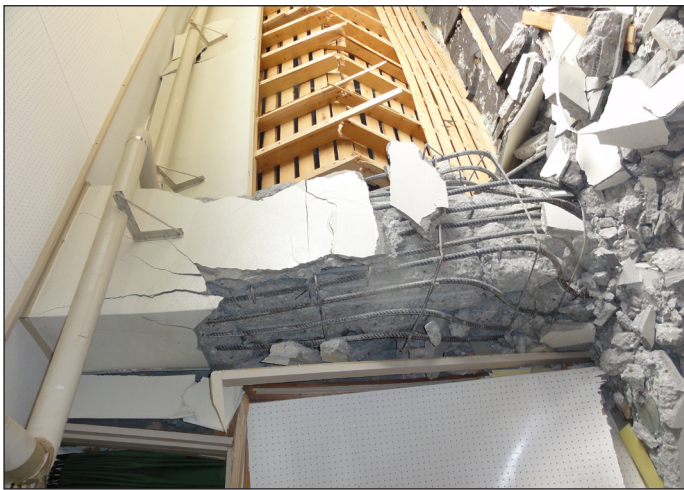
Columns located beneath discontinued shear walls were prone to severe damage. Figure 5 shows an interior column in the hallway on the lowest floor of a three-story school. The adjacent exterior hallway column, not located below a discontinued shear wall, had shear failure but was not crushed as severely. In contrast, columns that were integrated into shear walls were often protected from failure, at least in the low-rise construction we observed.

**Figure 5.** Junior high school located 10 km north of Koriyama. Interior column below end of discontinued shear wall above.

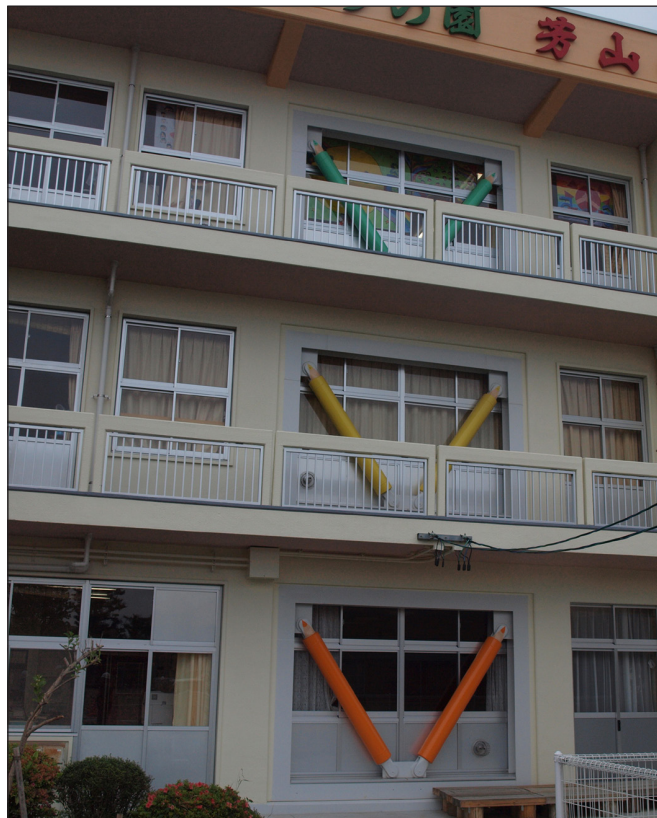
**Figure 7.** Elementary school approximately 1 km east of Koriyama. Stiff retrofits, such as diagonal steel bracing and infill shear walls, were effective at preventing structural damage.

**Repaired and Retrofitted Buildings.** Many school buildings and housing complexes had been evaluated and retrofitted prior to the earthquake, while others were repaired following previous quakes. In several retrofitted buildings, the “stiff” retrofits (diagonal bracing and/or infill shear walls) were successful in limiting damage to minor cracking at a few locations. In one case, supplemental dampers used to retrofit a ten-story housing complex near Sendai City likely limited interstory drift, but there was still enough to cause diagonal cracks in nonstructural cast-in-place walls. Figure 7 shows a three-story elementary school building near

Kuriyama that had been retrofitted with infill shear walls and diagonal bracing.

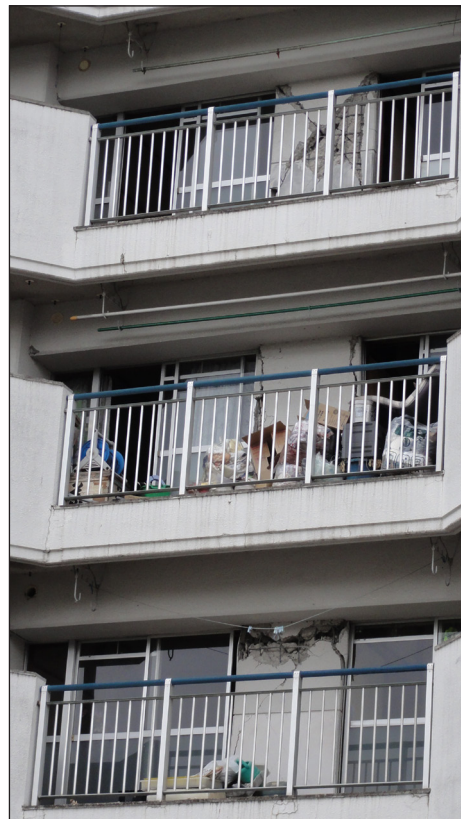
ly stiff elements, vulnerable to shear failure, they functioned as interstory drift gauges. Damage to these panels typically involved heavy diagonal cracking; however, the damage in mid-rise buildings (11-15 stories) generally decreased with height, suggesting that first mode contributions to interstory drift were dominant. While most of the shear panels had diagonal cracking characteristic of shear failure, some exhibited sliding failures or bond/anchorage failure (Figure 6).

**Figure 6.** Failure modes for shear panel include diagonal cracking, bond/anchorage slip of vertical reinforcement, and sliding at the top of the panel.

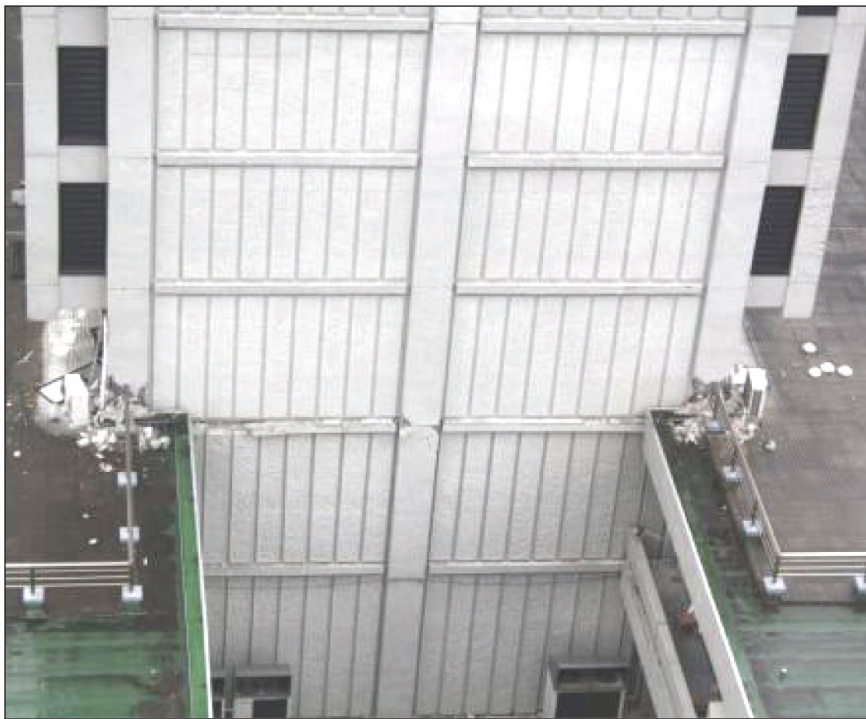
**Figure 8.** Civil Engineering & Architectural building damage to east transverse end wall (photo: M. Motosaka).

The most severe damage in the 2011 quake was at the vertical boundary elements of the transverse concrete shear walls at the transition floor from the tower to the podium level, as shown in Figure 8. The concrete columns crushed with buckled vertical reinforcement are shown in Figure 9. Additional concrete damage was evident at the concrete floor lines, especially at the tower-podium transition floor.

By early June 2011, the damage to the wall boundary elements had been temporarily repaired with addition of concrete encasement over the height of the damaged column section and of high-strength tension rods to connect the concrete column above the damaged area to the concrete column below the damaged area. Additionally, new longitudinal concrete walls

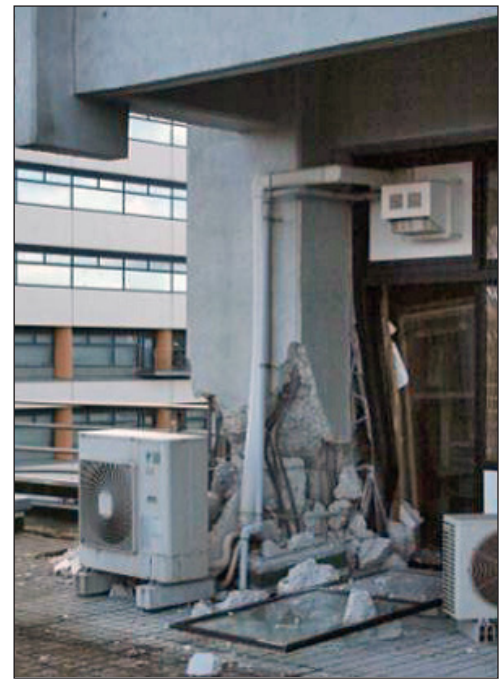
**Figure 9.** Damage to columns at tower-podium transition (photo: M. Motosaka).

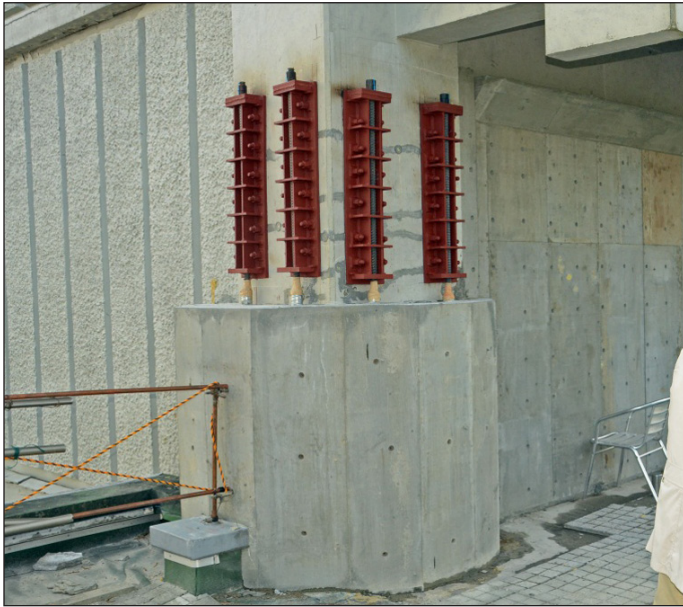
**Figure 10.** Temporary column repairs with adjacent new concrete walls.

were added at the corners of the tower at the first floor above the podium transition (Figure 10).

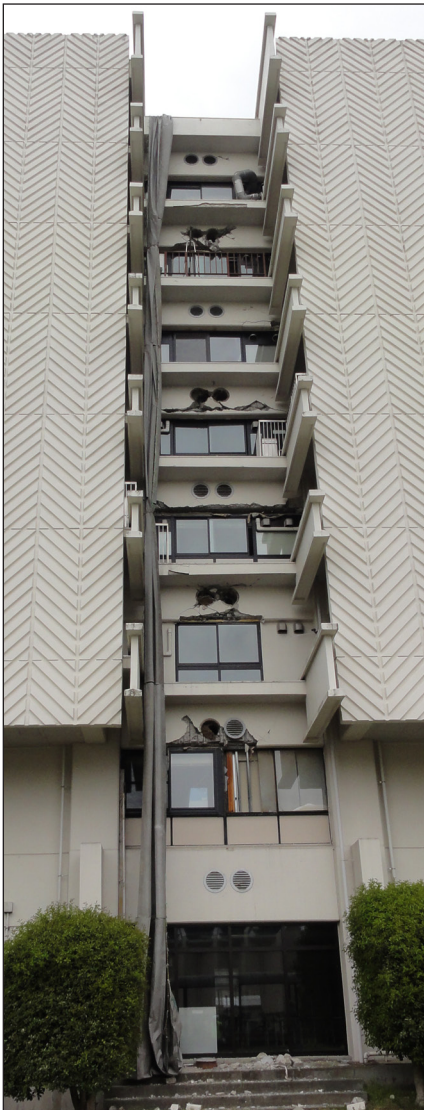
**Figure 12.** East elevation: Shear failures and bond-splitting failures of reinforced concrete coupling beams. Circular mechanical penetrations appear to have been installed after construction.

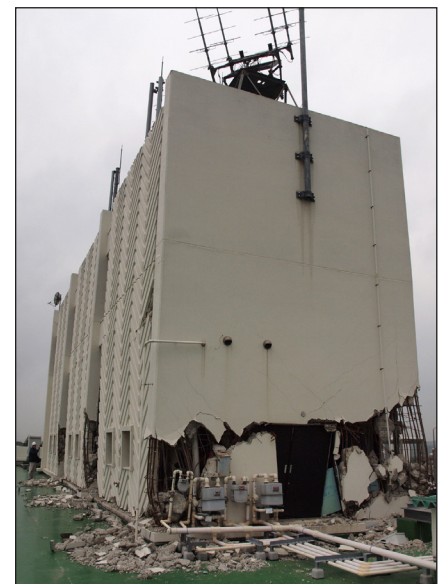
5th floor remained anchored. Also damaged were the walls of a two-story reinforced concrete mechanical penthouse above the roof (Figure 13).

**Figure 13.** Severe damage to two-story reinforced concrete mechanical penthouse.

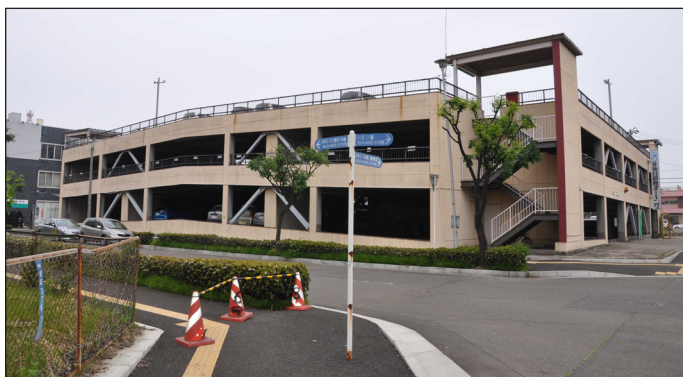
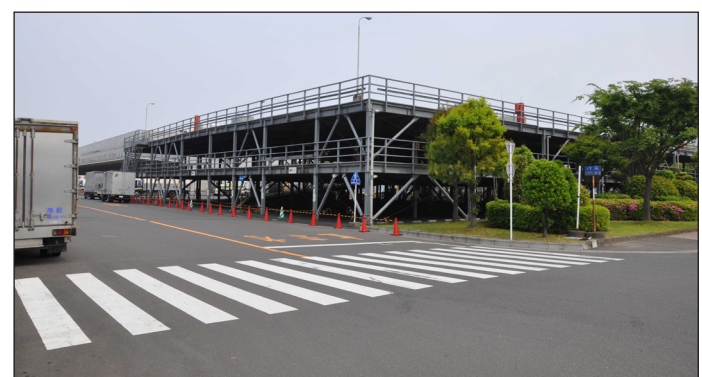
**Parking Garages.** In the Oroshimachi area, largely flat coastal plain, two-story parking garages (Figure 16) had moderate to extensive structural damage after the  $M_w = 9$  earthquake and the main  $M_w = 7.4$  aftershock. The early 1990s buildings had shear beam-to-column connections with steel braced frames in both loading directions, a typical story height of 3m, and a typical bay width of about 5m. Poor detailing of steel braces and gusset plates were identified as the main weaknesses.

**Figure 16.** Typical parking garages in the Oroshimachi area with moderate (left) and severe (right) structural damage.

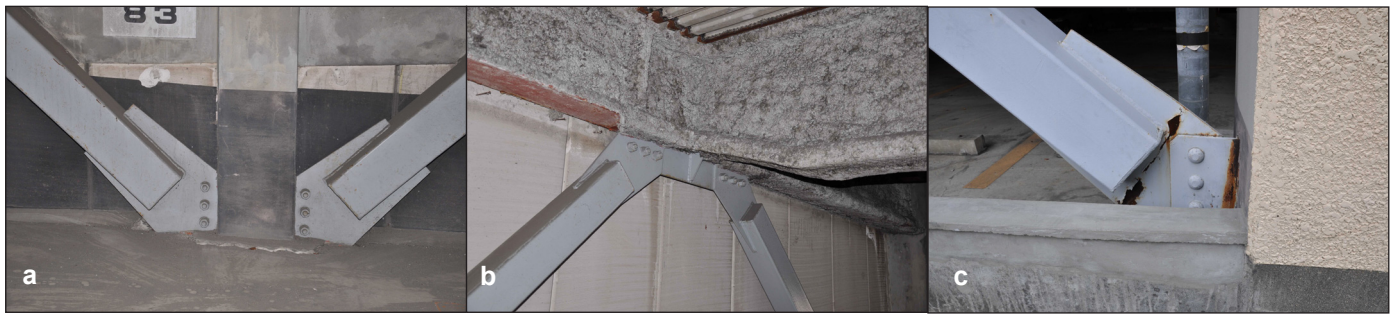
**Figure 17.** Typical gusset plate design details and failure modes in garage 16a: (a) foundation uplift, (b) welded stiffener, (c) gusset plate yielding.

column (see Figure 17c). In the parking garage shown in Figure 16a, gusset plates buckled in both loading directions. The gusset plates in this parking garage included a welded stiffener in the center (see Figure 17b), generally to prevent the out-of-plane movement of the gusset plate. The unbalanced vertical load, transferred to the columns from the damaged steel braces, caused column base foundation uplift (see Figure 17a). These gusset plates were not designed according to standard guidelines followed in the United States (AISC, 2005a) or to more recent recommendations by Lehman et al. (2008). Japanese practice for gusset plate design does not include providing a zone for flexure, out-of-plane deformation. AISC guidelines (2005b [6.1-179]) expect weak-axis bending in the gusset plates and require a suffi-

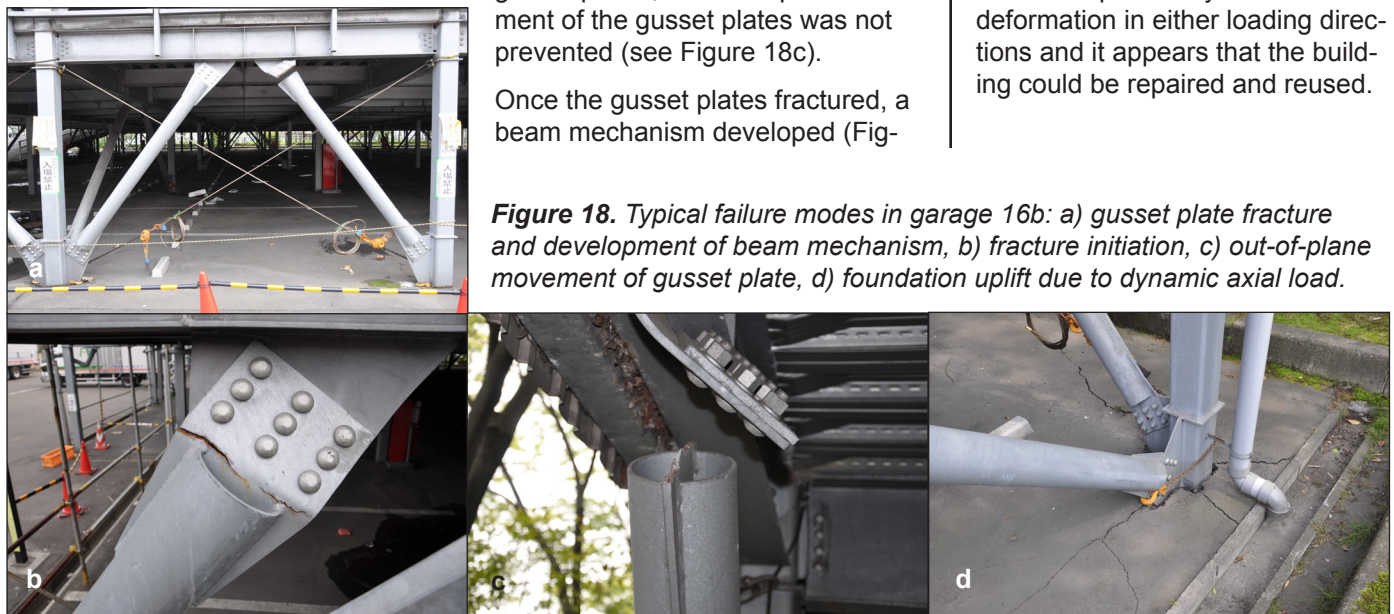
In the parking garage shown in Figure 16b, designed in 1991, all the top gusset plates of the steel braces in the east-west (EW) loading direction fractured due to low cycle fatigue (Figure 18a). This raises the issue of cumulative damage effect (cyclic deterioration and fracture due to low cycle fatigue) due to long-duration ground motions on steel components including beam-to-column connections (Chung et al. 2010, 2011; Lignos et al. 2011). In all the fractured gusset plates, fracture initiation started at the toe of the weld of the brace in the heat-affected zone and propagated along the length of the gusset plate after the many inelastic cycles of the ground motion (see Figure 18b). There was no stiffener welded in any of these gusset plates, so out-of-plane movement of the gusset plates was not prevented (see Figure 18c).

In the north-south (NS) loading direction, all the top gusset plates of the steel braces buckled, but almost none of them fractured, implying that the strong component of the ground motion was applied in the EW direction. Extensive cracks were observed around the exterior columns of the garage due to the dynamic axial load that was transferred to these columns from the steel braces in both loading directions. Notwithstanding the damage, there was practically no residual deformation in either loading directions and it appears that the building could be repaired and reused.

**Figure 18.** Typical failure modes in garage 16b: a) gusset plate fracture and development of beam mechanism, b) fracture initiation, c) out-of-plane movement of gusset plate, d) foundation uplift due to dynamic axial load.

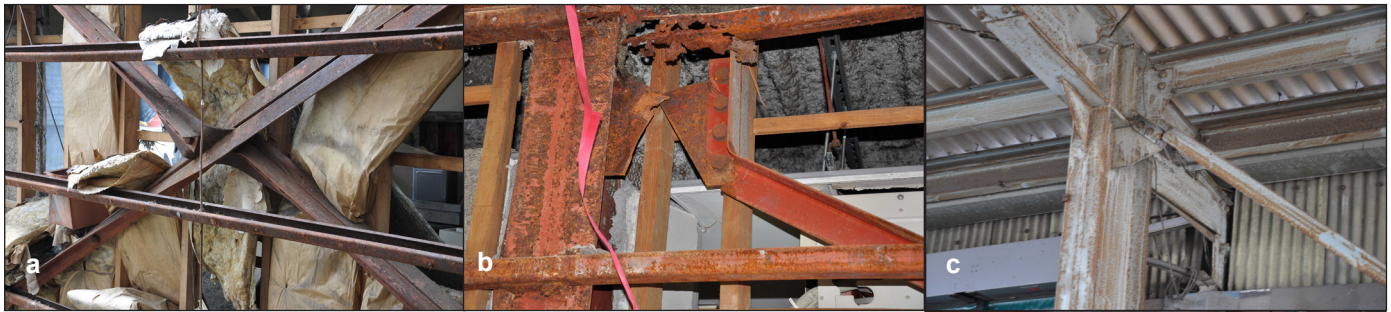
**Figure 19.** Typical failure modes in old Japanese construction design: (a) lateral torsional buckling, (b) net section fracture, (c) net section fracture, (d) panel zone yielding.

There were varying levels of damage in two- to four-story residential steel buildings with a steel moment frame in one loading direction and a braced frame in the other. The most common failure modes observed in braced frames involved (1) lateral torsional buckling of double angle steel braces with X-brace configurations due to thin gusset at the crossing of the double angle braces (Figure 19a), (2) net section fracture (Figures 19b and 19c), and (3) panel zone yielding (Figure 19d).

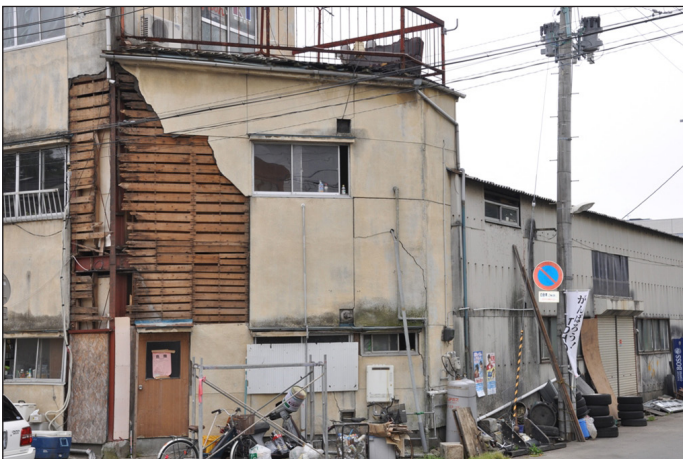
Widespread damage to all types of external finishes was observed in the Oroshohimachi area. Figure 20 shows an older residence where large blocks of mortar that covered timber lath fell. Figure 21 shows a three-story office building where ALC panels fell off a steel moment frame over

**Figure 20.** Cladding damage to older residential building.

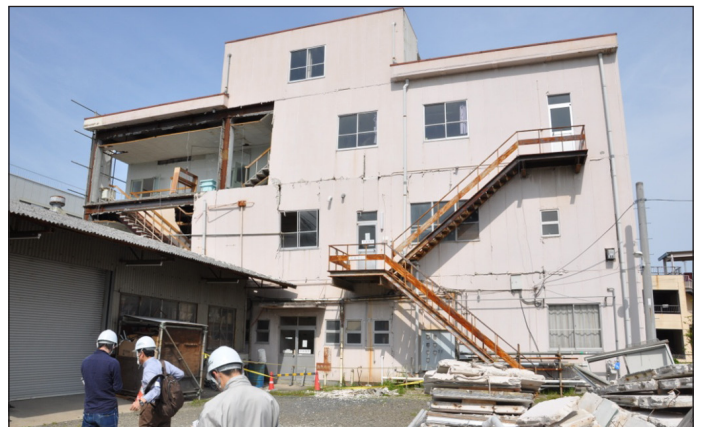
one quarter of the perimeter, and where the remaining ALC panels show extensive damage along the panel boundaries. Figure 22 shows a warehouse building where ALC panels fell from the second story. These buildings were two- to three-stories high, and believed to be at least ten years old.

**Figure 21.** ALC panels fallen from a three-story office building.

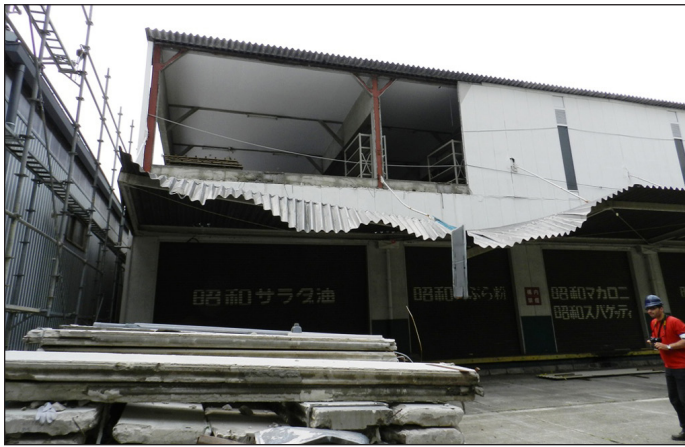
**Figure 22.** ALC panels fallen from a two-story office-and-warehouse building.

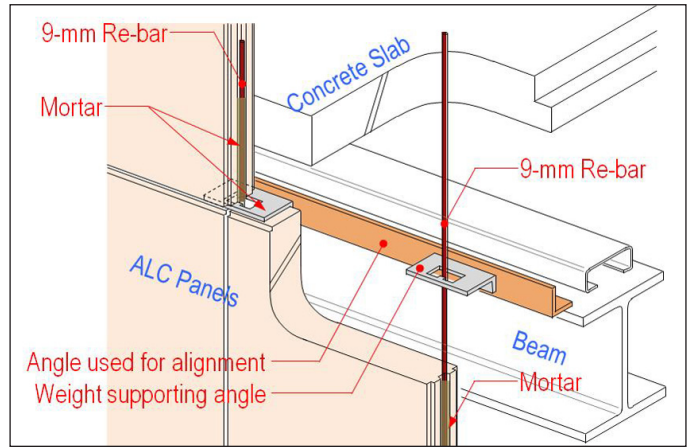
Figure 23 illustrates the typical method of ALC panel installation that was used until ten years ago. All ALC panel damage observed by the investigation team, including that shown in Figures 21 and 22, used this installation method. The observed damage to ALC panels was likely caused by the inability of the panels to accommodate story

**Figure 23.** Older method of ALC panel installation used up to ten years ago.

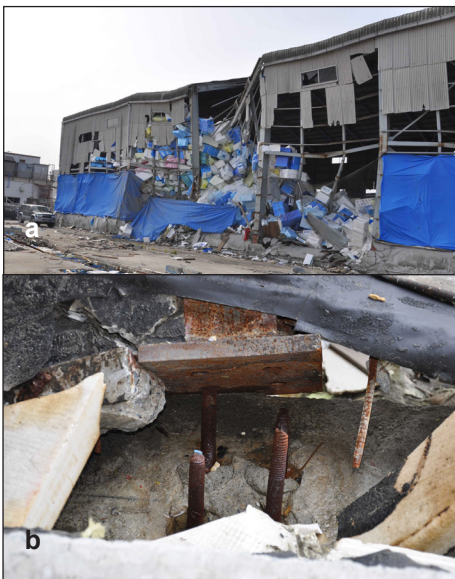
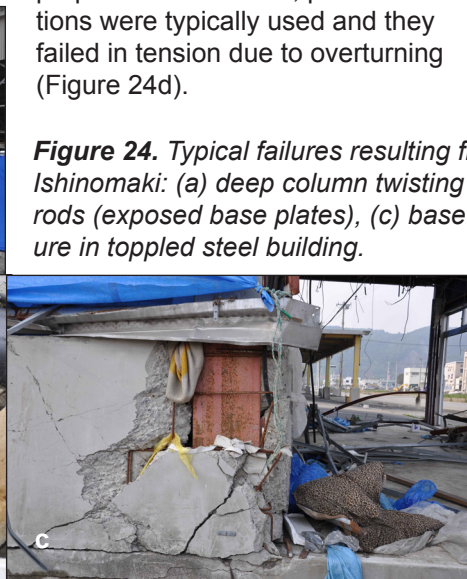
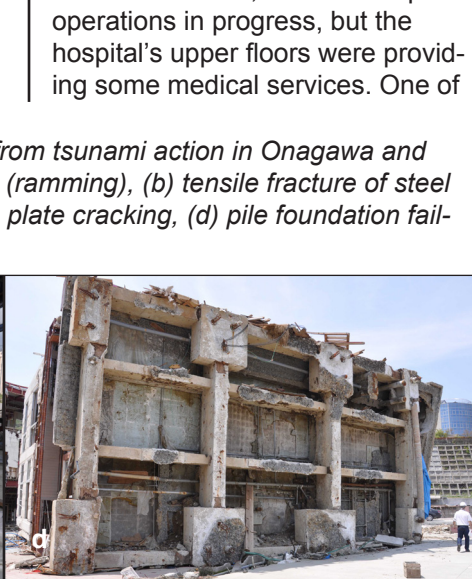
but a number of industrial buildings built close to the fishing ports were damaged by tsunami-carried debris. The most common failure mode associated with tsunami was steel column global buckling in addition to local and/or lateral torsional buckling (Figure 24a). This problem was acute when deep W sections were used in the design because these columns are susceptible to lateral torsional buckling. Other failure modes — due to water pressure from the tsunami waves — involved steel rod fractures of exposed base plate connections (Figure 24b), and cracking of base plate connections (Figure 24c). In the Onagawa area there were at least five buildings that toppled over, two of which were steel structures of three and four stories. Due to poor soil properties in this area, pile foundations were typically used and they failed in tension due to overturning (Figure 24d).

**Figure 24.** Typical failures resulting from tsunami action in Onagawa and Ishinomaki: (a) deep column twisting (ramming), (b) tensile fracture of steel rods (exposed base plates), (c) base plate cracking, (d) pile foundation failure in toppled steel building.

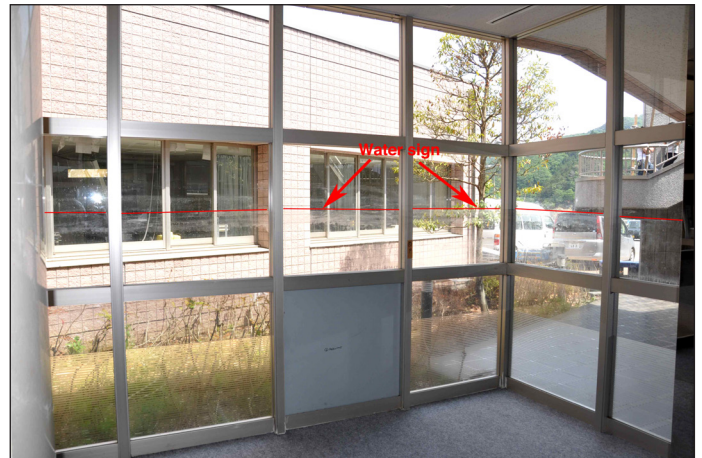
**Figure 26.** Water signs, first story of Onagawa hospital.

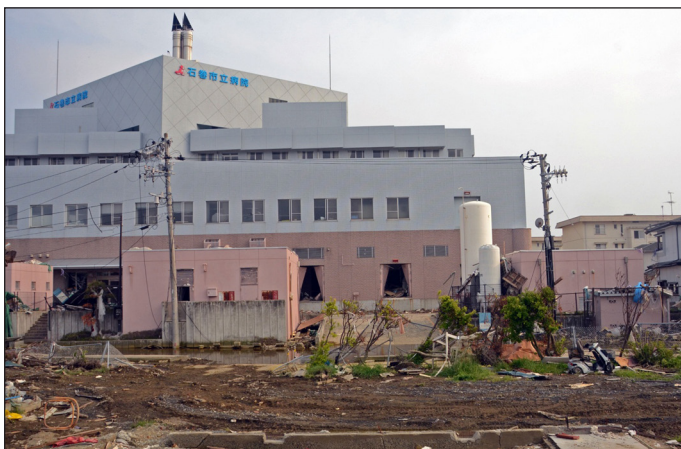
The Ishinomaki City Hospital, a modern four-story building, is located adjacent to the mouth of a river that empties into the bay and appeared to have been badly damaged by the tsunami (Figures 27 and 28). In early June, the hospital was not in service because of significant damage to the ground floor, although the upper floors did not appear to have significant damage.

**Figure 27.** Ishinomaki City hospital.

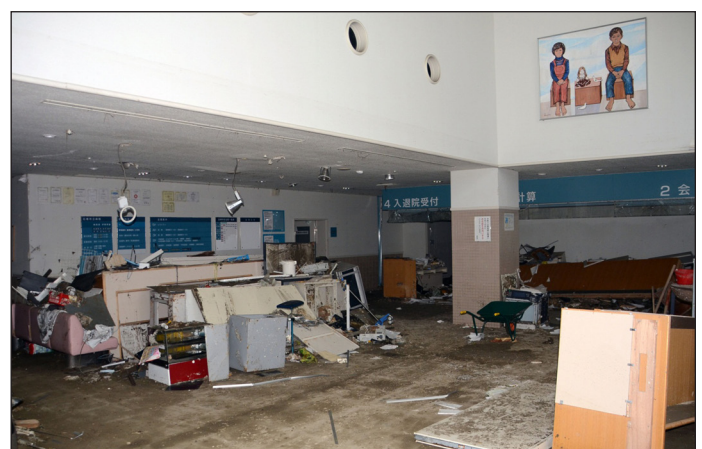
**Figure 28.** Main lobby of Ishinomaki City hospital.

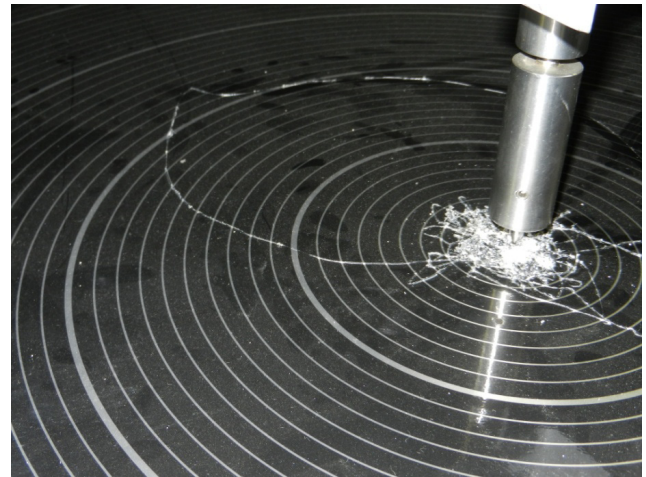
During the Tohoku earthquake, the maximum displacement of the isolation system was approximately 23cm, as recorded by a scratch plate at the

**Figure 31.** Scratch plate indicating maximum isolation system displacement of 23cm.

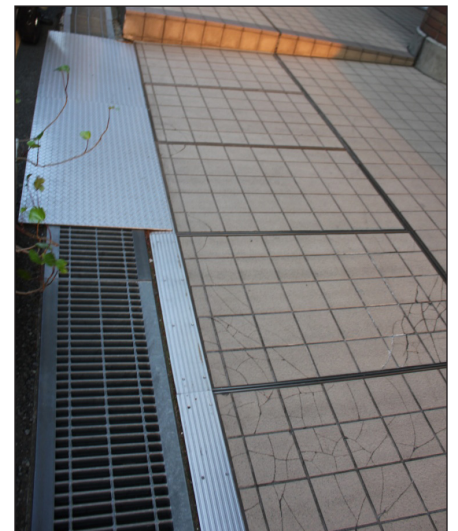
lation “moat” covers (see Figure 41) or cover plates over seismic isolation joints between base-isolated and fixed-base buildings. This damage could generally be classified as cosmetic since it did not inhibit the function or recovery of the building; however, it appeared that the damage could have been avoided by designing the moat and joint

**Figure 41.** Damage to moat cover of base isolated building.
