Field Survey northern Sumatra and Banda Aceh, Indonesia and after the Tsunami and Earthquake of 26 December 2004.

Jose C. Borrero

Preliminary report prepared for:
Earthquake Engineering Research Institute
February 9, 2005

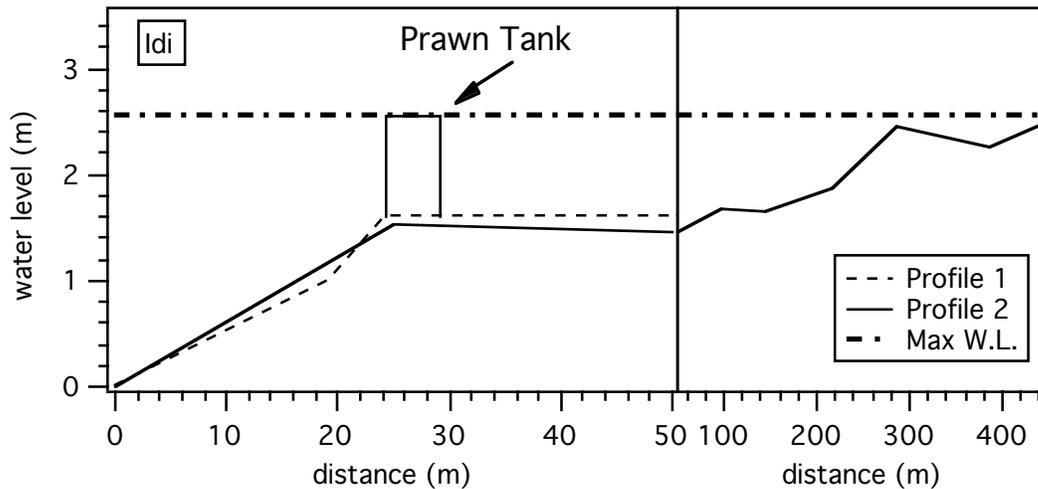
Figure2: Profile of data taken at Idi, northeastern Sumatra. Note the scale change.

The earthquake was widely felt throughout northern Sumatra. It was described as a long lasting gentle rocking in Medan that did not cause damage. Further north at Idi, residents reported feeling earthquake shaking for 10 minutes. About 1 and a half hours after the earthquake, witnesses reported seeing the ocean recede more than 500 m. The tsunami came in as 2 waves with the larger wave second. A cross-shore profile of the inundation zone showed that the wave penetrated over 500 m inland and attained a height of 2.5 m above sea level (figure 2).

We have an upper limit on the wave height at the shoreline because the tanks at the prawn hatchery were not overtopped. Wood construction at the shoreline was destroyed while reinforced concrete construction generally survived. There were no fatalities. The local residents said locally stationed Navy personnel warned them that a tsunami was coming, however they also reported that many ignored the warning.

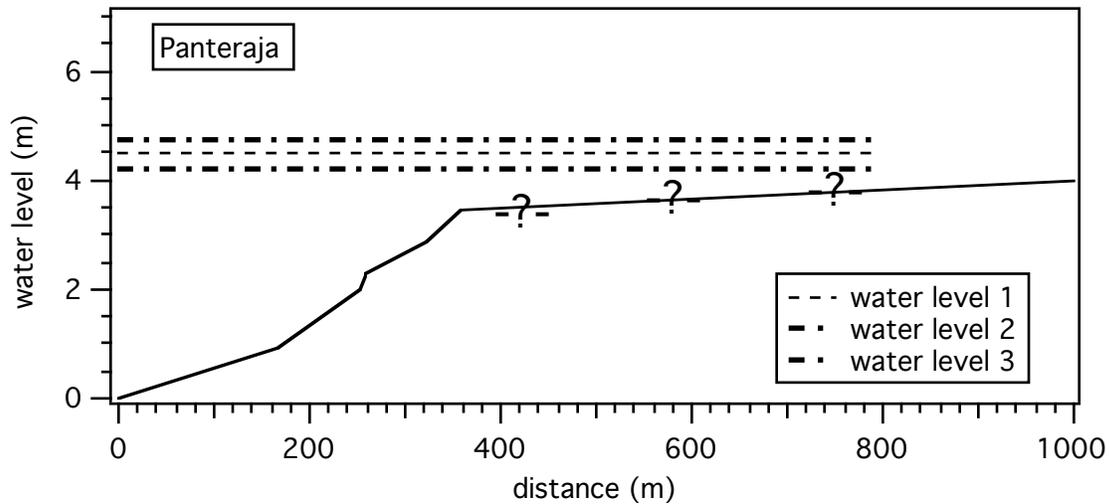
Figure 3: Profile at Panteraja. Question marks indicate that this region was not surveyed, however it was observed to be relatively flat rice fields that were completely inundated. Three water levels were measured on two different structures along this profile.

Continuing north along the coast, we observed the damage at Panteraja. Residents stated the earthquake as lasting for approximately 10 minutes. The shaking was severe in this area, residents reported not being able to walk or even squat during the shaking, that they were knocked to the ground. They also describe two shaking episodes, the first with a horizontal east-west oriented back and forth motion and the second feeling more 'up and down'. Earthquake damage to structures in the area was reported to be minor. The tsunami effects were much more severe here. The tsunami attack began with an initial withdrawal about 30 minutes after the earthquake. The local residents reported three waves with the third being the largest. The wave penetrated up to 1 km inland and attained a height of 4.2 to 4.7 m above sea level at the time of the tsunami (figure3).

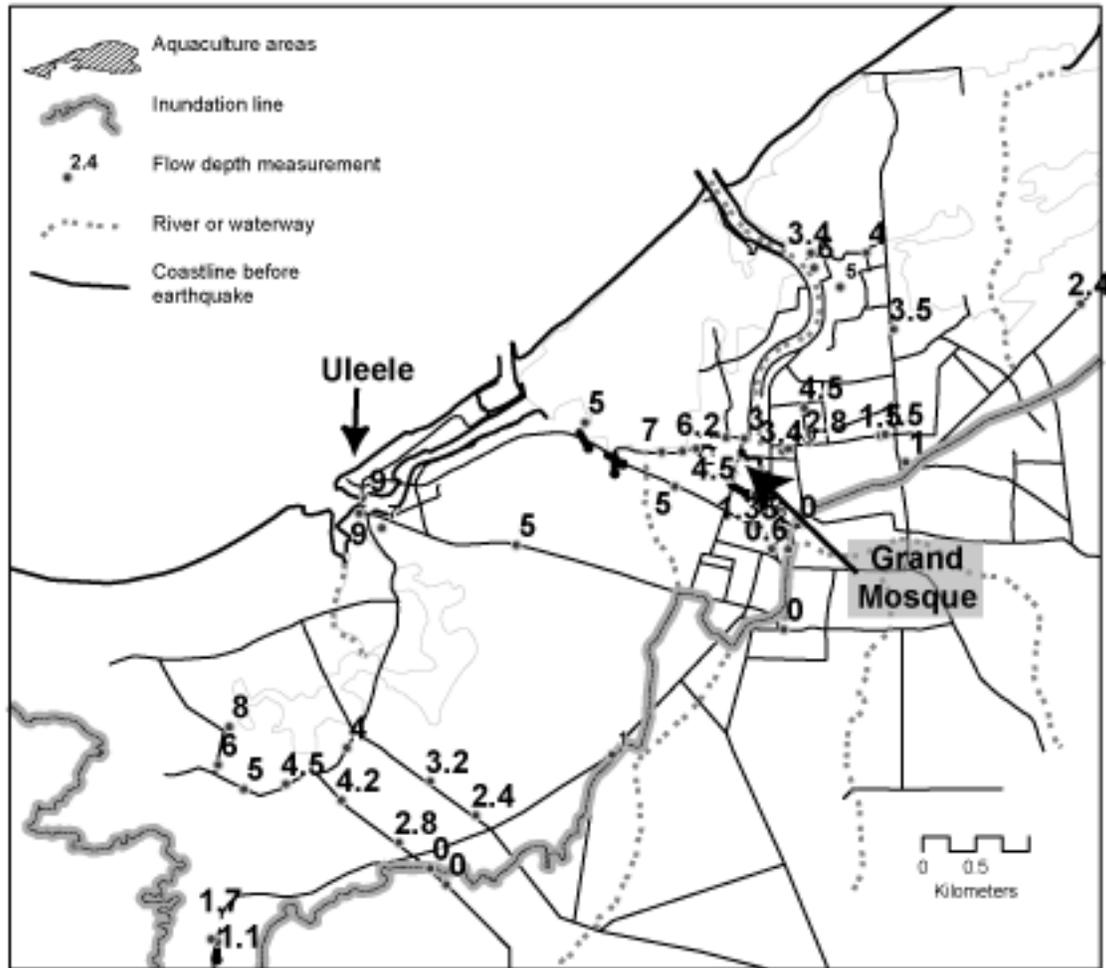
Figure 4: Map of Banda Aceh with flow depths as measured in the field.

The inundation line was observed to lie between 3 and 4 km inland throughout the city (figure 4). Flow depths over ground were observed to be over 9 m in the northern seaside section of Uleelee and tapered landward. The level of destruction was observed to be more extreme on the northwestern flank of the city in the areas immediately inland of the aquaculture ponds. The area towards the sea was wiped clean of nearly every structure while closer to the river, dense construction in a commercial district showed the effects of severe flooding. The spaces between the buildings served as conduits from the flow spilling over the riverbanks and through the cities streets. The flow depth was just at the level of the second floor and there were large amounts of debris piled along the streets and in to the ground floor storefronts. A survivor of the tsunami from Uleelee

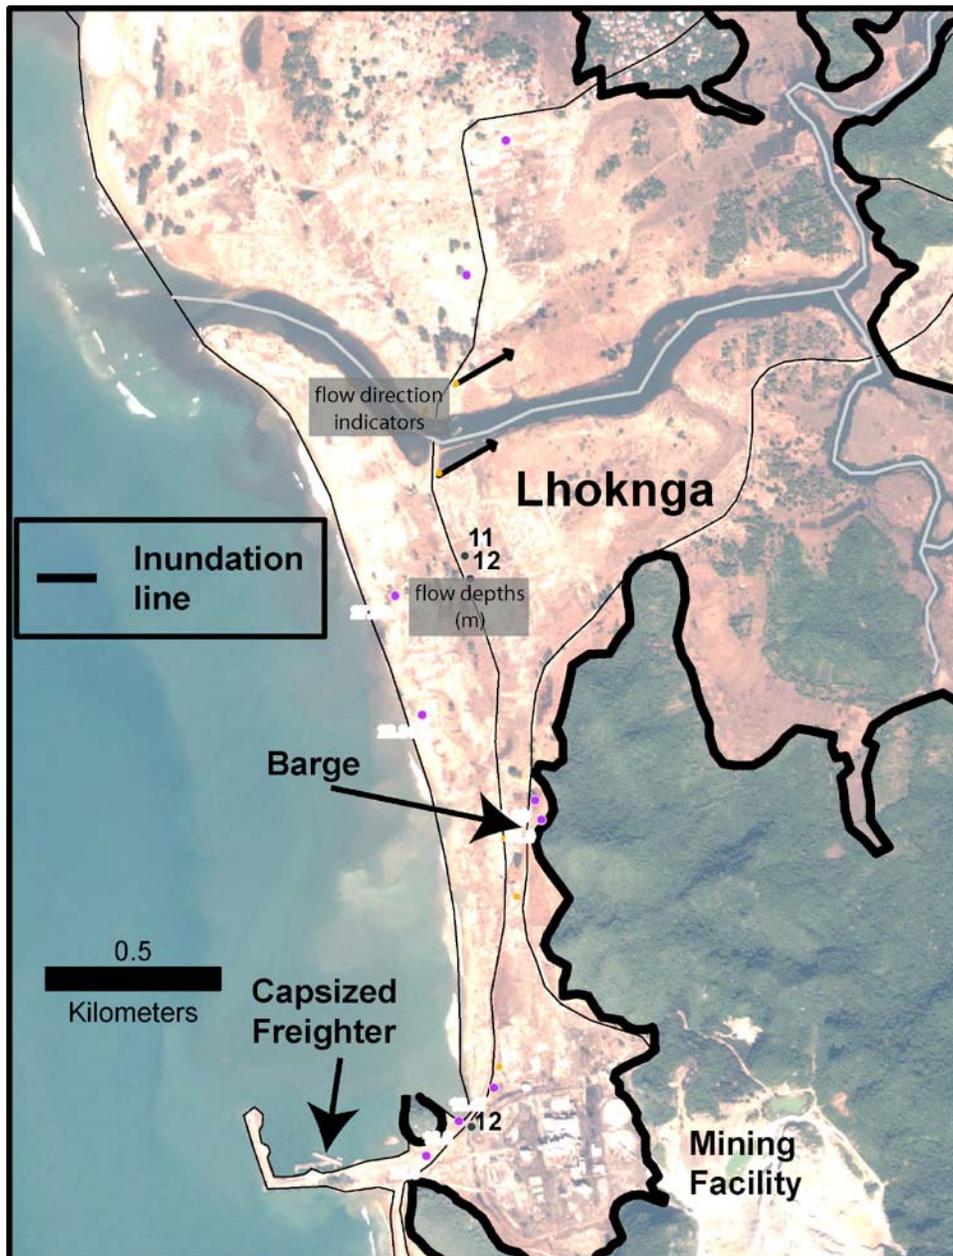
Figure 5: Satellite view of Lhoknga. The 25 m was the estimated runup at the trim line above the barge.

The most severe tsunami effects were observed to the west of Banda Aceh on the coastline that faces towards open Indian Ocean and the epicenter of the earthquake. On the beach at Lhoknga (figure 5), stripped bark on trees indicated a sustained flow depth of over 13 m at the shoreline. A mining facility at the south end of the beach was severely damaged by the tsunami. There were two large ships that were affected by the tsunami. A 90-m long coal barge was deposited over 160 m from shore on the beach at the base of a hill with its tugboat still attached. At the jetty in front of the mining facility, a 100-m freighter was capsized at its moorings.

A clearly defined trim line was visible all along a steep hill that backed the beach 300 m from the shoreline. The height of this trim line was estimated to be 25 m high, but

it was not measured precisely in the field during this survey. That value was later confirmed by comparing a satellite photograph of the inundated region to a 90-m digital elevation model, which gave a value of 23 m at that location. Later surveys by *Tsuji et al.* (2005b) reported runup heights at that location to be 22 and 32 meters.

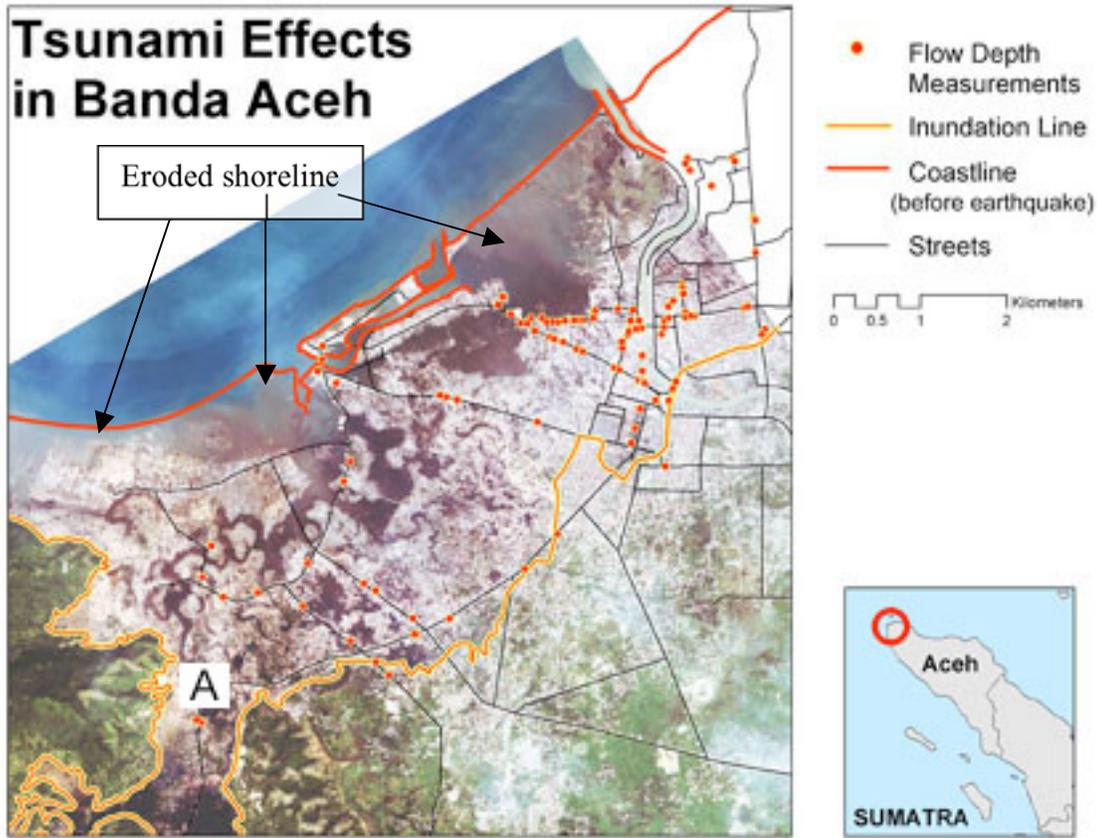
Figure 6: Satellite image of Banda Aceh after the earthquake and tsunami.

Comparing before and after satellite images shows a drastic change in the shoreline of Banda Aceh. Figure 6 shows a comparison of the shoreline from before the tsunami to a satellite image taken shortly after the tsunami. Extensive erosion can be seen all along the shoreline. The sand spit at Uleele was washed through in several places. A narrow strip of land between the sea and the aquaculture fields was completely washed away, effectively moving the shoreline inland by several hundred meters.

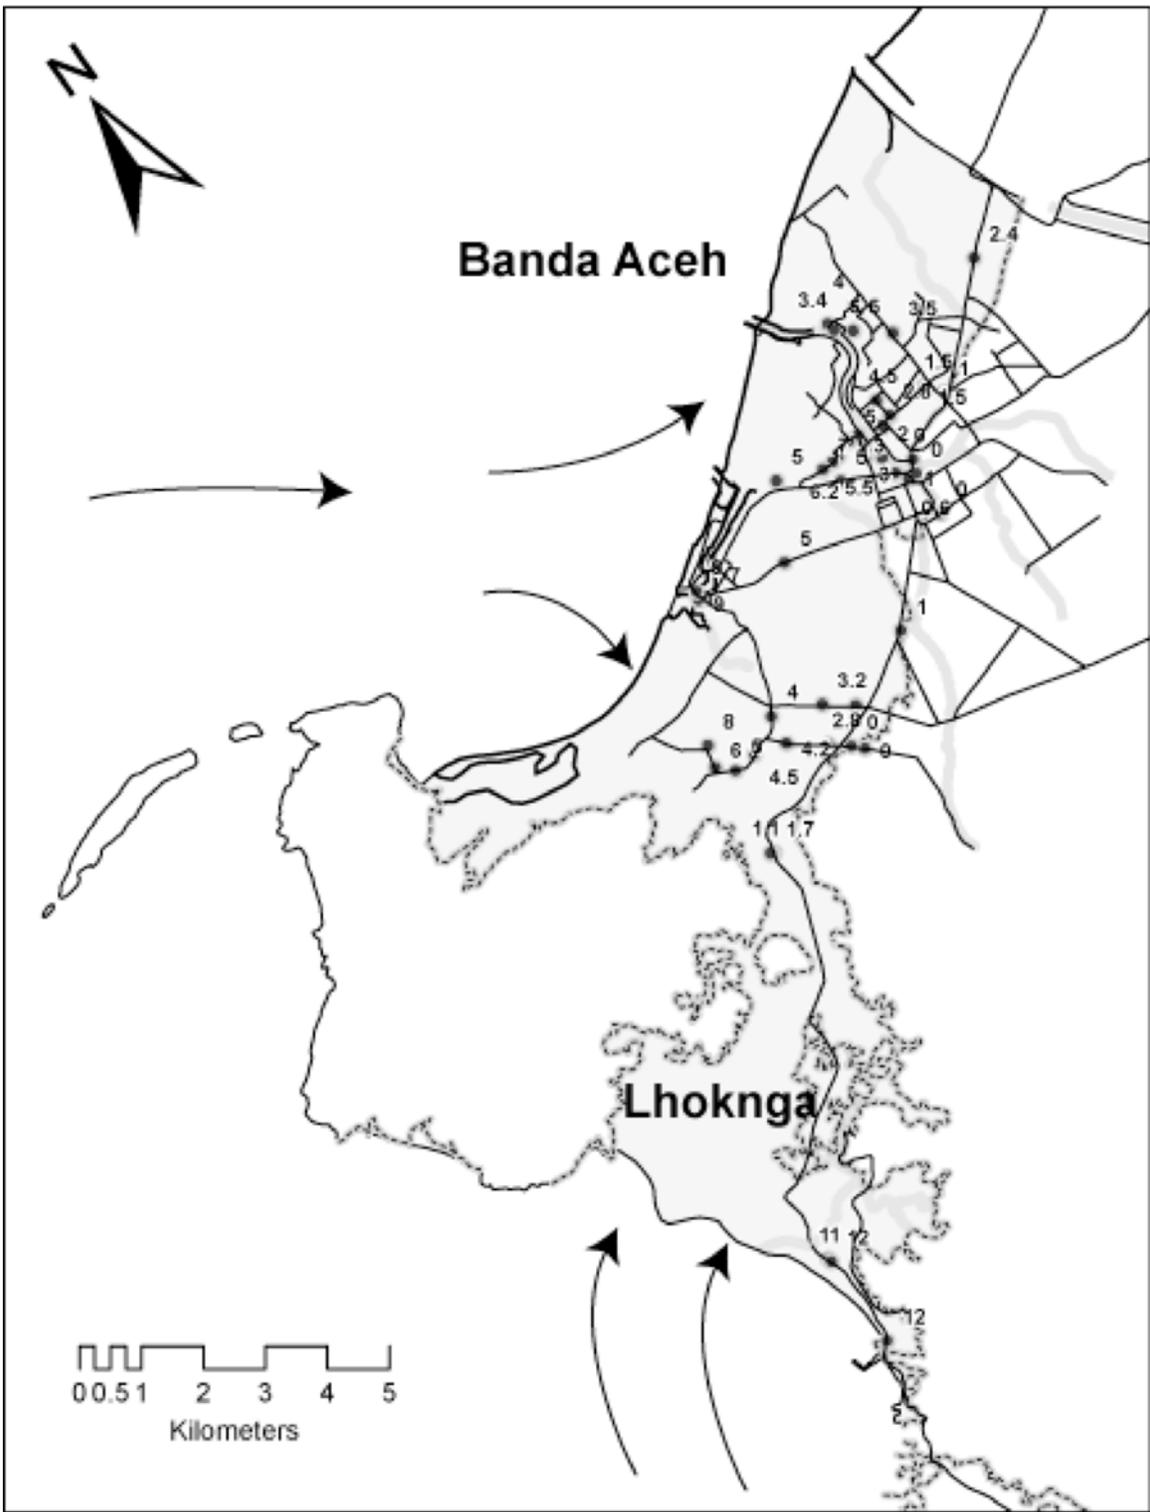
Figure 7: The over wash area between Lhoknga and Banda Aceh.

A witness interviewed at location A in figure 6 reported a wave approach from ‘both directions’. Analysis of satellite imagery taken after the tsunami clearly shows that the tsunami inundated across the northwestern tip of Sumatra. Digital elevation data show an area of low elevation cutting across a small ridge. Figure 7 shows the extent of inundation in the vicinity of Banda Aceh and Lhoknga. The tsunami wave fronts were able to cut across the northwestern tip of Sumatra.

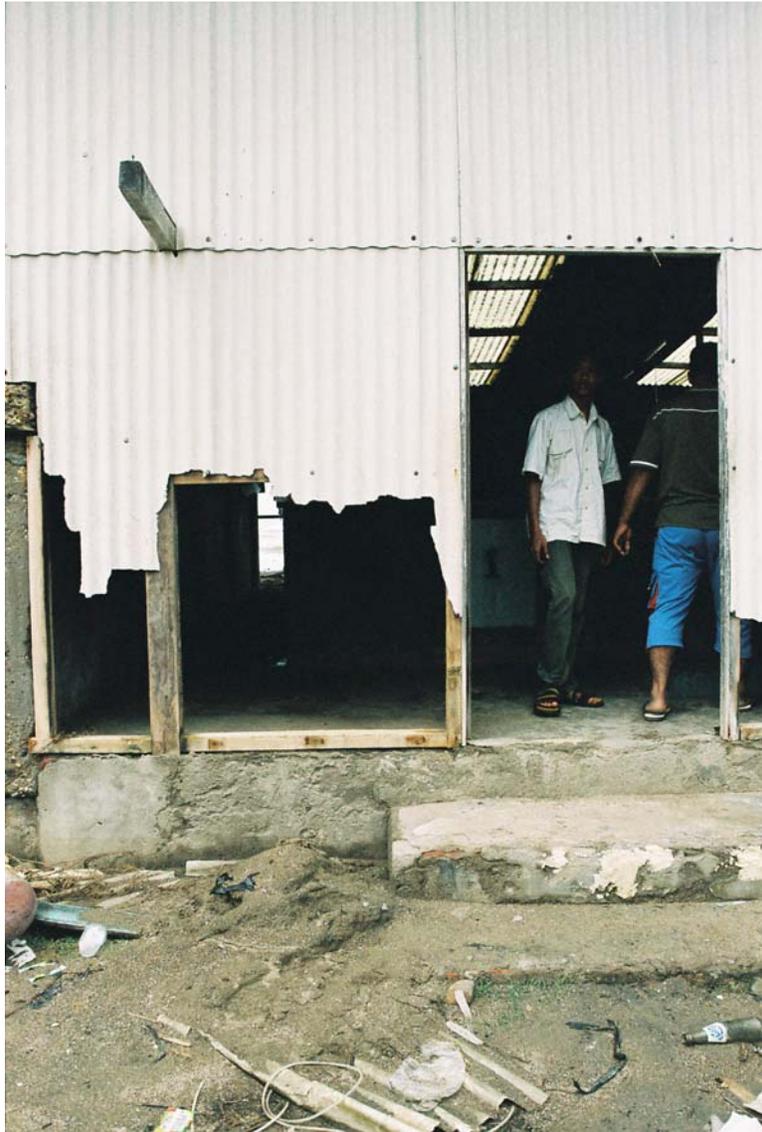
Photo 1

Photo 1: The prawn hatchery at Idi. Note how only the lower portion of the wall paneling was damaged.

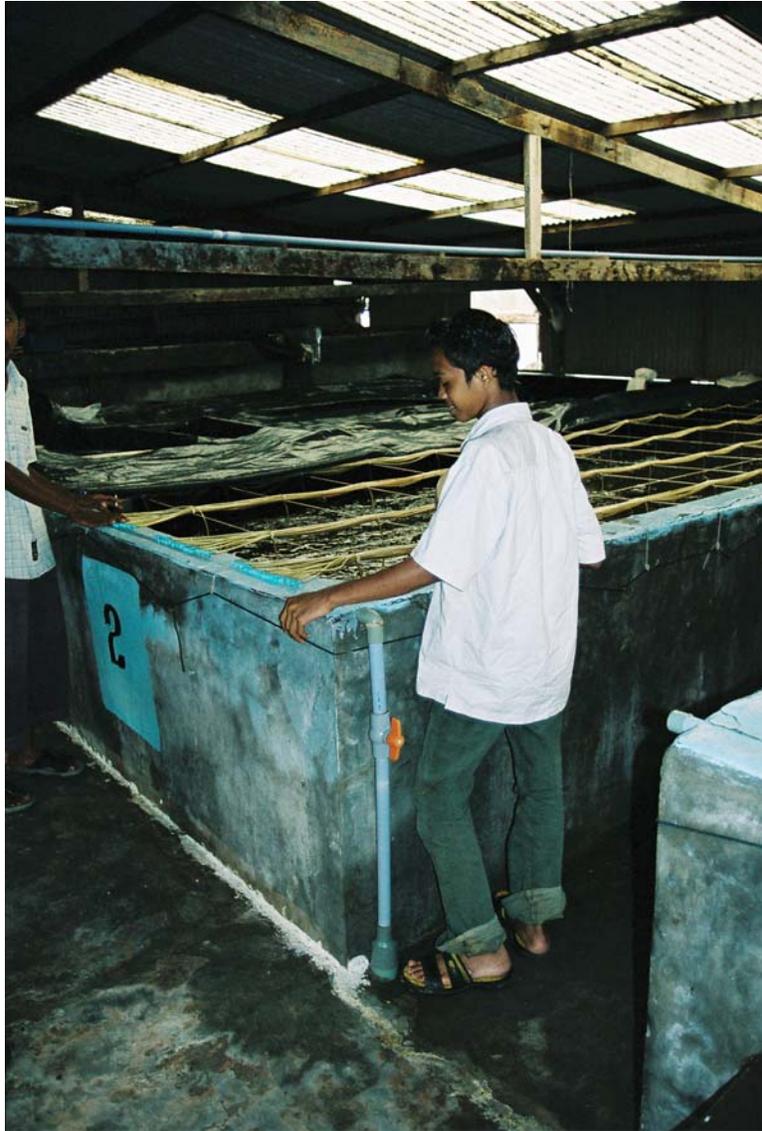
Photo 2

Photo 2: The prawn hatchery at Idi. The tsunami wave did not over top the hatching tank.

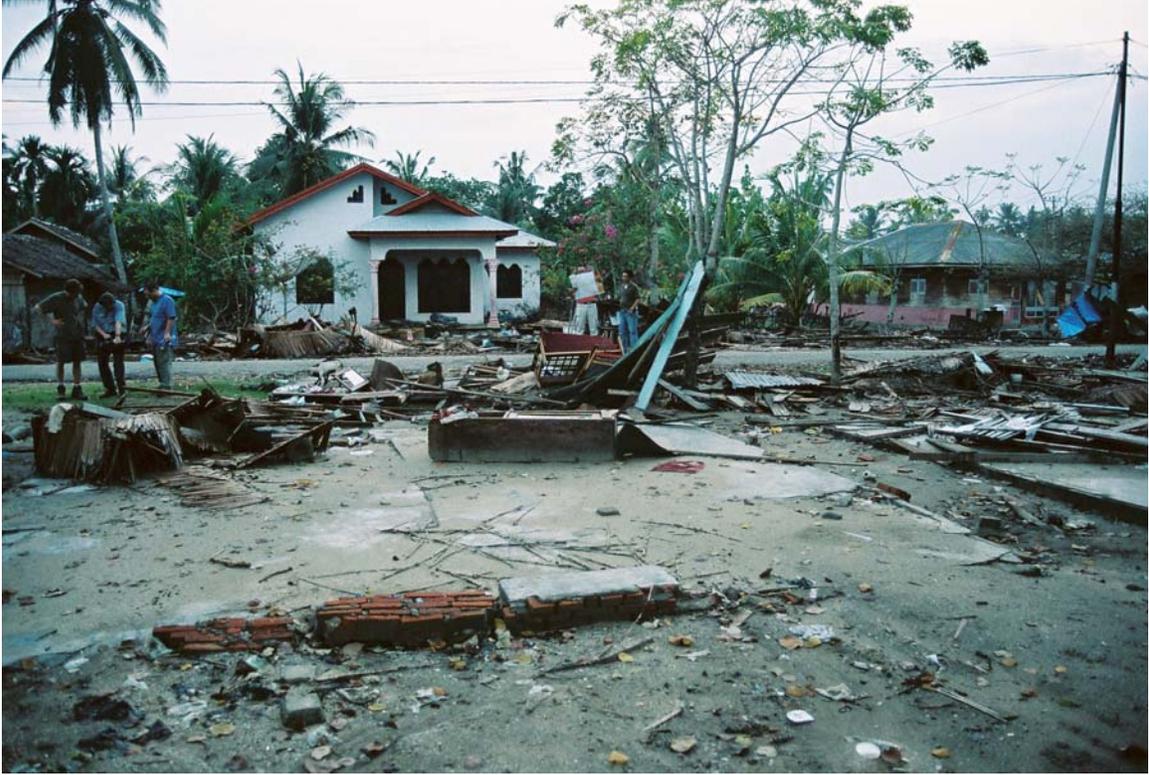
Photo 3

Photo 3: The beach front at Idi. Light wood or brick structures on the shoreline were destroyed by the tsunami.

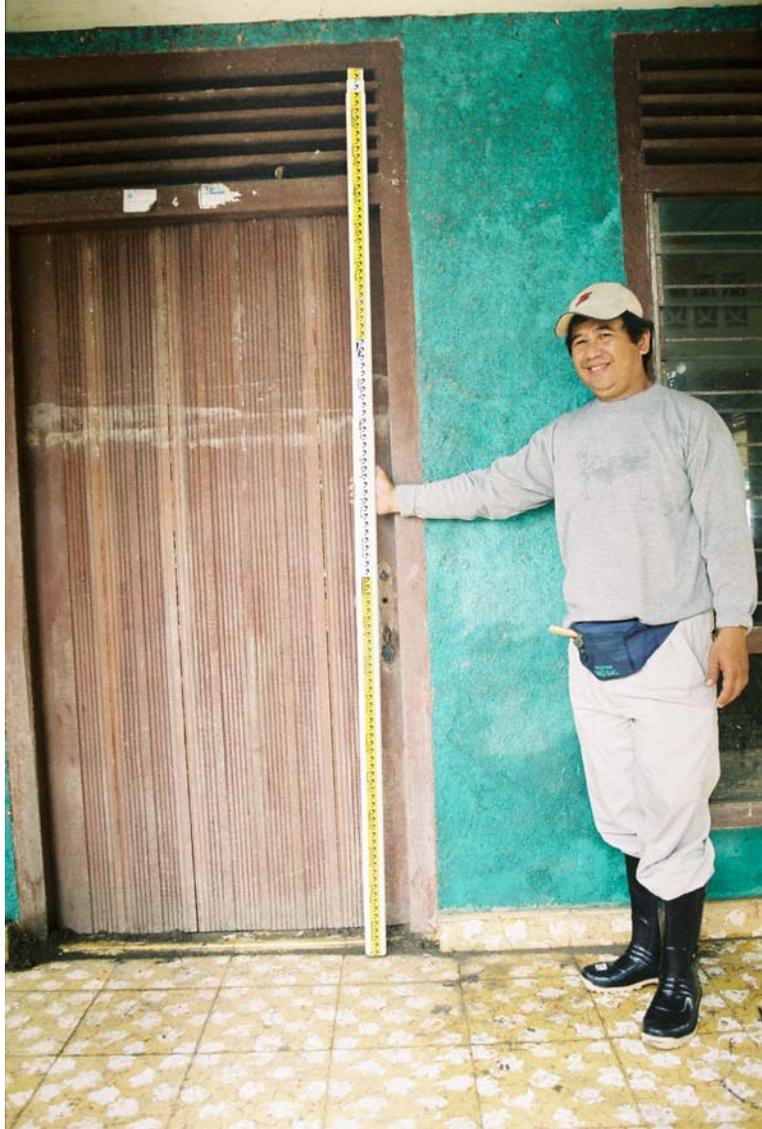
Photo 4

Photo 4: A flow depth indicator along the profile in Panteraja.

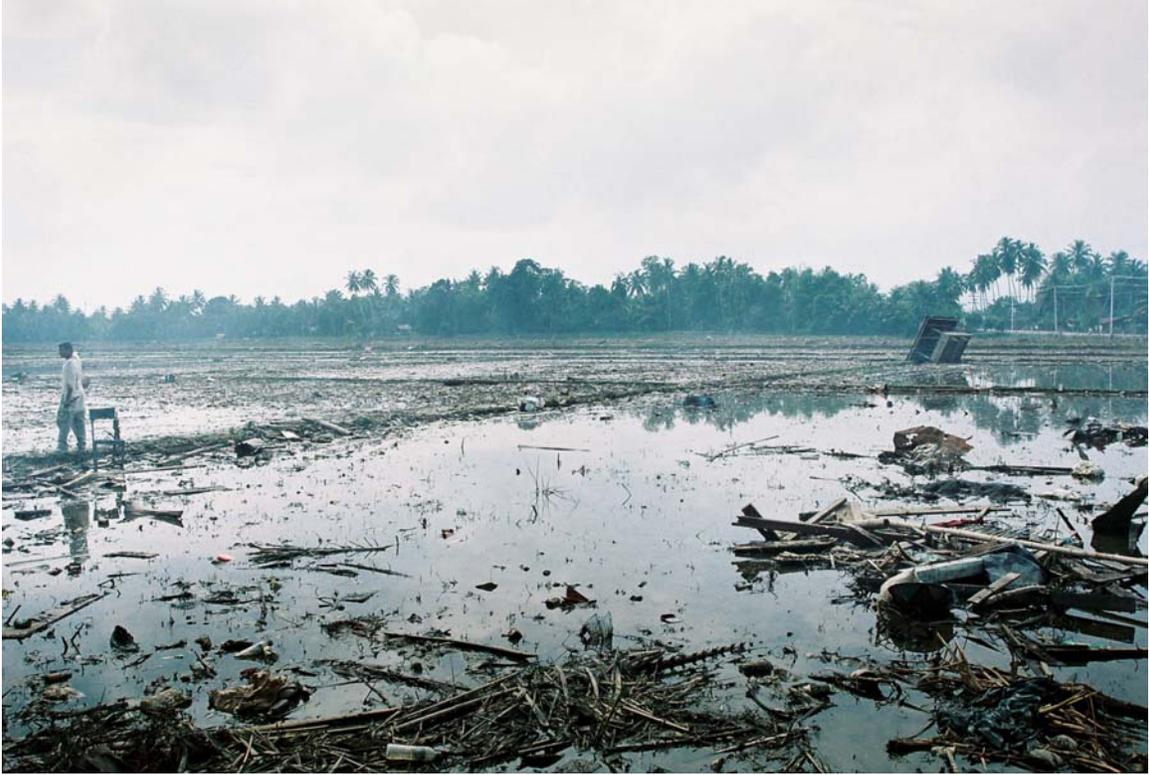
Photo 5

Photo 5: The extent of inundation in Panteraja. The tsunami wave covered the rice fields to the tree line in the distance.

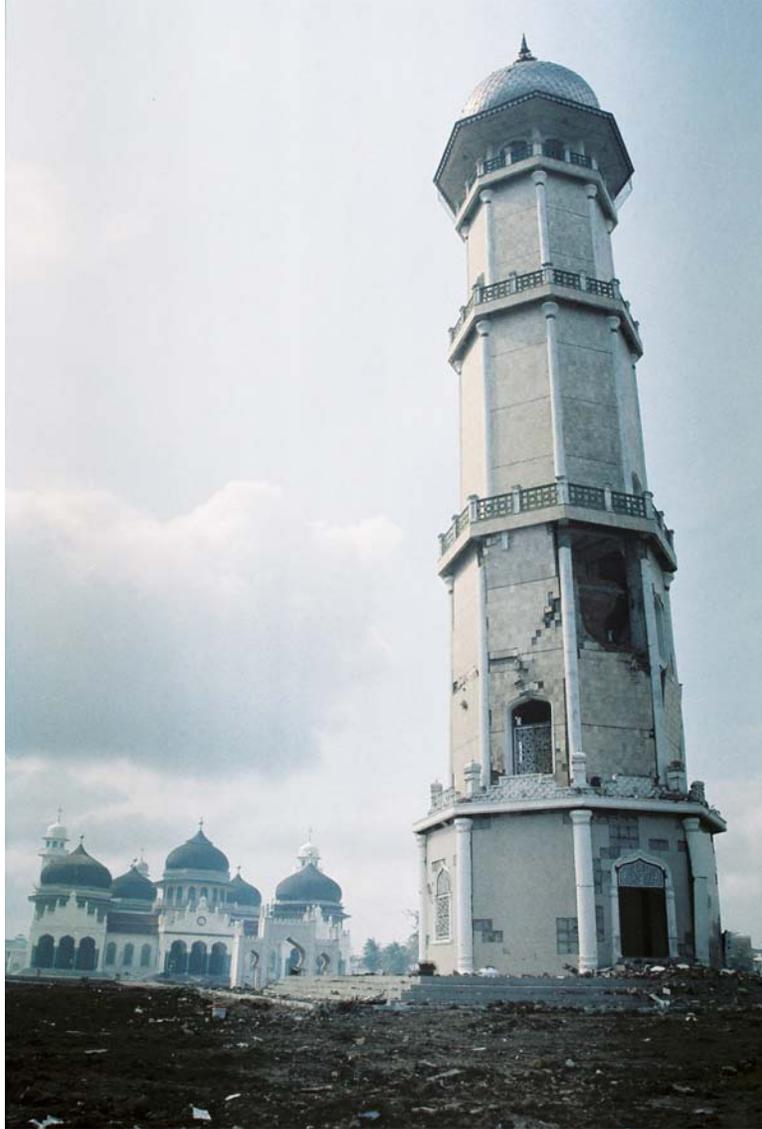
Photo 6

Photo 6: The tower at the Grand Mosque in central Banda Aceh. The water reached this section of town and the earthquake damaged the tower. This photo was taken 3 km from the open sea.

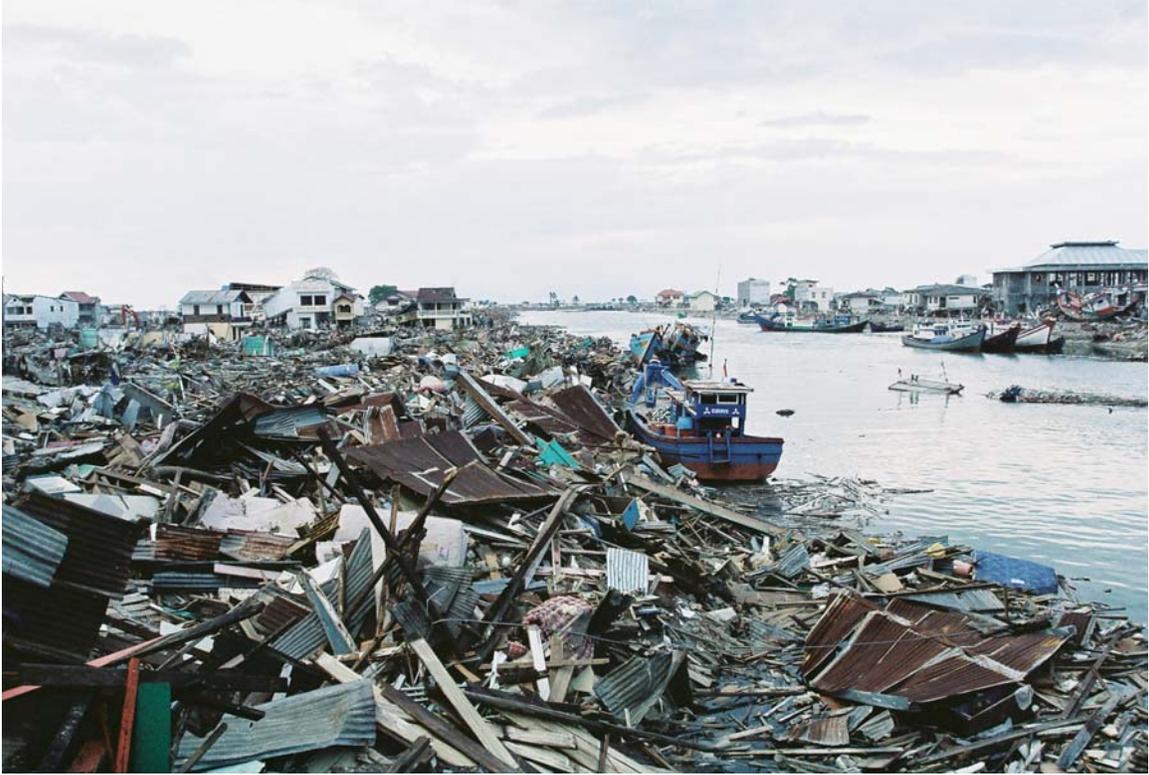
Photo 7

Photo 7: Debris left in the river at Banda Aceh.

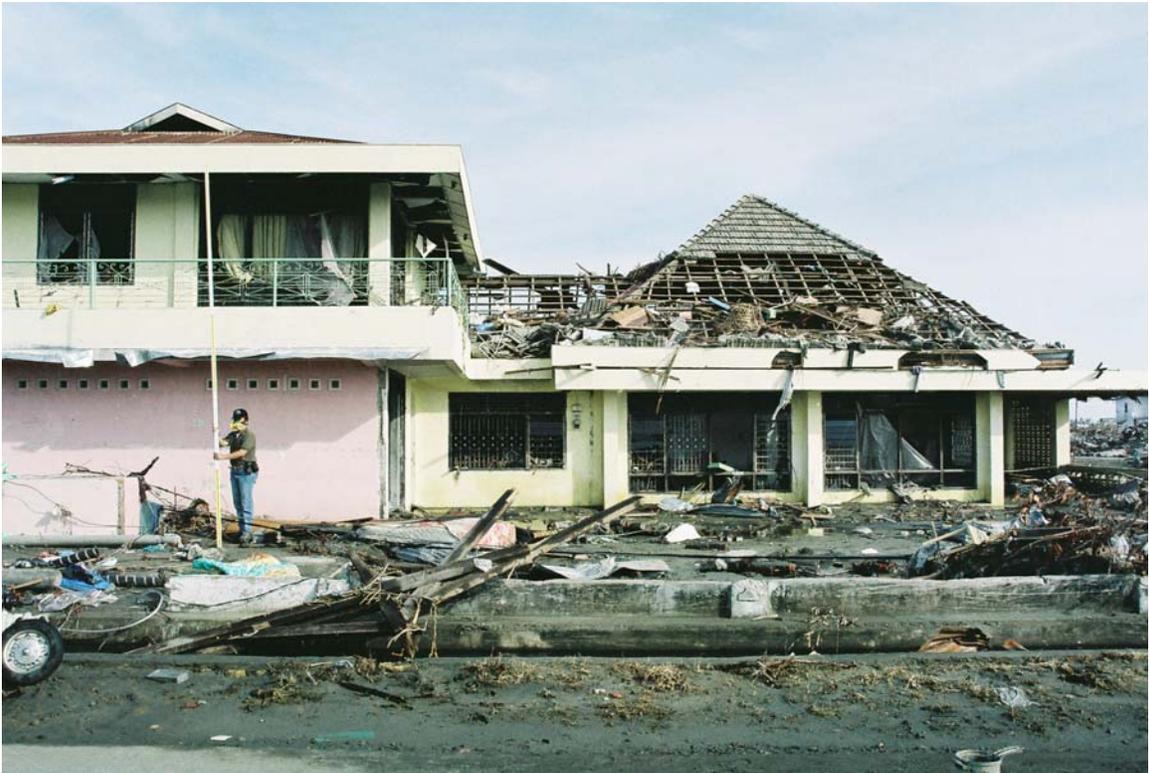
Photo 8

Photo 8: An example of a clear flow depth indicator. Roof tiles were removed by the flooding wave.

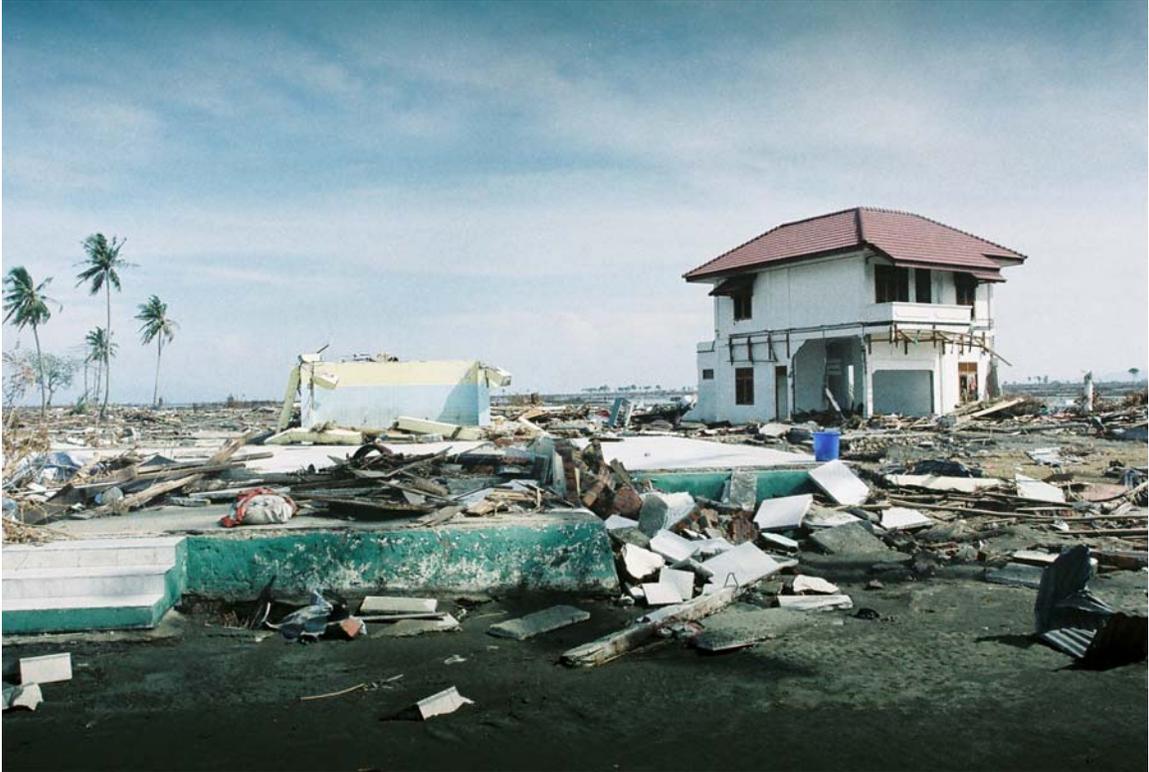
Photo 9

Photo 9: A well-built reinforced concrete structure survived the tsunami while other poorly built structures around it did not.

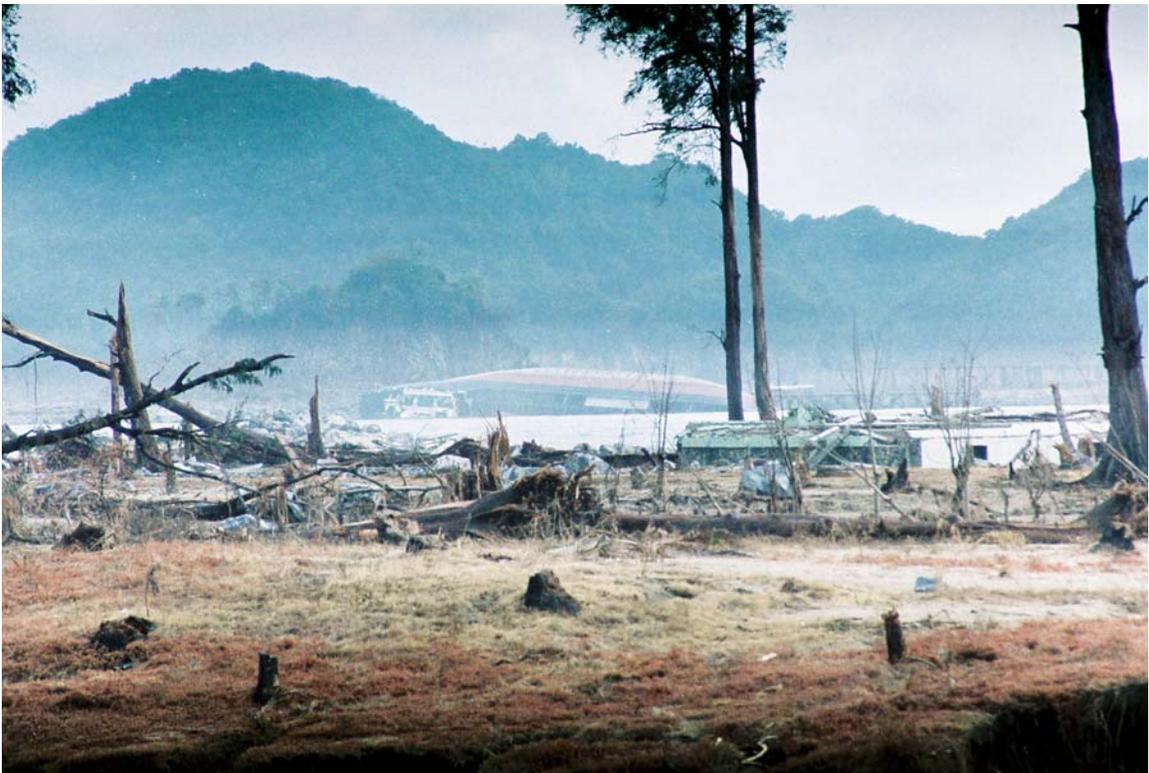
Photo 10

Photo 10: The freighter capsized at Lhoknga.

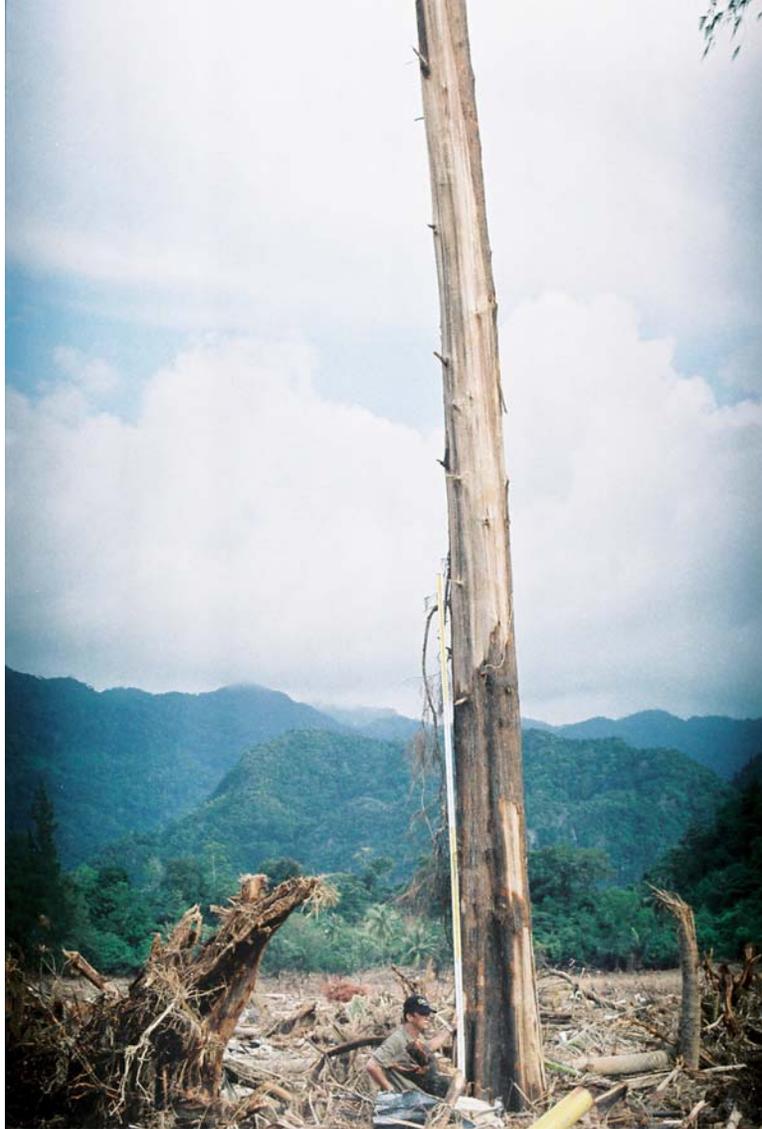
Photo 11

Photo 11: Bark stripped from the tree. Note the 5 m staff. Flow depths were over 10 m.

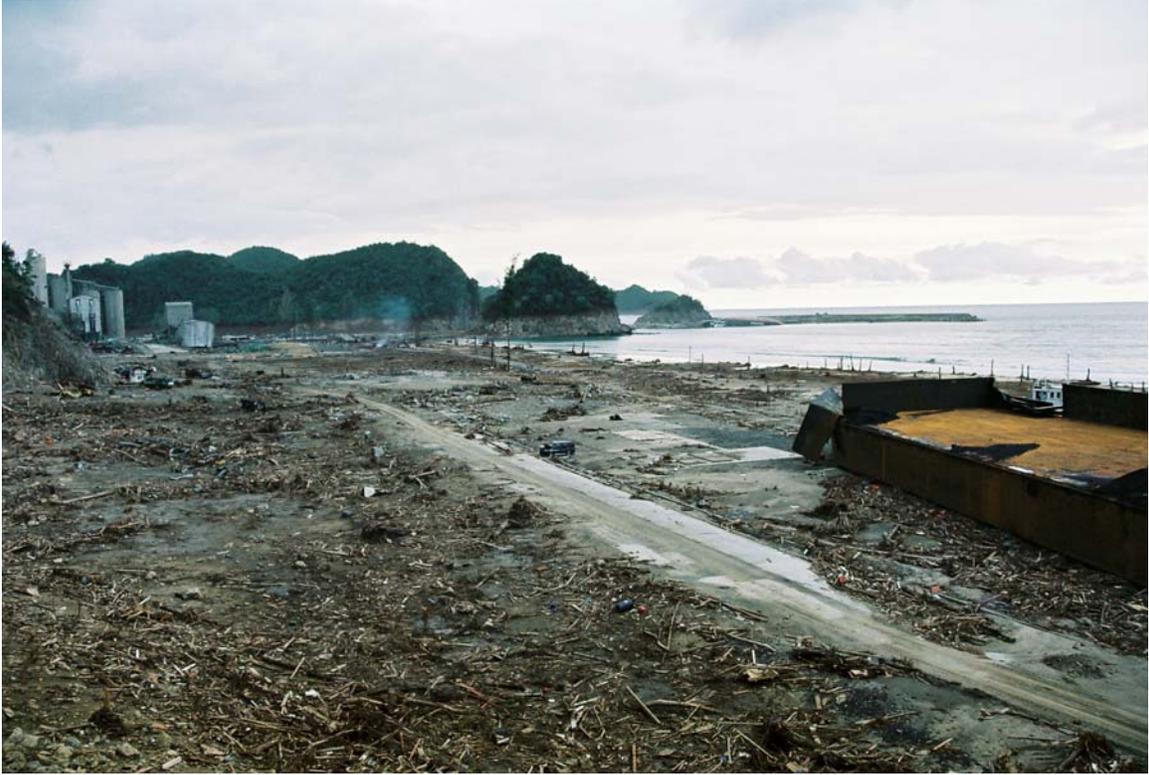
Photo 12

Photo 12: The view from the high water mark at Lhoknga. Note the coal barge in the foreground, the trim line along the base of the hill and the capsized freighter at the jetty in the distance.

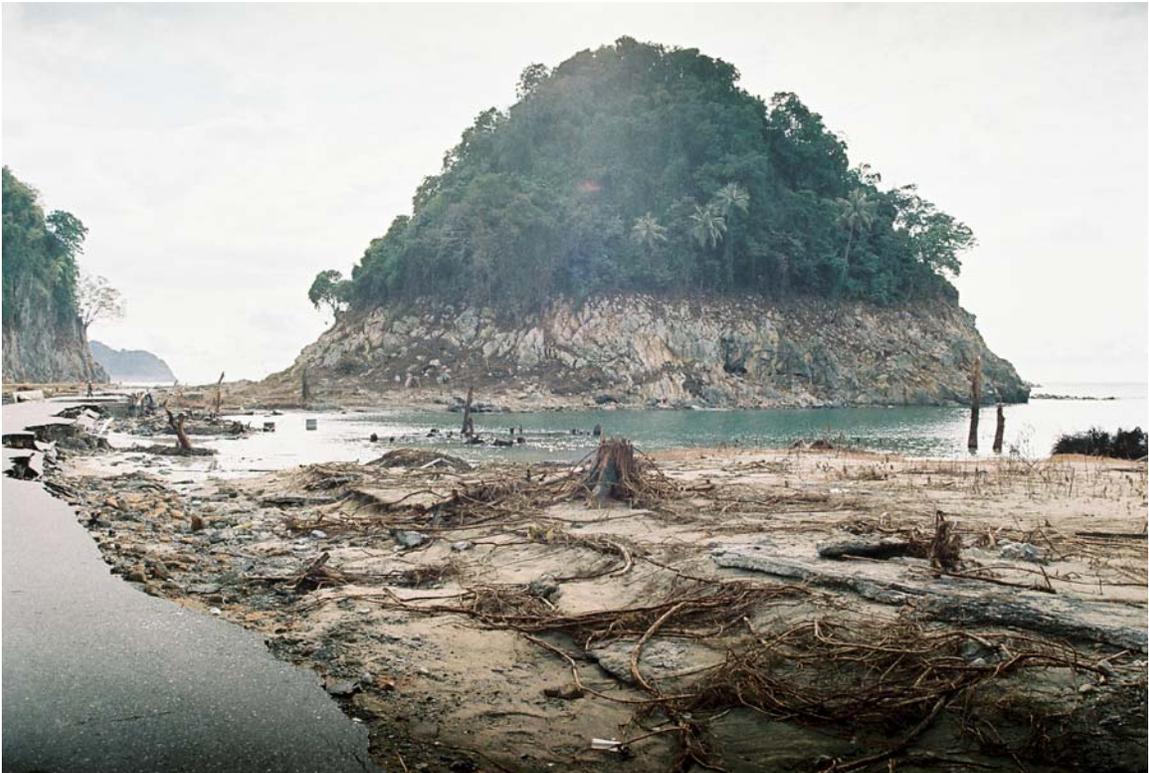
Photo 13

Photo 13: The trim line at a small headland at Lhoknga. This hill was previously covered by dense jungle to the waterline.

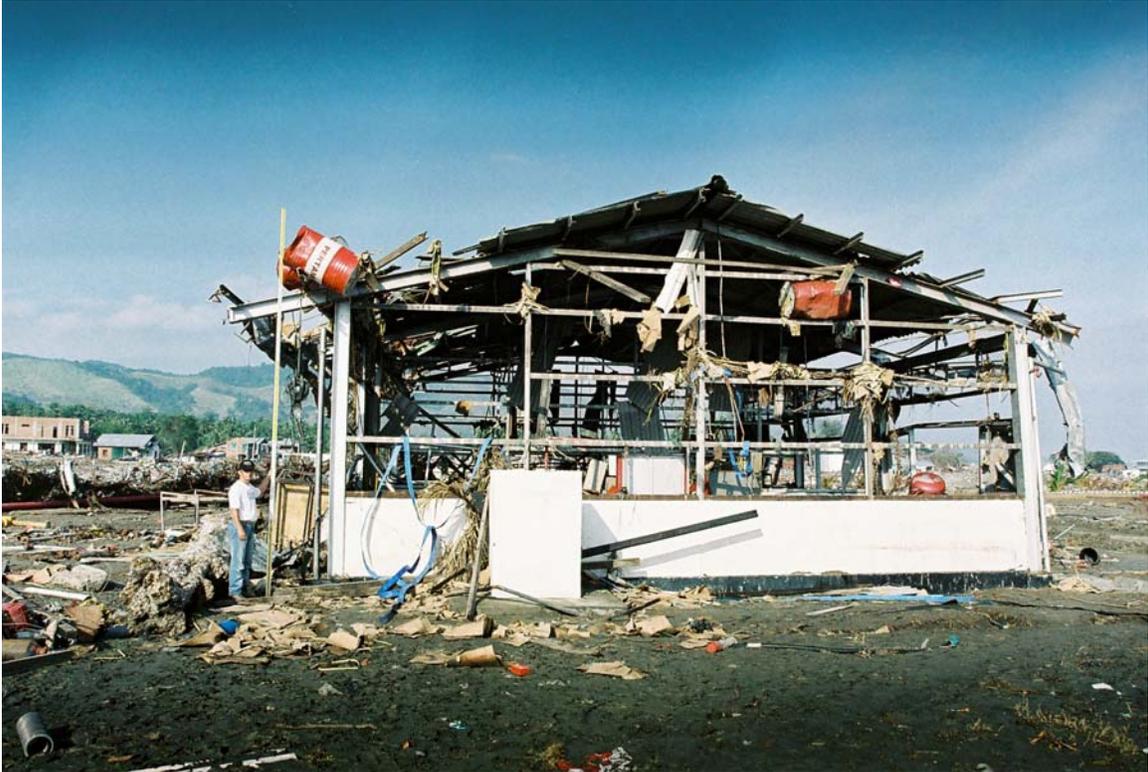
Photo 14

Photo 14: Evidence of 5 m flow depths at Kreung Raya oil transfer station.

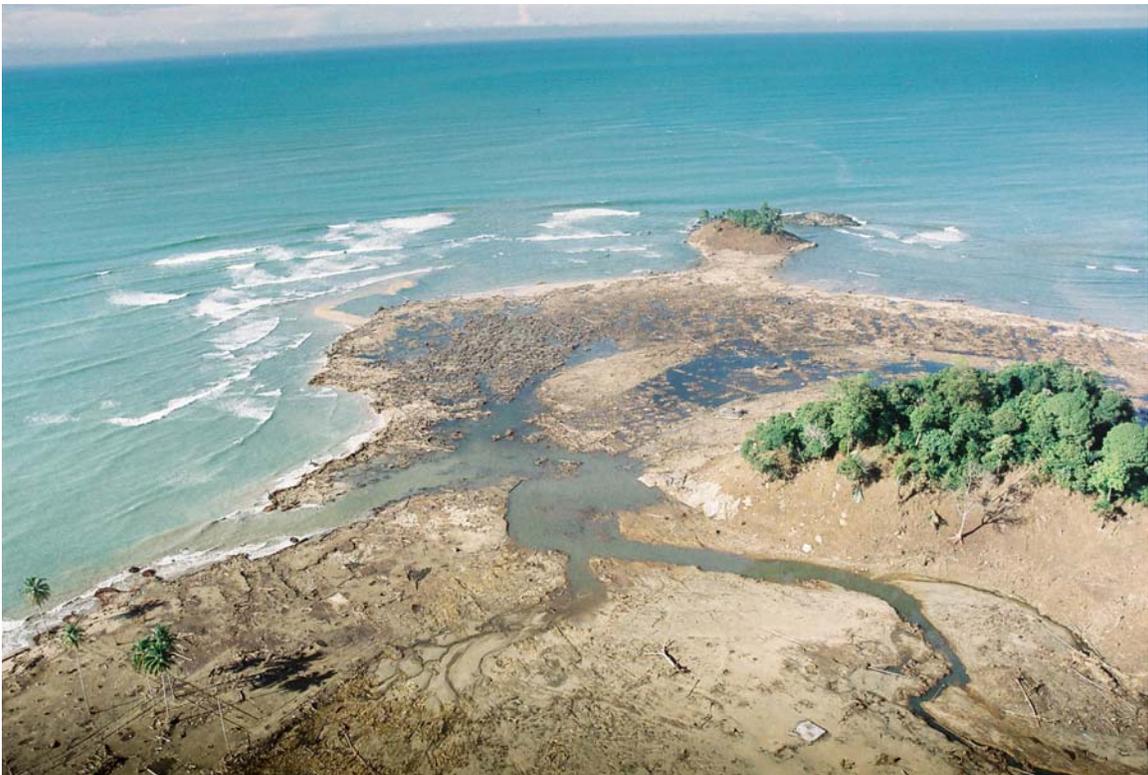
Photo 15

Photo 15: An example of the scale of inundation along the west coast of Sumatra.
