# 1987 ECUADOR EARTHQUAKES OF MARCH 5, 1987

March 5, 1987  
Ecuador Earthquakes

E. Crespo, K. J. Nyman, and  
T. D. O'Rourke  
Cornell University  
Ithaca, New York

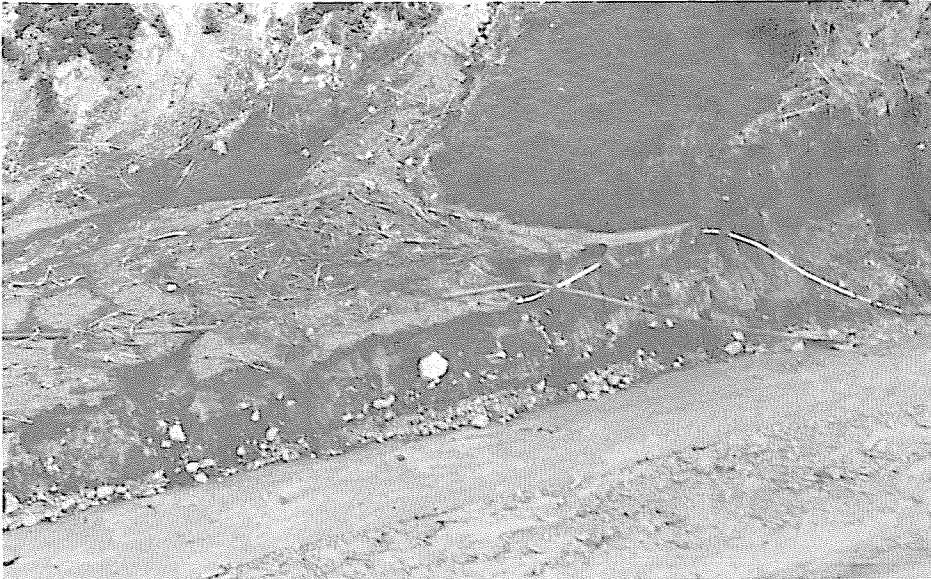
Fig. 1 Trans-Ecuadorian and Poliducto (white) Pipelines ruptured by debris flow and deep erosion along Coca River.

An 8-in.-diameter natural gas pipeline, known as the Poliducto Pipeline, follows approximately the same route as the Trans-Ecuadorian Pipeline. It was destroyed and damaged at the same locations as the Trans-Ecuadorian Pipeline.

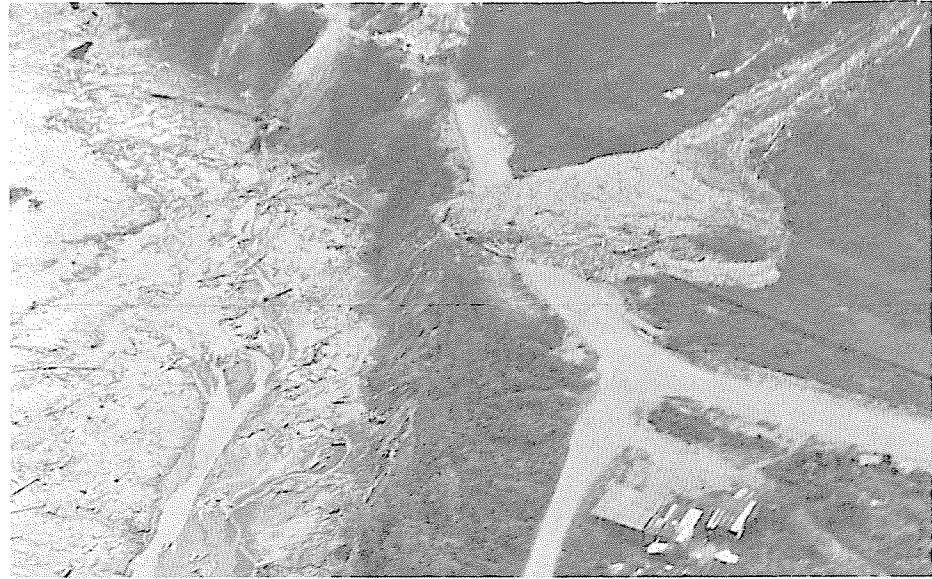
Fig. 2 Trans-Ecuadorian Pipeline damaged by debris flow and erosion. Note oil slick in upper left.

Of major importance is the damage from mudslides to the Trans-Ecuadorian Pipeline. The failure of this facility represents the largest single pipeline loss in history. The Trans-Ecuadorian Pipeline is a 26-in.-diameter pipeline, which carries oil 260 miles from the Ecuadorian oil

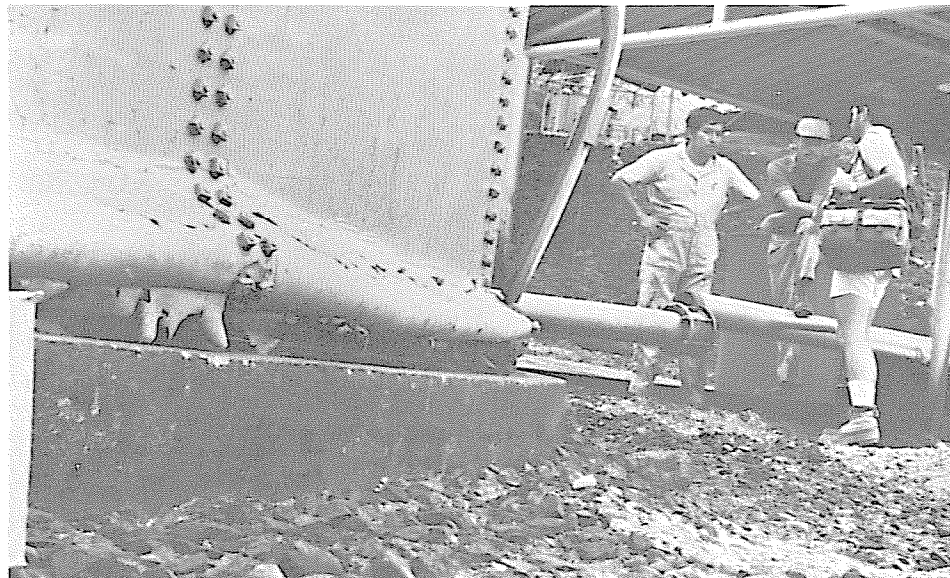
Fig. 3 Circumferential buckling and pipe pullout of water tank at Salado Pump Station.

ter tank buckled circumferentially with separation of all connecting lines, thereby rendering the emergency fire pumping system inoperable. A radio communications antenna used to transmit station operating information buckled and became inoperable. The personnel living quarters and mess hall facilities show severe cosmetic damage with some structural maintenance necessary.

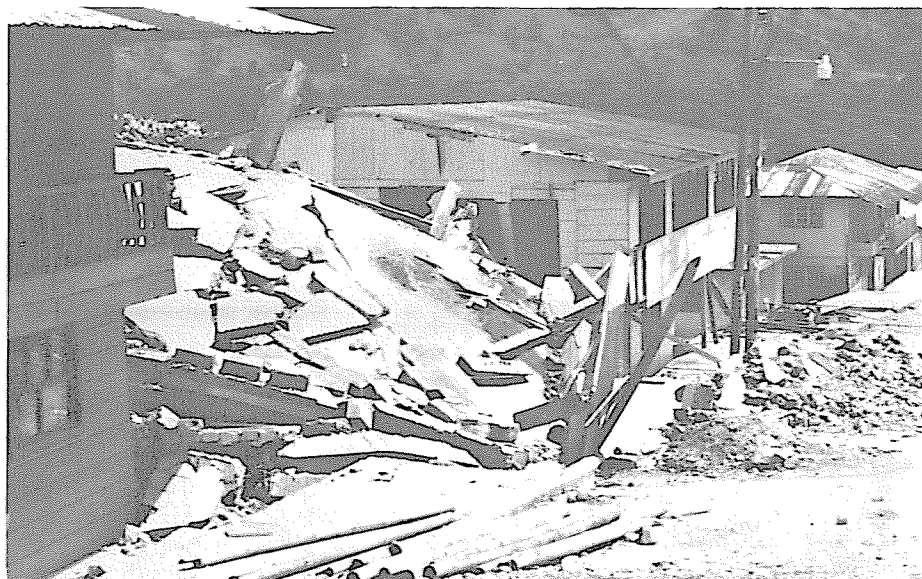
Fig. 4 Collapsed unreinforced masonry structure at Baeza.

The village of Baeza, located approximately 12 miles southwest of the epicenters, sustained structural damage and collapse of three reinforced concrete dwellings, with significant distortion of wood-framed structures. A large part of the town was evacuated to a temporary tent camp adjacent to the Baeza site. Villages in the mountainous region west of the epicenter sustained severe damage to dwellings constructed of adobe-panels.

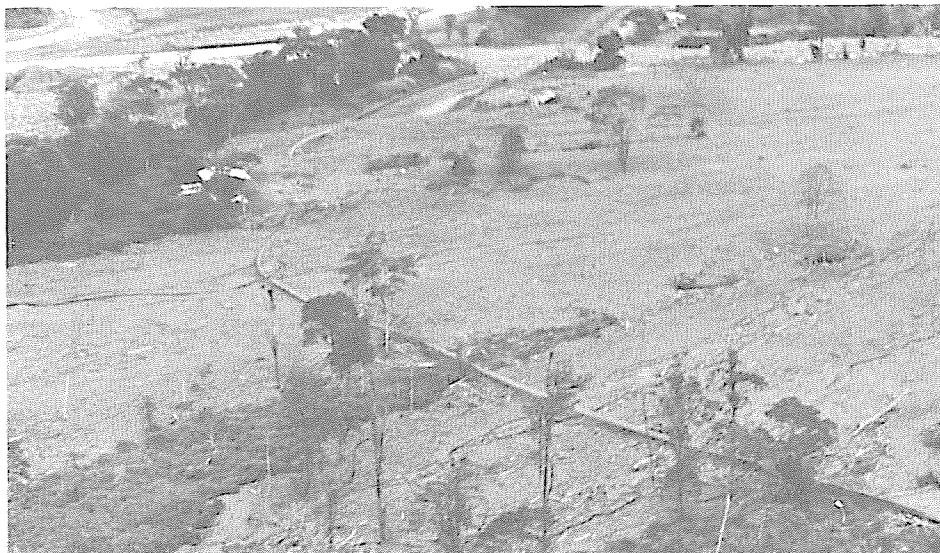
stroyed along the north bank of the Coca River east of its confluence with the Salado River. An additional 10 miles of the pipeline, east of the Malo River, have been damaged by local mud flows, which have severed the pipeline in at least eight places. Five miles of pipeline west of the Salado River have deformed, with significant distortion and displacement of above-ground pipeline supports. Approximately 30 miles west of the oil fields, the pipeline bridge across the Aquarico River was destroyed by flooding. The Aquarico River drains the north flanks of El Reventador, and was swollen with debris from the mudflow at the time of the bridge failure. The pipeline was pulled

Fig. 5 Trans-Ecuadorian Pipeline deformed by broad debris flow into Coca River.

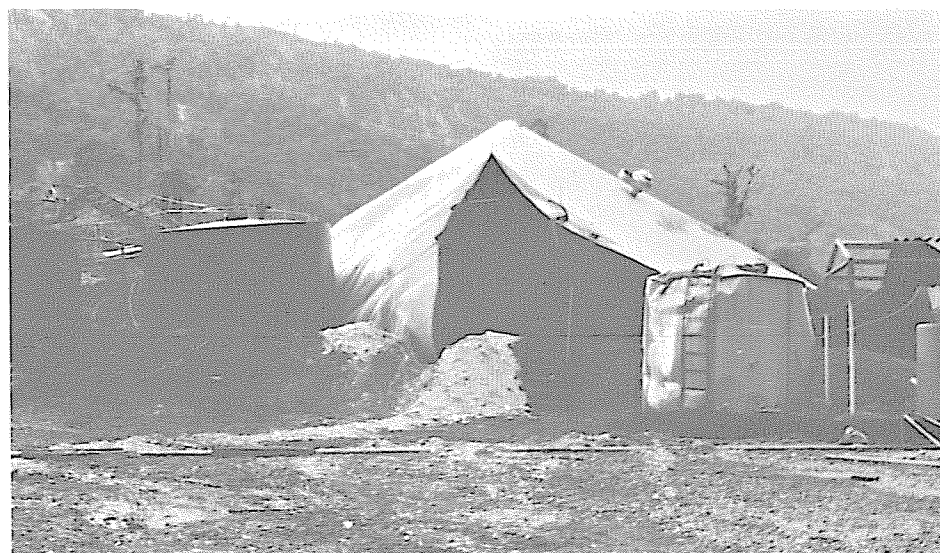
The Salado Pump Station, at the confluence of the Salado and Coca Rivers, was severely damaged. A landslide occurring uphill of the station toppled the main storage tank, spilling 4500 barrels of crude oil. All remaining structures sustained damage due to strong ground motions. Differential soil settlement across the site distorted all pump and power generator foundations, causing electrical power failure and overturning an elevated generator diesel storage tank. The fire wa-

Fig. 6 Destroyed oil storage tank at Salado Pump Station. Landslide debris ruptured tank, spilling 4,500 barrels of crude oil over pump station.

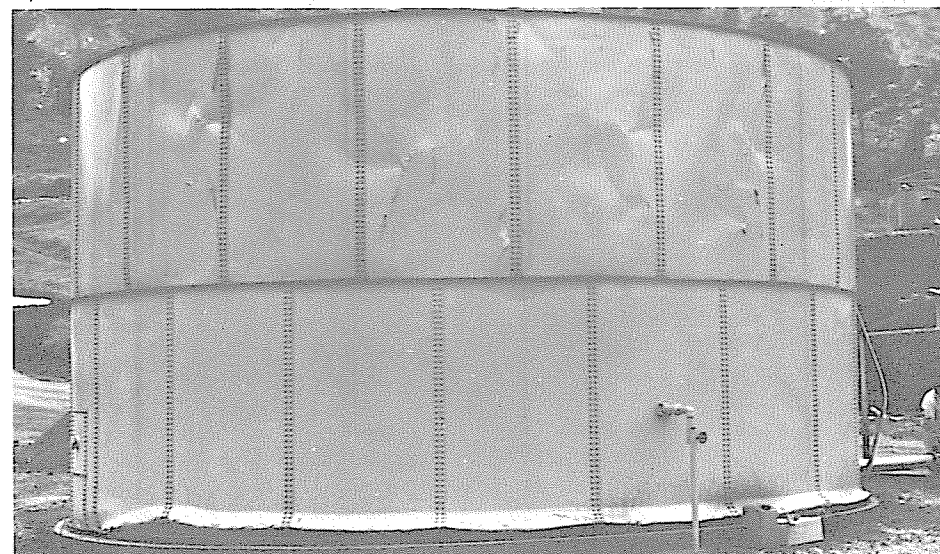
Fig. 7 Damaged water storage tank at Salado Pump Station.
