Cairo, Egypt, Earthquake of October 12, 1992

On October 12, 1992, at 3:10 p.m. local time, an earthquake of M_b 5.9 (M_s 5.4) occurred near Cairo, Egypt, that resulted in approximately 500 deaths, thousands of injuries, the collapse of a few structures, and damage to many structures in the Cairo metropolitan area (population 12,000,000).

EERI dispatched a team of earthquake engineers and scientists to investigate the effects of this event. Team members were Nabih Youssef, structural engineer, Team Leader; Samy Adham, structural engineer; Mehmet Çelebi, USGS; and Josephine Malilay, Centers for Disease Control. The following report contains information from the preliminary report filed by the team.

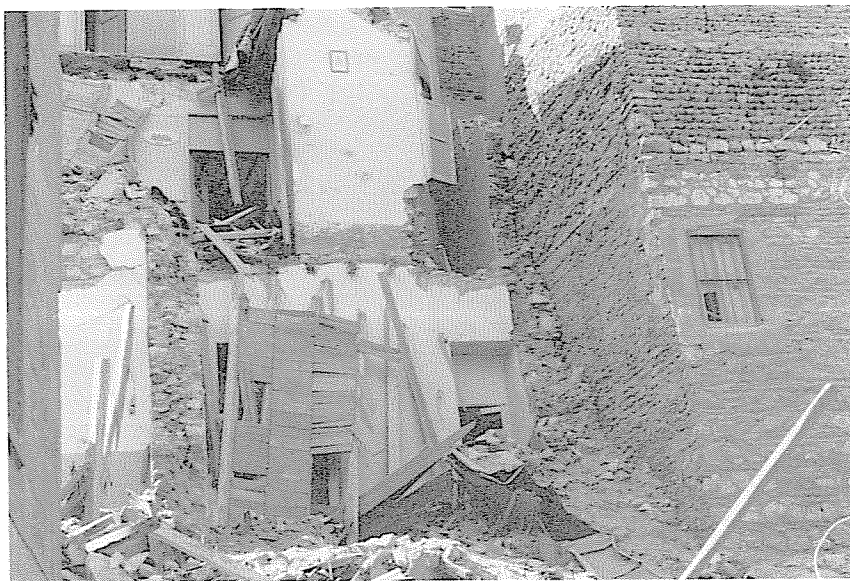
Mixture of stone and mud brick construction

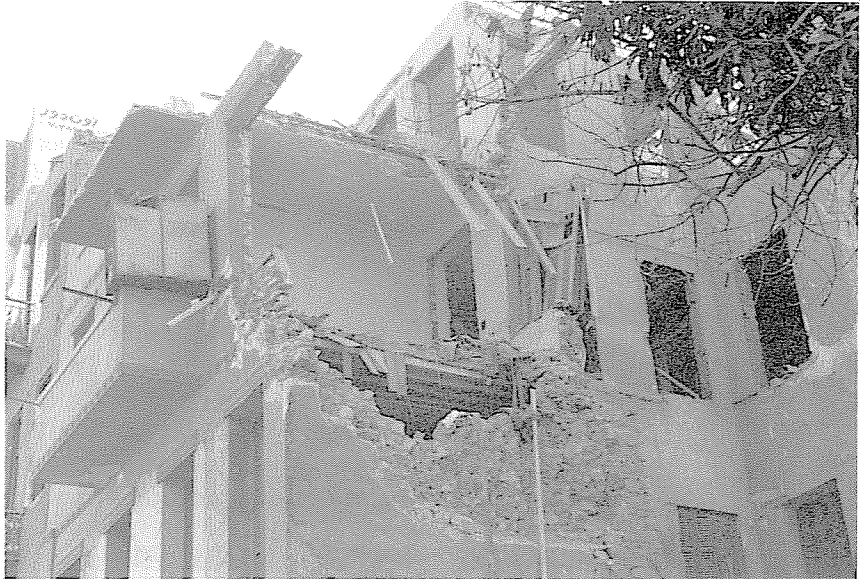
- cracks and separation in the corners of the walls due to lack of tie-beams,
- roof and wall separation due to lack of adequate anchorage (roof timbers are typically not anchored nor do they extend sufficiently over the width of the walls; this problem is compounded by heavy storage on the roof), and
- collapse of laterally unsupported masonry parapets and walls.

Old Cairo - Heavy damage to stone bearing wall buildings with unanchored wood roofs

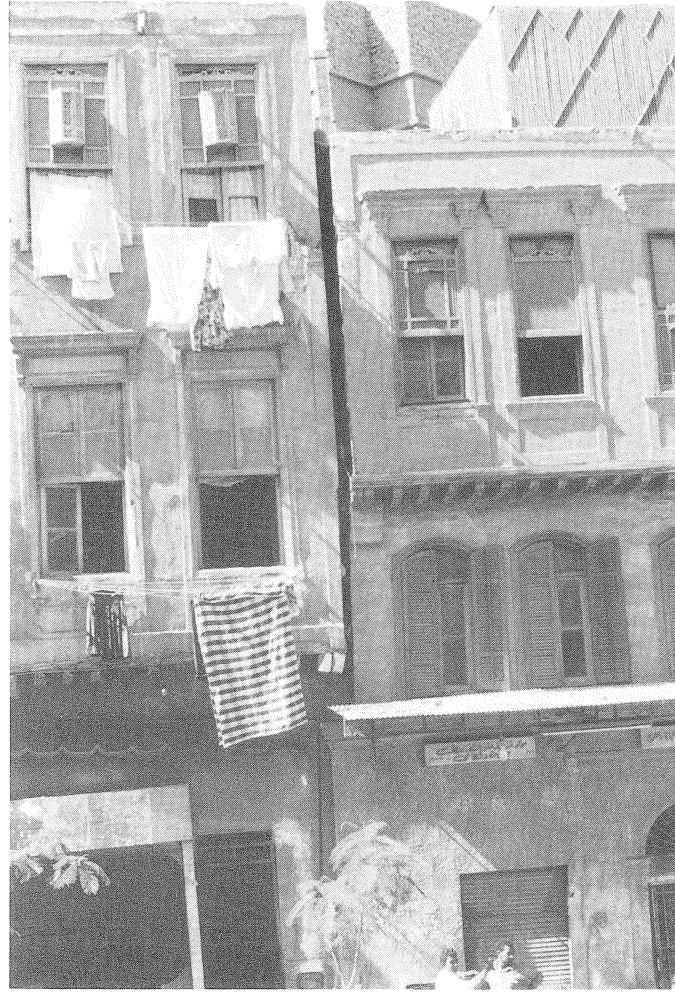
foundation systems on soft soil, for example, older buildings of heavy masonry which lacked piles tended to rotate and tilt with their shallow foundations. (This was partly due to the high underground water table ≈ 3.0 meters from the surface.)

Building separation at expansion joints and tilting of some buildings.

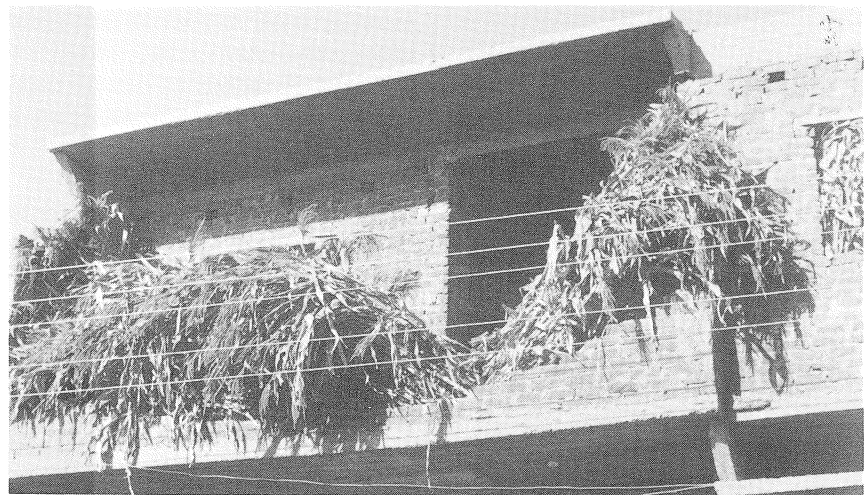
In general, reinforced concrete framed buildings with unreinforced masonry infill performed well in this earthquake.

Regular R.C. construction with in-filled wall performed well in villages.

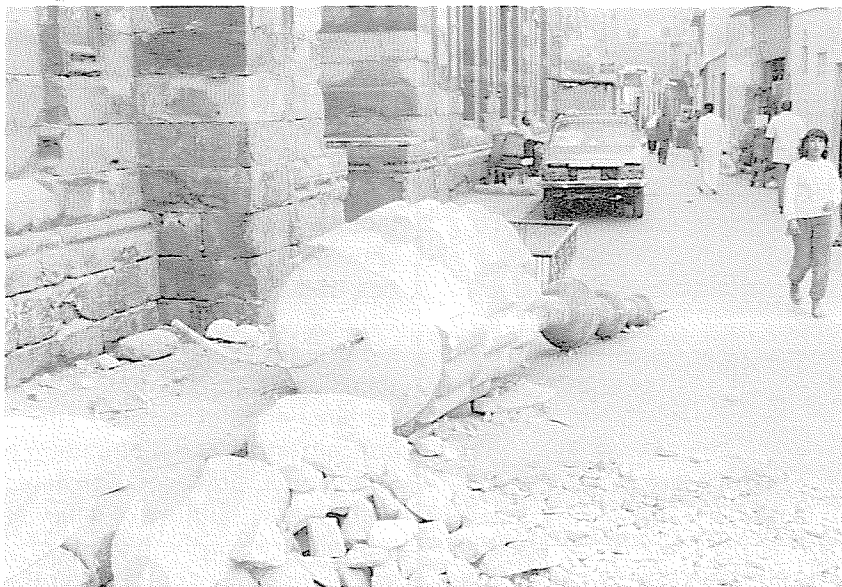
At the Al-Hanafi Mosque, three of four ornate posts on top of the minaret tower failed during the earthquake and fell to the street below. The posts appeared to be unreinforced except for a central dowel bar which apparently was used to align the concrete slices used to construct the top of each post.

Ornate top of minaret that failed during the earthquake (Al Hanafi Mosque).
