# EL SALVADOR EARTHQUAKE, JUNE 19, 1982

MAURICIO A. LARA G.\*

San Salvador, September 1982

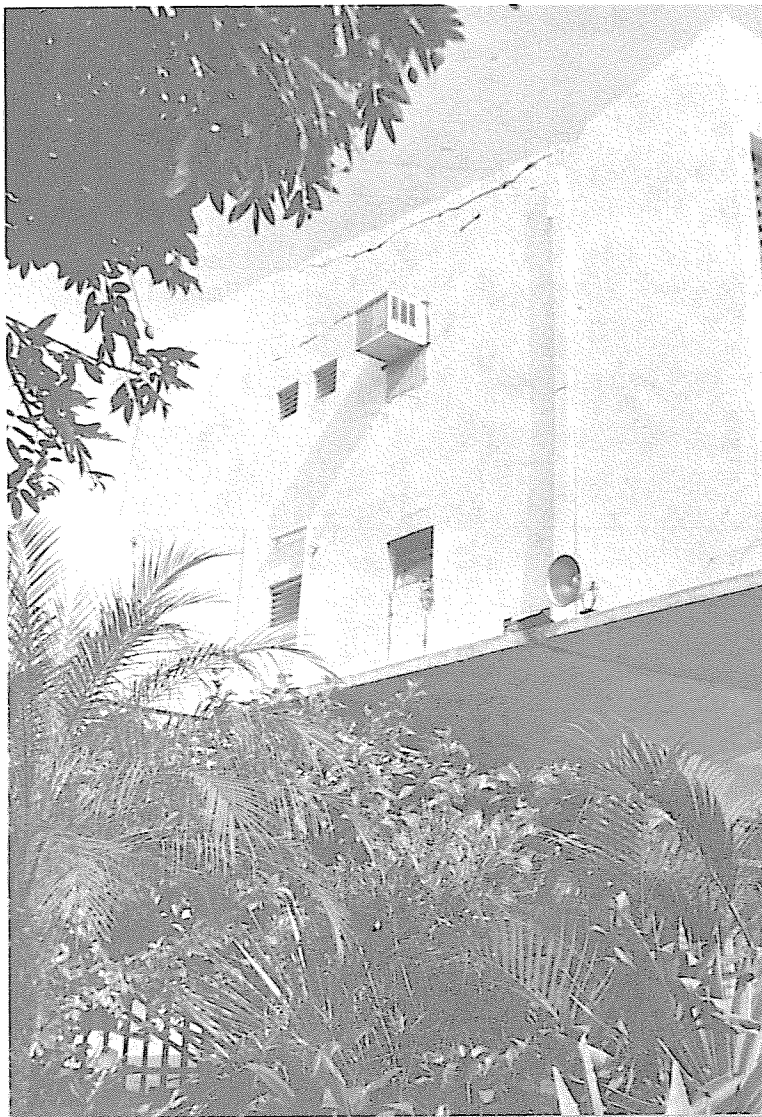
Building No. 10  
Exterior Masonry  
Wall Damage.

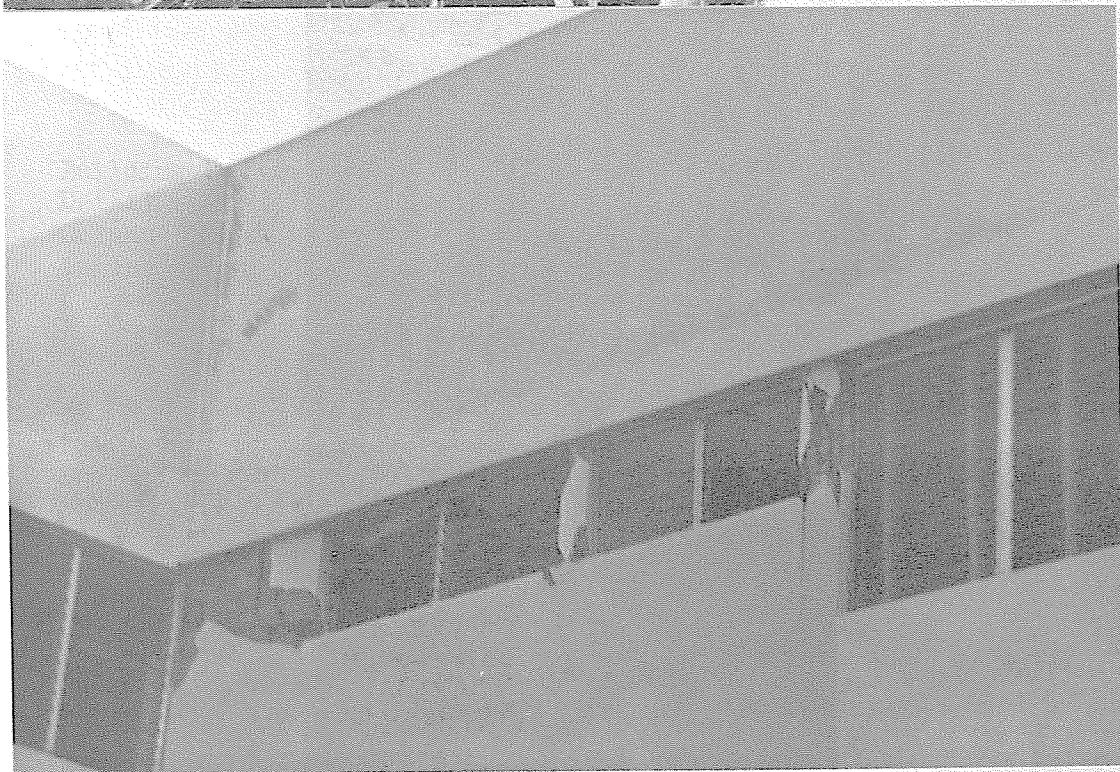
Building No. 10  
Detail of  
Column Damage  
at Third Story.

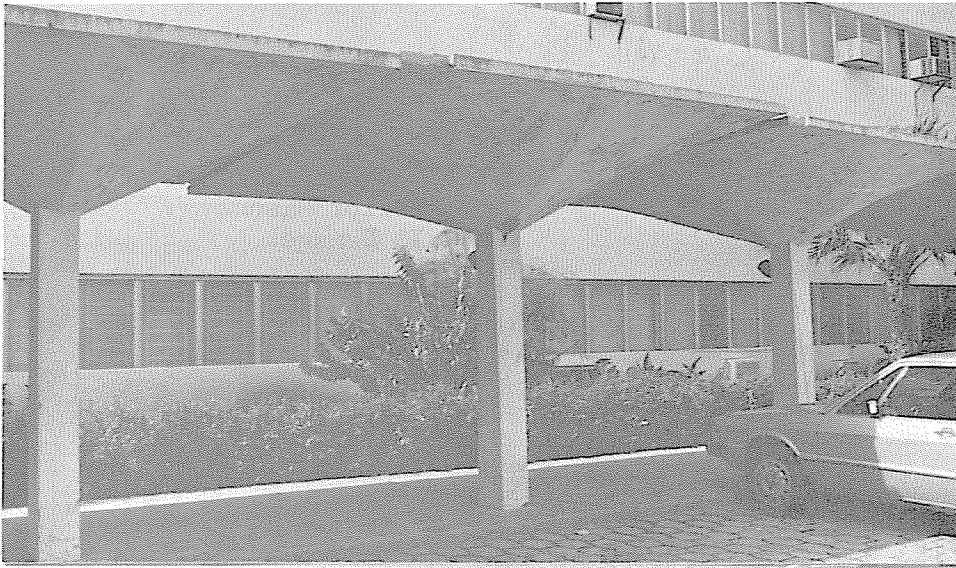
Building No. 10  
Tilted  
HP Umbrellas

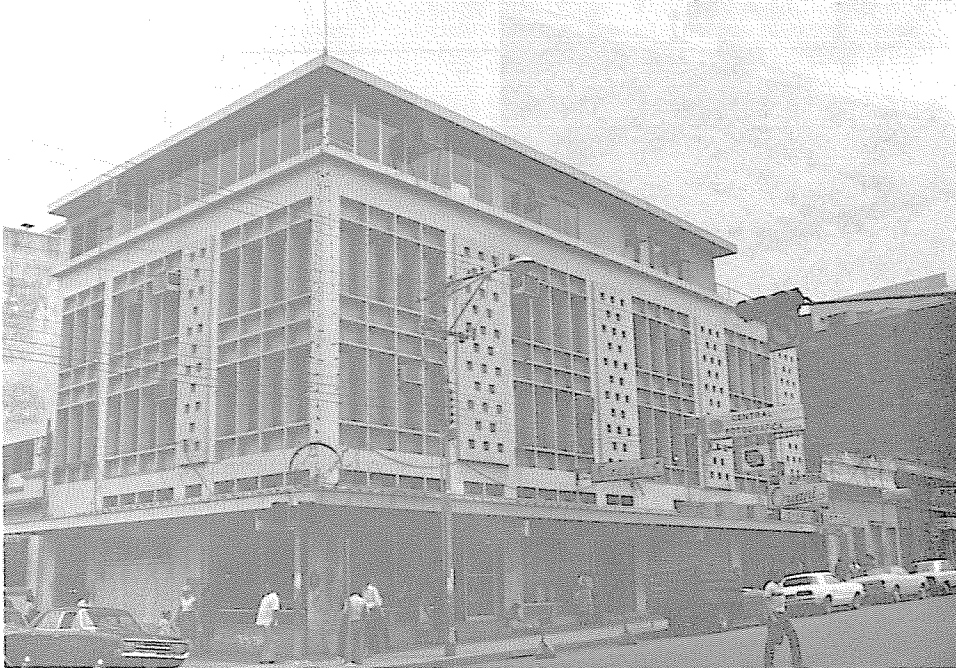
Building No. 13  
Ground Level  
Column Damage

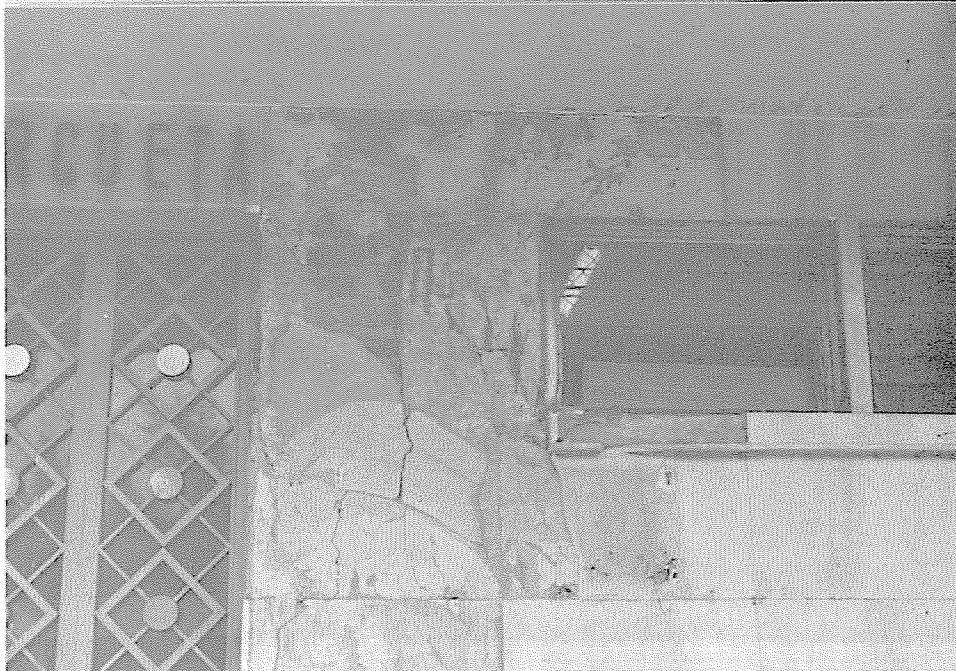
Building No. 13  
Detail of  
Column Damage

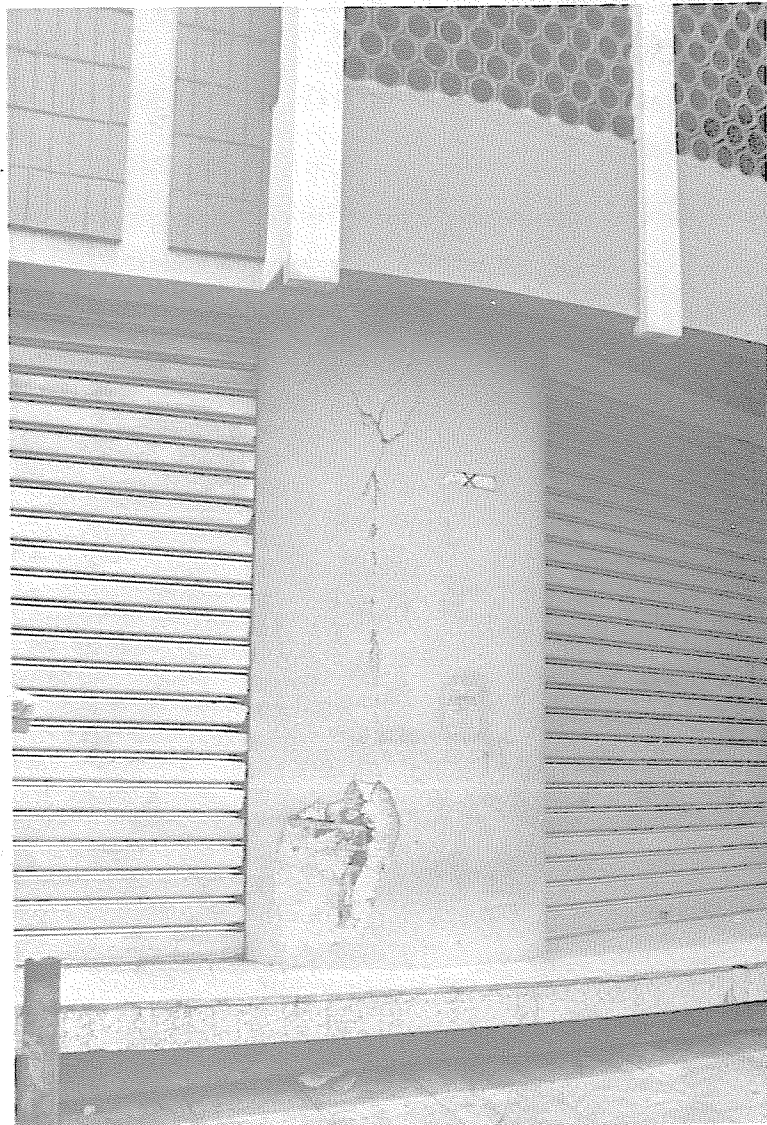
Building No. 16  
Detail of  
Column cracking  
in 1st Story column

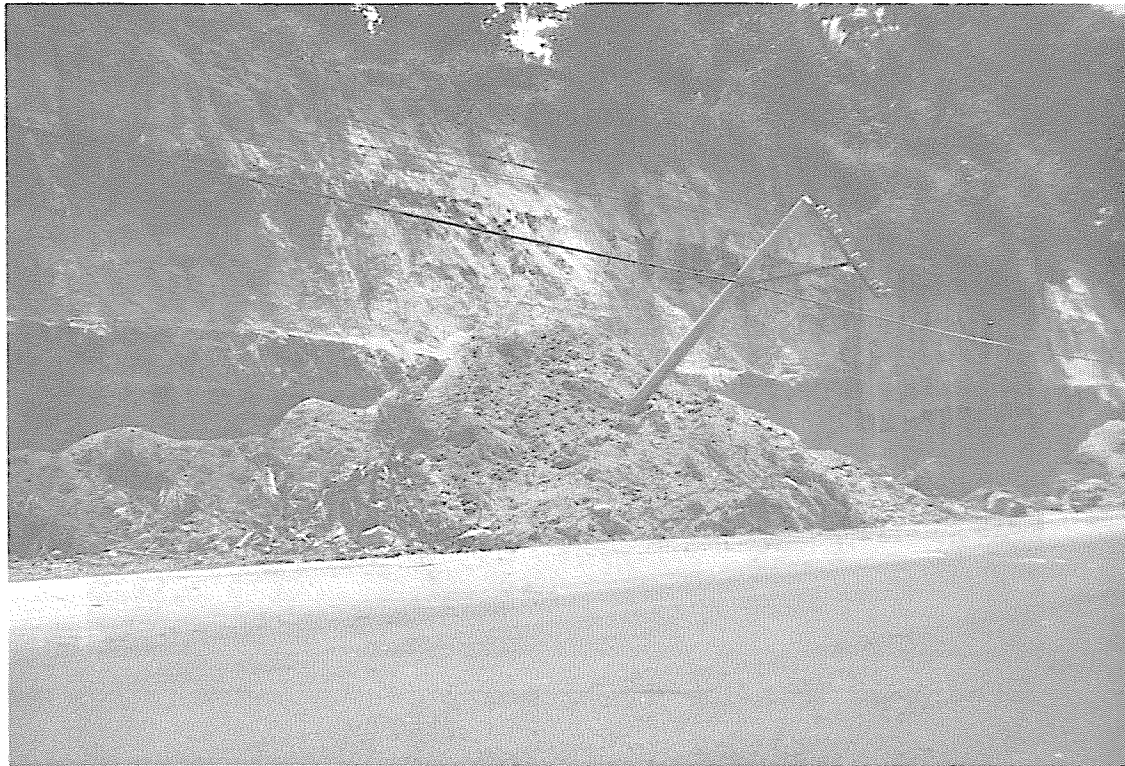
Damages were also observed in highways, which consisted mainly of obstructions due to landslides. Public utilities, such as pipelines and aqueducts broke down in several places.

Typical Landslide on Highway

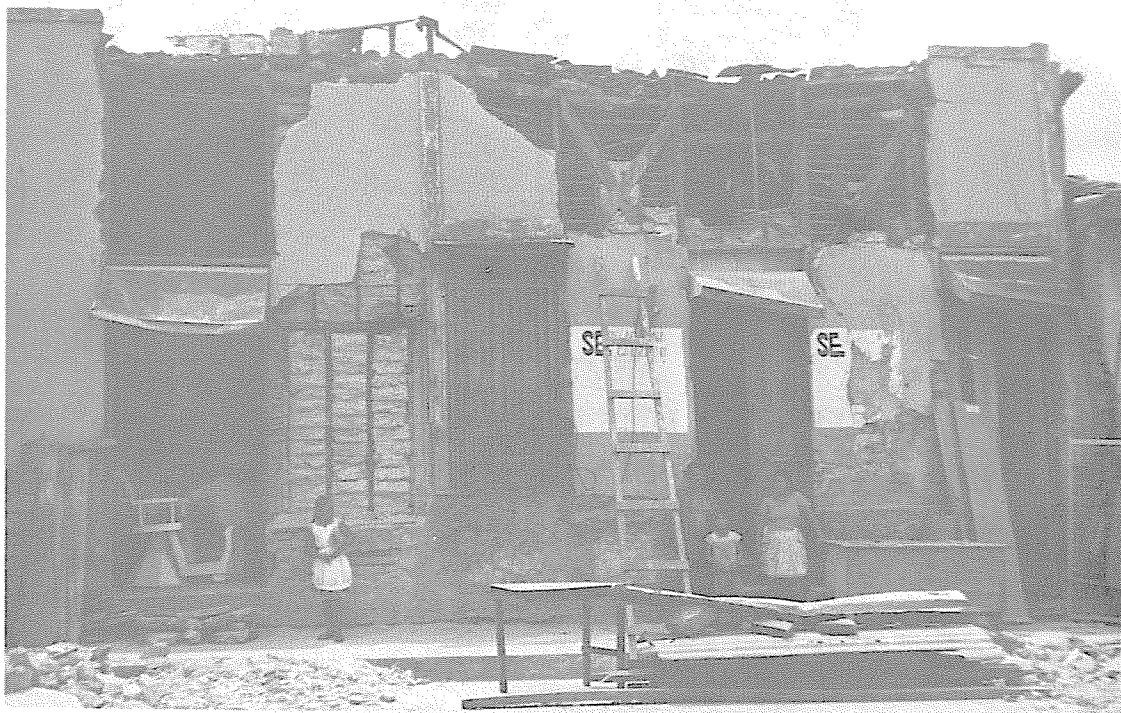
Severely Damaged 2-Story House in Ahuachapan -- Wattle Construction
