Learning from Earthquakes

The Egion, Greece, Earthquake of June 15, 1995

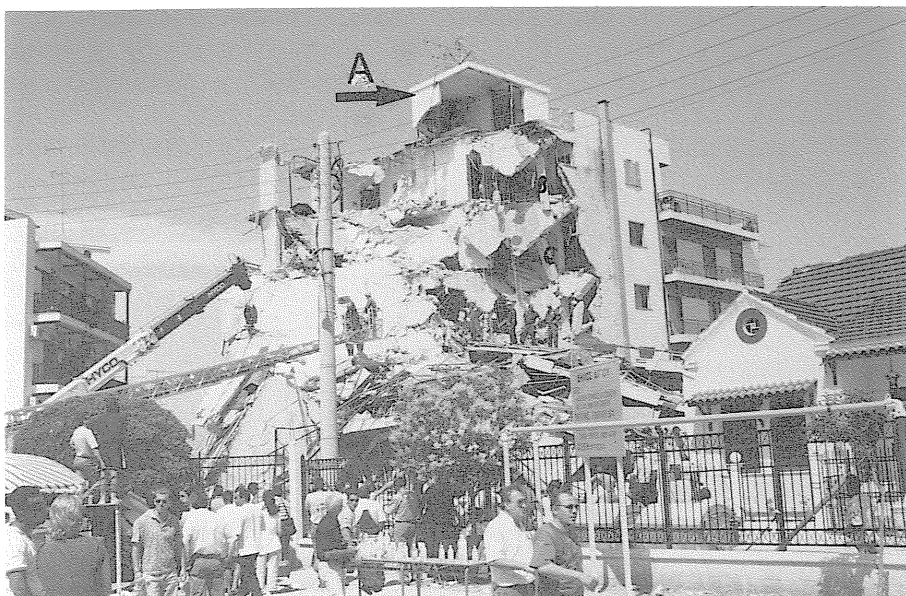
Figure 2 - An L-shaped five-story apartment building in Egion partially collapsed. The collapse was in a counterclockwise torsional direction.

The partially-collapsed five story L-shaped apartment building in the center of Egion was built in 1978-1979. One leg of the L collapsed, blocking the exit stairwell. Most of the victims were later found around or in the stairwell. The collapsed section had 27 apartments (22 inhabited, 5 empty) and 3 shops. Fifty-four persons were trapped in the debris of this section, 38 of whom were rescued

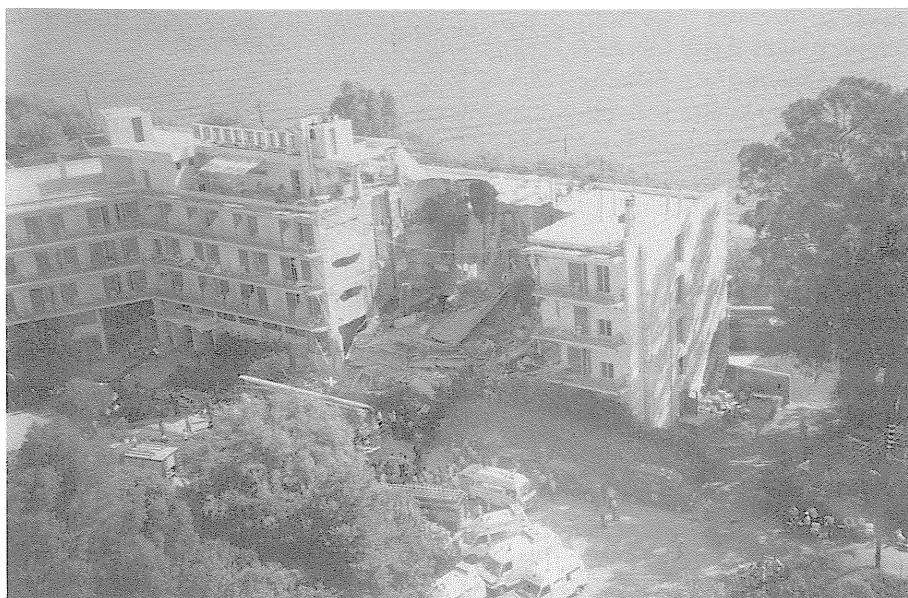
The Elikh Hotel, a four-story, three-section building in Valimitika, suffered a partial collapse of the middle section. That night, 167 persons were lodged at the hotel. After the quake, 127 managed to escape the damaged building; 40 remained trapped under the debris. The operations of the Greek rescue teams, supported by a French rescue team, were rigorous. They managed to find and rescue 30 persons alive; the remaining 10 missing, all French tourists, were found dead. The entire operation lasted 40 hours.

Figure 3 - One wing of the Elikh Hotel in Valimitika partially collapsed, killing 10 tourists.
