REPORT ON THE SEPTEMBER 13, 1986 EARTHQUAKE —KALAMATA, GREECE

PRELIMINARY REPORT ON THE KALAMATA, GREECE, EARTHQUAKE OF SEPTEMBER 13, 1986 Panayotis Gr. Carydis, M.EERI

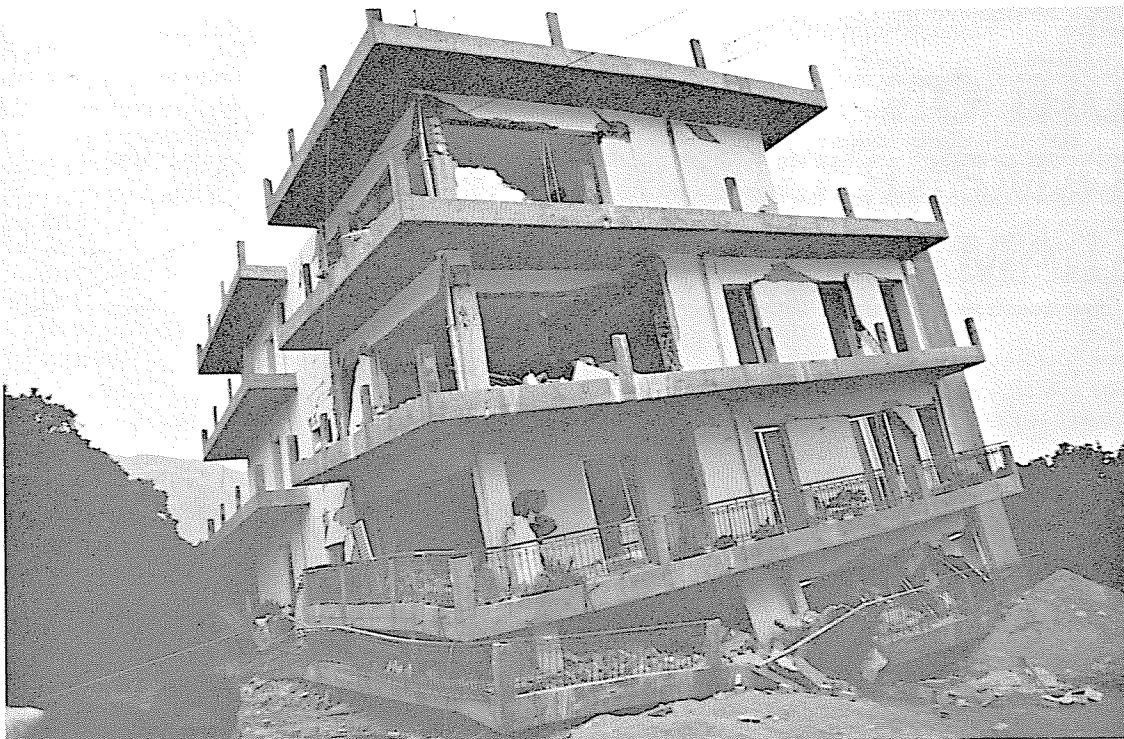
Figure 2. Partial collapse of a five-story reinforced concrete apartment building. The partitions are brick walls. The building was brand new.

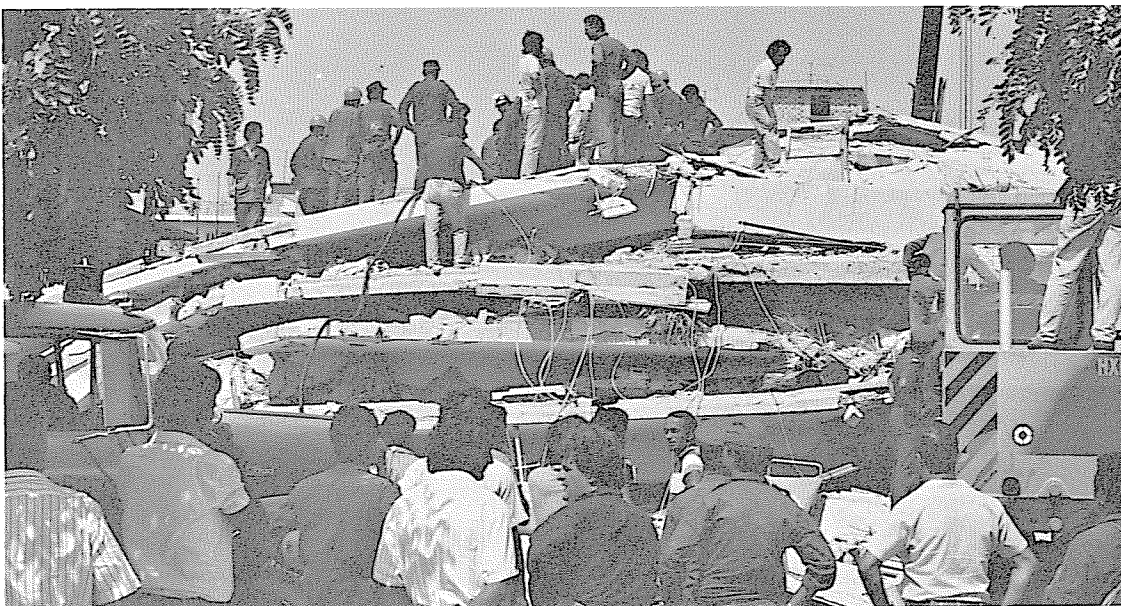
Figure 3. Total collapse of a five-story reinforced concrete apartment building. The partitions are brick walls. Many inhabitants were buried under the debris. The figure shows rescue operations.

In the city, one five-story block of flats collapsed, causing most fatalities. About 10 trapped people were rescued the next day. Other modern buildings suffered heavy damage which increased with the $M=5.6$ shock of September 15. Some buildings collapsed due to this shock.

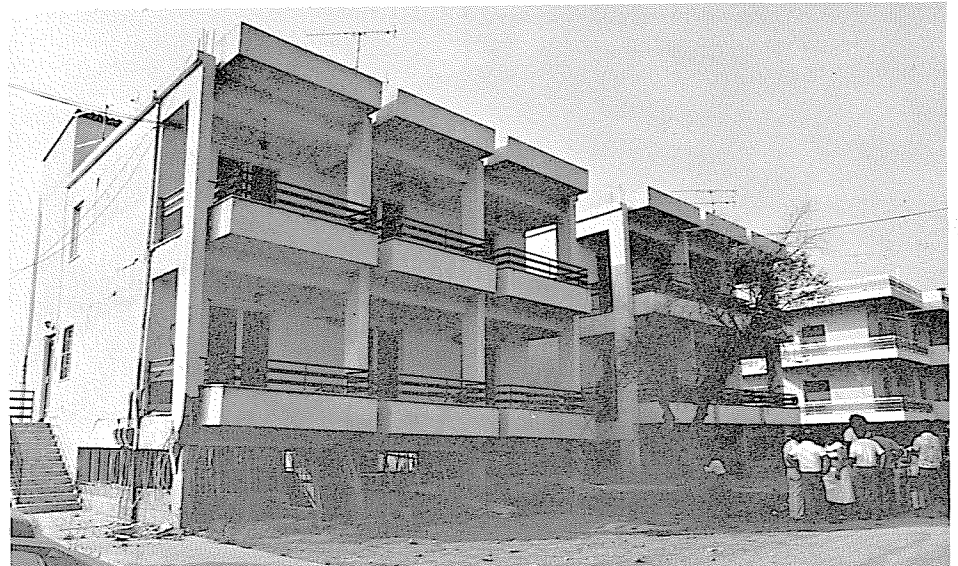
Figure 4. Two almost similar buildings behaved quite differently. The one at the left experienced extensive damage in the "short columns" of the basement, coming to rest as though torsion behavior had been prominent.

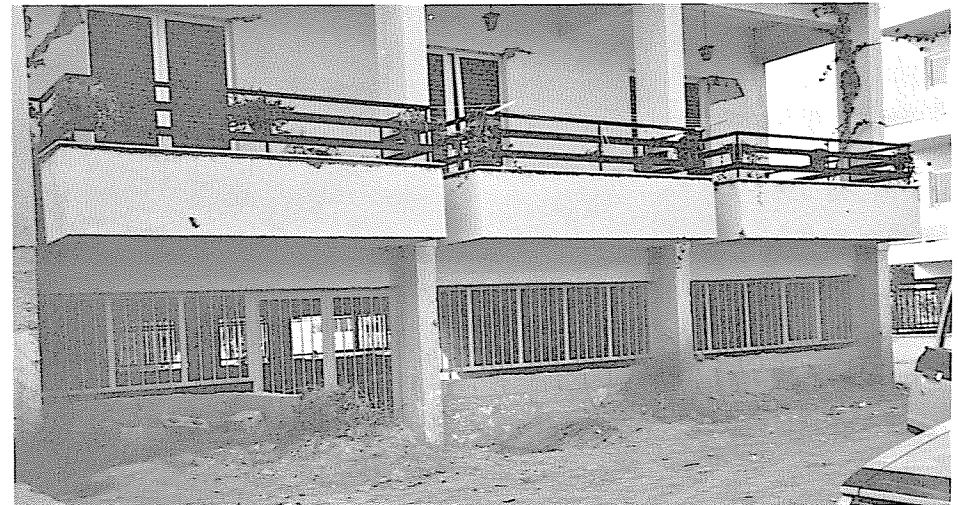
Figure 5. The building on the right hand side of the previous figure survived the earthquake with very small cracks.

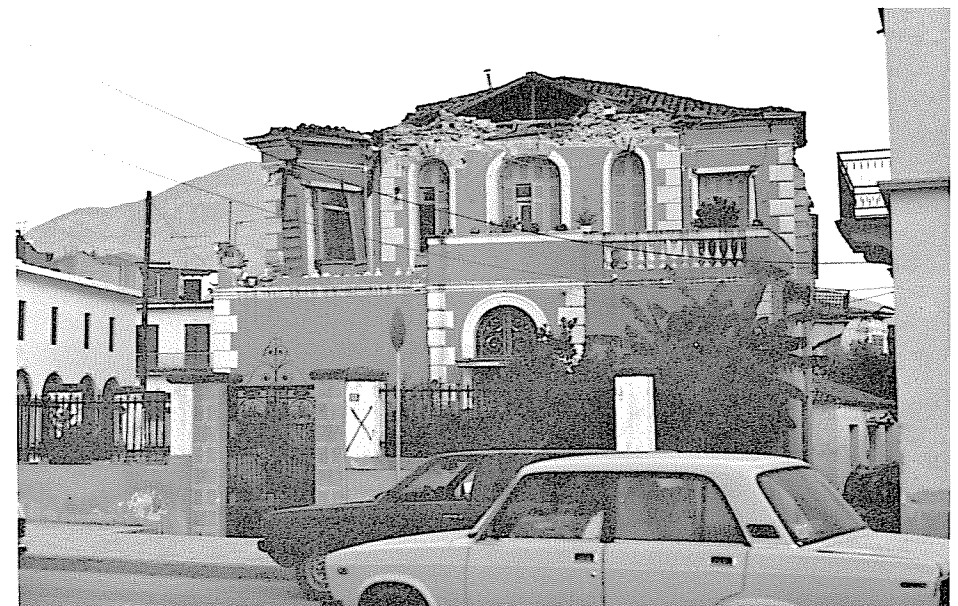
The material of the old buildings is stone or unreinforced brick masonry, with wooden floors, while that of the modern buildings is reinforced concrete with brick infill walls. The old buildings have one or two stories, while the modern ones may reach five stories.

Figure 6. Stone masonry buildings suffered severe damage.

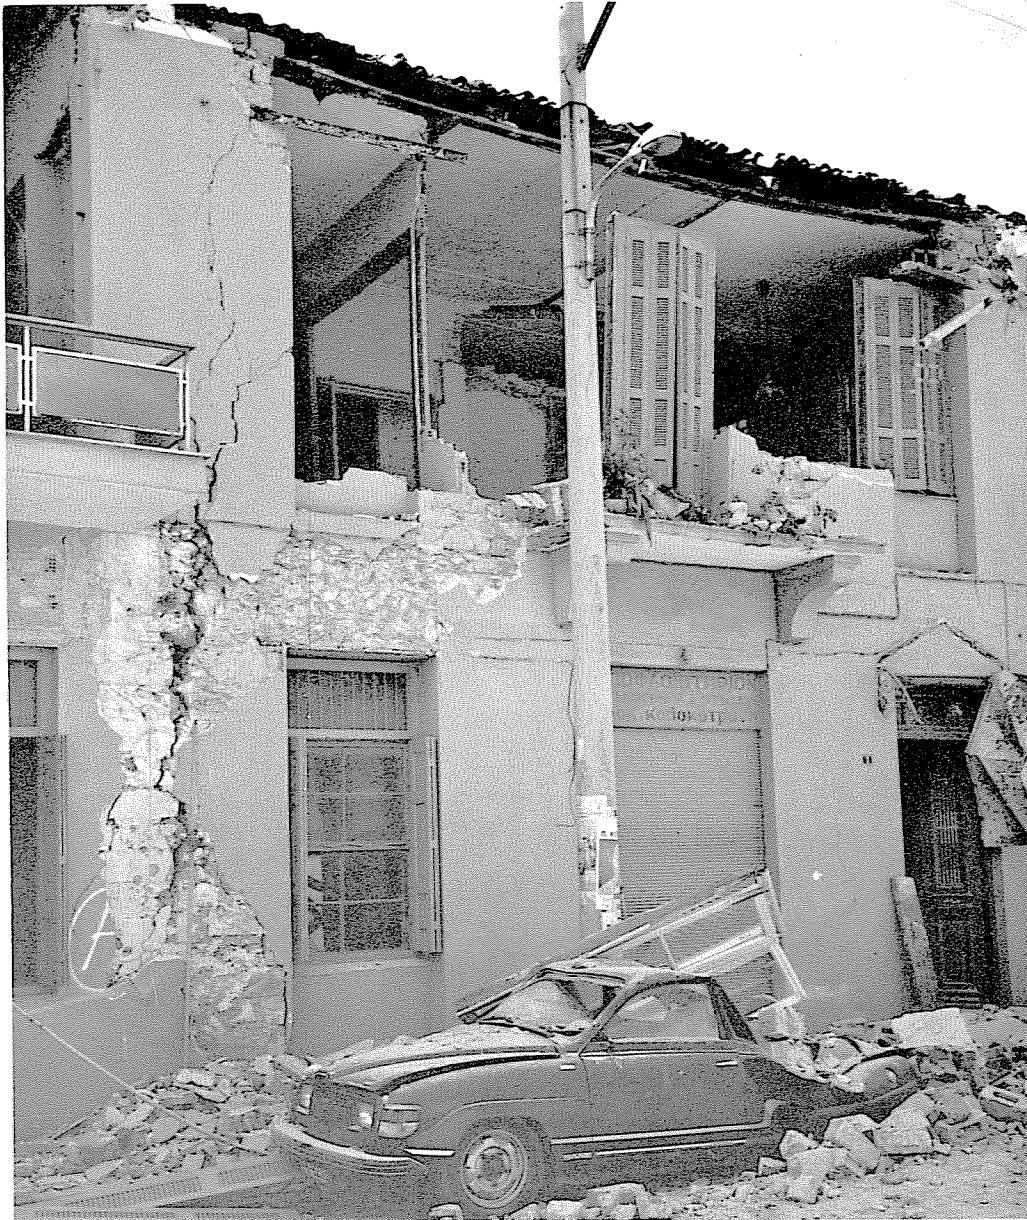
Many cars were damaged due to the fall of facades of buildings on to the streets below. This was also the reason for some fatalities and injuries.

Figure 7. Many cars were damaged by fallen facades.

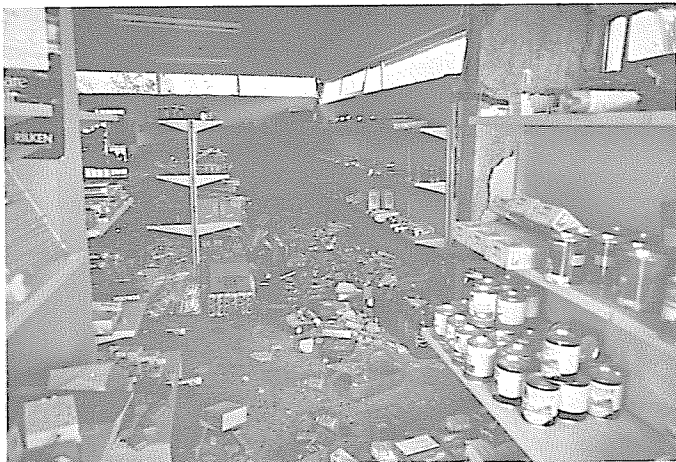
Figure 8. Figure typical of most of the shops in the city.

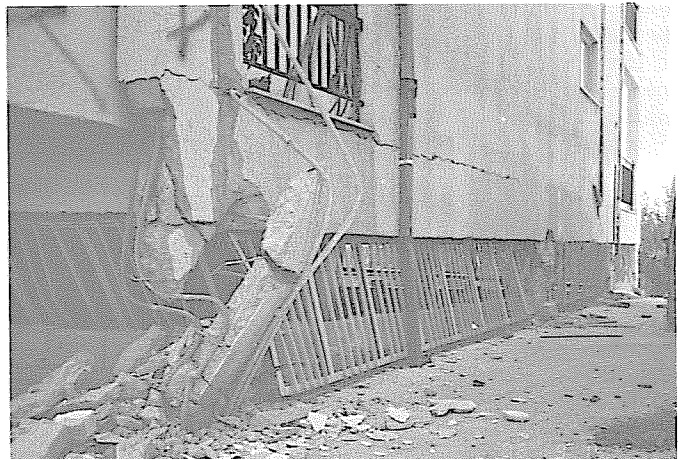
Figure 9. The front, right-hand corner column of the damaged building on the left in Fig. 4.
