Learning from Earthquakes

January 8, 2006, Kythira Island (Greece) 6.8 Earthquake

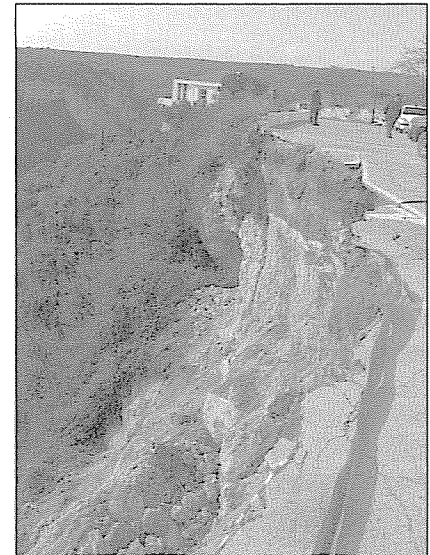
Secondary geodynamic effects triggered by the earthquake included rockfalls and landslides along the local network of roads. The most impressive landslide was located at the Mitata village square with a collapsed volume estimated to be 5,000 m³. The event caused the detachment of large masses of rock with an approximate volume up to 500 m³ each along the road between Mitata village and Viaradika village. As a consequence of the landslide on the upper section of the slope, a section of the Mitata village square was detached. At the base of the slope a section of the road from Mitata to Biaradika was damaged.

Landslide at Mitata (Photo: E. Lekkas).
