## Learning from Earthquakes

### The November 22, 1995, Aqaba Earthquake

*The following report was prepared by Yehia M. Said, Sherif W. Agai-by, Ashraf M. Osman, and Sherif A. Mourad of the Civil Eng. Dept., Cairo University, Egypt. EERI member Samy A. Adham of Agbajian Associates arranged to have this report made available to the EERI Newsletter.*

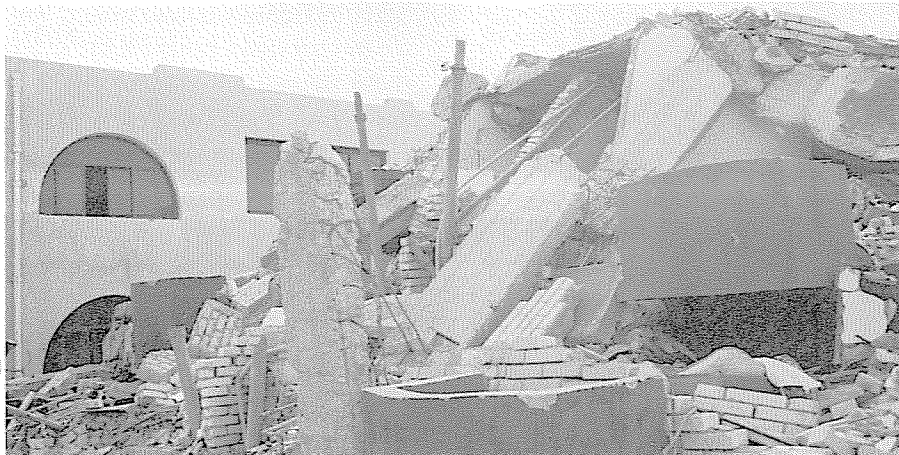
Several hotels were damaged in Nuweibaa. The most dramatic incident was the complete collapse of a three-story reinforced concrete hotel built more than ten years ago (Fig. 1). Evidence of low quality materials and poor quality

construction could be seen in the rubble. At another hotel, cracks were observed at the beam-column connection at the roof as well as at the mezzanine floor. Slender columns supporting arched facades were also damaged. At a third hotel, a large entrance arch and the main hall suffered structural as well as non-structural damage. Other buildings suffering structural damage included a two-story building in Nuweibaa where short columns along the perimeter of the building, which supported the ground floor slab over a basement, collapsed under excessive shear deformation. Several other buildings suffered extensive cracking and failure of nonstructural infill walls.

Figure 1 - Collapse of a 3-story hotel in Nuweibaa.
