## Learning from Earthquakes

### The M7.3 September 2, 2009, West Java Quake

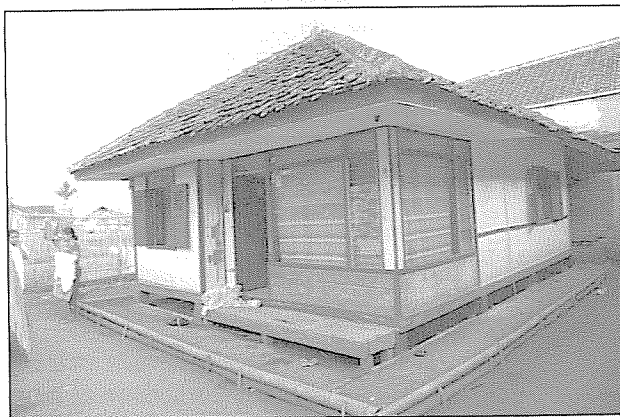
Most of the damaged or collapsed buildings were not engineered. Single-story residential units that use simple timber frames, bamboo plaited mats for walls, clay tiles for roofs, and a raised floor system generally survived unscathed (Figure 1). However, houses using unreinforced clay bricks as their bearing walls suffered severe damage. Similar failures were also seen in one-story buildings using confined masonry walls, but with low-quality materials and poor workmanship (Figure 2). Many of the damaged buildings were made more vulnerable by a lack of maintenance over the years.

**Figure 1.** Type of single-story dwelling that survived the quake (photo: N.K. Widiada).

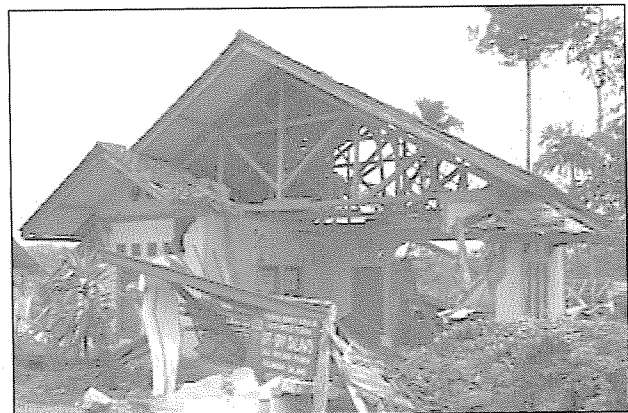
**Figure 2.** A building with confined masonry walls failed due to low-quality materials and poor workmanship.

The badly damaged structures were not built according to the building standards and construction practices specified for seismic areas. A special effort is therefore required to encourage people to rebuild using appropriate seismic-resistant techniques.
