Learning from Earthquakes

Western Sumatra Earthquakes of March 6, 2007

Report #1

Building Damage

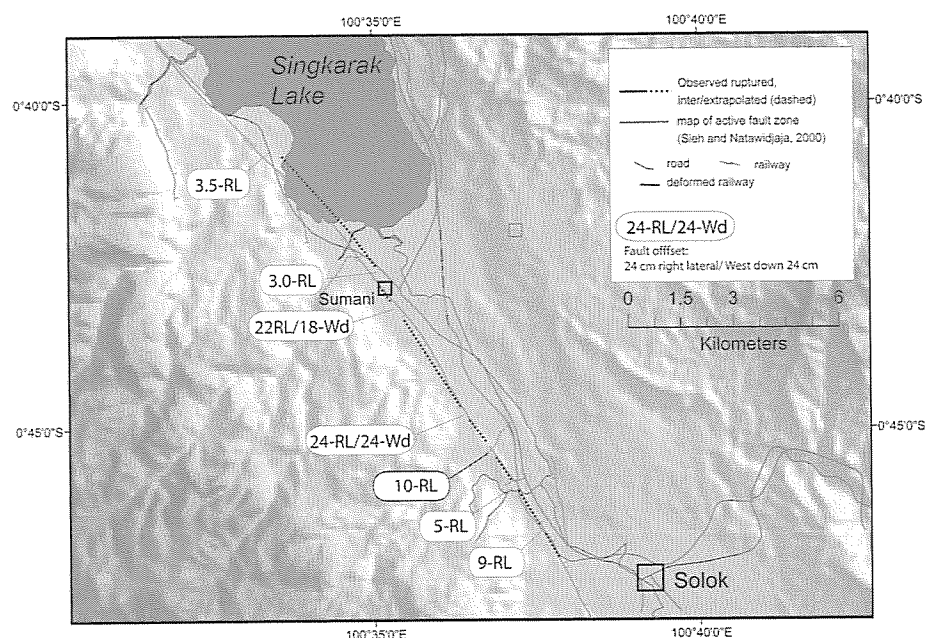
Figure 2. Surface fault ruptures and measured fault offsets of the first main-shock. The length of the rupture zone is up to 15 km. The offsets vary from a few up to 24 cm displacement (west side down) of right-lateral movements. The largest slip occurred on the central part of the rupture. The dip-slip movements are also observed.

We measured the geological fault offsets from the displaced road's asphalt edges, house fences and water canals in the rice fields. The observed offset ranged from 3-24 cm, with a sense of a right-lateral movement. The maximum offset was about 22-24 cm, in the central part of the ruptured segment. The fault slips or offsets seemed to get smaller toward both ends. Our measurements also indicated they also showed a significant compo-

nent of vertical movement, or dip slip, with the western side moving down up to 24 cm.

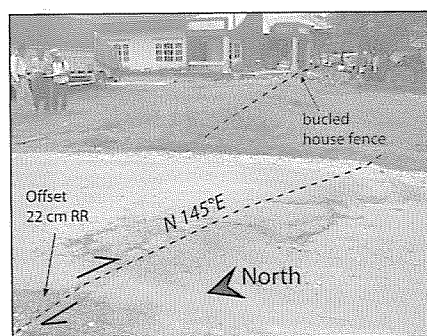
(a)▲

Figure 3. Examples of expressions of the surface ruptures. (a) Left-stepping moletracks are observed near Sumani. The rupture cut the asphalt road and right laterally offset it about 22 cm. (b) Surface rupture/moletracks crossing the asphalt road in village west of the main road, halfway between Sumani and Solok. The road is right laterally offset about 24 cm. The west side is also down about the same amount. (c) Same feature viewed from the south.

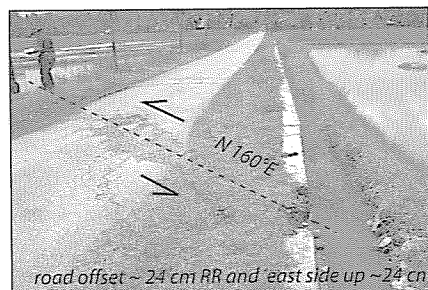
▼(b)

road offset ~ 24 cm RR and east side up ~ 24 cm

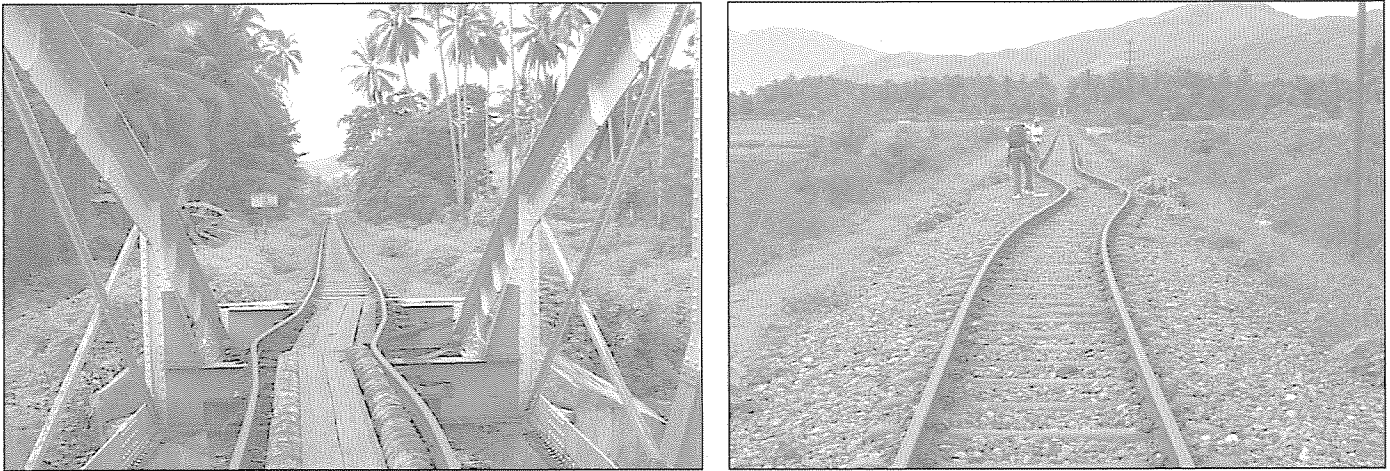
Figure 4. The N-S trending railway tracks on the east side of Sumani that were deformed during the earthquake.

Evidence of another interesting surface deformation phenomena was found in the railway tracks that run along the east side of the main rupture zone: they deformed or buckled in several places, especially along 3.5 km of the N-S trending train track on the east side of Sumani (Figure 4). Local people reported that, during the earthquake, the railway was swinging sideways back and forth.

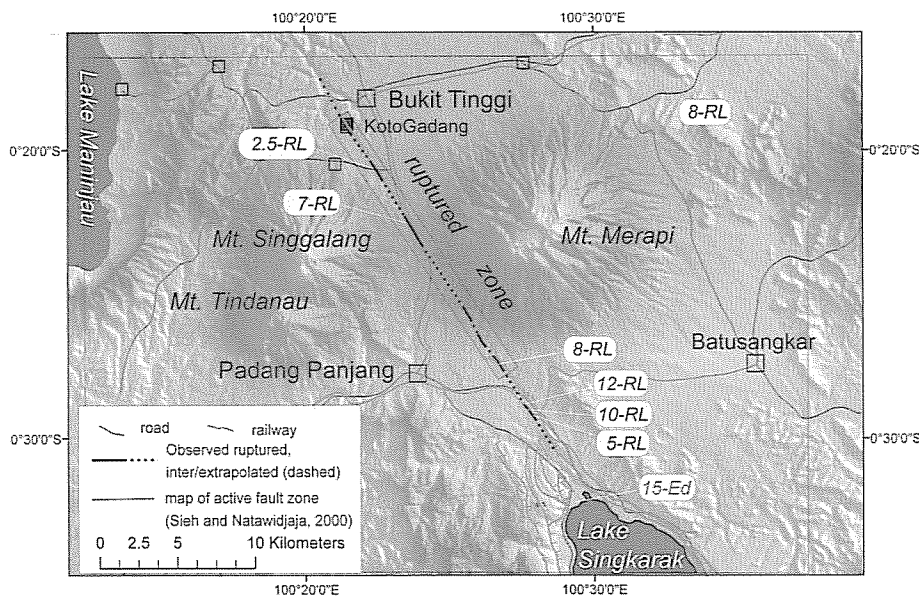
Second event (M6.3). In the region north of the Singkarak Lake, we observed evidence of surface rupture between the northern tip of the lake and the city of Bukit Tinggi; i.e., along the southern half of the Sianok fault segment. Our mapping shows that the total length of the rupture zone is about 22 km. We found that the maximum fault offsets were about 8-12 cm along the southern half of the rupture zone (Figure 5). The fault slips seem to diminish toward both ends.

Figure 5. Surface fault ruptures and fault offsets of the second mainshock. The length of the rupture zone is up to 22 km. The largest slip, up to 12 cm, occurred on the central part of the rupture.

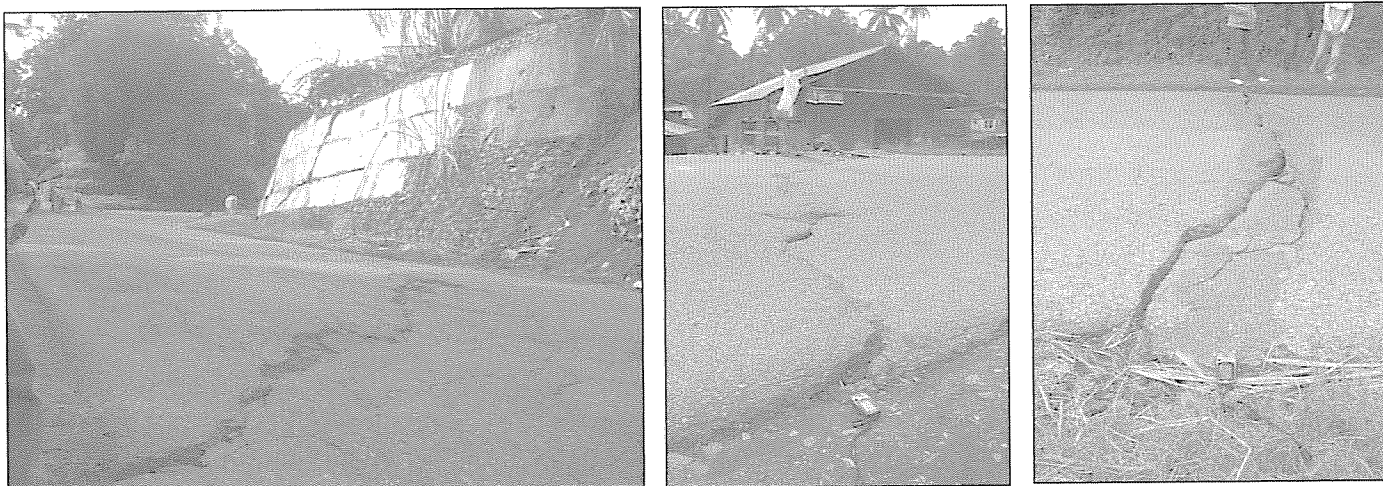
The 8-12 cm right-lateral offsets were observed near Jambak village, Batipuh regency. The fault trace cuts the main road and runs through the collapsed or heavily damaged houses (Figure 6). This rupture zone with maximum offset coincides with the most damaged village (i.e., Jambak) in the region.

Figure 6. Surface ruptures in Batipuh area. The ruptures cut and right-laterally displaced the roads 5–12 cm.

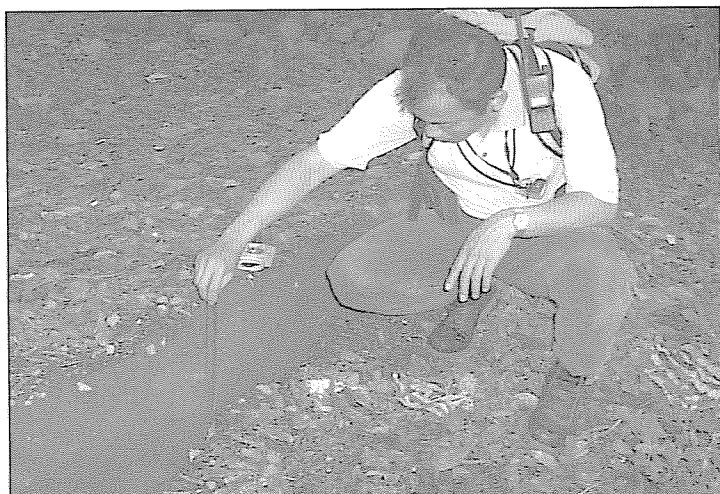
Near the northern tip of Singkarak Lake, instead of the major NNW-trending rupture, we found ground ruptures trending NE with a pure dip slip motion, SE side down up to 30 cm (Figure 7a). Many houses were deformed due this rupture (Figure 7b). We could not be sure whether this is tectonic normal faulting or a head scarp of a landslide. We favor the former, however, since this mechanism is consistent with the interpretation that the Singkarak Lake basin has formed by a tectonic pull-apart mechanism between the movements of the two major fault strands (i.e., Sianok and Sumani segments) (Sieh and Natawidjaja, 2000).

Figure 7. (a) (left) Dip slip near the northern tip of Singkarak Lake. The vertical movement was up to 30 cm, south-east side down. (b) (right) It damaged the houses that sit right on the ground rupture.

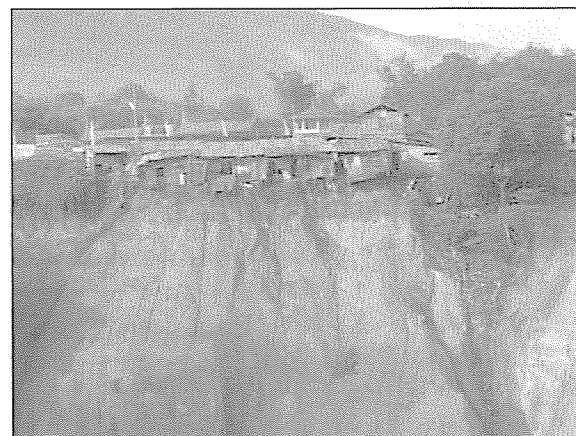
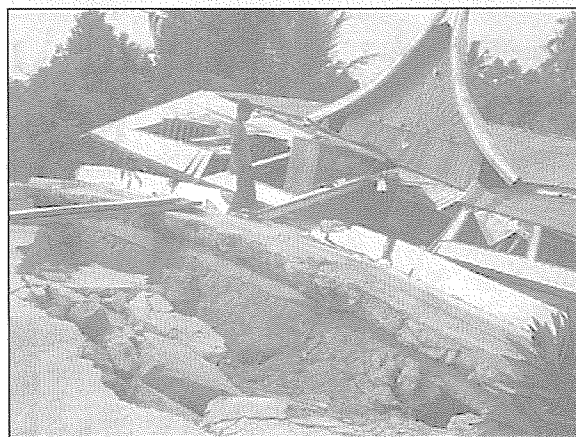
Several landslides and ground settlements could be seen in a few places. The most serious landslides occurred at Ngarai Sianok and Bukit Tinggi (Figure 1a). However,

several of the landslides had occurred prior to the March 6 earthquake in periods of heavy rainfall. The soil types at Ngarai Sianok mostly consist of silt and sand, with a slope of almost 90°. One house in Sumani Village, Solok, located at the edge of a river was damaged and moved because of ground settlement.

Figure 1. (a) (top) Landslide at Ngarai Sianok, Bukit Tinggi. (b) (bottom) Settlement at Sumani Village (source: Indo Pos, 7 March 2007).

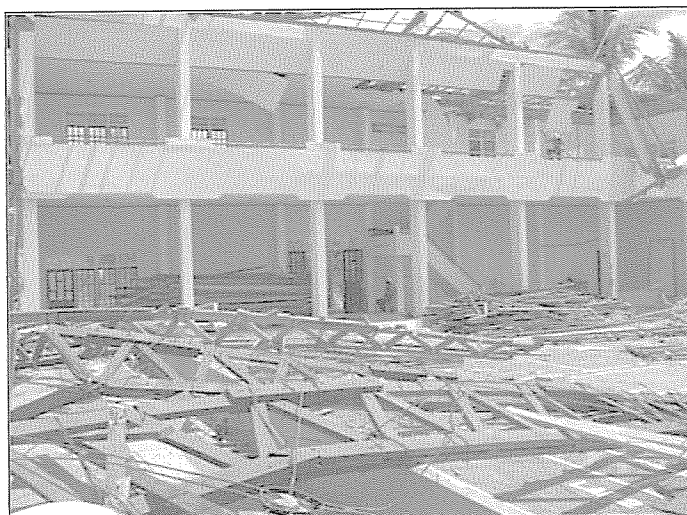
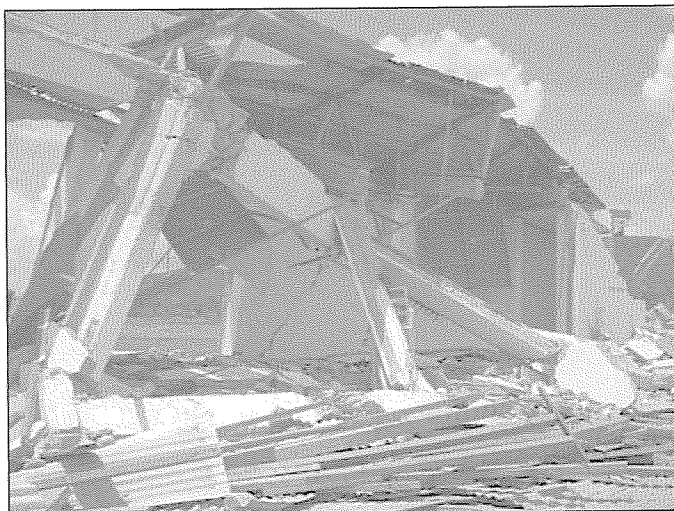
In the earthquake-stricken areas, there are very few "engineered" buildings beyond hospitals and some other government buildings. Engineered buildings consist mostly of reinforced concrete combined with masonry walls. The engineered buildings were damaged because they were not designed to withstand the seismicity of West Sumatra (see Figure 2). Even though Indonesia has a seismic

Figure 2. Engineered multipurpose building — Arsyandi Hall, Sumani Village.

code, it was not enforced in the affected areas. The building permit system was also not strictly followed. The poor quality of concrete and detailing contributed to the collapse of the buildings.

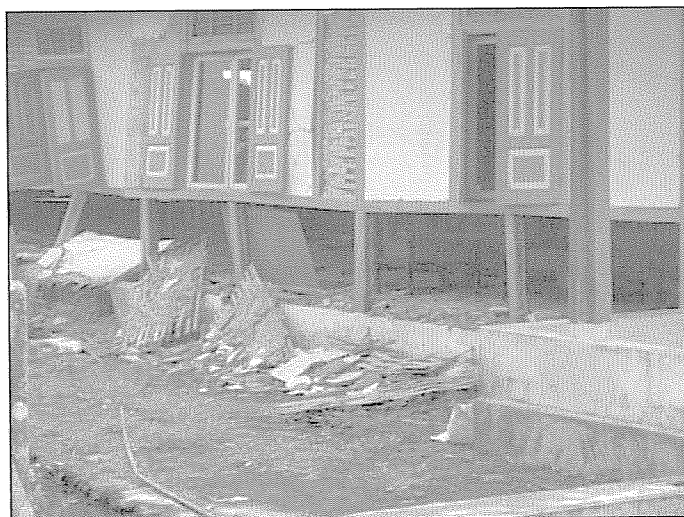
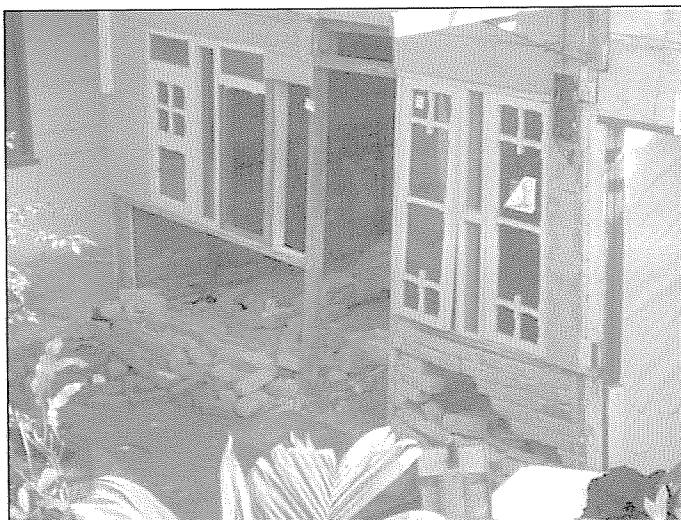
walls at the lower part, and the upper part of the wall was made from timber or bamboo mat plastered on both sides. This type of building is also earthquake-resistant. But like the first type, some buildings were damaged because of deterioration due to lack of maintenance (see Figure 3).

Figure 3. The traditional buildings based on architecture introduced by the Dutch were slightly damaged due to lack of maintenance.

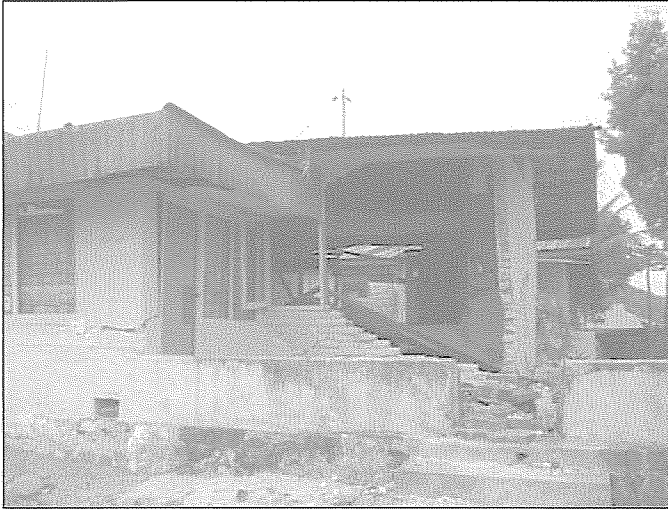
Figure 4. Walls collapse due to out of plane loading.

Problems have arisen when the reinforcement of the practical columns and beams is not in accordance with the code requirements or when the reinforcing bars detailing is not appropriate for earthquake resistance. The damage to two-story buildings was caused by the so-called “soft first story.” Damage includes out-of-plane bending (see Figures 4 and 5), failure

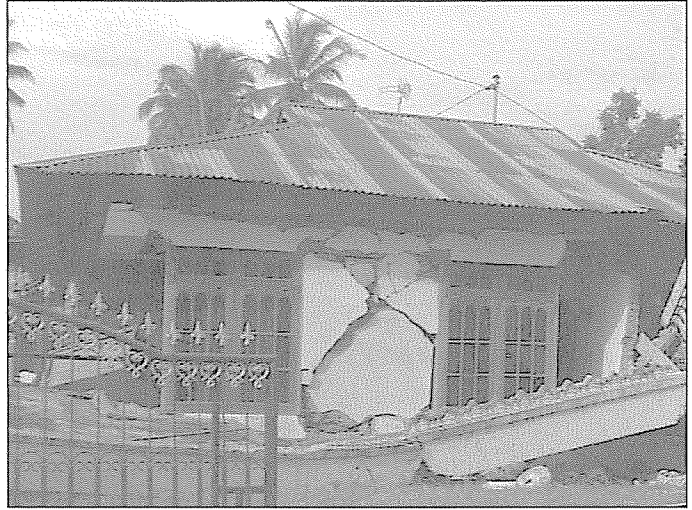
Figure 5. Diagonal cracks in walls due to out of plane loading.

of walls, in-plane shear failure, and failure at corners of walls and corners of openings. Walls tend to shear off diagonally due to twisting or warping in unsymmetrical buildings.

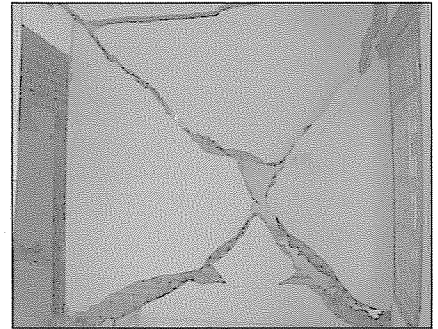
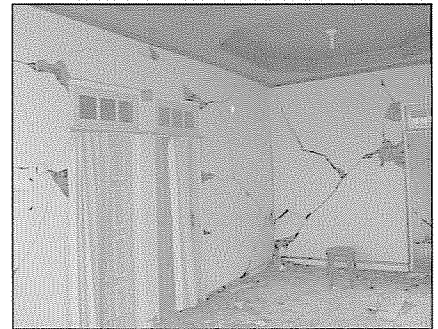
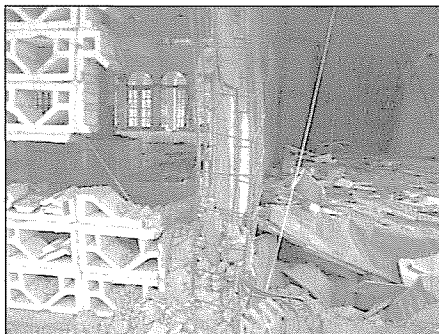
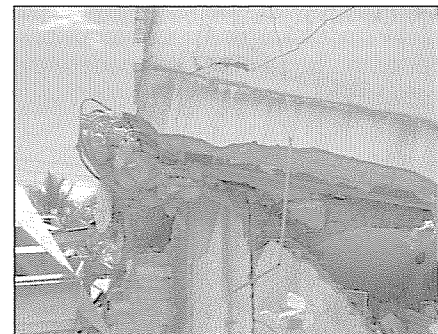
Figure 6. Poor reinforcement detailing and poor workmanship.

Factors contributing to such failures are weak connections between wall and wall, wall and roof, and wall and foundation. Poor quality materials and poor workmanship results in poor detailing (Figure 6), poor mortar quality, poor concrete quality, and poor brick laying (Figure 7). It is a common practice that roof trusses are not strongly anchored to the ring beams.

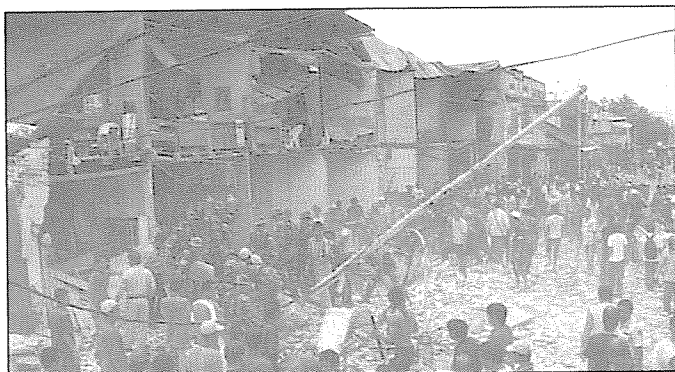
Figure 7. Poorly built shop houses damaged at Payakumbuh (source: *Warta Kota*, 7 March 2007).

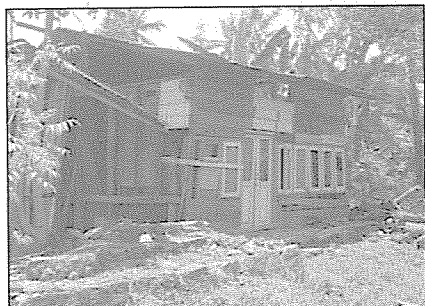
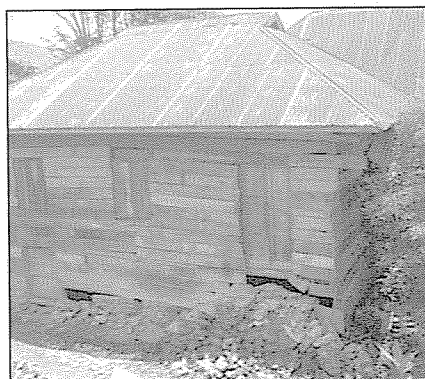
Figure 8. Damaged timber buildings due to deterioration.

doned and replaced by the “new culture” type building as soon as the owner manages to secure the funds. Timber buildings in general are earthquake-resistant and survived the March 6 earthquakes. The timber buildings that were damaged had deteriorated due to lack of maintenance (see Figure 8).

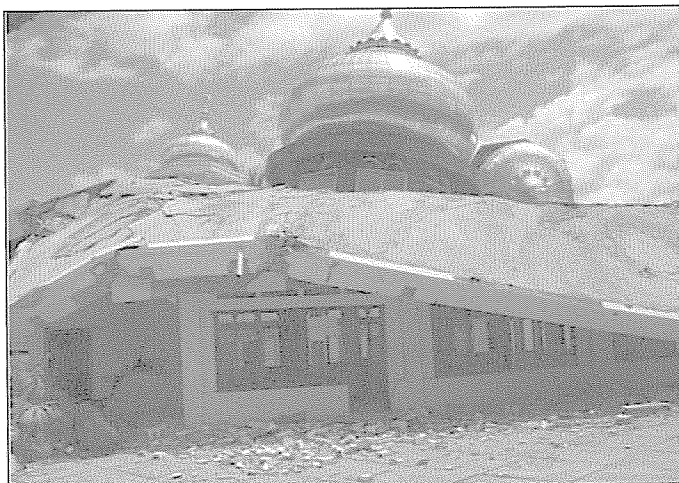
Several mosques were damaged, due largely to inappropriate design and construction. Usually mosques are built by the community on a self-reliant base and without any engineering intervention. The construction is based on the inadequate local artisan’s knowledge of concrete, concreting, and reinforcing, which is based on observations of past practices when constructing confined masonry houses. Most of the damage, particularly the collapse of the domes, is caused by poor quality of concrete and inappropriate reinforcing bar detailing. One other factor is the heavy weight caused by excessive thickness in the dome — a clear indication of the absence of engineering input (see Figure 9).

Figure 9. Damage to mosque domes.
