# EDGCUMBE, NEW ZEALAND, EARTHQUAKE - MARCH 2, 1987

## Introduction

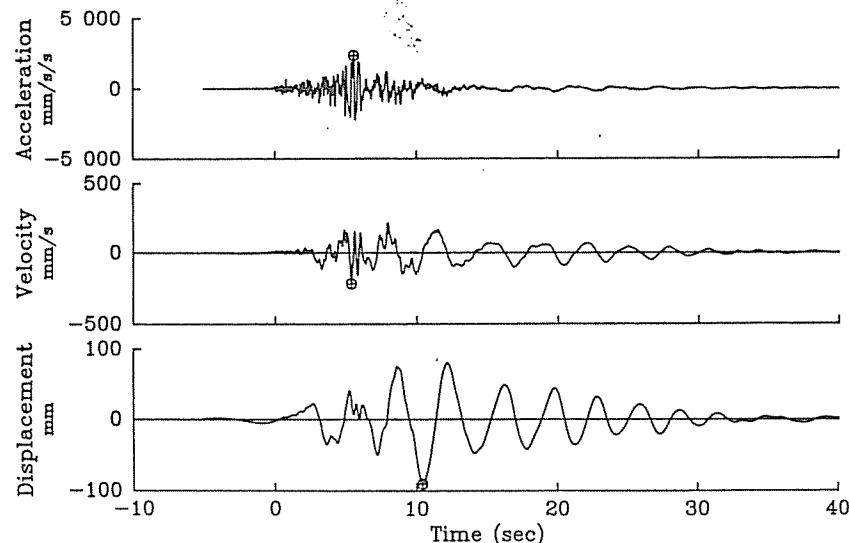
#### AB7085D2 MATAHINA DAM D (BOTTOM CENTRE) COMPONENT NO7W

⊕ Peak values: acceleration 2381 mm/s/s, velocity -216.5 mm/s, displacement -90.56 mm

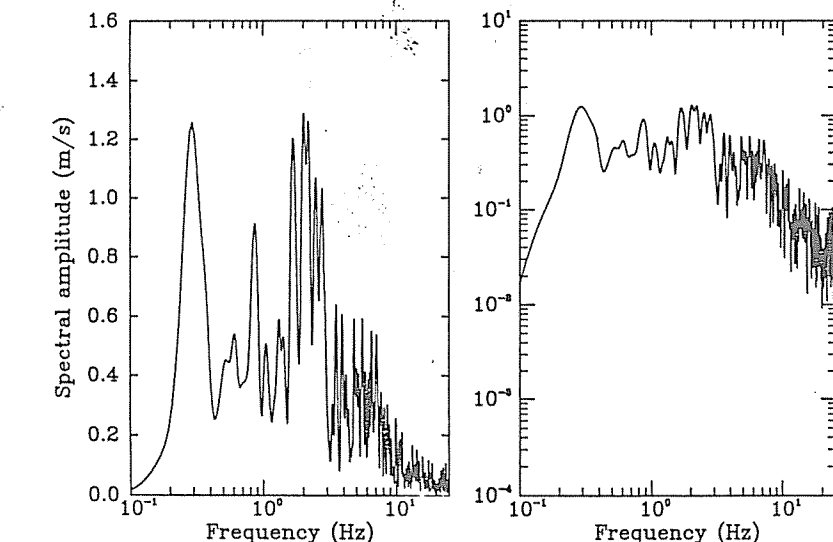
#### AB7085D2 MATAHINA DAM D (BOTTOM CENTRE) COMPONENT NO7W

Peak spectral amplitude = 1.288 m/s at 2.014 Hz

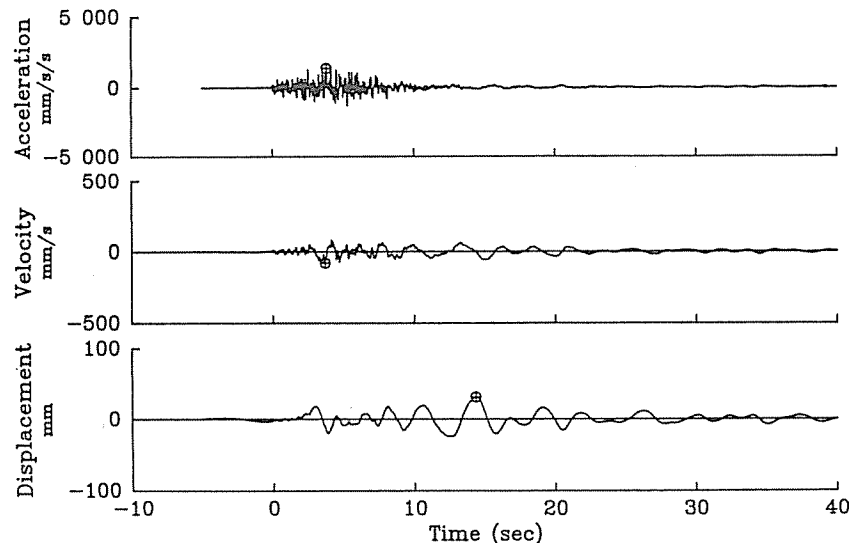
A87085D2 MATAHINA DAM D (BOTTOM CENTRE) COMPONENT UP

BAY OF PLENTY EARTHQUAKE 1987 MARCH 02 0142 UT  
 BAND-PASS FILTER TRANSITION BANDS ARE 0.100-0.250 HZ AND 24.5-25.5 HZ  
 Peak values: acceleration 1378 mm/s/s, velocity -80.5 mm/s, displacement 30.93 mm

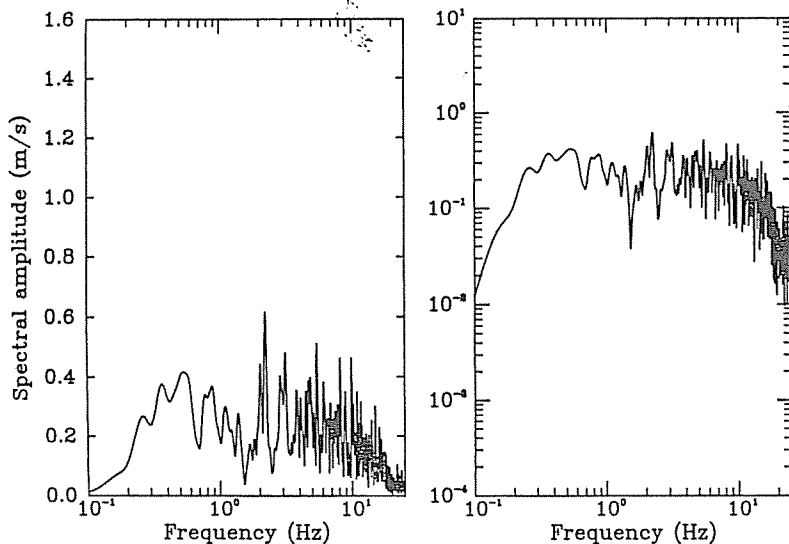
A87085D2 MATAHINA DAM D (BOTTOM CENTRE) COMPONENT UP

BAY OF PLENTY EARTHQUAKE 1987 MARCH 02 0142 UT  
 FOURIER AMPLITUDE SPECTRUM OF ACCELERATION  
 Peak spectral amplitude = 0.816 m/s at 2.234 Hz
