The November 15, 1994, M7.1 Mindoro Island Earthquake in the Philippines

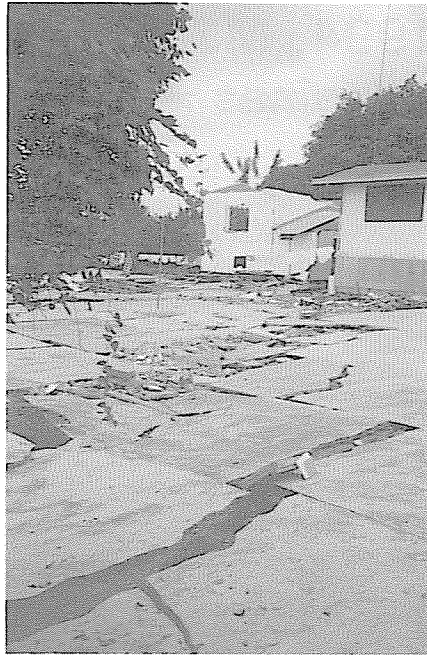
Figure 2—Trace of fault rupture as it passed through a residential lot, shattering concrete slab and displacing adjacent buildings. Fault movement in this area was slightly more than 2 m horizontal and 0.3 m vertical. Damage to these buildings appeared to be largely related to ground displacement rather than a result of strong shaking.

The centroid moment tensor solution released by NEIC indicates dominantly right-lateral slip along a steeply dipping north-south trending fault. This is consistent with the orientation and sense of displacement of the mapped surface rupture. The focal depth was 7 to 12 km, and the rupture apparently propagated from north to south. Surface rupture has been mapped over a length of about 35 km from the northern coast of Mindoro to west of Victoria along a previously unmapped structure named the Agulubang fault (Figure 1). The sense of slip is dominantly right lateral, with a variable component of vertical displacement. The fault displaced numerous roads, irrigation canals, rice paddy dikes, and several residential buildings (Figure 2). The maximum right-lateral slip of 3.45 m was measured in the

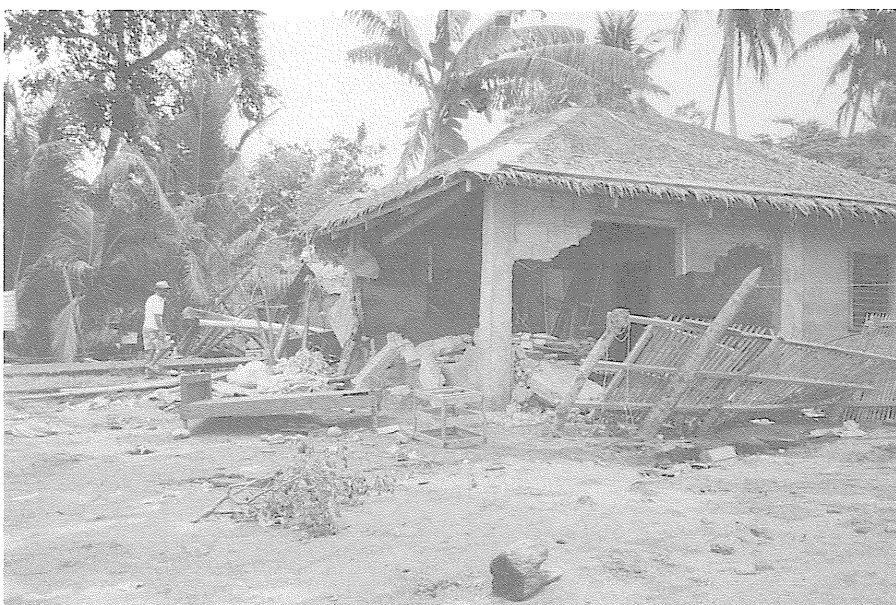
The tsunami scoured and eroded parts of the original coastline and nearshore sea bottom and deposited sand and debris inland. The waves transported small boats and massive pieces of coral inland, smashed concrete and nipa (light frame bamboo) huts (Figure 3), and swept occupants away. A power barge originally located near the mouth of Baruyan River at Calapan was separated from its moorings and transported about 2 km upstream by the tsunami. At least 58 deaths were attributed to the effects of the tsunami.

Figure 3—Severely damaged residence in the coastal town of Wawa. The tsunami was estimated to have attained a vertical runup of 2.5 m and a horizontal runup of 200 m in this area. The wave apparently exited back to the sea as indicated by the direction of compressed grass and bushes.

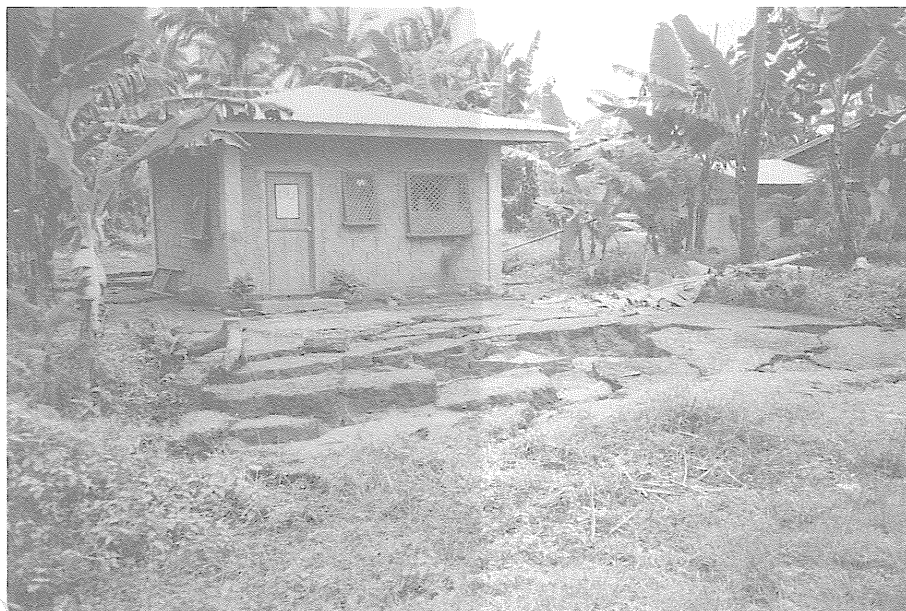
Figure 4—Liquefaction and lateral spreading cracks developed in a low-lying fluvial floodplain. Site is located within 1 km of the surface rupture. Note absence of damage to small concrete frame and hollow block structure.

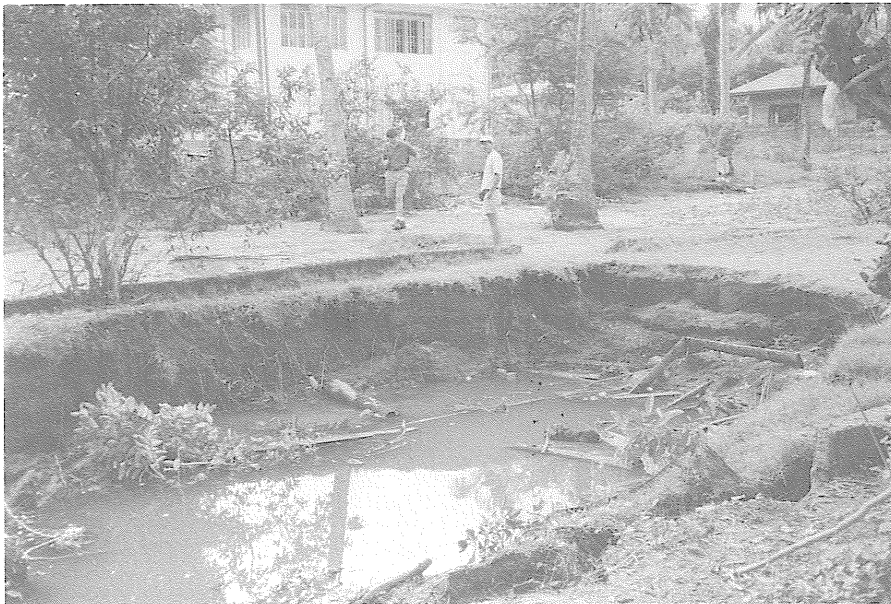
Figure 5—Large collapse near airport and beach area formed in dirt road by venting of sand into low-lying area at right side of photograph. Road constructed on loose fill placed on sand deposits. Throat of sand boil is in center of photo, at rear. Note shallow water table and large volume of sand expelled towards top of photo.

where large fissures, some as large as 5 to 10 m long and 0.5 to 2 m deep, developed subparallel to the shoreline (Figure 5). In the inland areas, lateral spreading occurred along river banks and in point bar deposits, while sand boils occurred near the river banks, in abandoned stream meanders, and in overbank deposits on floodplains. Lateral spreading was observed along highways and roads especially in areas near the ground rupture (Figure 6). The damage to roads included large fractures up to 1 m in width and 2 m in depth; these fractures were especially well developed in areas where the roads were constructed on loose fill placed on saturated ground. The fill typically failed laterally towards lower ground, such that the road surfaces were split open along fractures parallel to the margins of the fill.

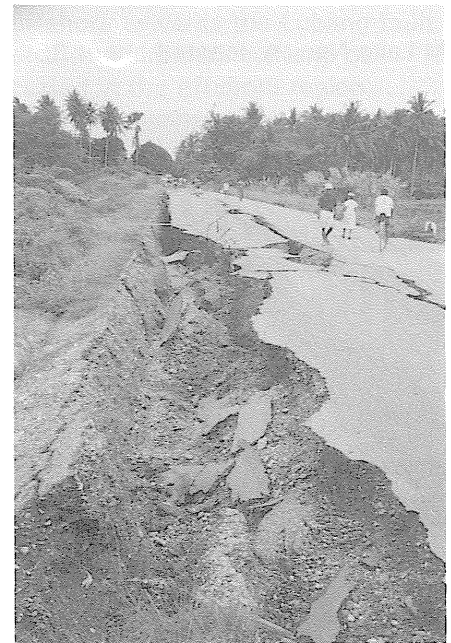
Figure 6—Typical liquefaction and lateral spreading damage along highway near Baco. This was probably one of the more dramatic and pervasive aspects of the earthquake. Site located within 2 km of surface rupture.

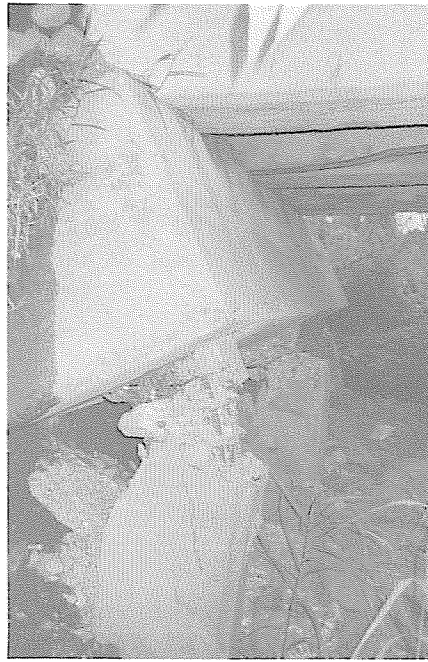
A few of the damaged bridges located in the immediate vicinity of the surface rupture exhibited more extensive damage due to ground shaking effects, resulting in severely rotated abutments and broken pile heads (Figure 7); bridges located further from the surface rupture were observed to have undergone moderate movements of the rocker bearings, causing light damage to abutments and some pounding damage at bridge expansion joints. A number of bridge abutment failures also appear to have been associated with the presence of a deeply buried tie-beam connecting the bottom edges of the abutment wingwalls and serving to magnify the effects of soil movements. Poor repair procedures, such as the use of horizontal lagging between the piles supporting abutments (apparently placed to help retain previously scoured fill), was noted at one bridge abutment; such procedures probably contributed to the damage to the abutments. Bridge damage patterns for this earthquake appear to follow

Figure 7—A simply supported, reinforced concrete deck and girder bridge that was badly damaged as shown by the severely rotated seat-type abutment with broken piles. Area is within 2 km of the fault in an upland terrace area. Damage to nearby concrete frame and hollow block structures indicates that this area experienced significant strong ground shaking, as well as extensive liquefaction and lateral spreading.
