Reconnaissance Report of Geotechnical Observations
for the 4 March 1977 Romanian Earthquake

T. L. Youd
U. S. Geological Survey
Menlo Park, California
Open File Report 77-375

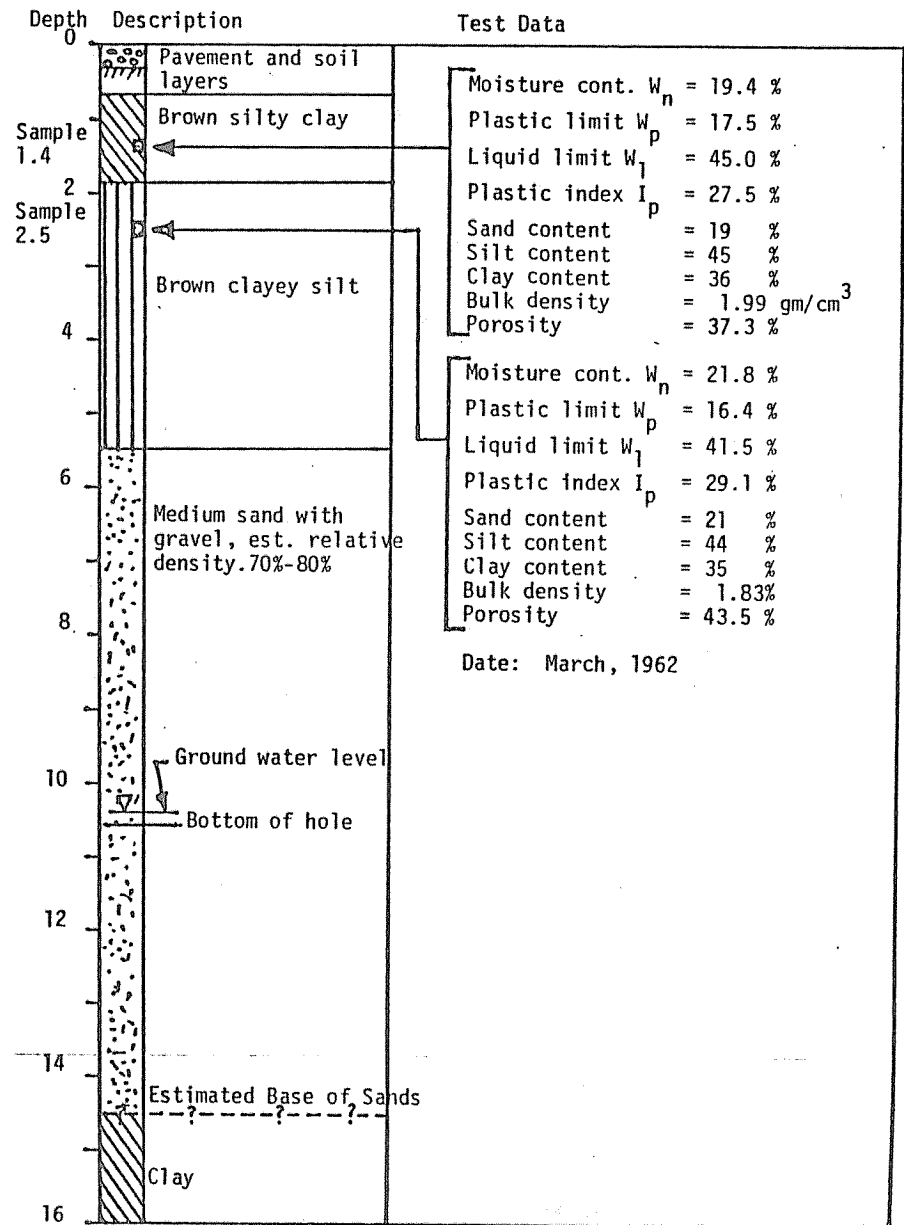
Fig. 3--Boring log from Building Research Institute (INCERC), Bucharest

Bucharest.--Although about 33 multistory buildings collapsed in Bucharest during the earthquake, no foundation failures were involved in any of these collapses. One collapsed building was left in an inclined position after the shock; however investigators from the Building Design Institute found that the failure was entirely within the structure and did not involve the foundation. The Building Design Institute has monitored the settlement history of many buildings in Bucharest on an annual basis by surveying a series of bench marks established on the buildings. A resurvey of these bench marks following the earthquake revealed that no increased settlement had occurred during the earthquake. A boring log showing some details of subsurface conditions at INCERC in Bucharest is given in Figure 3.
