Learning from Earthquakes

The Chi-Chi, Taiwan Earthquake of September 21, 1999

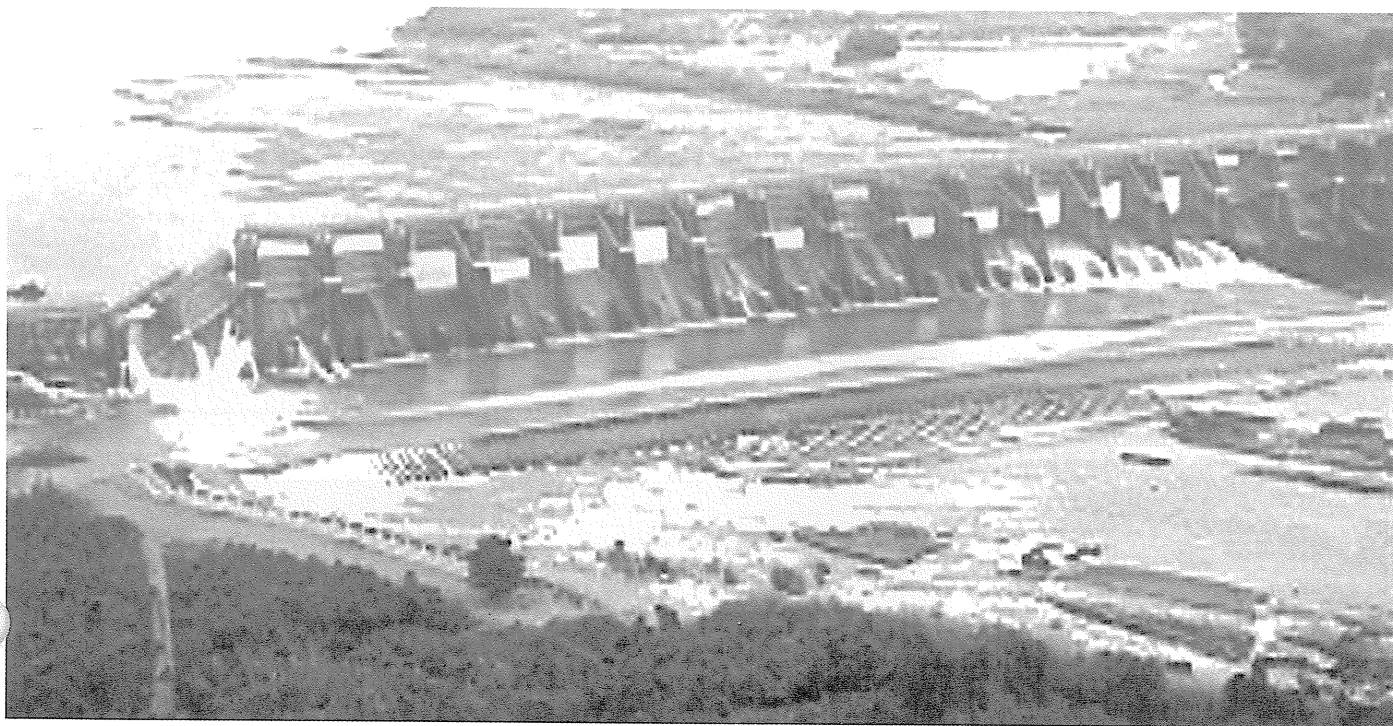
Figure 4 - Fault surface rupture across Shih-Kang Dam.

Damage to the Shih-Kang dam (Figure 4) reduced the water supply for Taichung City and County by between 40% and 50%. The Feng-Yuen water treatment plant consists of settling basins, finish water reservoirs and associated under-

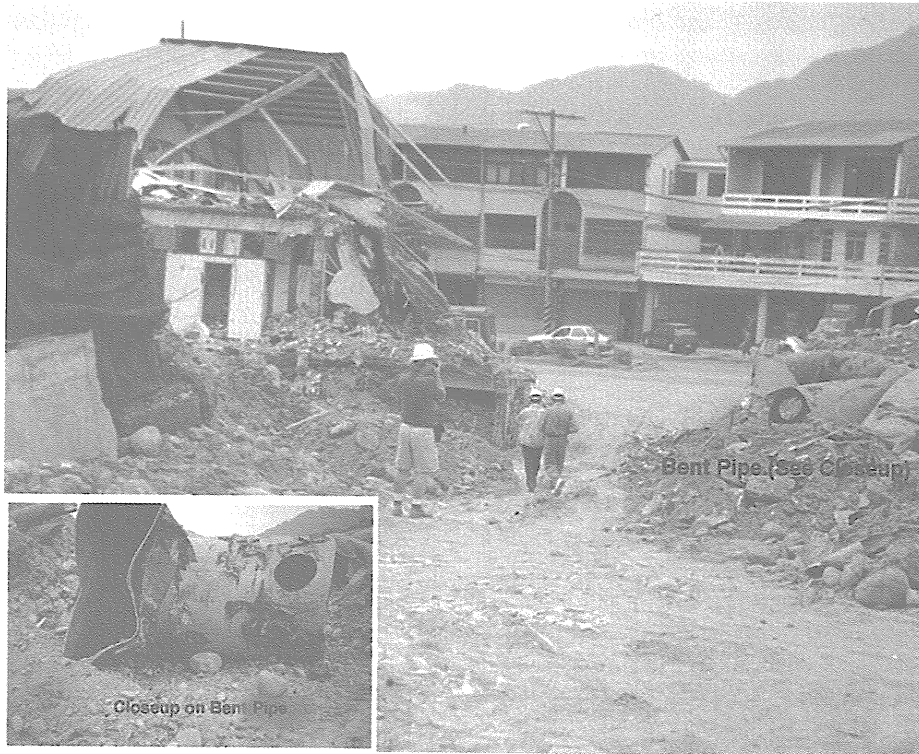
Figure 5 shows surface rupture at a water filtration plant located near Feng-Yuan. The figure also shows a water pipe, originally straight, which was bent 90 degrees and buckled by the large forces exerted by permanent ground distortion. Most buildings across the

Figure 5 - Fault surface rupture at a water filtration plant near Feng-Yuan.
(Photo: I.P. Lam)

Portions of the reinforced concrete roofs over the finished water reservoirs collapsed. The fault rupture passed directly through one corner of the plant. The vertical offset at the fault trace was about 4 m, and the horizontal offset was in the 1 m to 2 m range. These offsets were large enough to sever four steel pipelines, with diameters of 400, 1100, 1500 and 2000 mm, which traversed the fault.

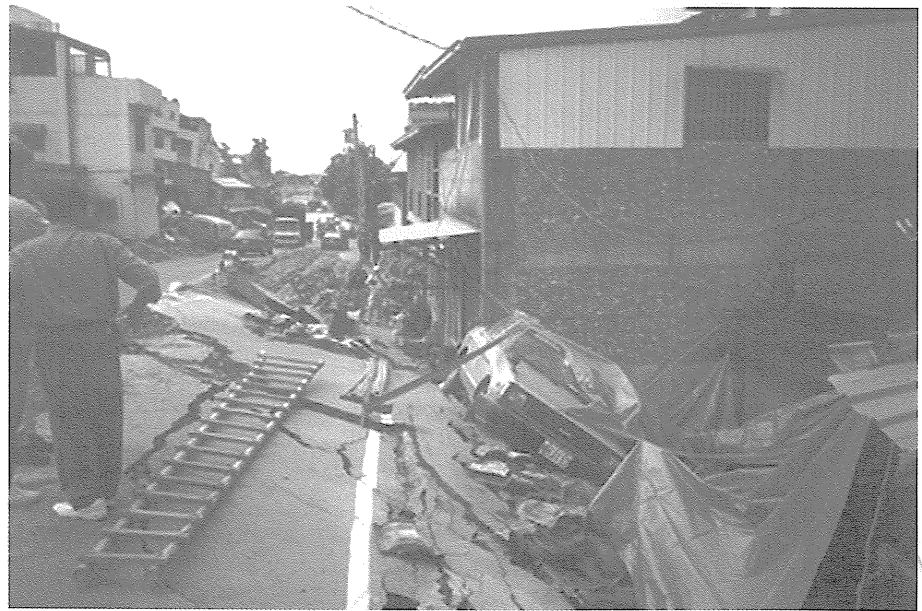
street (not directly within the fault rupture zone) showed no apparent damage (see Figure 6), in contrast to severe damage within the 15-20-m-wide rupture zone. This suggests that ground motion associated with permanent fault offset occurred slowly compared to dynamic shaking. These observations were common.

Figure 6 - Undamaged building with unreinforced brick walls immediately adjacent to fault rupture.
(Photo: Uzarski)

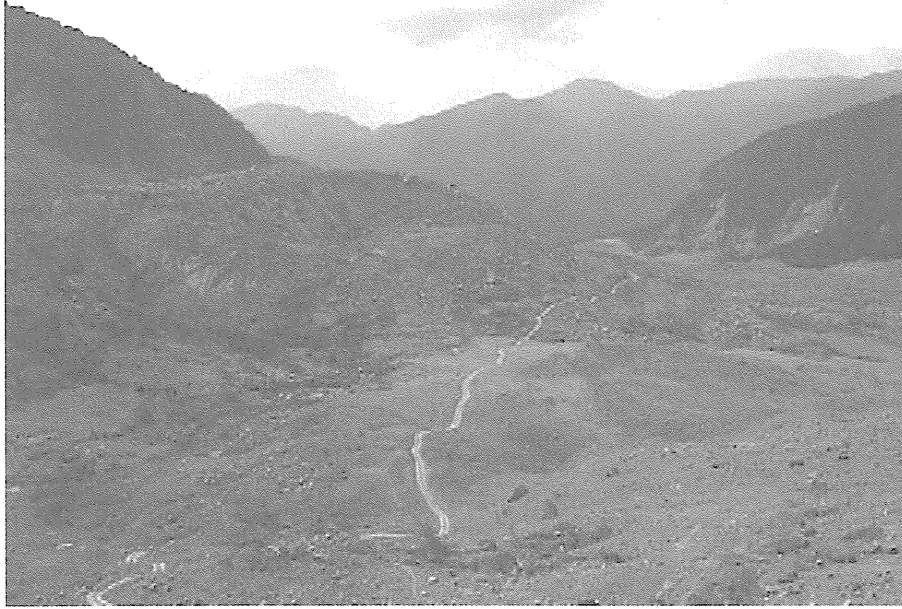
Figure 7 - Large-scale landslide at Tsaoling involving a large debris flow moving 2-3 km. (Photo: J.P. Bardet)

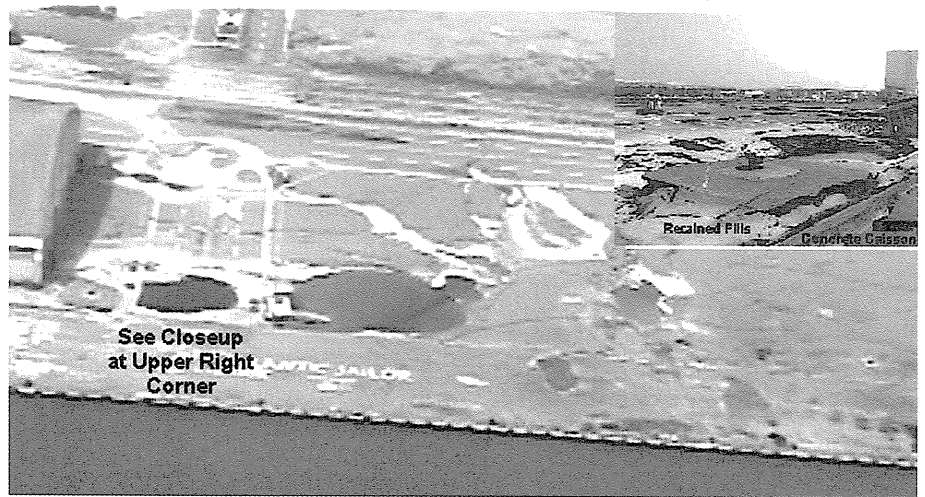
crete rectangular caissons) were damaged. The undamaged piers were pile-supported (with both vertical and battered piles). Liquefaction of hydraulic fill behind the concrete caissons caused widespread settlement of the pavement behind the piers and caused as much as 2 m of backfill settlement (Figure 8). Car-

Figure 8 - Settlement behind laterally displaced caisson sections at Berth 1, Port of Taichung. (Photo: J.D. Bray)

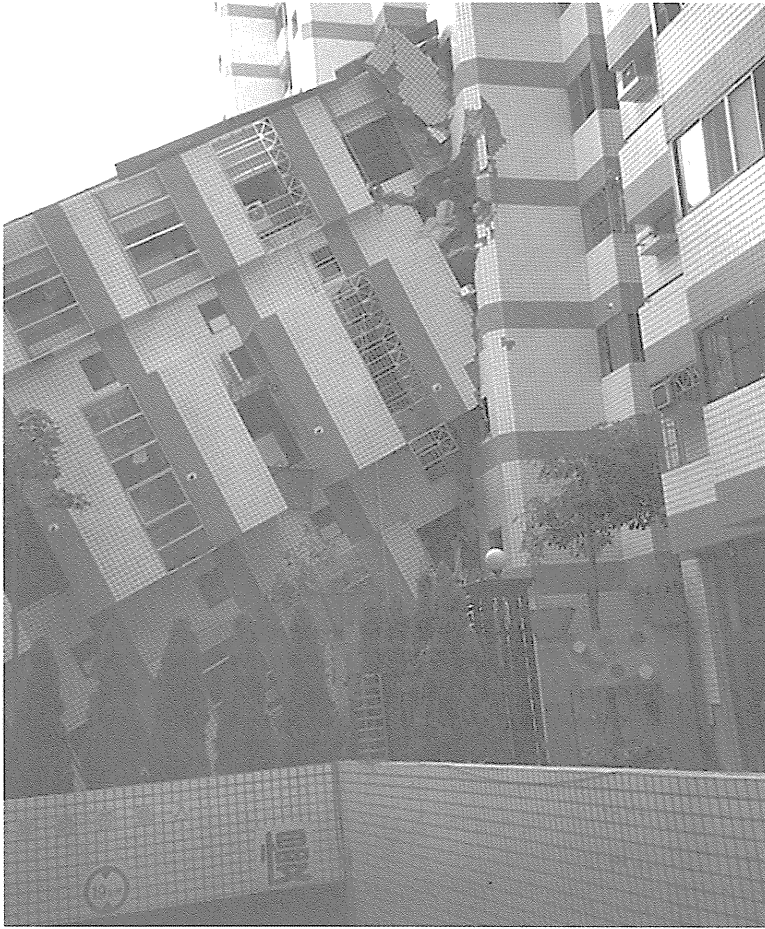
Figure 9 - Soft-story collapse of a mid-rise apartment building, Dali.
(Photo: Meyer)

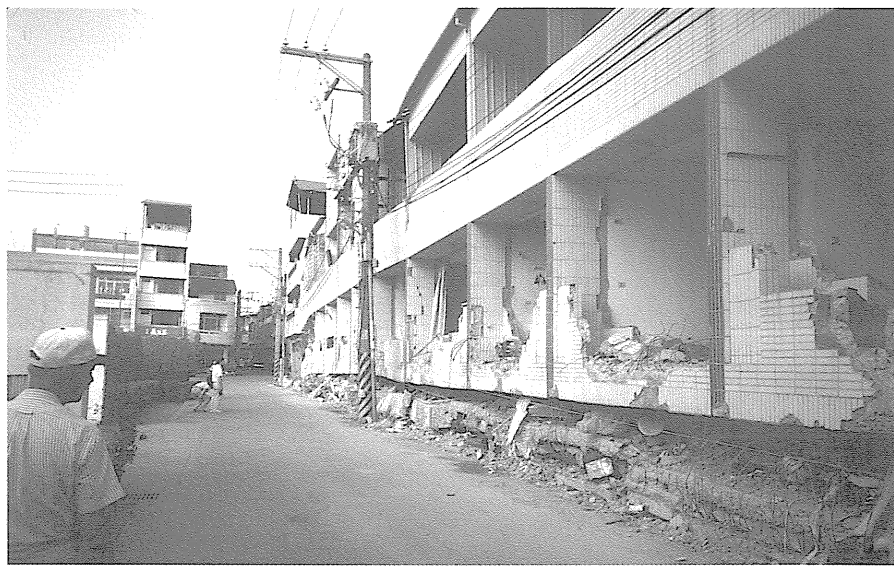
Arcade Buildings: Arcade style buildings are very common in Taiwan, and many of them were damaged (Figure 10). These buildings

Figure 10 - Double pancake of four-story building. Only two stories remain.
(Photo: Uzarski)

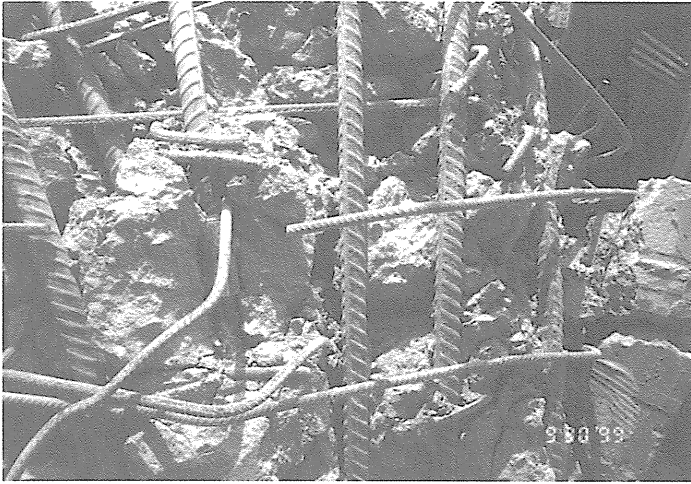
Figure 11 - Typical deficient column details: ties with 90-degree hooks instead of 135-degree hooks, excessive spacing of ties, and inadequate transverse cross ties. (Photo: Amin)

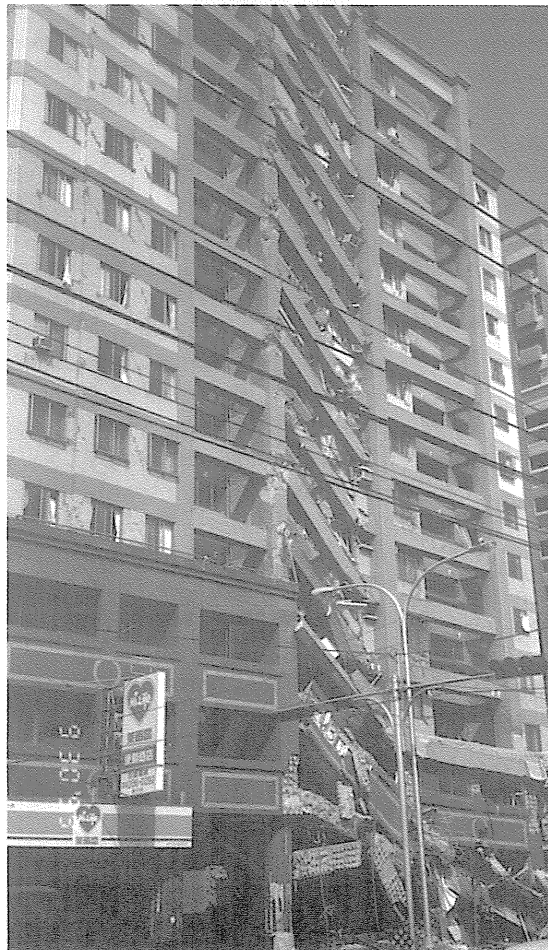
Figure 12- View of a partially collapsed 15-story building (less than 50 m high). Reinforced concrete with infill brick partitions. Beam column joint failure at facade.

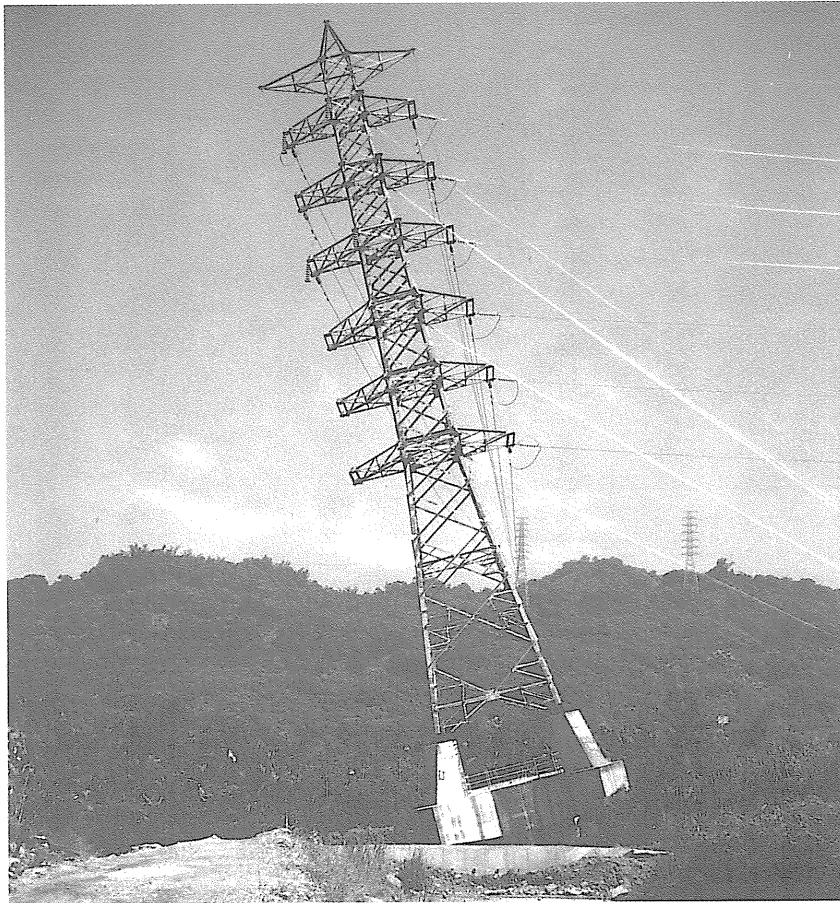
Figure 13 - Leaning transmission tower. (Photo: Tseng)

Many high-voltage transmission towers were damaged; some collapsed, while others tilted or settled due to ground deformation. One example of transmission tower damage due to fault rupture was observed near the town of Ming-Chien (Figure 13), about 10 km from the epicenter. The

scarp, with an approximate 2 m vertical offset, skirted the edge of the tower's concrete foundation pedestal. This caused the tower to tilt roughly 20 degrees from vertical. Some of the lines had snapped due to rotation of the tower and were repaired by splicing. As an emergency measure, the tower was temporarily stabilized by ground-anchored guy wires.

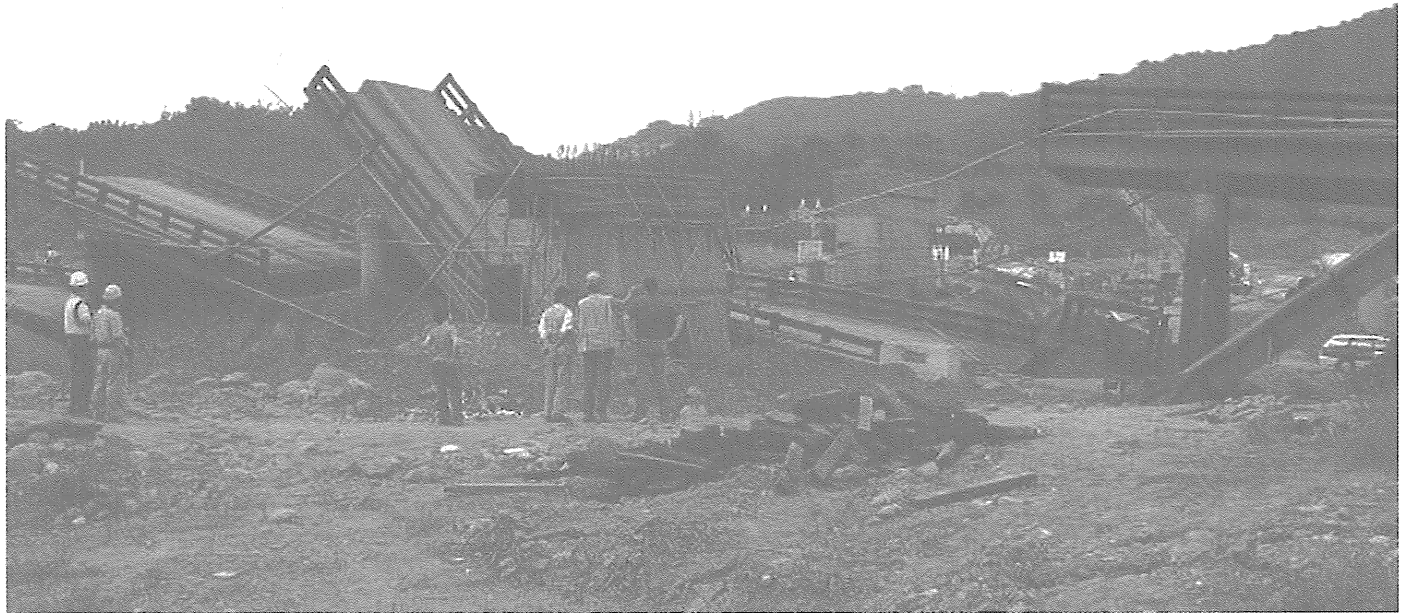
Figure 14 - The fault ruptured beneath the I-Jiang Bridge, about 30 km NNW of the epicenter. (Photo: Moehle)

The fault ruptured beneath the I-Jiang Bridge (Figure 14), about 30 km NNW of the epicenter. This structure comprised 24 spans (11 m each), simply supported without bearings on reinforced concrete pier walls. When the rupture passed between the first and second piers from the northwest abutment, the first pier rose approximately 3 m relative to the second pier. In its final rest position, the deck

overhangs the pier wall by approximately 4 m. It seems unlikely that the deck moved that distance slowly, because had it done so, it would have fallen to the ground after a relatively small movement as it became unseated at one end. It seems more likely that the span was propelled at a high velocity before coming to rest in this final position.

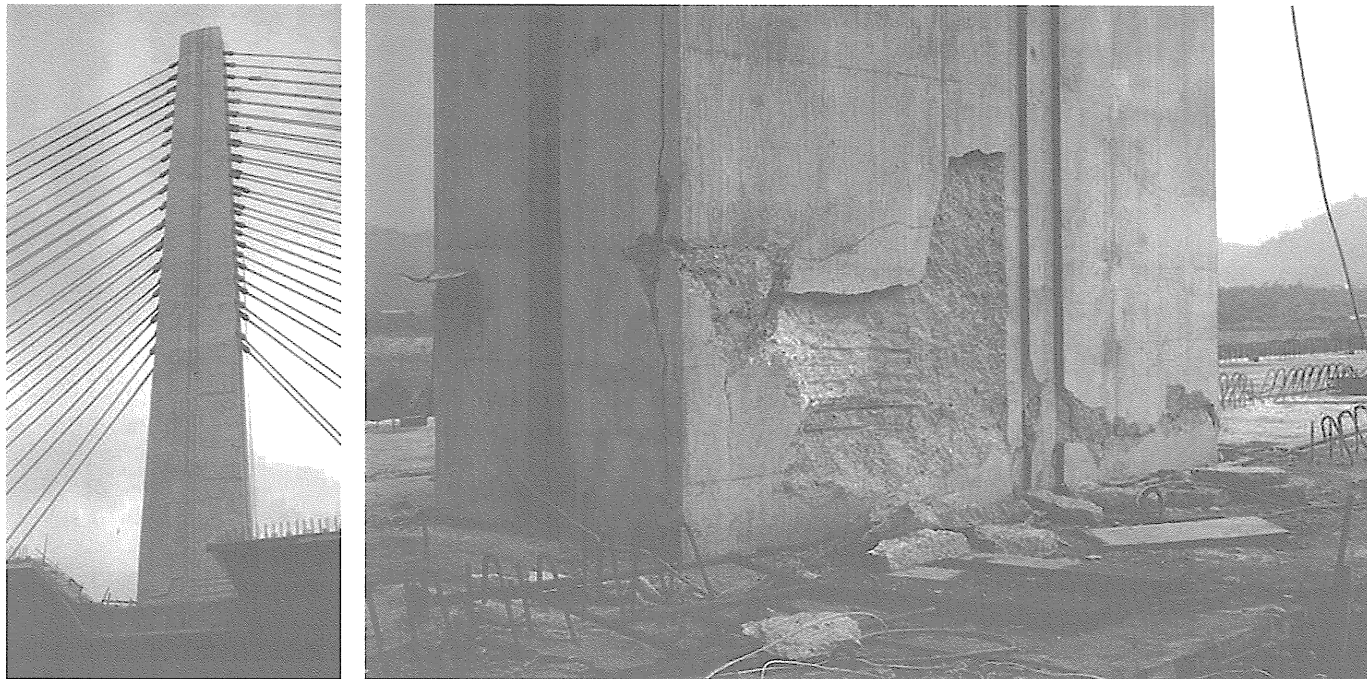
Figure 15 - The Jyi-Luh cable-stayed bridge, about 10 km SW of the epicenter, was under construction and sustained significant damage. (Photo: Moehle)

The Jyi-Luh cable-stayed bridge (Figure 15) across the Choshun River, about 10km SW of the epicenter, was under construction and sustained significant damage. The bridge deck had not been completed near the pylon, and closure joints at both ends of the stayed deck had not yet been placed, leaving the structure in a relatively vulnerable condition. The soil around the supporting bents had apparently liquefied, and may have permitted some to settle and rotate. The shear keys at both ends of the stayed spans apparently had translated laterally approximately two meters, gouging the supporting bent cap and inducing severe shear cracking. The pylon spalled to expose the core concrete and reinforcement over approximately two meters in height; splitting of the concrete around the core was evident nearly to the height of the lowest cables. One cable had sustained anchorage failure and was lying on the bridge deck.

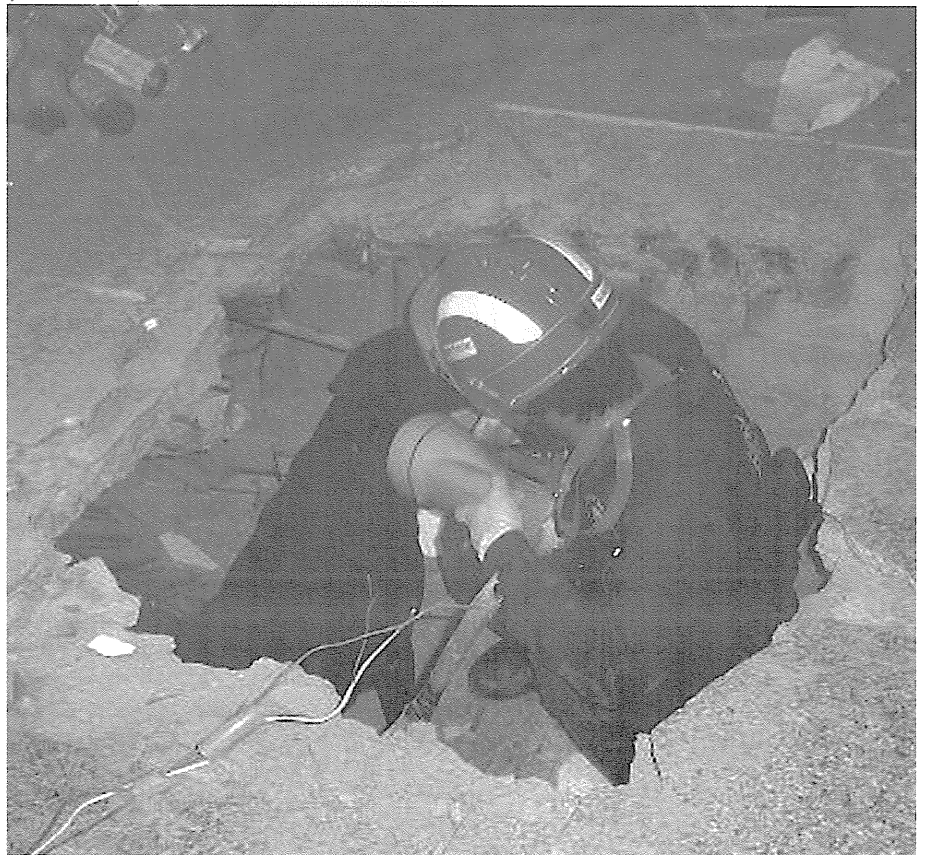
Figure 16 - Rescue worker searches for survivors in collapsed building, Taipei.
(Photo: Tomohide Atsumi, Osaka University)
