Learning from Earthquakes

Preliminary Observations on the August 14, 2003, Lefkada Island (Western Greece) Earthquake

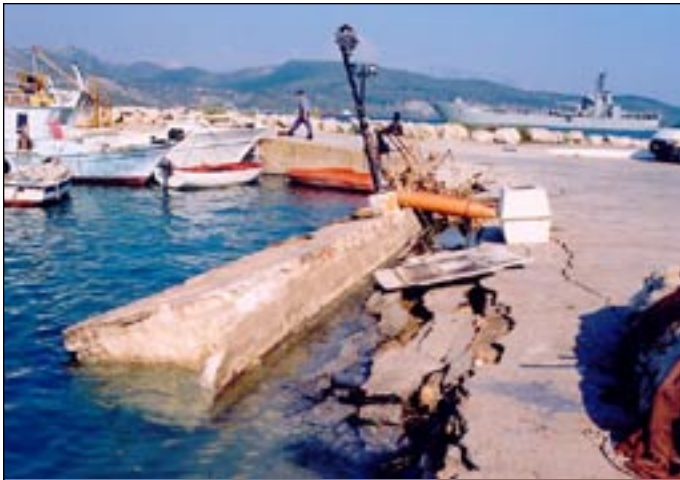
Figure 10. Ground subsidence of the fill material of about 30 cm (NTUA-UoA team).

differential seismic response of the various unconsolidated phases of the formations (figures 9 and 10). Most of them are also connected to liquefaction phenomena and represent lateral spreads and extensional failures.

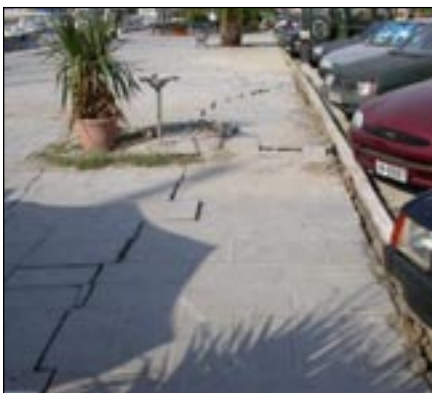
In the town of Lefkada, damage included uplifted, sunken or cracked concrete slabs, and distorted pavement and sidewalks (figure 11). Shallow subsurface materials at these sites probably consisted of uncompacted, miscellaneous fill. Local residents reported that muddy water was ejected from cracks in pavement surfaces. Observed ground cracking with lateral spreading, as well as silty-sandy boils along the waterfront in the town of Lefkada and in Nydri village, were the primary surface evidences of liquefaction, indicating high excess pore pressure generation during earthquake shaking.

Figure 11. In the town of Lefkada, distorted pavement and sidewalks due to ground settlement and lateral spread (ITSAK team).

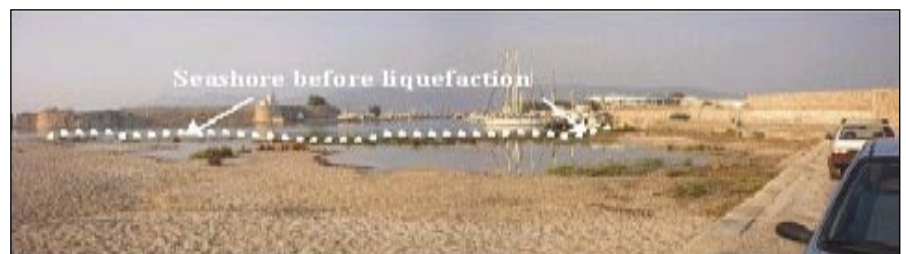
Figure 12. Area near the castle of Lefkada where soil liquefaction, lateral spreading, and ground settlement occurred (ITSAK team).

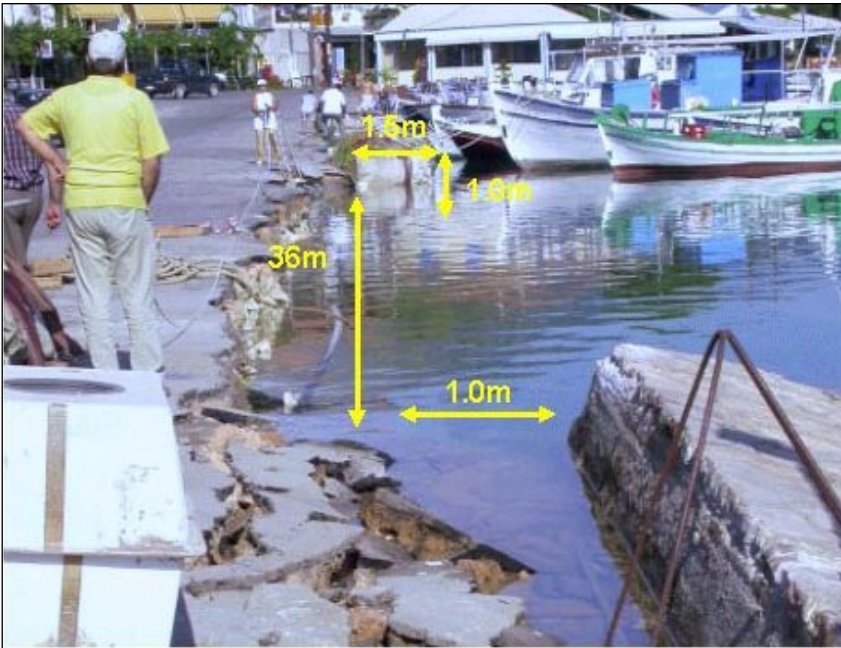
Densification of loose surface soil layers and of poorly compacted fills behind seawall facilities caused settlements and lateral spreading towards the free face. The horizontal and vertical displacements varied between sites, but they were in the range of 10-25 cm. Figure 13 shows ground settlement near the coastline. Lateral spreading was prevented due to the seawall, but an up-lift of the ground just behind the seawall tilted the lampposts.

Figure 13. Part of the seawall has been laterally shifted and overturned (ITSAK team).

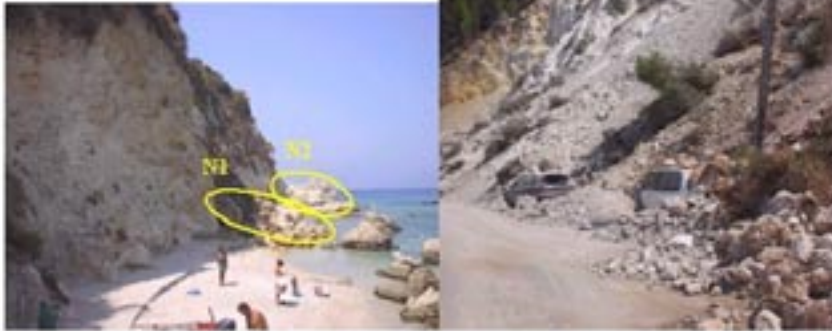
Figure 16. Rockfalls due to detachment and possible overturn at the Agios Nikitas (left); Cars were buried under landslides near the same beach (right) (ITSAK team).

swimming and sunbathing, but they did not cause any casualties, thanks to the early morning hour of the main shock. Figure 16 shows rockfalls and scree deposits due to overturn, detachment, and sliding at Agios Nikitas Beach.

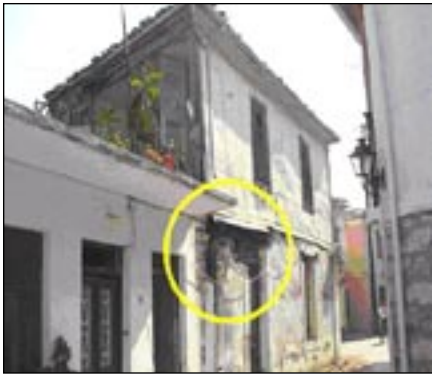
Figure 18. Partial collapse of masonry wall in a category B building (ITSAK team).

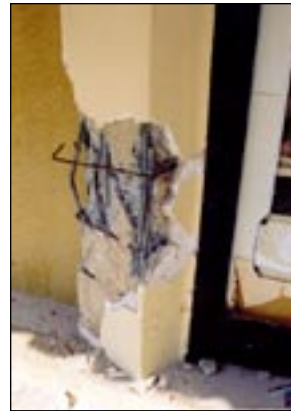
20a

In a building with a market and mezzanine on the ground floor: insufficient stirrups with poor detailing (a).

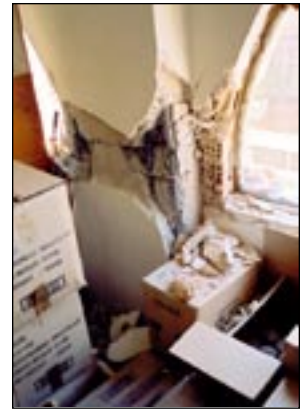
20b

In the mezzanine: damaged columns on the surface between phases of concrete and the lower part of the arches, formed with brickwalls (b) (NTUA-UoA team).

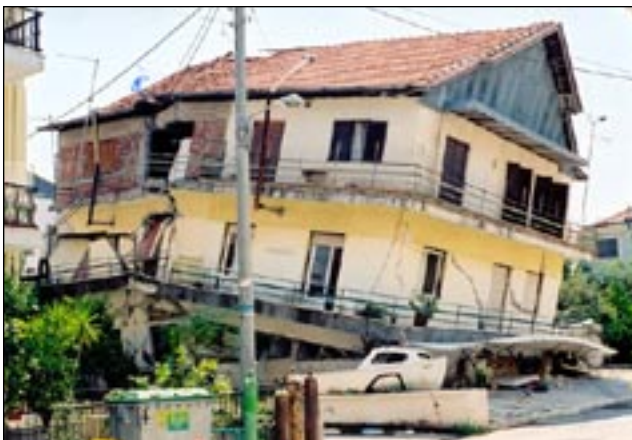
Figure 19. Collapse of R/C building in the town of Lefkada. On the right side, there are no brickwalls on the ground floor, where the building collapsed. The remaining part on the left side has partitions down to the foundation (NTUA-UoA team).

A total collapse occurred in a three-story R/C building (category C) with short columns on the ground floor at the front and thick brick infill walls at the back. The building was poorly designed with inadequate stirrups at the columns (figure 19).

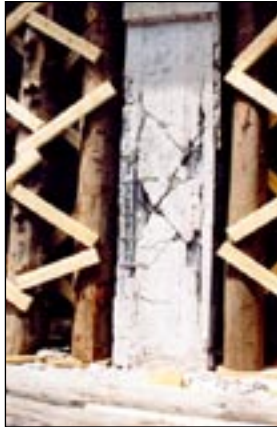
Figures 21a and b. A four-story building with a mezzanine was heavily damaged in the ground floor columns. The columns seem to have swollen in the center due to insufficient transverse reinforcement (NTUA-UoA team).

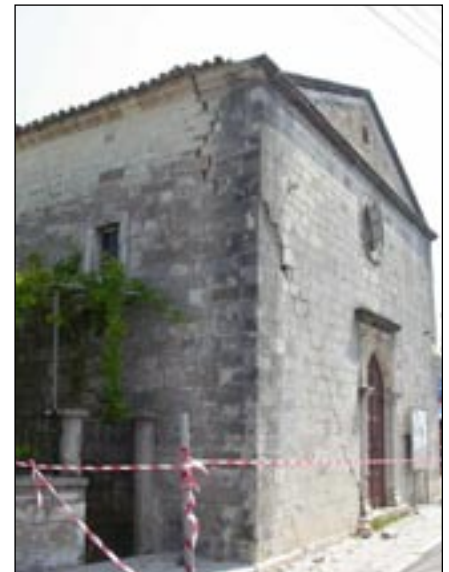
Figure 22. Churches built of stone masonry suffered heavy damage. In various parts of Lefkada, the tiles at the center of roofs moved. This might be explained by the vertical flexibility of the roof at its center (NTUA-UoA team).

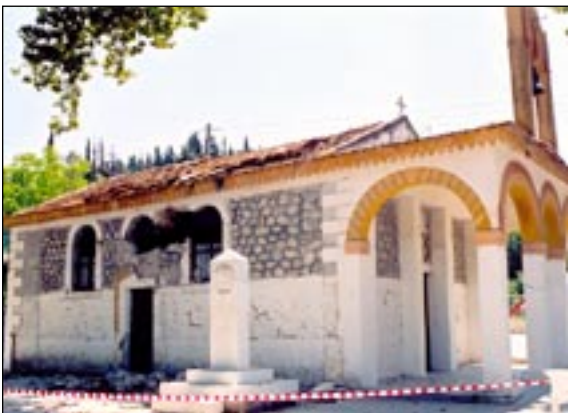
Figure 23. Cracking of masonry walls of Agios Minas church (town of Lefkada) (ITSACK team).
