Learning from Earthquakes

The M_w 6.3 Java, Indonesia, Earthquake of May 27, 2006

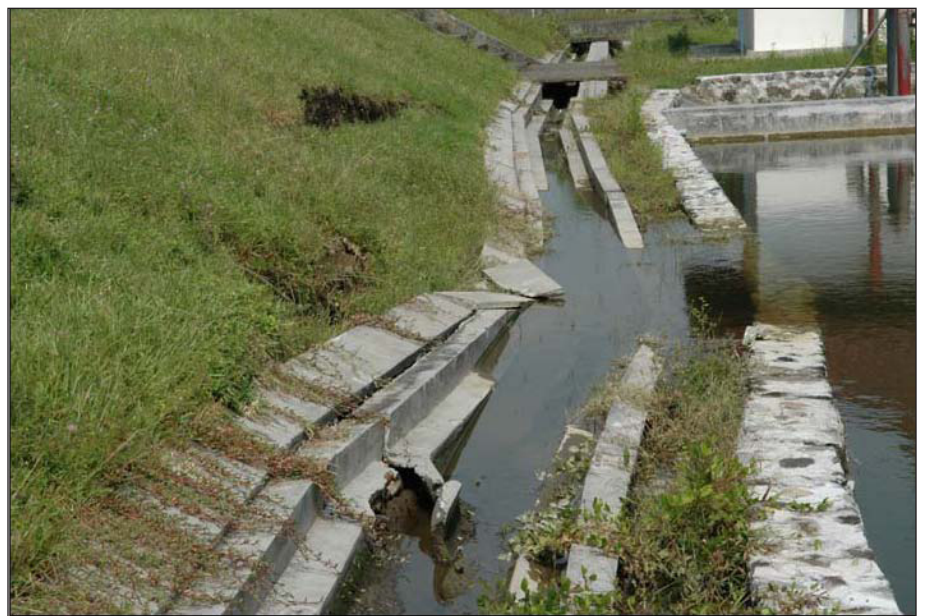
Figure 3. Lateral spread at Muhammadiyah University (7.8108°S, 110.3210°E) (photo Hartono).

The other distinct geotechnical phenomenon was ground cracking associated with lateral spreading, settlement, permanent deformations, dynamic densification, or a combination. Lateral spreading of embankment fill soil led to the failure of a section of stone masonry retaining wall around a pond at Muhammadiyah University campus (Figure 3). At the same location, a stairway supported on a pad footing over clayey fill settled about 2 inches. No evidence of sand boils or liquefaction was found in the site vicinity.

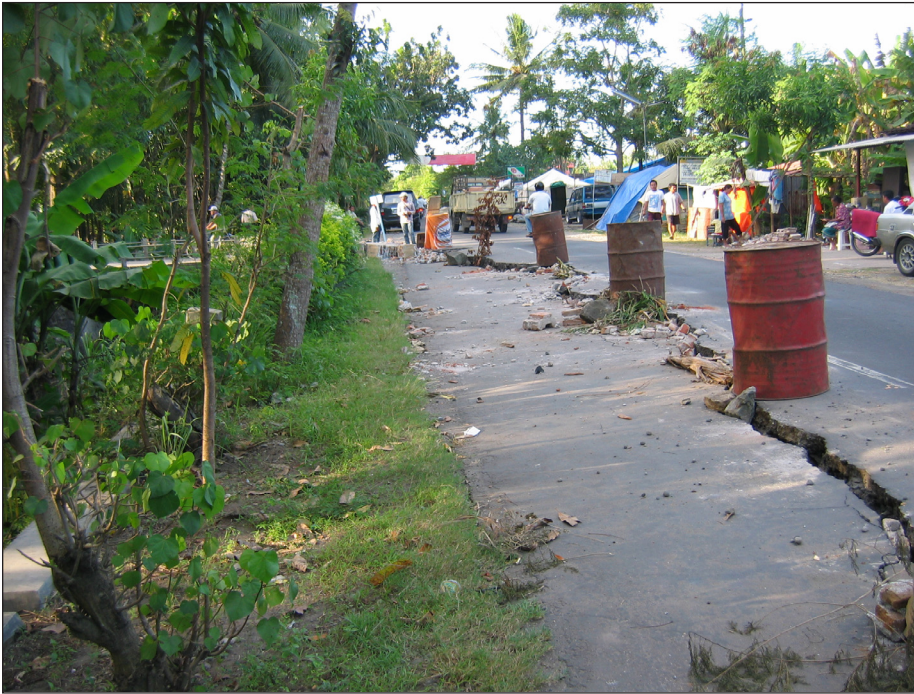
Figure 4. Ground cracking, settlement and lateral deformation toward stream channel (7.9464°S, 110.2974°E) (photo Hausler).

Figure 4 shows ground cracking and settlement due to permanent deformation along a road shoulder. This road runs parallel to a small stream along which stone masonry retaining walls failed at several locations along its length, in some places settling as much as 20 cm. The same phenomenon was observed along several bridge ap-

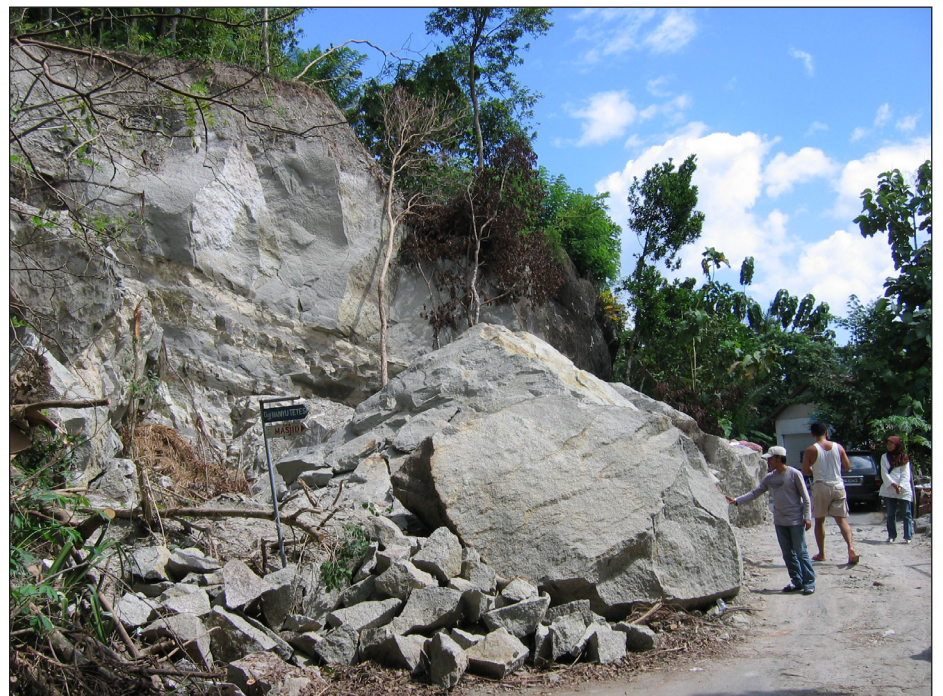
A rock fall occurred in the hills near Imogiri, southeast of Yogyakarta and probably very close to the fault rupture area (Figure 5). Some natural slopes along river banks near the Sriharjo Bridge also failed during the shaking. There were no other reports of landslides. There were no reported dams, port structures, or facilities on improved ground affected by the earthquake.

Figure 5. Rock fall near epicenter (7.8789°S, 110.3955°E) (photo Hausler).

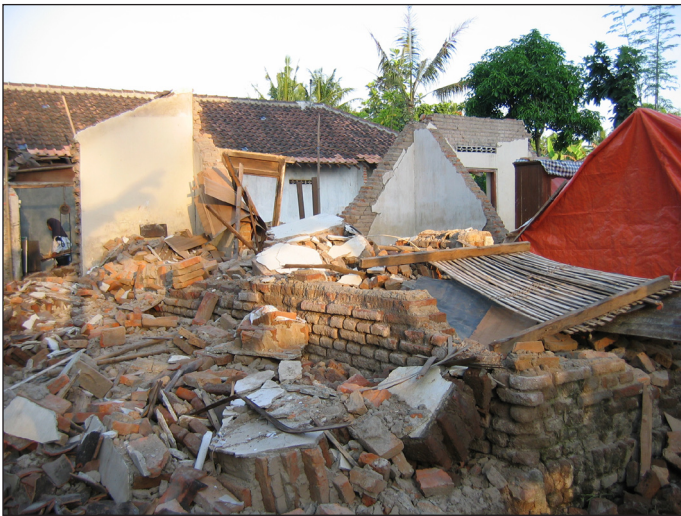
Figure 6. Destroyed unreinforced masonry houses, Pleret (Bantul) (S7.83686° E110.41552°).

Unreinforced Masonry: Unreinforced masonry houses were ubiquitous throughout the affected area and the most severely damaged (Figure 6). The collapse of such buildings was responsible for most of the deaths and injuries. URM failures were associated with poor quality materials and lack of wall integrity in the transverse direction for out-of-plane forces: no mechanical connection between the top of the wall and the roof or floor, and inadequate out-of-plane strength due to a lack of reinforcement. No steel reinforced concrete foundation beams, columns, or ring

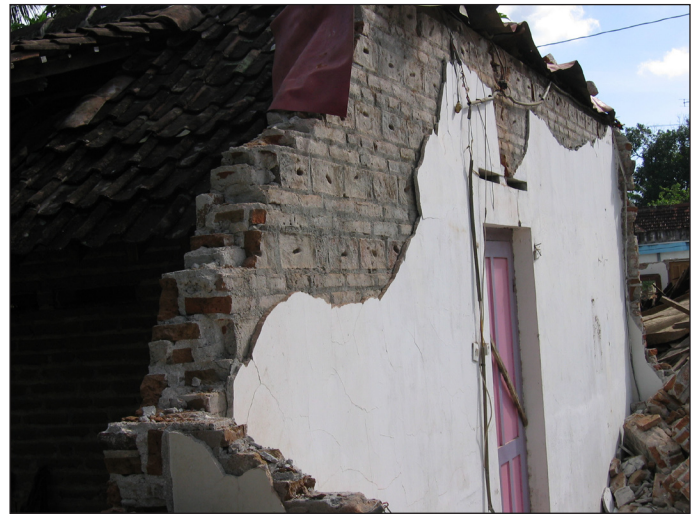
Figure 7. Typical unreinforced masonry bricklaying, Sumbermilo (Bantul).

ern counterparts (22 cm x 11cm x 4 cm). Full brick wide bonding is not possible with the shorter bricks, so common practice transitioned to a 17 cm wide bond in which two bricks were laid in the plane of the wall and one brick turned on its side (see Figure 7).

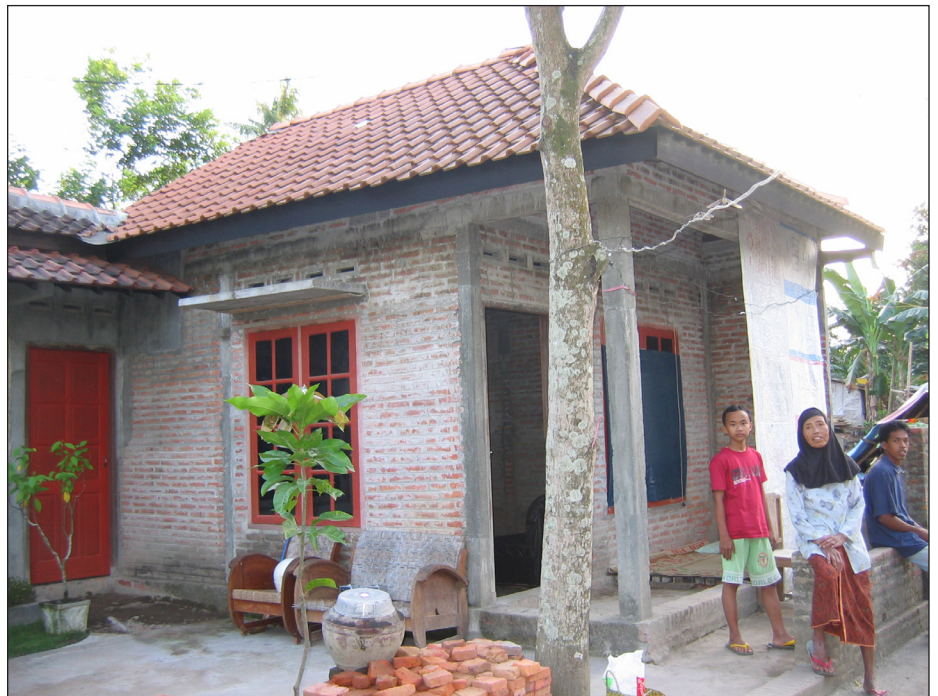
Figure 8. Well-designed and built confined brick masonry house, edge of heavily damaged Pleret (Bantul) (S7.83686° E110.41552°).

finer masonry houses performed well due to their reinforced concrete tie columns and bond beams at the plinth and roof levels. Examples of good performance of confined fired brick, solid concrete block, and stone masonry were scattered throughout the heavily affected areas (Figures 8 and 9). Columns were typically cast after the masonry wall was built, flush with the wall, and thus the same width as a brick or block (10 or 11 cm). Smooth reinforcing steel was common, typically 6 or 8mm in diameter with stir-

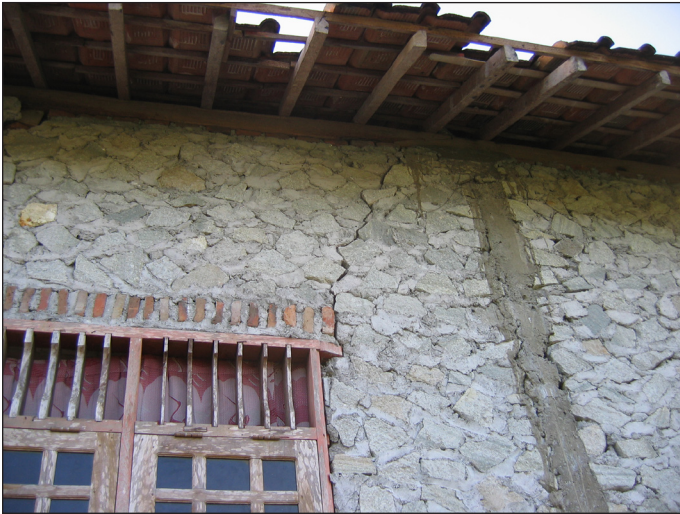
Figure 9. Partially confined stone masonry house with timber ring beam, Platar Somopuro, Jokonalan (Klaten) (S7.75478°, E110.53557°).

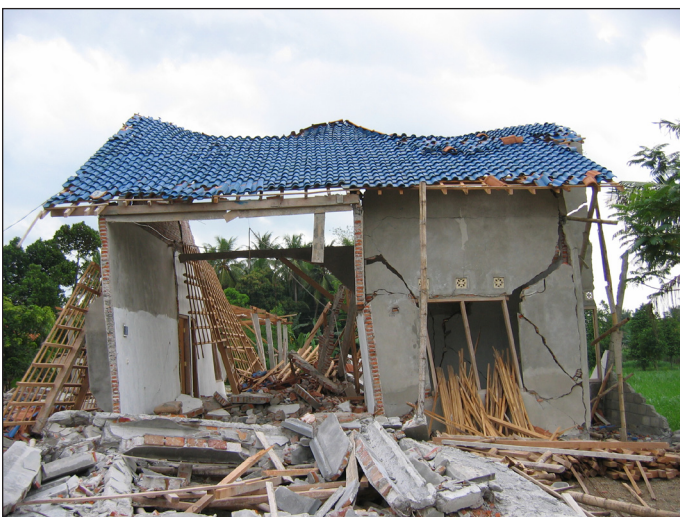
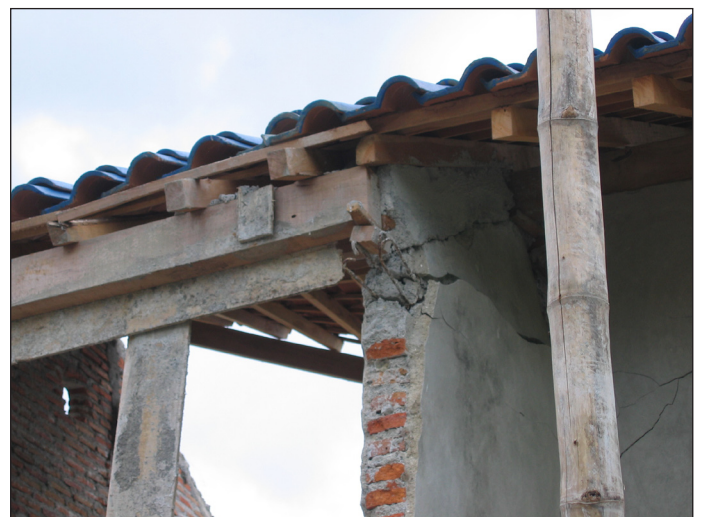
1) Insufficient connections between reinforced concrete tie columns and bond beams, and between tie columns and masonry walls (Figure 11). Typical reinforcement in the heavily damaged houses terminates in the joint with a poorly made hook.

Figure 11. (left) Confined masonry house under construction, insufficient connections, and (right) zoom-in view of ring beam-column connection, Pleret (Bantul) (S7.87574°, E110.40703°).

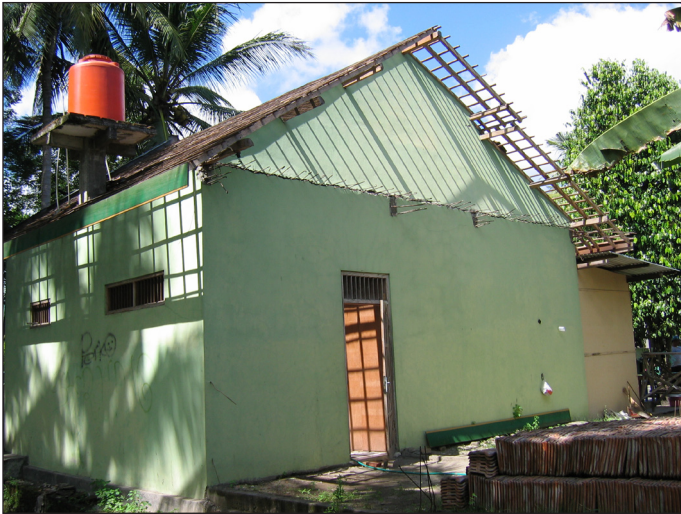
Figure 12. Masonry gable wall overturning, Keputren, Pleret (Bantul) ($S7.86905^{\circ}$ $E110.40272^{\circ}$).

2) Tall, slender poorly confined masonry walls. Newer houses use running bond for the masonry wall, resulting in a half-brick wide wall (13 cm with plaster, 10-11 cm without) that is often over 3 m tall. Gables add another 1–2 m to the height. Damage and failure to masonry gable walls were widespread throughout the affected region and plagued both new and older houses with and without reinforced concrete ring beams (Figure 12). In most cases, gable masonry was neither properly confined nor properly connected to the roof. Cross-bracing

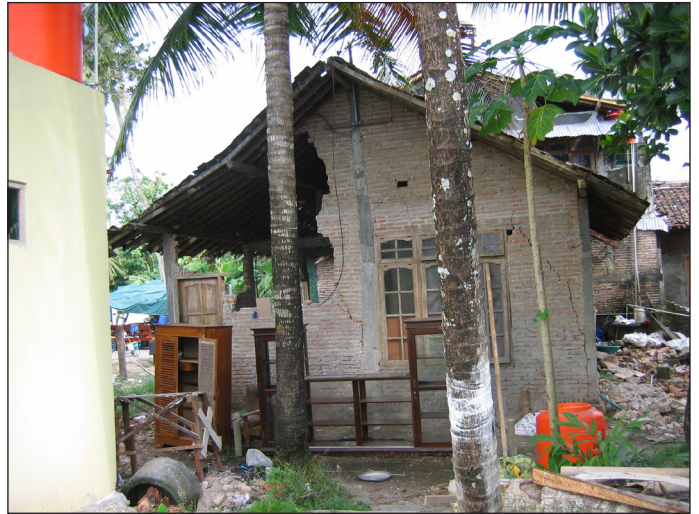
Figure 13. Collapse of masonry wall (note absence of reinforced concrete plinth and ring beams).

3) Absence of plinth beams and ring beams. Many newer houses had reinforced concrete tie columns but no reinforced concrete plinth or ring beams (Figure 13).

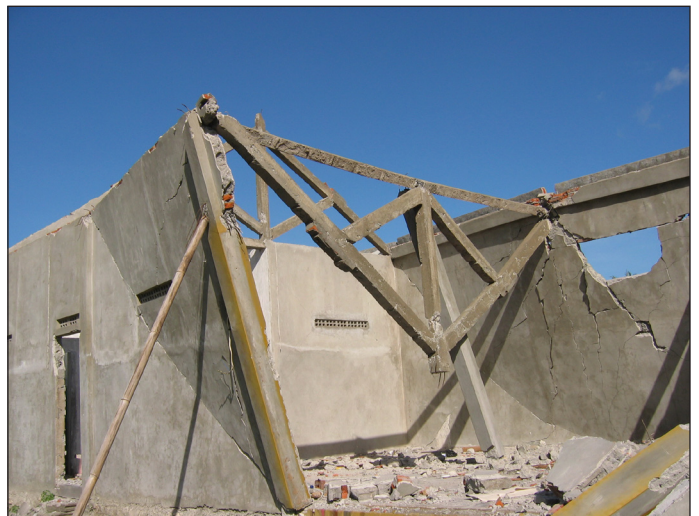
5) Use of reinforced concrete trusses. Reinforced concrete trusses were seen in a few of the houses, all of which had nonductile failures at the beam-column con-

Figure 15. House/shop with reinforced concrete truss, Bebekan Mulyodadi, Bambang Lipuro (Bantul) ($S7.93460^{\circ}$ $E110.32194^{\circ}$).

nections (Figure 15). These single-story buildings were mixed use: the rear part was used for storage or living area, and the front for a shop. The front was typically an open frame (no shear wall).

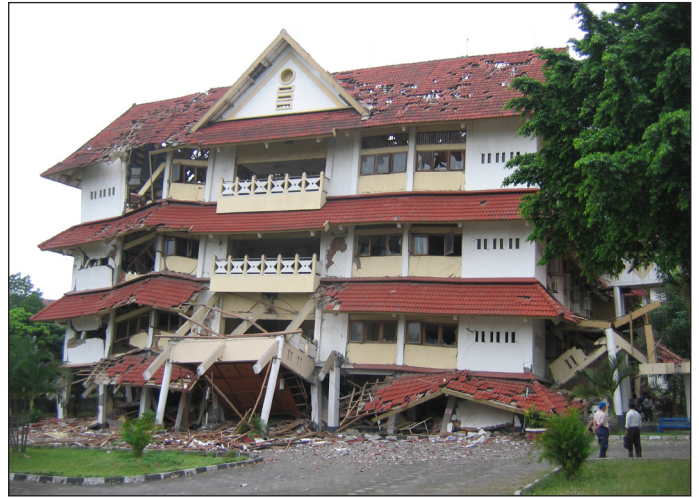
Figure 17. First floor collapse of building on STIE Campus, Yogyakarta ($S7.82733^{\circ}$ $E110.36789^{\circ}$) (photo Chavez)

Several buildings on the STIE (Sekolah Tinggi Ilmu Ekonomi) University campus were severely damaged. One building partially collapsed (Figure 17) due to poor detailing, insufficient splicing length, and insufficient spacing and number of ties. In addition, there was brittle failure of columns at the first floor (Figure 18), and the infill created vulnerable short columns at the second floor.

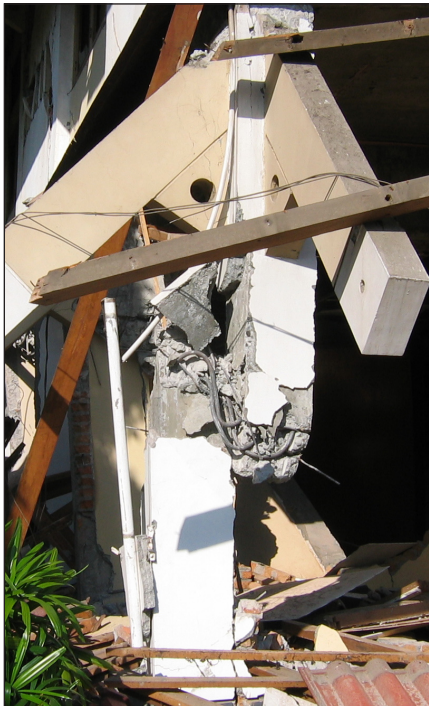
Figure 18. Brittle failure of columns at the first floor of the STIE building, Yogyakarta (S7.82733° E110.36789°) (photo Chavez).

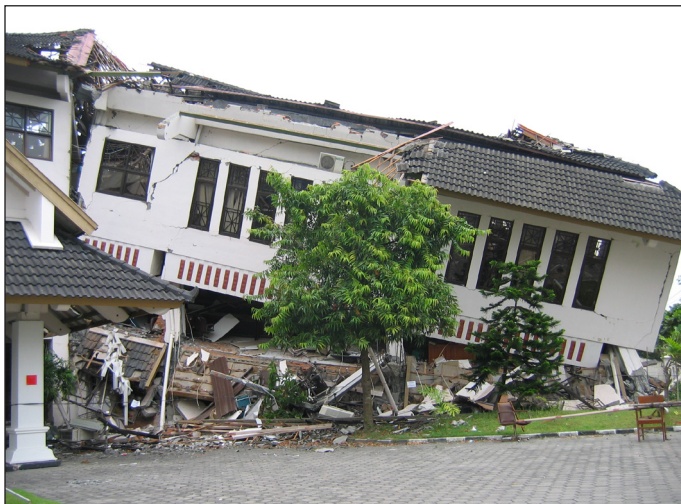
The south wing of the BPKP (Badan Pengawasan Keuangan Dan Pembangunan: Indonesian Finance and Development Committee) governmental building collapsed due to poor detailing and insufficient confinement reinforcement (Figure 19). Flexural hinging of the columns near the joint led to buckling of longitudinal reinforcement. A soft story mechanism also appears to have contributed to the failure of this building.

Figure 19. Collapse of the south wing of the BPKP building, Yogyakarta (S7.84497° E110.36131°) (photo Chavez).

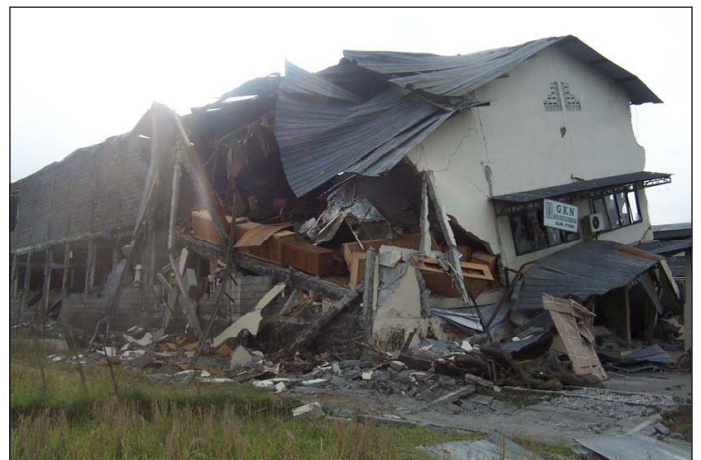
lapse. Figure 20 shows a two-story reinforced concrete furniture shop and warehouse, where concrete columns and concrete beams are used for the framing at the interior of the buildings. Unreinforced solid concrete block masonry confined by RC columns is used as the lateral

system at the exterior of the building. The concrete blocks and masonry work are of poor quality and not tied to the floor diaphragm, creating an incomplete load path. Once the exterior URM walls failed, only slender columns were left to support the building.

Figure 20. Collapse of a two-story RC frame building. Unreinforced masonry concrete block is the main lateral resisting system, Baturetno (S7.84450° E110.41048°) (photo Chavez).
