Learning from Earthquakes

Preliminary Observations on the Niigata Ken Chuetsu, Japan, Earthquake of October 23, 2004

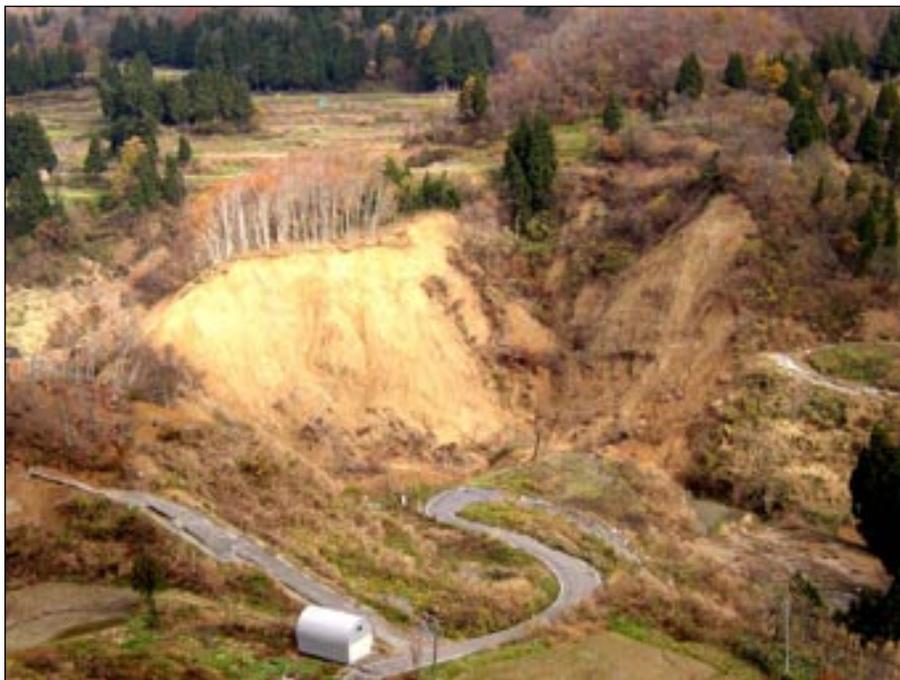
The most widespread type of observed failure consisted of translational slip of the regolith and highly weathered bedrock materials on very steep slopes flanking floodplains and along incised river and creek channels. This type of failure generally involves the upper 5-10 feet of soil, and slip appears generally to be concentrated along the interface between significant root growth and underlying highly weathered bedrock. Examples of this type of failure are shown in Figure 4.

Figure 4. North-facing valley wall with extensive translational soil sliding into valley bottom, Yamakoshi epicentral area (photo: K. Kelson).

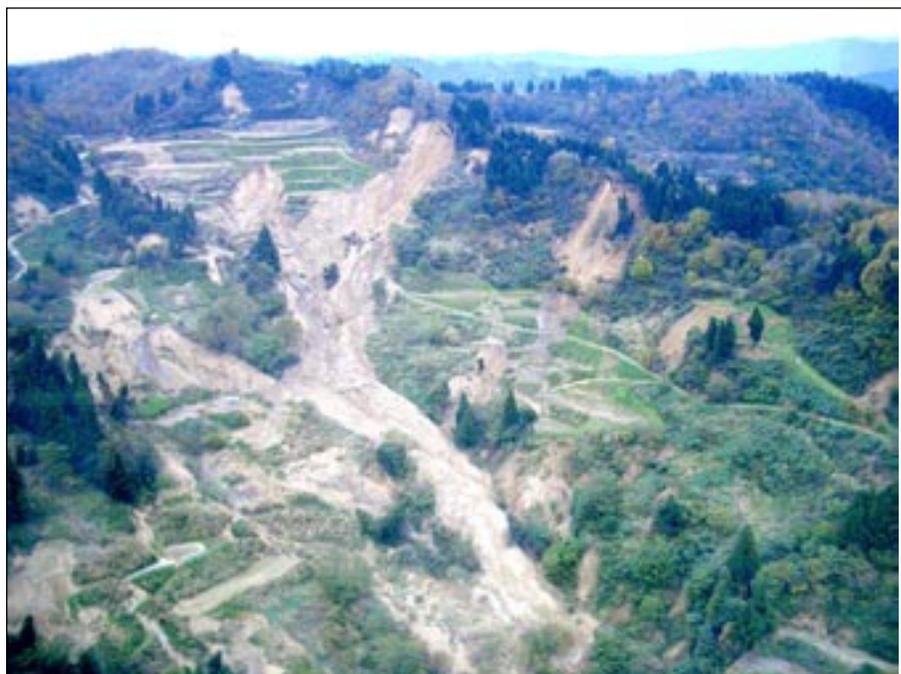
Figure 5. Typical debris flow, exhibiting a narrow path and long runout (photo: S. Kieffer).

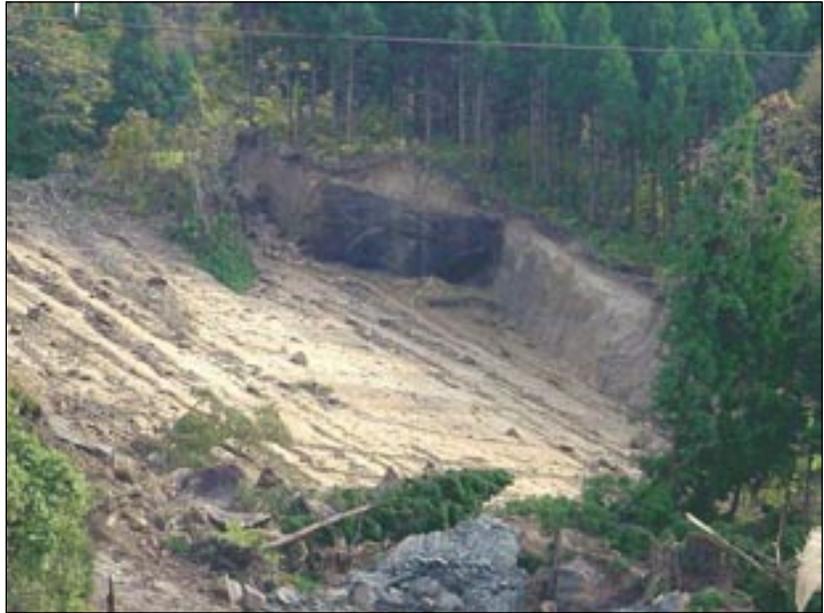
(negative impression) of the block is defined by a bedding surface dipping at about 30° toward the free face of the slope, along with vertical joint release surfaces intersecting the right side of the bedding plane. The overlying block of bedrock traveled on the order of 100-150 feet, riding over the valley floor. This failure occurred along a hogback ridge, and bedding plane slides of similar or larger size were observed at several locations along the hogback.

A classic example of a block slide can be seen in Figure 7. The mould

Figure 7. Block slide formed by bedding plane (sliding surface) and two sets of vertical joint release surfaces (photo: S. Kieffer).

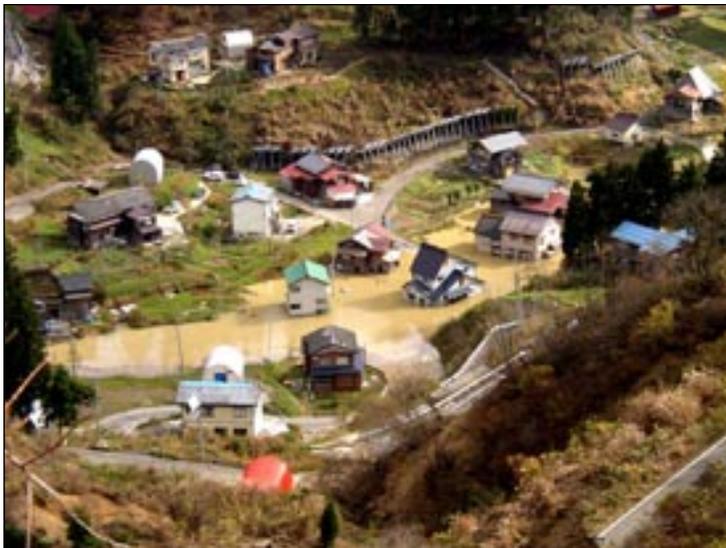
These events have already resulted in the flooding of villages and infrastructure (Figure 6), and there is potential for large sudden floods to initiate if the landslide dams are breached in an uncontrolled manner.

Figure 6. Inundation of homes upstream of landslide dam (photo: K. Kelson).

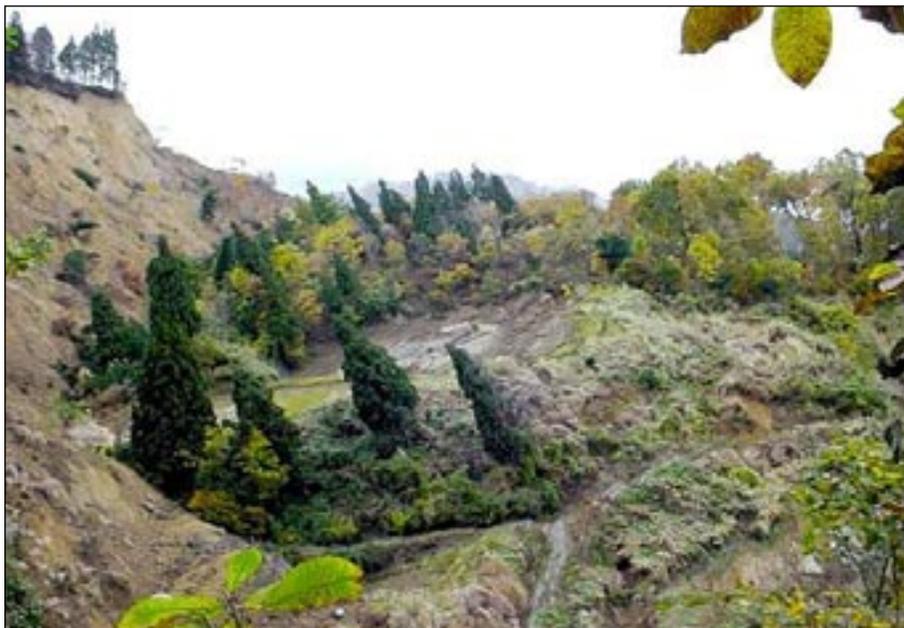
Figure 8 shows a deep rotational slide, as evidenced by a block of back-rotated trees and agricultural land bordering an approximately 100-foot high headscarp to the left. Farther downslope, similar back-rotated blocks were observed, and the estimated maximum depth of the sliding surface is on the order of several hundred feet.

Figure 8. Deep rotational slump, indicated by a block of back-rotated trees and agricultural land, beneath an approximately 100 foot high headscarp (photo: S. Kieffer).

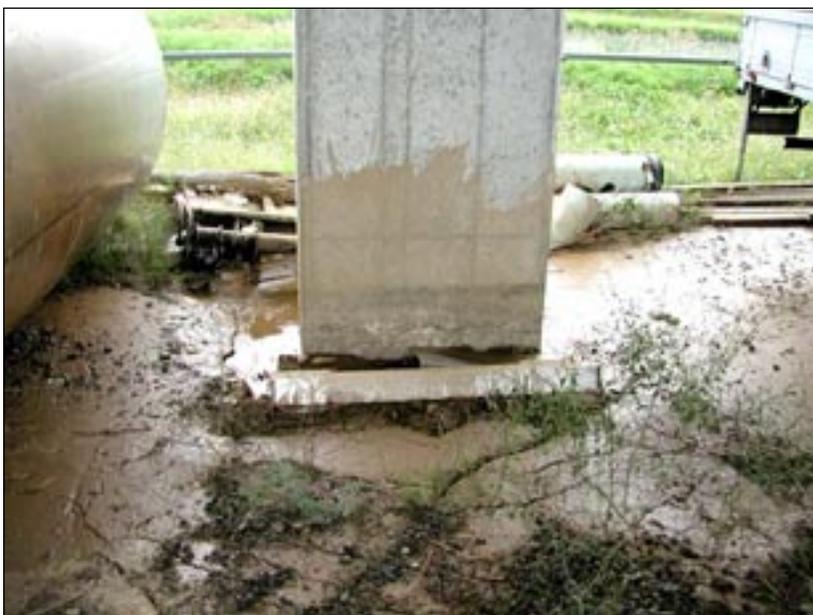
Figure 9. Sand boils at the derailing site of the Johetsu Shinkansen (Oct. 25) (photo: K. Kiyono).

tion of elevated, level viaduct through rice farms. The viaduct, constructed in the 1970s, is composed of several different types of segments with varying heights and section design, some of which were damaged in the earthquake. Ground cracking, ground settlement, and signs of significant soil softening were observed at many locations along the viaduct (Figure 9).

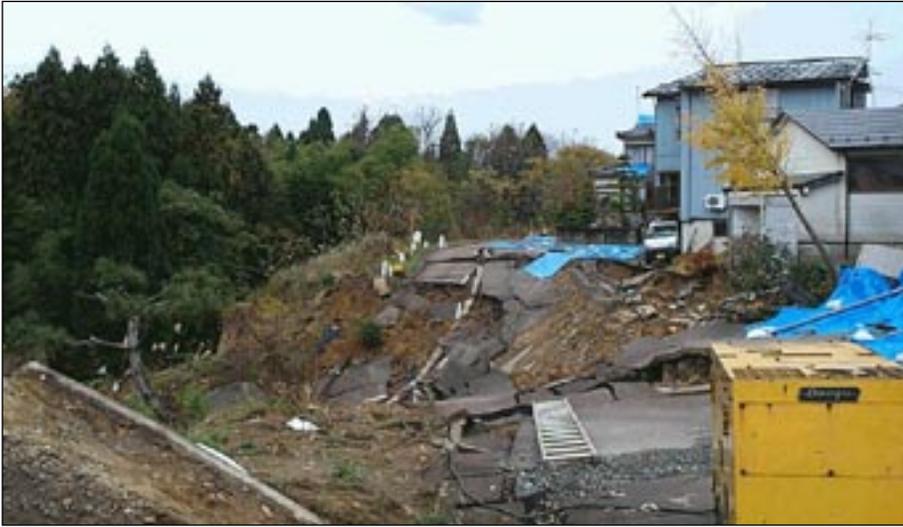
Hillside fills: The hillside residential area of Takamashi, located on the eastern edge of Nagaoka, experienced significant slope failures during the earthquake. Takamashi is located on a natural hill at the edge of the Shinano valley and the native soil consists of early Pleistocene sand and silt. It is assumed that the area was constructed by cutting the top of the hillside and using this material as fill along the edges. In most places, the fill was confined by a 4-m high rigid, concrete retaining wall. Four large sections of retaining wall failed catastrophically, with the soil sliding a significant distance downslope. Figure 10 shows one of the large failures, extending across the road and close to the adjacent homes. Four segments of the concrete retaining wall translated significantly during the earthquake,

Figure 10. Failure of hillside fill in Takamachi residential area (photo: E. Rathje).

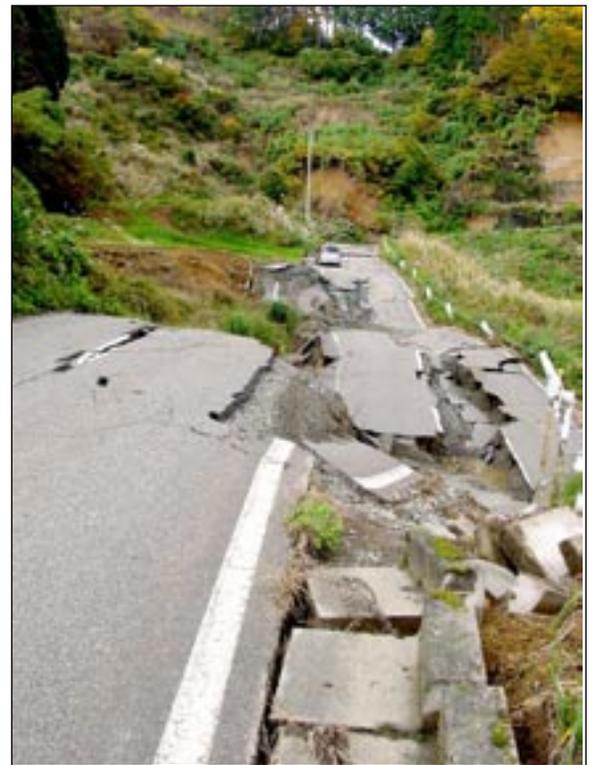
at over 6,000 locations throughout the region. Virtually all roads in the Uonoma Hills were cut by landslides (Figure 11) and many pavements in the lowland areas were disrupted by floating manholes, settlements at culverts and bridge abutments, and general disruption of the paved surface.

Figure 11. Damage to road in Uonoma Hills. Note abandoned car in distance (photo: J.P. Bardet).

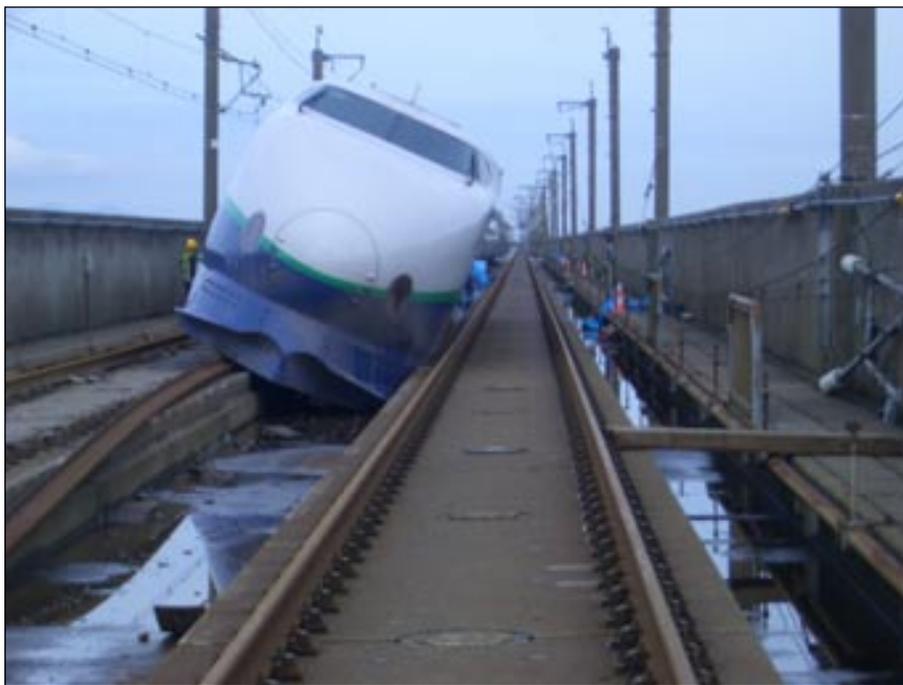
Figure 12. Derailed Shinkansen (Oct. 31) (photo: C. Scawthorn).

Railroads: There was extensive damage to roadbeds caused by ground failures. Significant damage was observed on the Shinkansen elevated viaduct, as well as on some local railway lines, but all appeared to be repairable. The Joetsu Shinkansen line carries 360,000 passengers per day, and was scheduled to restore service on December 28, 2004. A northbound Shinkansen train derailed just south of Nagaoka City (Figure 12). As the train traveling over 200 km/hr was exiting a tunnel, the driver felt the earthquake and applied the brakes. The train passed under a 300-m-long covered section, and began to derail along a viaduct, approximately 500 m from the exit of the tunnel. The train engine came to rest approximately 1.9 km from the tunnel exit, taking over 1.5 km to stop. There were no reported injuries as a result of the derailment, which occurred entirely along a straight sec-

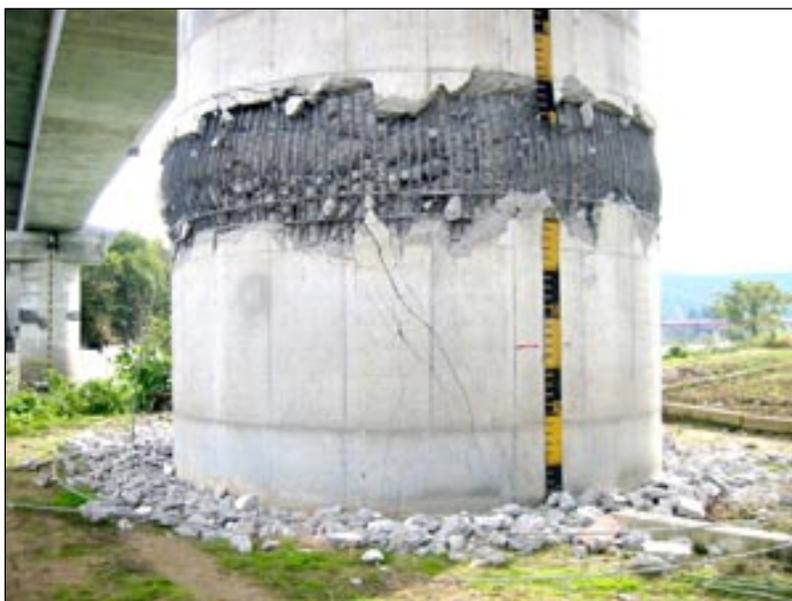
In the town of Kawaguchi, the Joetsu Shinkansen railway bridge was damaged. Piers supporting the Wanazu Bridge over the Uono River suffered a flexural failure due to a reinforcement discontinuity, as shown in Figure 13. Several columns of a viaduct section just south of the bridge also failed. Repairs were underway at both locations by the end of the team's time in the area. Tracks of the JR Joetsu Line were also damaged due to minor fill settlement in the Wanazu area. In Kawaguchi, rails were buckled in numerous locations, and several plain concrete piers of the JR Iiyama Line were damaged, while the superstructure remained intact.

Figure 13. Damaged piers of Joetsu Shinkansen Wanazu Bridge (Nov. 1) (photo: S. Ashford).

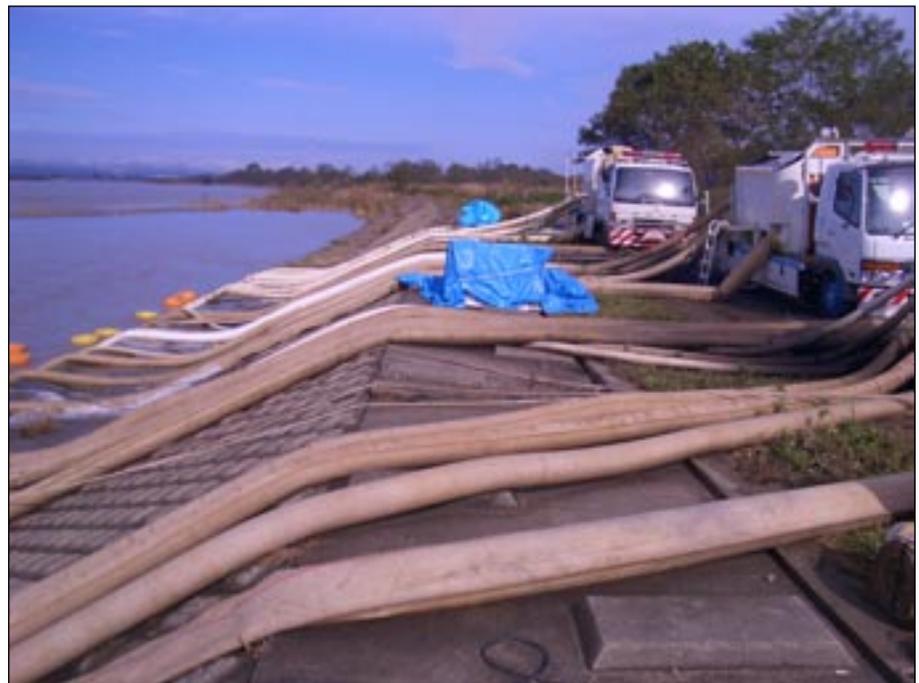
Nagaoka City receives its water from the Shinano River, upstream of the city. Water level in the river is raised by lowering gates across the river, and water is diverted into a pipe that carries the water to a treatment plant downstream of the gates. The earthquake disrupted power to the gates and also caused some damage to the wire rope machinery used to raise the gates, so the gates could not be lowered and the treatment plant received no water. As a result, the plant had to resort to emergency drafting from the Shinano River (Figure 14).

Figure 14. Emergency drafting of water from Shinano River for Nagaoka City Water Treatment Plant (photo: C. Scawthorn).

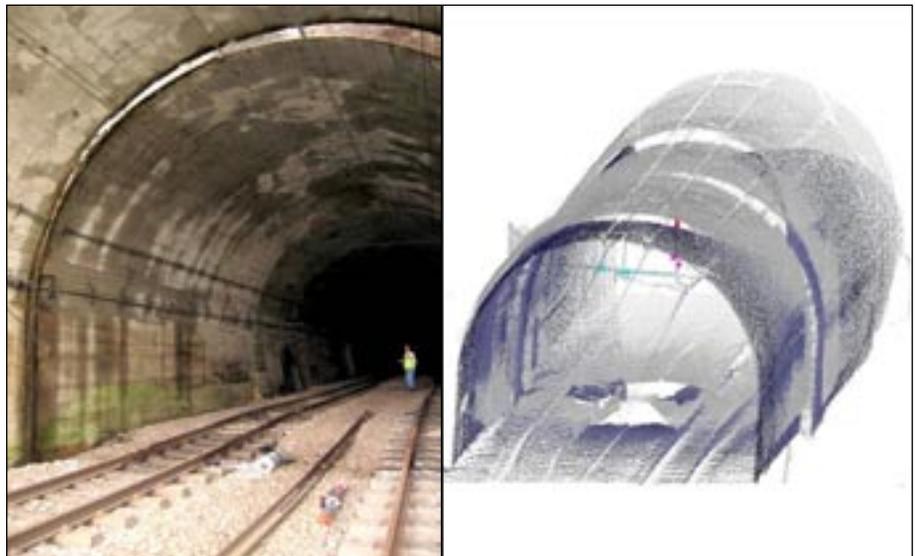
An example of structural damage captured by the USGS LiDAR unit is presented in Figure 16, collected in the damaged portal of the Juetsu railroad tunnel, north of Horinouchi town. The portal is founded on a poorly compacted embankment fill that failed during the earthquake. The portal pulled away from the tunnel, settling vertically, sliding downslope, and rotating. In the photograph, the offset in the portal can be seen along the left wall of the tunnel, and the rotation can be seen in the ceiling. An oblique view of the LiDAR point-cloud data can be seen on the right. The left-lateral offset in the portal is clearly visible in the LiDAR model. In the LiDAR imagery, precise centimeter-scale measurements can be made of the three-dimensional deformation of the structure.

Figure 16. Photograph (left) and LiDAR image (right) of damage to the Juetsu Railroad portal at Kita-Horinouchi from the portal entrance. Lateral displacement of the portal in the photo is visible and measurable in the LiDAR scan. (Source: R. Kayen)
