## Learning from Earthquakes

# Preliminary Observations on the Al Hoceima, Morocco, Earthquake of February 24, 2004

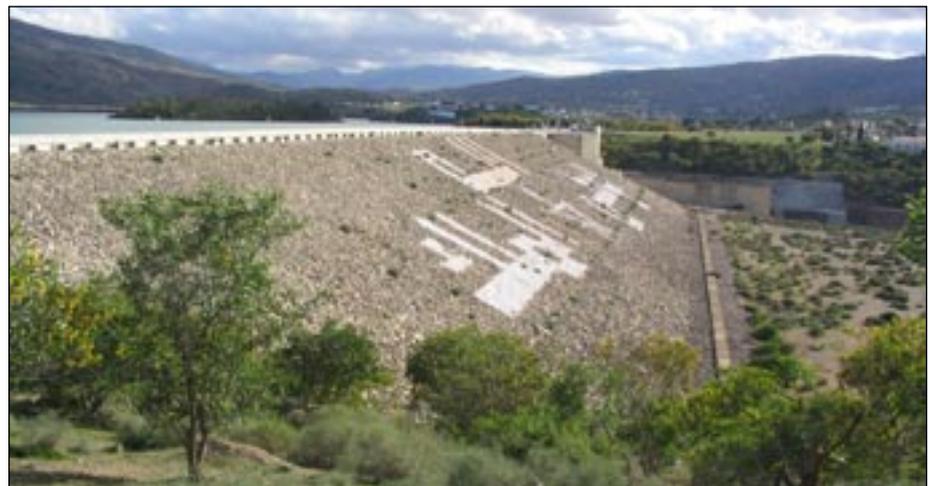
**Figure 2.** Post-earthquake view of the El Khattabi dam from right abutment (near the strong-motion instrument) (photo: Youd).

The only earthquake-related effects noted were two small transverse cracks in the asphalt-paved roadway surface on the crest of the dam. The southerly crack was approximately above the contact between the eastern edge of a buried concrete slab in the spillway structure and above the southern contact between bedrock on which the spillway structure is founded and the valley alluvium on which most of the embankment section is founded. The northern transverse crack was similarly located approximately above the contact between valley alluvium and bedrock contact beneath the northern

part of the embankment. Neither crack was wider than a few millimeters. The cracks were caused either by differential response of the embankment to ground shaking, or by slight settlement within the valley alluvium or possibly within the embankment. A re-survey of benchmarks on the crest of the dam indicates that as much as 10 mm of settlement occurred between the two cracks during the earthquake. The cracks were assessed as superficial and insignificant with respect to the performance and safety of the dam.

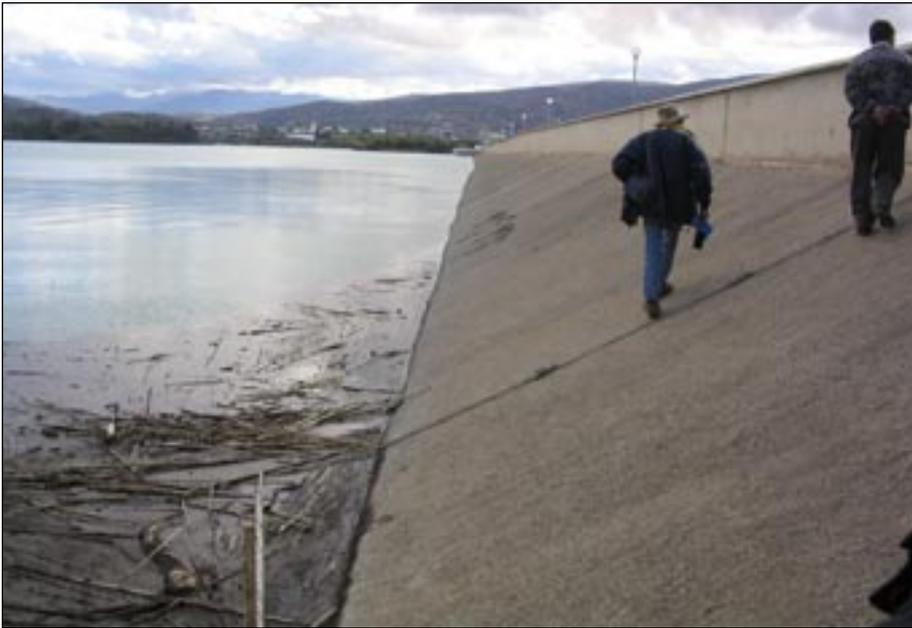
**Figure 3.** View of reinforced concrete face of the El Khattabi Dam from right abutment (photo: Youd).

The exposed reinforced concrete face of the dam was also examined. The reservoir was at its maximum operating level at both the time of the earthquake and the time of the visit, so only the upper 3 m of the face was exposed. There was no visible distress to the concrete slabs or the joints between the slabs. The lack of damage to the exposed face is an indicator that the submerged face was also undamaged. Had there been significant damage to the concrete face or to the junction between the face and the underlying slurry-trench cutoff wall, leakage through the dam would have increased, but the operator of the dam reported no increase of leakage.

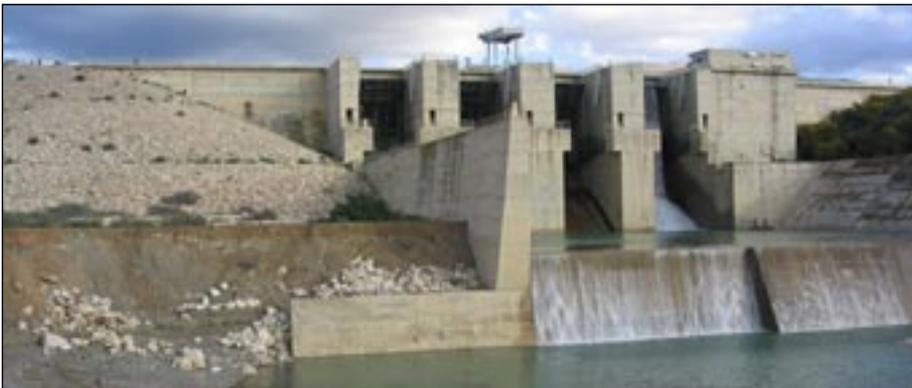
**Figure 4.** Junction between gravel embankment and concrete gravity sections of the El Khattabi dam (photo: Youd).

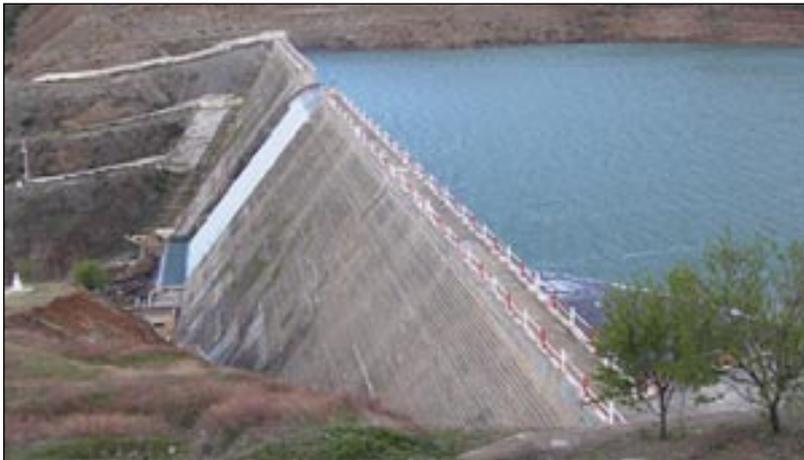
A 60-m-high roller-compacted-concrete (RCC) dam (Figure 6), located almost 30 km (straight line) southwest of the epicenter, was also inspected. This dam, which has been operational since 1990, contained a full reservoir at the time of the earthquake, with water flowing over the spillway structure. A close inspection of this structure revealed no observable damage, not even minor cracks.

**Figure 6.** Joumoua Dam, a roller-compacted concrete structure completed in 1990, was undamaged by earthquake shaking (photo: Chraïbi).

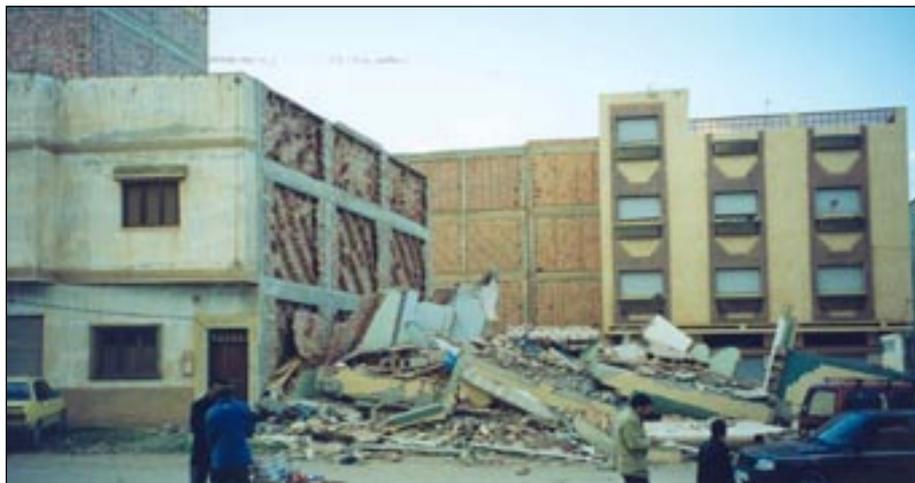
**Figure 7** Collapsed building in foreground and undamaged buildings with typical construction in background (photo: Youd).

Newspaper reports indicate that approximately 40 residential buildings collapsed during the earthquake. Many additional buildings were cracked and structurally damaged to varying degrees (Figures 7-8). Collapsed and seriously damaged buildings represent only a small fraction of the total building stock, but they were the primary cause of the 622 reported casualties. No serious fires were ignited by the earthquake. The destruction caused much distress among the local population, with many people choosing to sleep in tents or other temporary shelters rather than return to their homes, damaged or undamaged.

Inspections were being made at the time of the visit to assess the damage state and safety of each building. Unsafe buildings were marked with a spray-painted red X (Figure 7). Governmental programs were being prepared to repair or replace damaged or collapsed buildings.

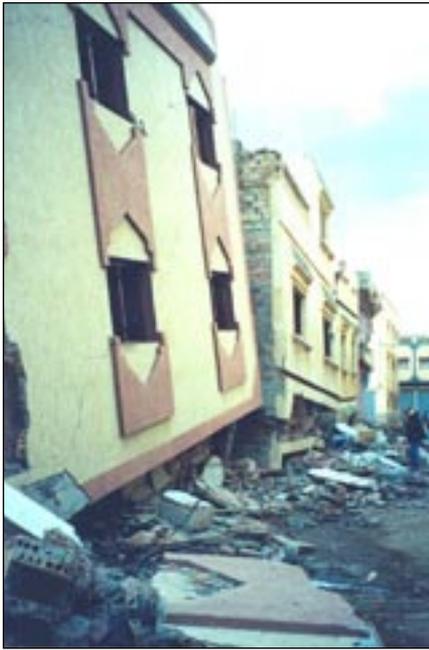
**Figure 8.** First-story collapse of several buildings (photo: Youd).
