## Learning from Earthquakes

# Preliminary Observations on the Southern Peru Earthquake of June 23, 2001

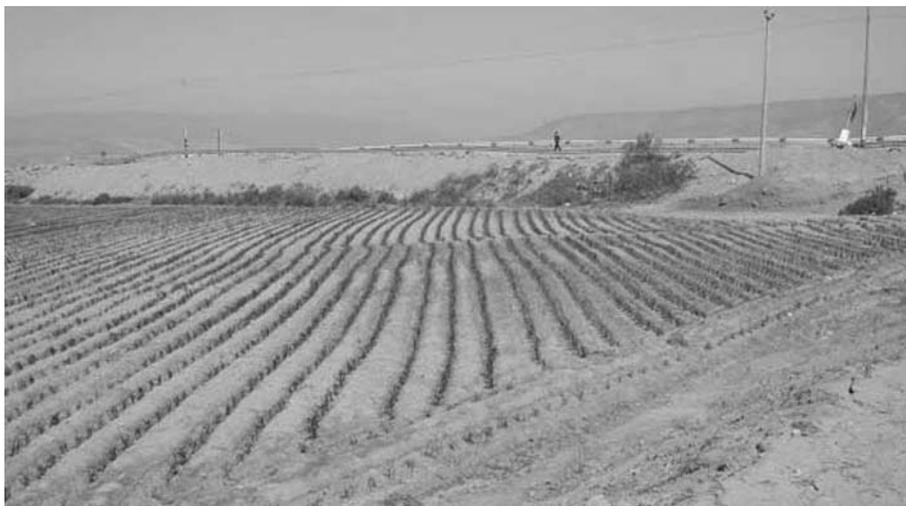
Liquefaction was observed at three bridge sites located in alluvial valleys. In one instance, liquefaction-induced lateral spread severely damaged a concrete bridge and several residences located along the banks of a river (Figure 4). At another site, liquefaction caused a

**Figure 4** The offset in the corn rows (left to right near middle of photo) is due to localized displacement induced by lateral spread. (photo: geotechnical reconnaissance team)

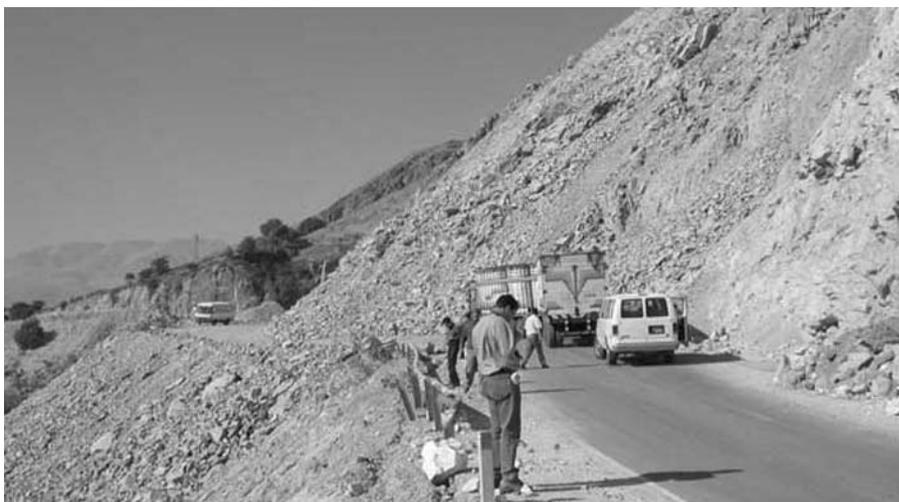
Landslides and slope stability failures occurred at localized cut and fill sections along highways (Figure 5). In most cases, slope movements in the fill section were due to fill densification. Rockfalls were observed along many of the steep road cuts in the region. Observed rockfalls ranged from single-block failures to raveling of both bedrock and the exposed colluvial material. Some planar and wedge failures within the bedrock were also observed. Natural slopes composed of bedrock or colluvium had very little observed failure, with the exception of displacements of a shallow veneer of soil in sandy slopes.

**Figure 5** Slope failure along highway between Cuajone and Moquegua. (photo: geotechnical reconnaissance team)

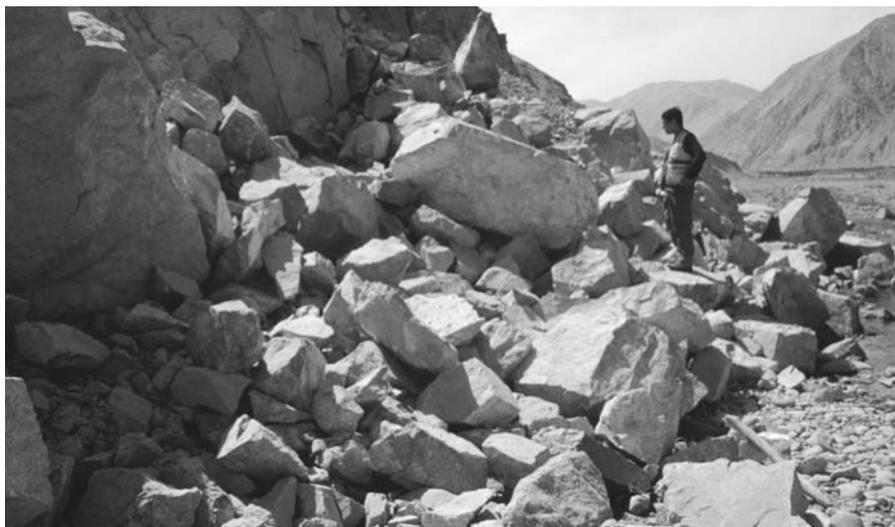
**Figure 6** Typical rock fall from wall of lower Ilo Valley near Algarrobal. (photo: David K. Keefer)

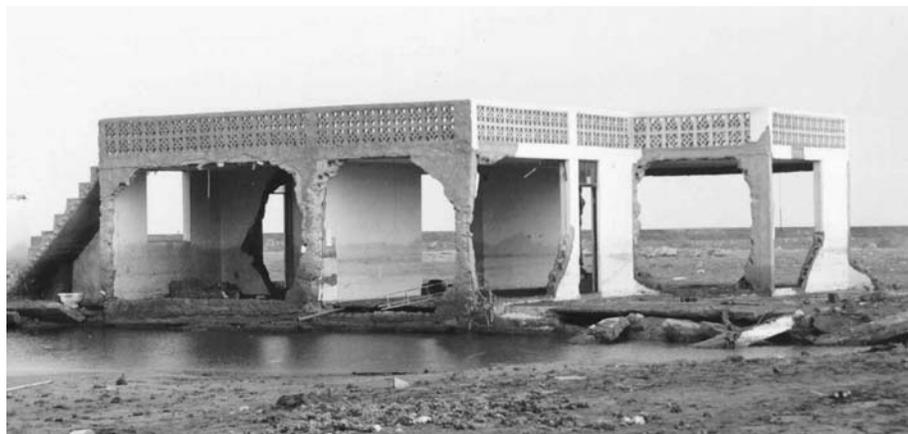
**Figure 8** Reinforced column/infilled brick wall structure in the La Punta area. Brick walls perpendicular to wave impact were typically blown out. (photo: Sebastian Araya)

formed very poorly. No signs of adobe structures remained. Infilled walls were typically blown out on walls perpendicular to the wave direction (Figure 8). Significant scour occurred to structures at the corners, often undermining the slab foundations. Reinforced concrete structures with thicker foundations were most likely to survive.

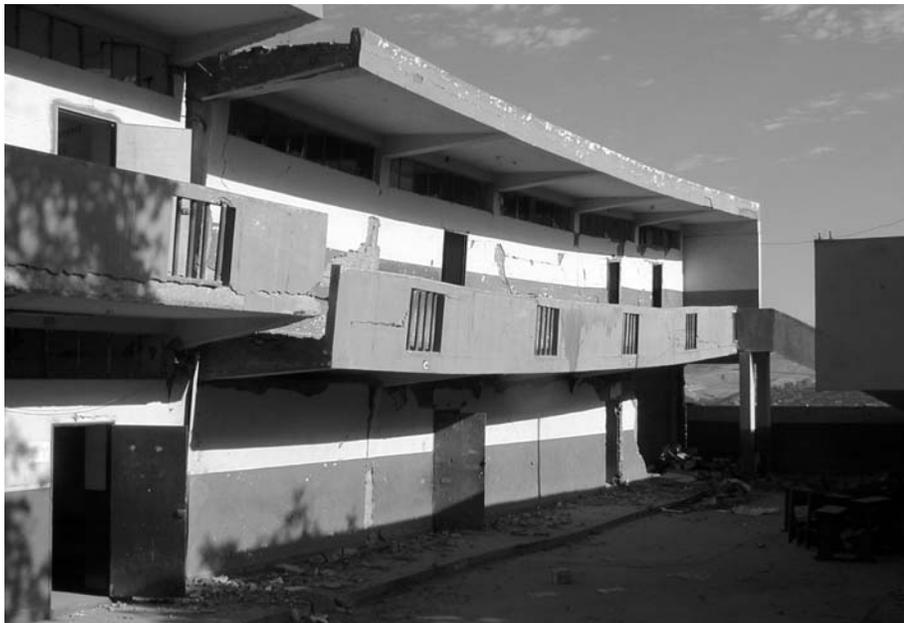
**Figure 9** School building in Moquegua. Partial collapse due to failure of short columns. (Photo: E. Fierro)

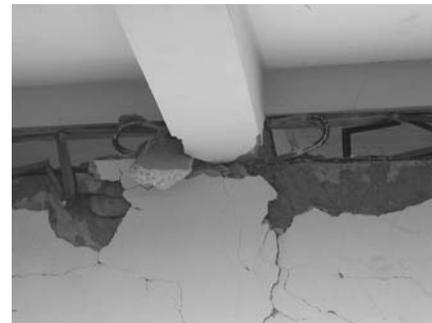
**Figure 10** View of the collapse of one of the short columns in the school building shown in Figure 9. (Photo: E. Fierro)

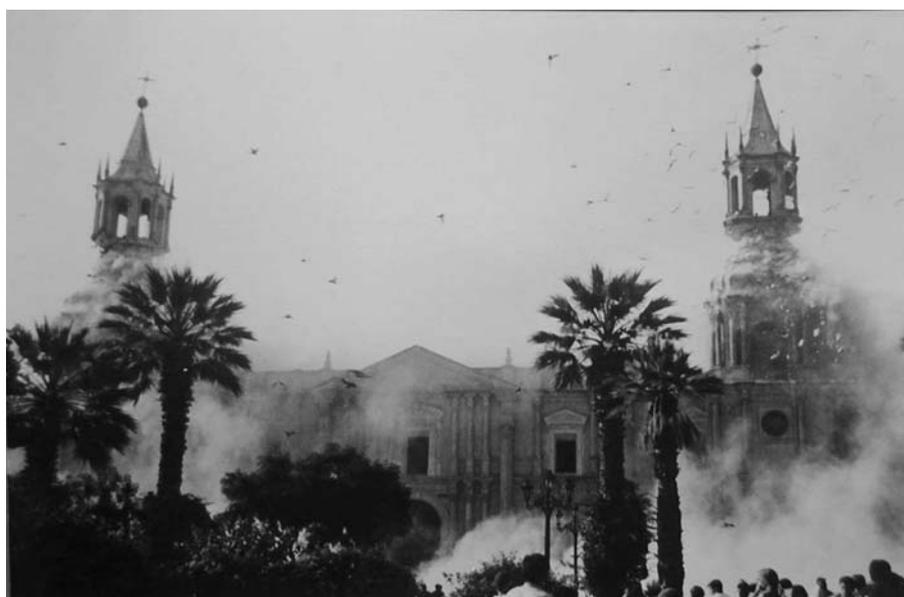
The city's historic cathedral, built in 1612, sustained heavy damage, mainly due to the collapse of one of its towers. The cathedral is situated on the Plaza de Armas in Arequipa's historic center, a UNESCO World Heritage site. It was damaged by previous earthquakes and fire, and was substantially rebuilt in the 19th century. Both towers were apparently rebuilt most recently in about 1940. A photo extracted from a video taken during the earthquake shows part of the collapse sequence of the tower (Figure 11). The tower on the left collapsed and fell through the vaulted dome above the main altar of the cathedral.

**Figure 11** Cathedral of Arequipa, still photo from sequence taken during main event. (photo purchased by E. Fierro)

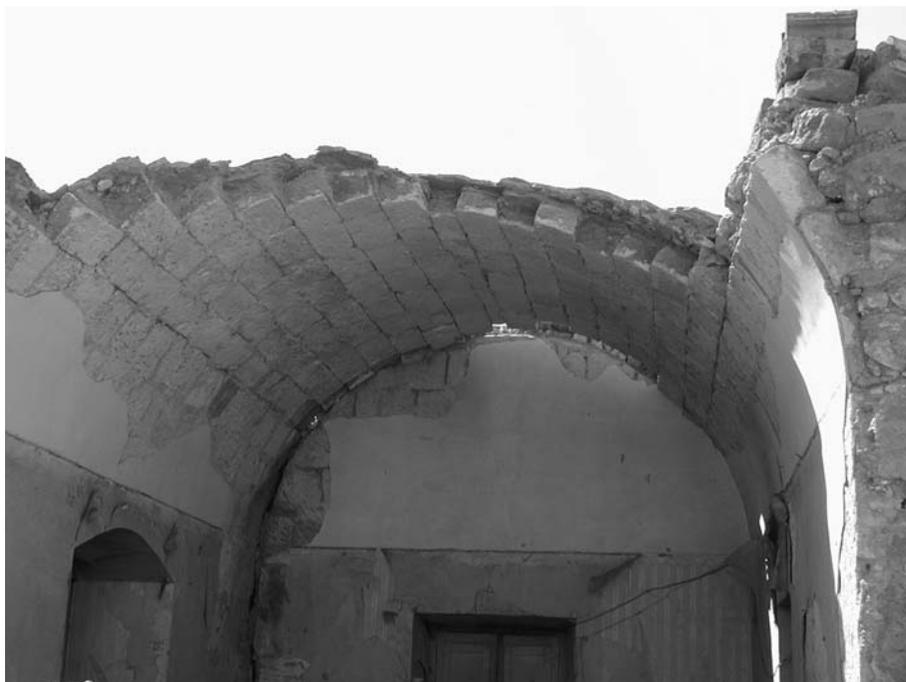
founded in 1579. Many traditional domed and vaulted structures were extensively damaged. Most of the historical monuments are made with blocks of sillar (consolidated volcanic ash) laid with lime or cement mortar. Sillar is also used for housing. A damaged vaulted ceiling in an older home is shown in Figure 12. Many of the older roofs were made

**Figure 12** Damage to typical historic dwelling with vaulted roof constructed of "sillar" blocks. (Photo: E. Fierro)

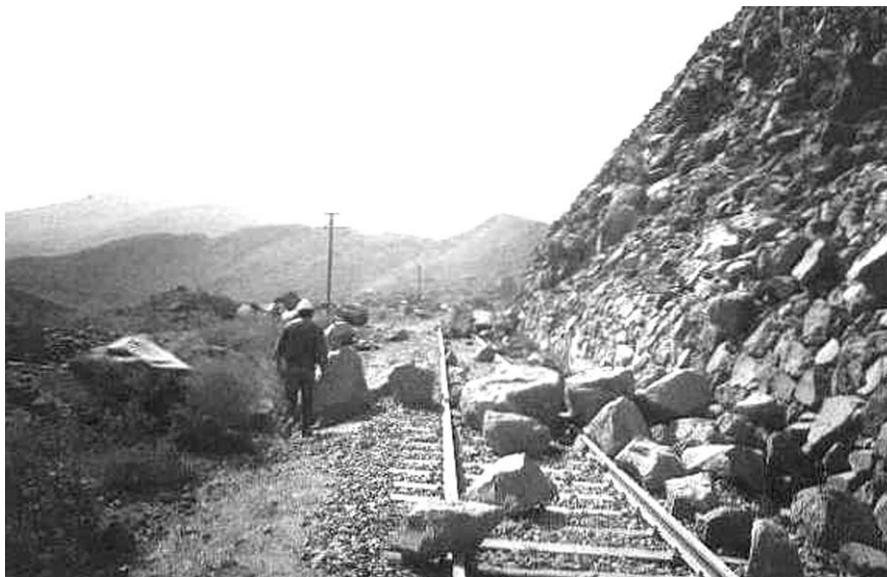
**Railroads:** The railroads of Peru do not constitute a network, but include separate entities not physically connected. Two of these sustained extensive damage: PeruRail, a common carrier providing freight and passenger service; and the industrial railroad of the Southern Peru Copper Corporation, which transports copper concentrate from inland mines to a smelter and refinery on the coast, and supplies and equipment to the mines. Major line segments, with a combined length on the order of 700 km, were out of service for three to seven days. The most severe damage involved material sliding or falling onto the track, or embankment failures. In some cuts, track was buried under as much as 5 meters of material (Figure 13).

**Figure 13** Rock Fall Blocking PeruRail Line. (photo: PeruRail)

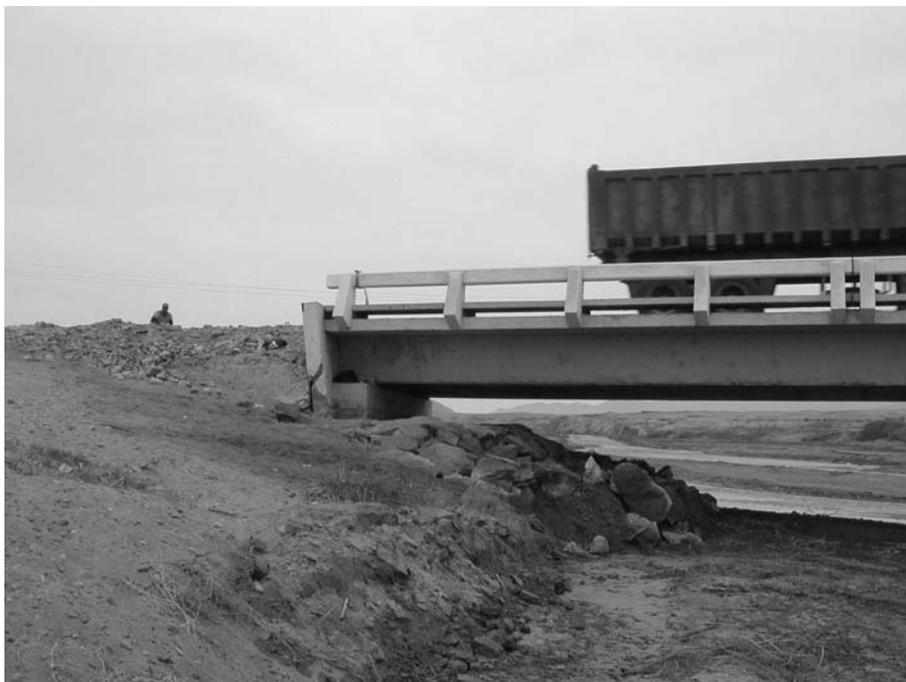
Highway structures such as bridges and culverts were also damaged due to the use of poorly compacted material around abutments and wingwalls. This resulted in subsidence of the bridge approaches. In addition, liquefaction caused failure of some wingwalls and approaches. Most bridges were in use 30 days later, but one older steel truss bridge was closed due to failure of bearing supports (Figure 14). Box culverts also performed poorly due to loosely compacted material. An 18'-by-40'-tall single-box culvert remained undamaged on the Pan-American Highway, but the roadway over the culvert settled several feet, and the wingwalls were shattered due to active pressure from the surrounding soil.

**Figure 14** *Damaged bridge abutment.* (photo: Yashinsky)

The severity of damage to the highway system can be reduced in the future by replacing weak fills along roads and highway structures with 90% compacted material. Slopes

above roads should be carefully inspected for loose material, which should be removed or draped to prevent future movement. Catchment walls should be constructed between slopes and roads to prevent falling rocks from impeding traffic.
