## Learning from Earthquakes

# Preliminary Observations on the Hawai'i Earthquakes of October 15, 2006

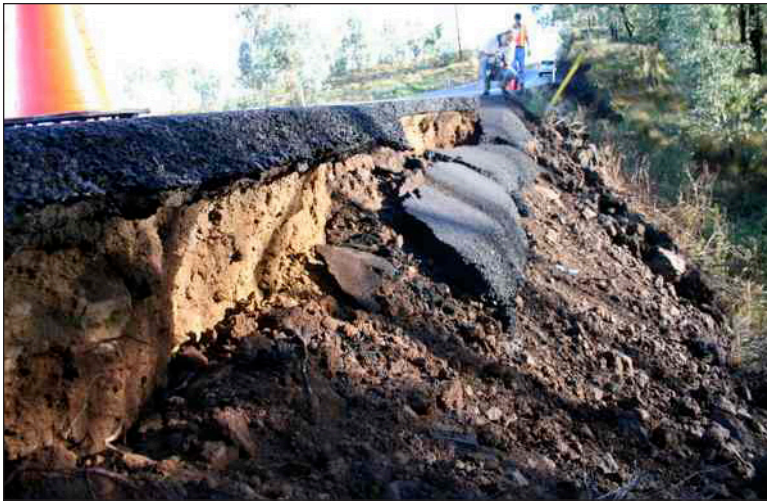
**Figure 4.**  
*Highway embankment failure.*

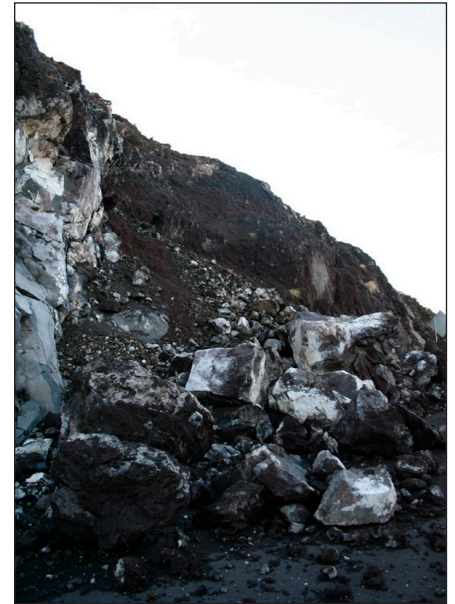
**Figure 5a.** *Rockfall typical at steep roadcuts.*

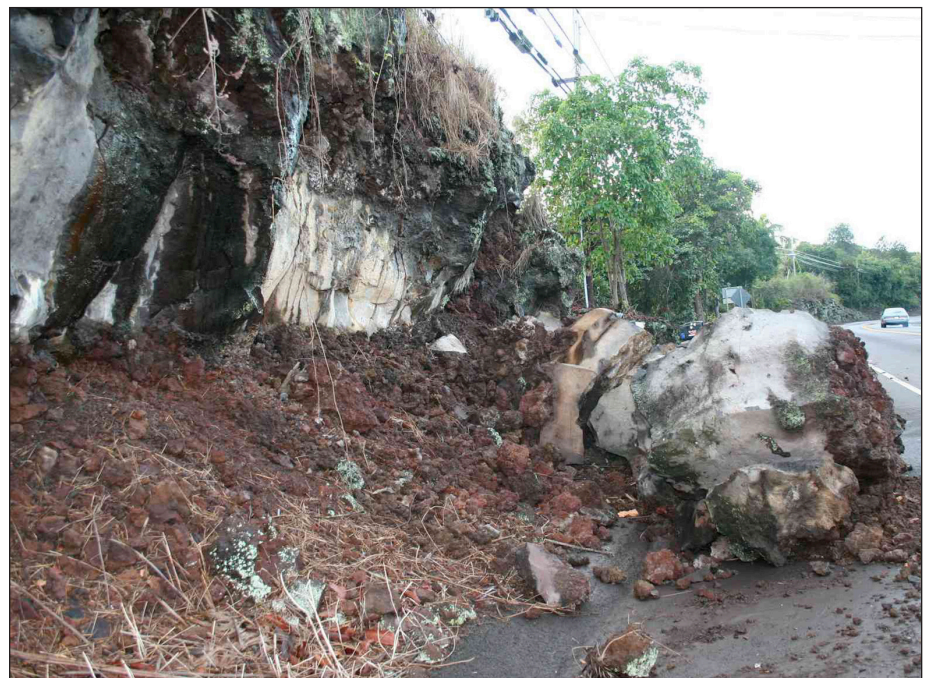
During the earthquakes, the loose *a'a* clinker raveled and removed support from overlying massive blocks (Figure 5b). The blocks can sustain significant cantilevers, influenced by the extent, spacing, and nature of the internal discontinuities, but many overhanging blocks failed during the earthquakes. In particular, large boulders fell where there was a noticeable layering of volcanic rock strata with dense, blocky basalt overlying more friable pyroclastic tuff, ash, and clinker. The underlying weaker layers typically consist of

**Figure 5b.** *Example of discontinuous geology where dense basalt rock overlies weaker, less stable clinker.*

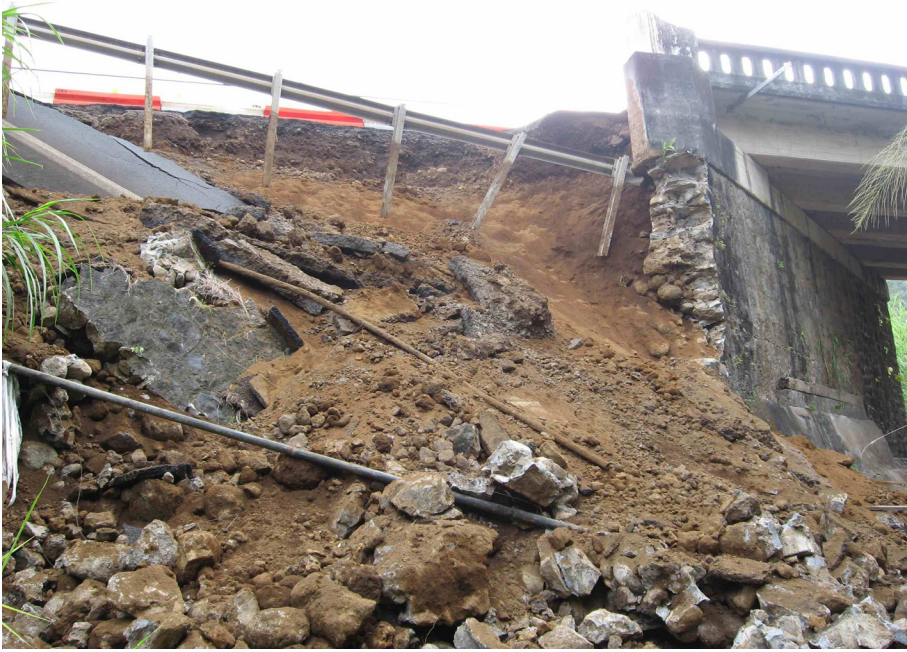
In one case, the failure of a highway embankment resulted in the collapse of a traffic lane on the approach to a bridge (Figure 6). For a number of hours after the earth-

**Figure 6.** Failure of bridge approach embankment on Highway 19 (photo: State of Hawaii Dept. of Transportation, Highways Division).

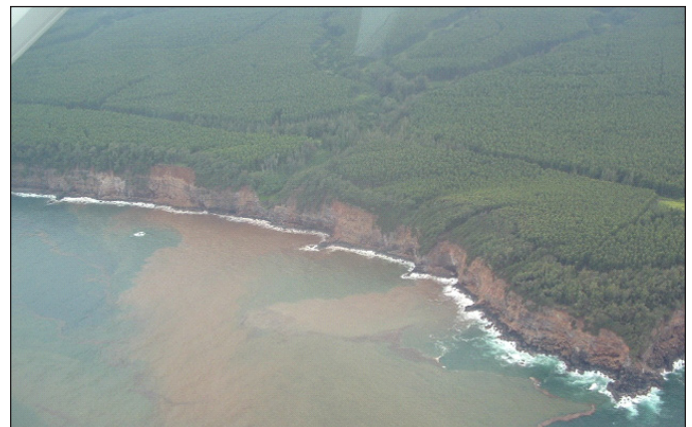
**Figure 7.** Massive coastal escarpment landslides into the ocean (photo: Hawai'i County Civil Defense Agency [HCDA]).

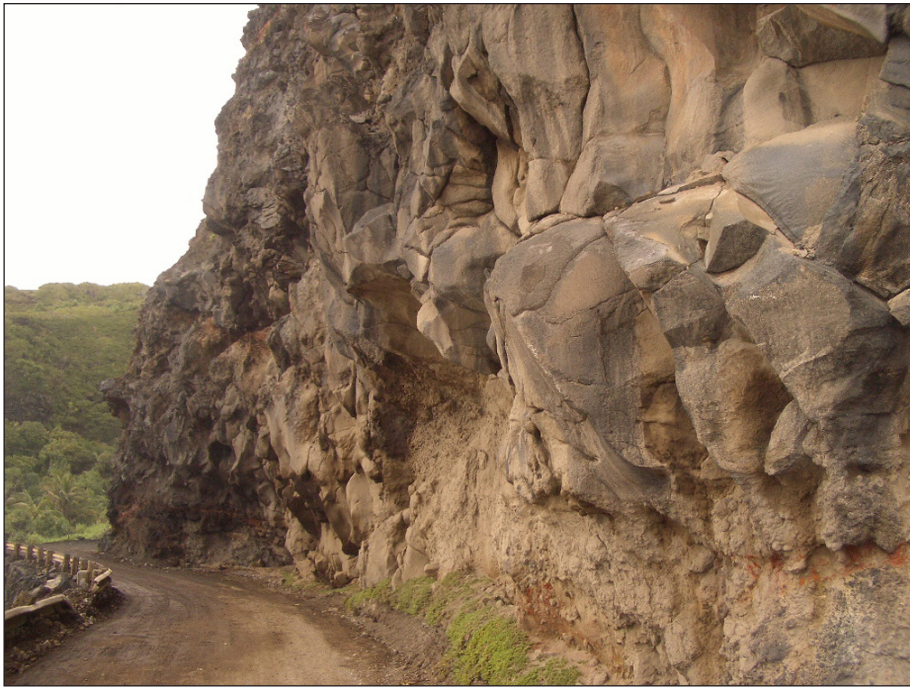
**Figure 8.** A potential rockfall area along Maui Highway 31 (photo: Maui CDA).

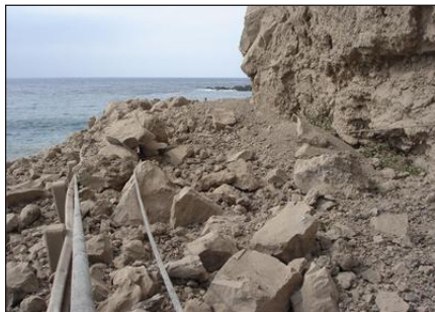
**Figure 9.** Maui rockfall near Kalepa cliffs (photo: Maui CDA).

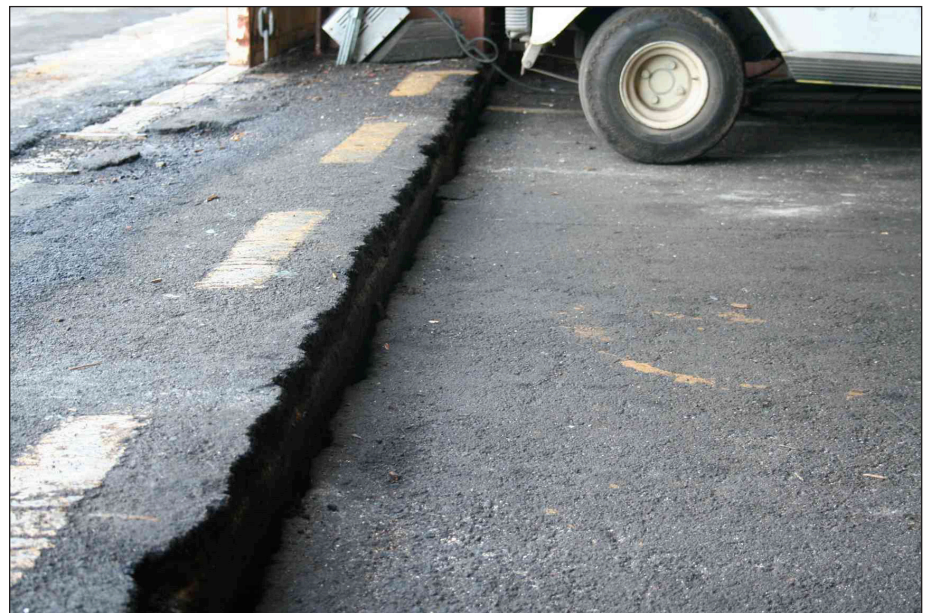
This movement indicates that the piles were moved and/or distressed by the lateral spreading of the liquefied soil beneath and landward of the pier. Gasoline and diesel fuel lines on the north end of Pier 2, supported from the undersides of the piers, were also damaged, and some had reportedly fallen from their hangars into the waters of the harbor. Three days after the earthquake, Pier 2B was opened, but Piers 1 and 2A remain closed indefinitely.

**Figure 10.** Liquefaction induced lateral and vertical displacements of approximately 6 inches at port facility, Kawaihae Harbor.

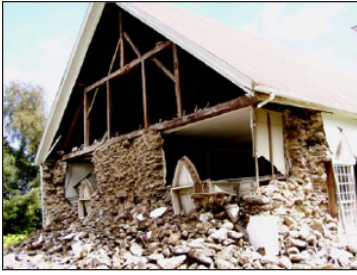
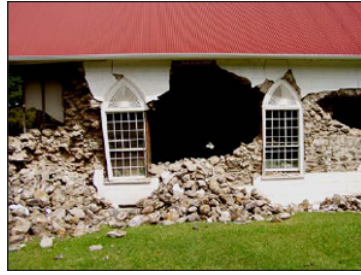
**Figure 11.**  
*Roof trusses supported by interior columns and window frames after wall collapse.*

The historic Kalahikiola Church in Hawi, North Kohala, suffered extensive damage to the exterior rock-masonry walls supporting the roof trusses (Figure 11). This 1855-vintage stone church was constructed with rough lava stone walls and a wood roof of “barn-type” construction having interior wood columns. The walls appeared to be approximately three feet thick, and the interior and exterior faces of the walls were covered with a plaster. The end wall fell outward due to a lack of lateral restraint; the two side walls failed similarly, but to a lesser degree. Total collapse of the roof system appears to have been prevented by a single line of interior columns supporting the center of each roof truss, and door and window frames supporting the eaves.

The unreinforced rock-masonry walls were grouted with low-strength mortar, similar to many other rock-masonry walls built in the 19th and early 20th centuries. Many of these walls suffered damage in the form of cracking, partial collapse, or complete collapse. The other end of the building is constructed with a wood end wall and wood tower. This end of the building appeared unscathed. The timber-framed bell tower appeared to have survived the earthquake with limited damage.

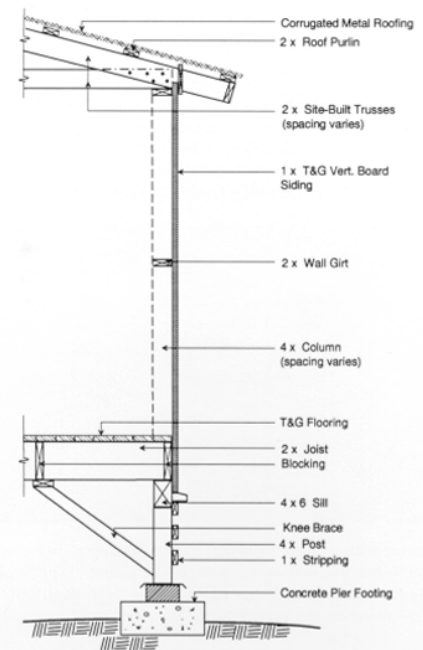
**Figure 12.** *Example of one style of Hawaii single-wall construction on post and pier (there are several variations from this style).*

(Figure 12). The soft-story lateral resisting “system” below the floor consists of toenailed 2x4 braces in each direction and no shear walls. Each individual post is supported on unanchored small concrete blocks locally known as “tofu blocks,” which in turn rest on 18”x18”x9” unreinforced concrete foundation blocks that have little or no embedment into the soil. The height of piers can vary from just over a foot to much more than 12 feet high.

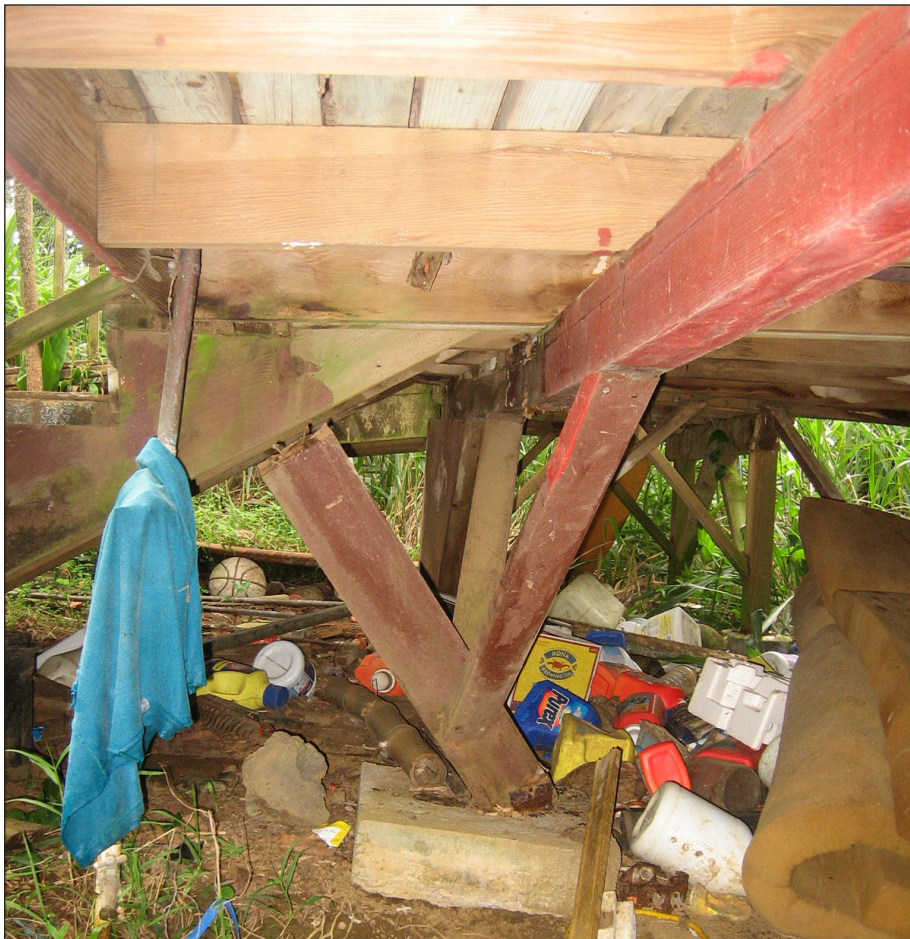
**Figure 13.** Rotational instability of a post and beam “single” wall home on a sloping hillside site.

Almost all of the single-family homes that were red-tagged as unsafe were of single-wall or similar post- and-pier construction (see Figure 13). Failure modes observed were posts shaken off the small footing or smaller upper “tofu” pedestal, post rotation due to inadequate lateral bracing, splitting at the bases of the heavier loaded posts, or overturned footings. As a result, such homes were vulnerable to lateral sideways displacement, dropping, potential collapse of the first floor, and severing of utilities. In some cases, the building collapsed and was totally destroyed.

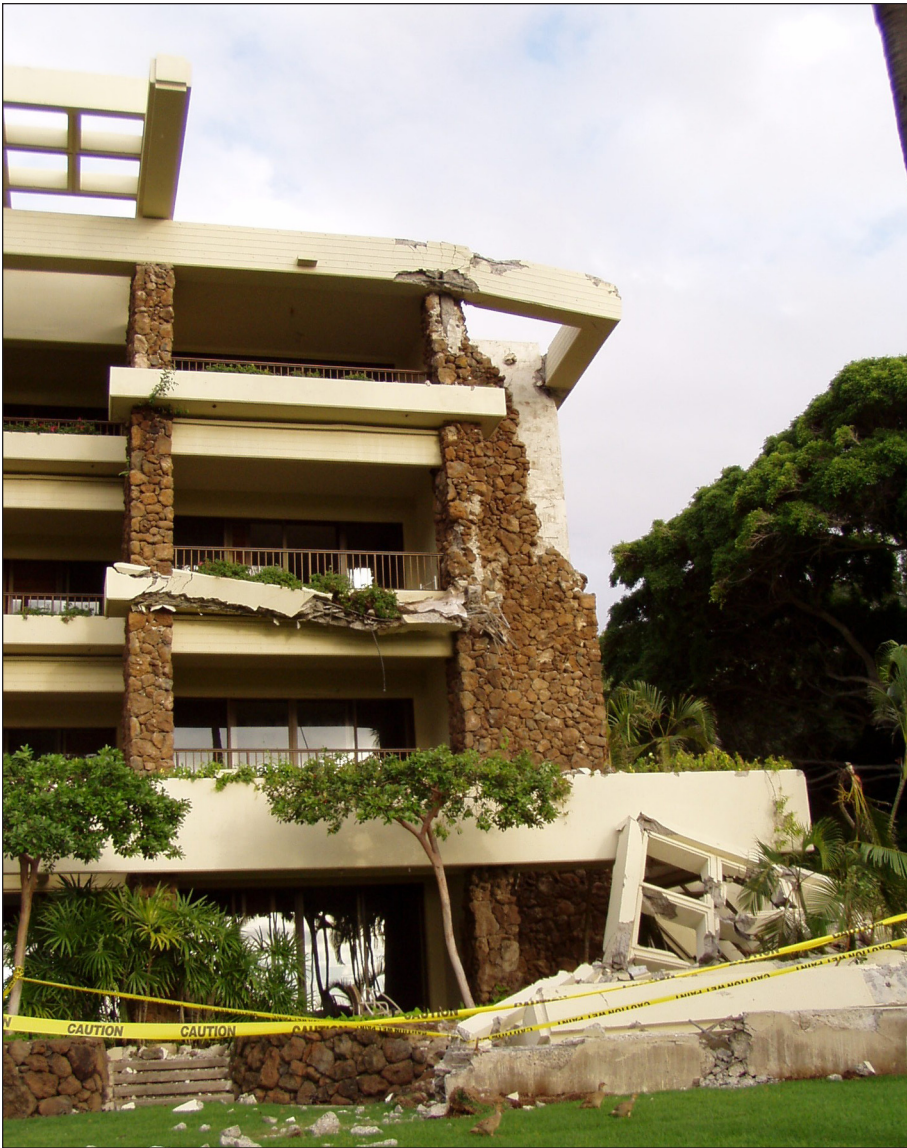
**Figure 14.** Collapse of concrete trellis frame at Mauna Kea Hotel.

The Mauna Kea Hotel is located on the shoreline just 11 miles from the Kiholo Bay earthquake epicenter. A reinforced concrete trellis structure above the low-rise four-story south wing of the hotel collapsed (Figure 14). This failure is attributed to combined vertical and horizontal ground shaking causing separation of the precast trellis elements from the supporting cast-in-situ cantilever beams. Fortunately, no injuries resulted from this collapse. Damage to a balcony below this structure was probably the result of impact from falling debris. The north and south exterior shear walls are configured as a series of vertically discontinuous leaning "stair-step" panels that are supported by cantilever transfer girders. Horizontal buttress beams transmit the leaning force of the walls to the elevator shaft walls. Portions of the upper buttress beams suffered some damage. There was significant damage to the concrete surrounding two connector plates and the construction joint between a precast exhaust flume and the ele-

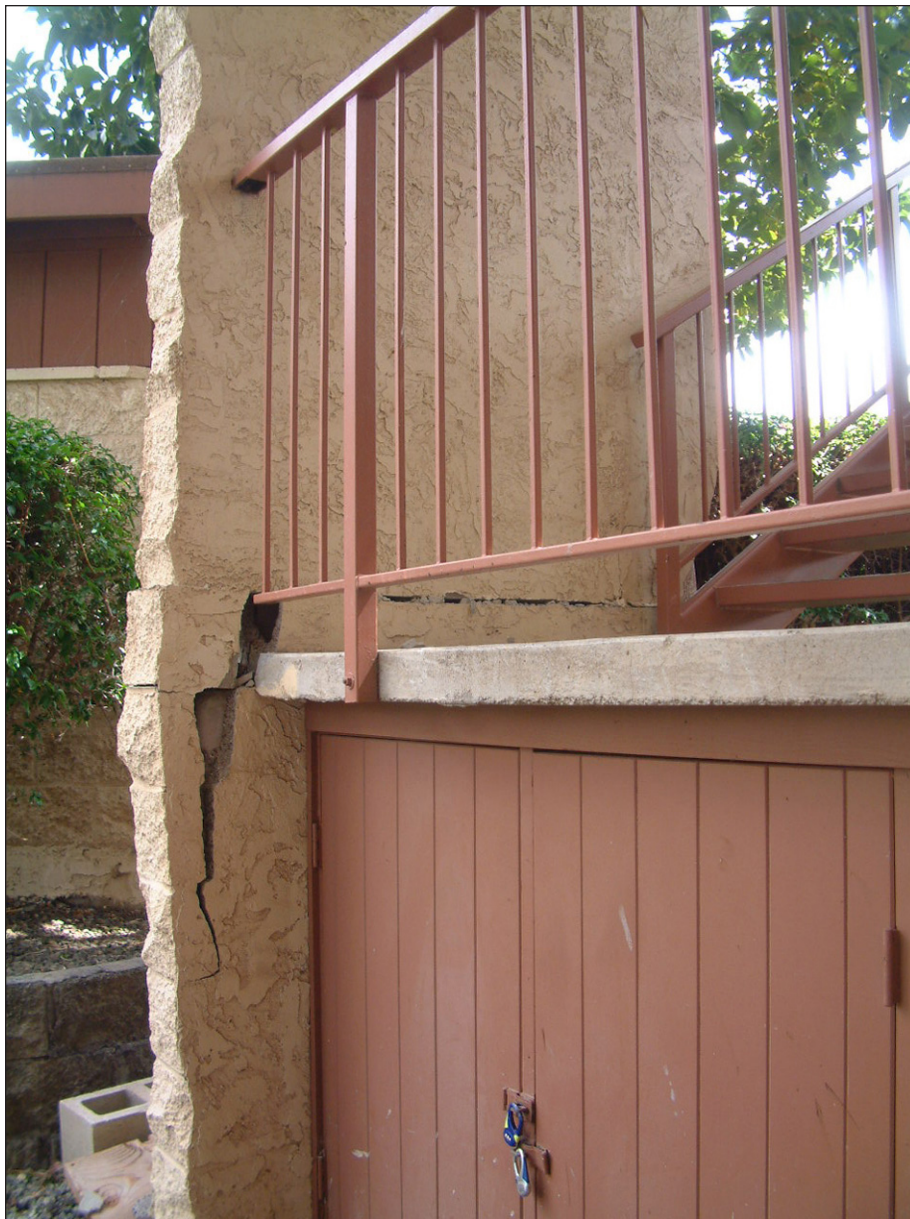
**Figure 15.** This wall was grouted at the end cells, but apparently not in the main body of the wall.

The masonry walls are partially grouted (Figure 15). The roof is configured with gable ends where the main roof beams and rim rafters bear on angled masonry walls. The roofing consisted of concrete tiles on straight sheathed wood decking. The CMU at the tops of the gable-ended masonry walls suffered out-of-plane dislodgements, particularly at the roof beam pockets. In some cases, portions of the wall fell out onto the grounds or onto the floor of the units. The most severely damaged buildings were red-tagged as

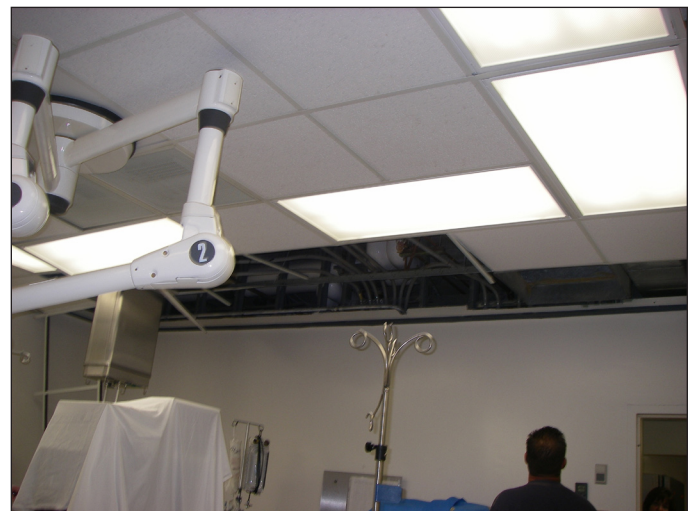
**Figure 17.** Kona Community Hospital Operating Room (photo: Glenn Miyasato).
