Napa M5.2 Earthquake of September 3, 2000

Evaluation of Lifeline Performance

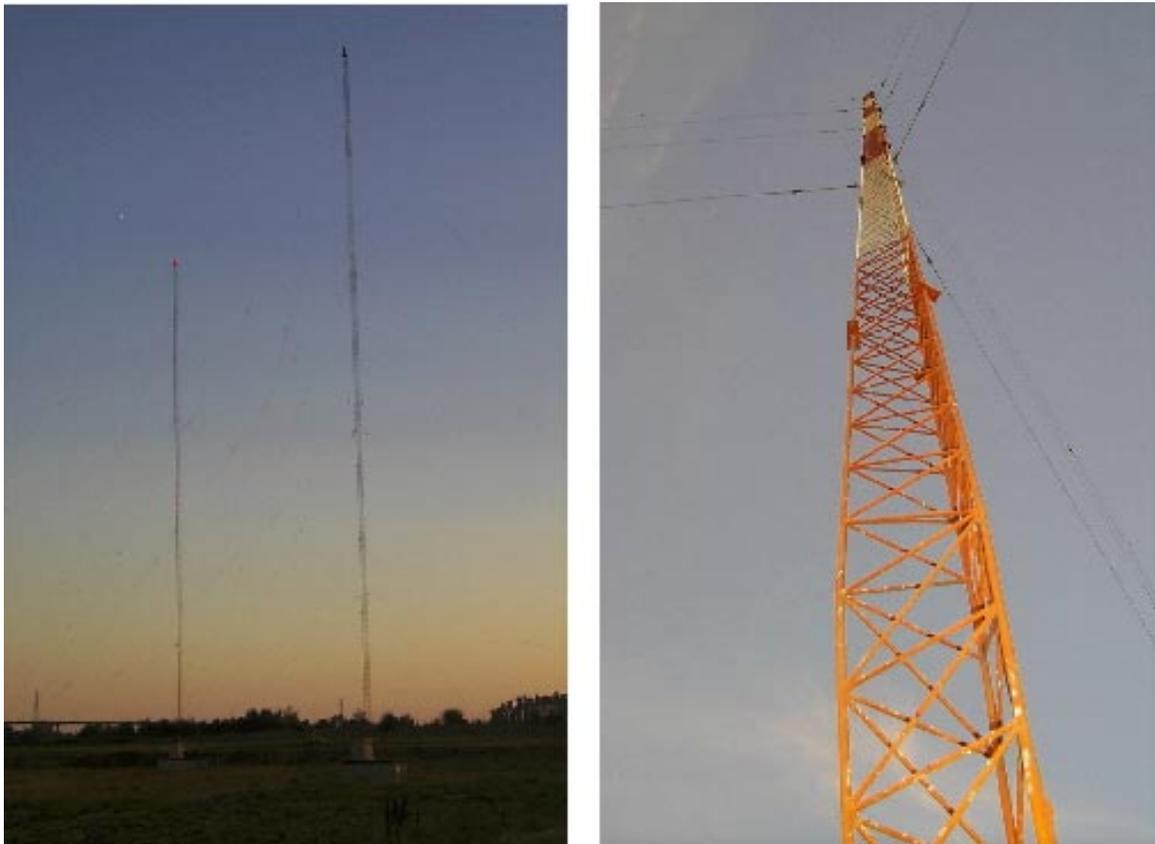
Figure 3. AM Transmission Towers - Guy Wires and Mast

Other than some minor items falling on the floor, the radio station had no other ground-shaking-induced damage at the broadcast studio. At the AM transmission site, the radio station operates four towers. Each tower is a steel truss with guy lines (Figure 3). Apparently, the guy lines experienced high loading during the earthquake, and three of the four towers were displaced sufficiently such that their signals were no longer being broadcast in optimal directions. The fourth tower experienced some damage to the central tower itself, which will need to be replaced. As of 5 days after the earthquake, the transmission towers were not yet repaired, but remained operable with signals going off in non-optimal directions. The exact cause for the tower damage is not clear, but could be due to settlements of some of the guy wire anchors; and/or high transient loading of the guy wires during the earthquake.

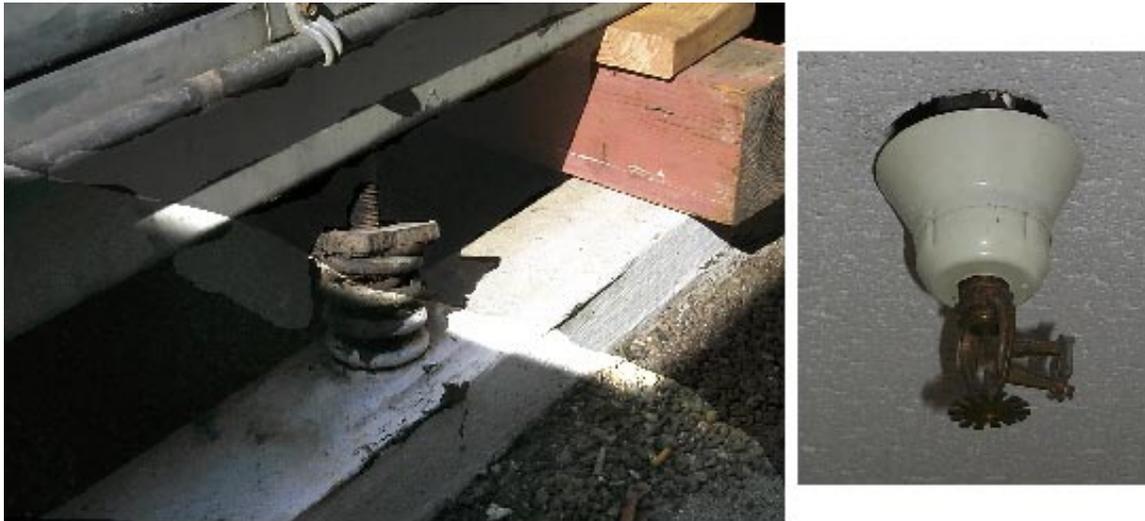
- Fire sprinklers. The hospital has an extensive sprinkler system. No sprinkler heads were damaged to the point where they went off. However, many sprinkler heads had moved sufficiently to knock off / dislodge the metal annulus caps around the sprinkler heads and the suspended ceiling tiles (Figure 4). Dozens of these caps were being replaced 5 days after the earthquake. In one case, the sprinkler head had lifted up through the suspended ceiling, and ended up resting atop the suspended ceiling.

- Air chiller. One air chiller unit located at a rooftop fell off its vibration isolation mounts. When it fell off its mounts, it also broke the inlet/outlet water pipes. This air chiller unit served the administration building, and was thus not "critical" to hospital operations. It was temporarily repaired within days following the earthquake (see Figure 4) by mounting the unit on wooden blocks and repairing the attached pipes.

Figure 4. Hospital - Air Chiller Isolator, Sprinkler Head

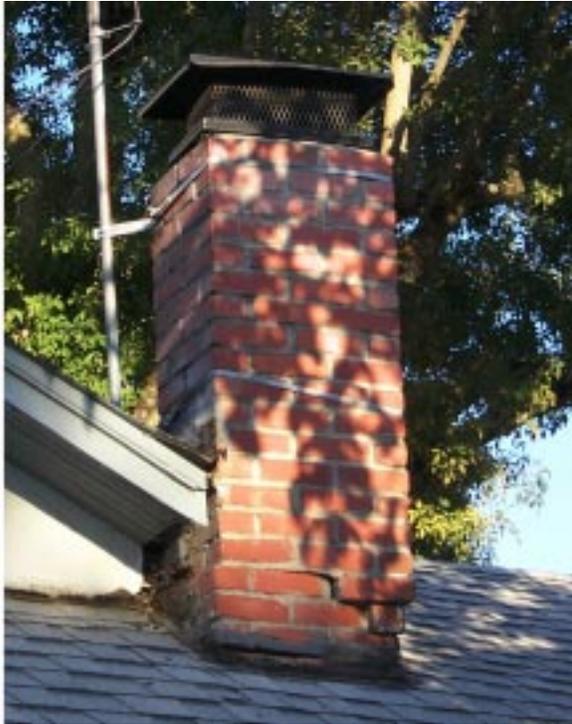
Figure 5. Damaged Chimney.

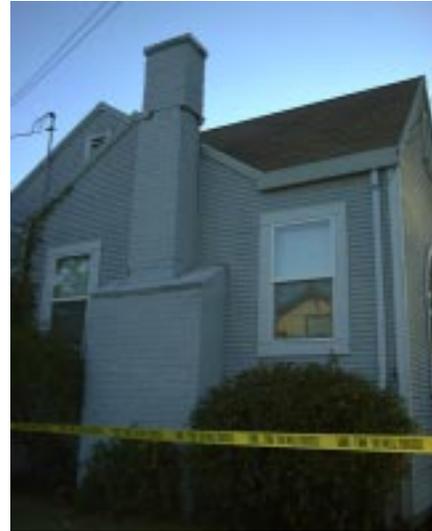
Figure 6. Broken Chimney.

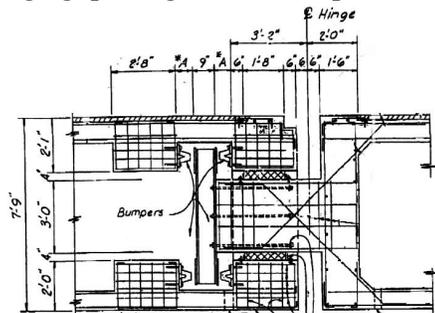
Figure 7. Hinge Detail.

- **The Napa River Bridge and Overhead** (Br. #21-0049) was built in 1977. It is a 13 span precast, segmentally constructed, concrete box girder bridge that carries State Route 29 over the Napa River (see Figure 1). The bridge is supported on tall single-column bents and end-diaphragm abutments; all on pile caps that were retrofitted in the 1990’s. The structure is composed of four frames separated by three unusual hinges. Instead of a bench for the longer cantilevered span to rest on, they are supported by concrete pistons with steel stoppers (Figure 7). The earthquake widened the hinge openings (and moved the bearings) an inch or two, but the very large gaps (Figure 8) are a pre-existing condition.

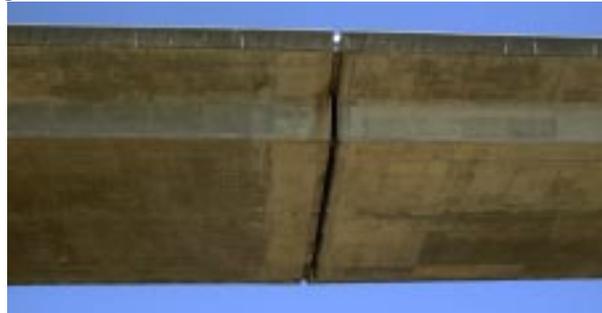
Figure 8. Hinge Opening at Napa River BOH.

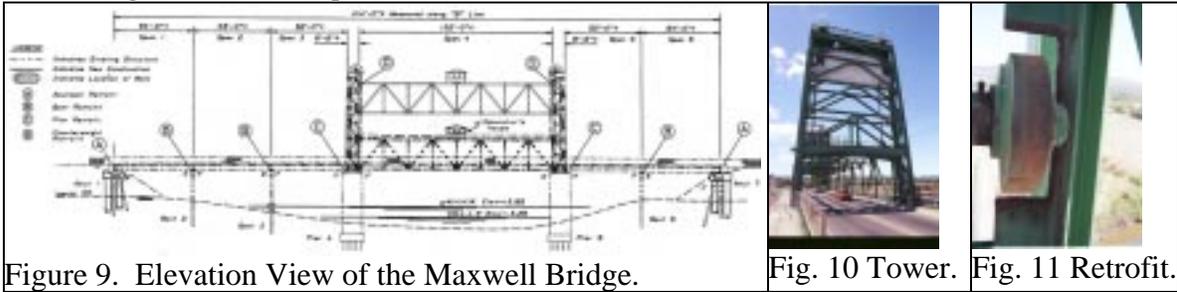
Figure 9. Elevation View of the Maxwell Bridge.

- **The Maxwell Bridge** (Br. #21-0075) is a two-lane vertical lift bridge (with a main span of 130 ft) that was built in 1949 (Figures 9 and 10). It was recently retrofitted to provide greater seismic resistance for the maximum credible earthquake. This retrofit included some work to the towers that carry large concrete counterweights to lift the bridge. The main vertical tower members are ‘double (back-to-back) angle sections from which small squares were (almost completely) gas-cut out to allow the counterweight to move freely both transversely and longitudinally after knocking out the cut pieces (instead of banging against the tower legs during the earthquake). The metal squares were left in so the guides on the counterweight wouldn’t bind against the holes. During the earthquake, the retrofit worked perfectly, with the guides knocking out the cut metal squares, thus allowing it to swing without hitting the tower legs (Figure 11). However, the metal squares fell onto the roadway, which could have banged up a vehicle or even endangered a driver if the earthquake had occurred when someone was on the road. Therefore, the designer has asked that the plates be tack-welded back onto the channels (to help guide the counterweight) and

that little chains should be attached to keep the plates from falling onto the roadway during the next earthquake.
