RECONNAISSANCE REPORT: YOUNTVILLE/NAPA, CALIFORNIA EARTHQUAKE

Submitted by Kevin Moore, Kent Yu, Ron LaPlante
Degenkolb Engineers – Oakland, San Francisco

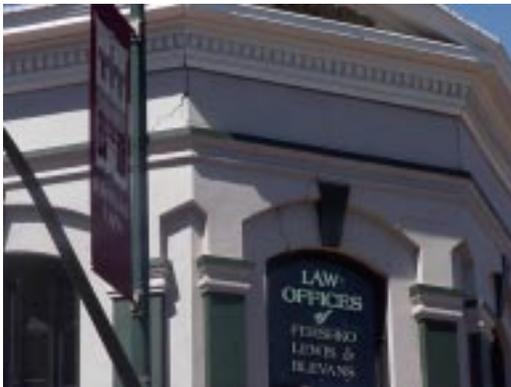
No structural damage was observed at the Napa Valley College campus, the Napa State Hospital campus or the Yountville Veterans Home of California. Nonstructural damage observed in these locations consisted of a limited amount of cracked plaster and broken window glass. The following damage was observed in the downtown Napa area: minor cracking in unreinforced brick walls (Figure 3), glass breakage, veneer and plaster damage and nonstructural damage. Most damage appeared to be concentrated in low-rise structures constructed of nonductile materials with inadequate detailing of nonstructural components to accommodate drift (e.g. glass damage). Reports from occupants indicated that more significant amounts nonstructural damage occurred in upper stories of multi-story structures. Unreinforced brick fireplace and chimney damage, plaster damage, falling lights and glass damage was observed in select areas of residential and commercial buildings throughout Napa (Figure 4). The Napa area experienced an MMI of VI to VII.

Figure 3 – Cracking in Unreinforced Brick Wall Building

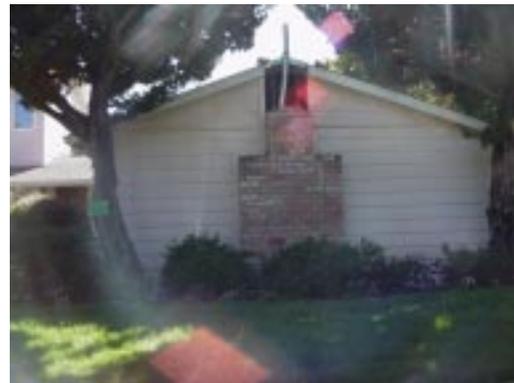
Figure 4 – Chimney Damage

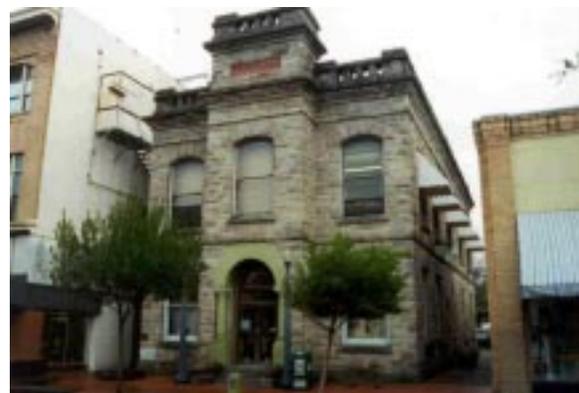
During the reconnaissance, two structures were studied extensively; a two-story unreinforced stone building constructed in 1901 (Figure 5) and a two-story unreinforced stone building constructed in the late 1880's. Both buildings sustained minor structural damage and very limited nonstructural damage. Out-of-plane wall anchors in both structures showed signs of working and each structure showed minor cracking and stone loosening at the parapets. Based on the observed damage, the ground shaking at both locations appears to be aligned in the north-south direction (contrary to the predominant direction of shaking recorded by the strong motion instrument at Napa Valley College).

Figure 5 – 1901 Unreinforced Stone Building

The 1901 building sustained damage consisting of a loose stone falling from the north-facing parapet and other stones in the same area of the parapet appear to have cracked and bulged outward. Small (1/8") vertical cracks were observed running through some spandrels located on the west elevation. The structure was evaluated and strengthened in the 1970's.

The evaluation report, developed during the 70's, indicated the presence of cracking and delaminating (bulging) in some areas of the stone walls. The 1970's damage (attributable to the 1969 M 5+ Santa Rosa earthquakes) correlates well with the observed damage for this event. The strengthening for the 1901 building consisted of the addition of wall anchors and parapet bracing, both strengthening elements showed signs of distress following this earthquake.
