## PRELIMINARY REPORT ON SEPTEMBER 28, 2004 PARKFIELD EARTHQUAKE

Rakesh K. Goel, M.EERI and Charles B. Chadwell, M. EERI  
Department of Civil & Environmental Engineering,  
California Polytechnic State University, San Luis Obispo, CA 93407  
Email: [rgoel@calpoly.edu](mailto:rgoel@calpoly.edu), [chadwell@calpoly.edu](mailto:chadwell@calpoly.edu)

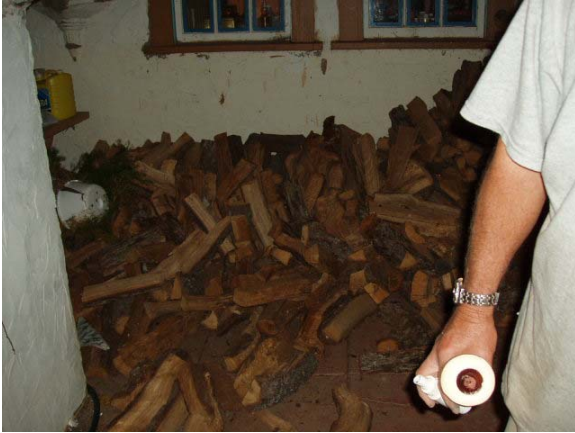
The first residence is a two-story timber building constructed originally in the late 1800's with a substantial addition constructed in the 1930's. The house is located less than 0.5 km from the San Andreas Fault. The strongest shaking at this location occurred in the fault-normal, east-west direction, as evident by fallen stacks of firewood in the east-west direction (Figure 9). Significant cracking was observed in the plaster (stucco finish) throughout the house but primarily in the east-west direction (Figure 10). As expected, separation also occurred between the older and newer portions of the residence (Figure 11). Although shaking at the site caused significant cracking in the stucco, the masonry chimney of the house did not show any signs of distress (Figure 12). This is due to retrofit of the chimney by strapping it at several levels to the house (Figure 13).

Figure 9. Stack of firewood collapsed in due to strong east-west shaking (Photo: Goel).

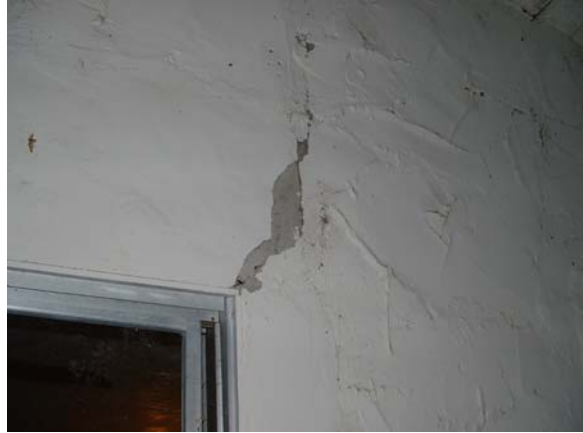
Figure 10. Typical cracks in the stucco finish (Photo: Chadwell).

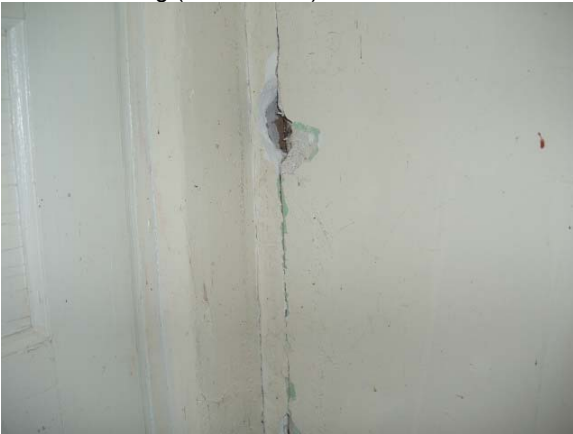
Figure 11. Separation between older and newer portions of the house (Photo: Goel).

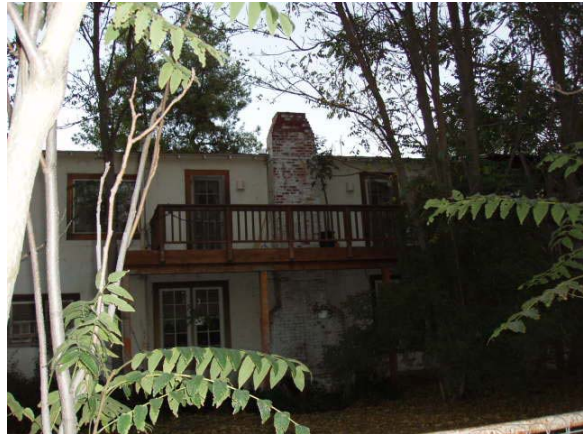
Figure 12. Undamaged chimney of the house (Photo: Goel).

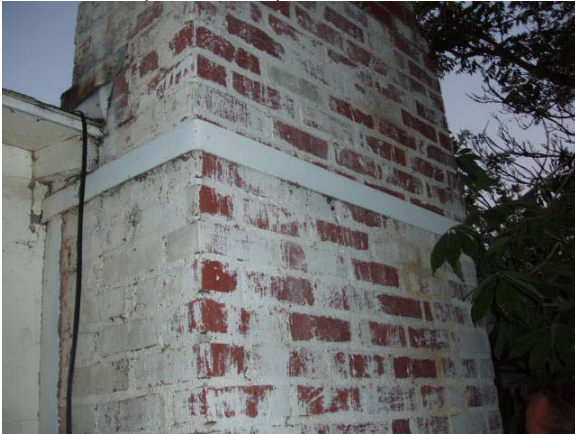
Figure 13. Undamaged chimney retrofitted by strapping to the house (Photo: Goel).

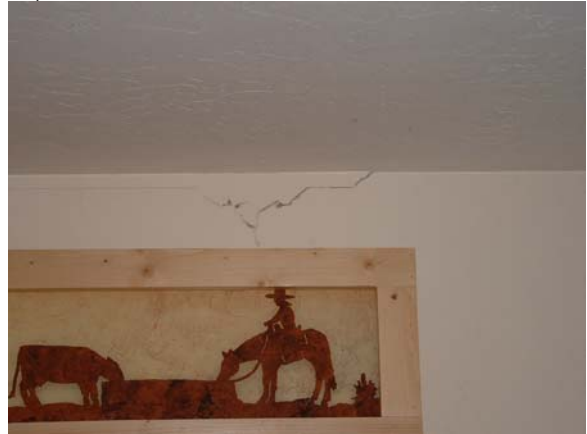
The second home was constructed in the 1950's but had undergone several renovations and upgrades in recent times. This house is located immediately adjacent to the San Andreas Fault that runs through the backyard. The damage in the residence predominately was nonstructural but substantial. The home suffered extensive drywall cracking (Figure 14) and other content damage (Figures 15 and 16). Outside, a timber canopy separated from the house and was dangerously leaning (Figure 17) and a portion of the unreinforced masonry parapet wall collapsed (Figure 18).

Figure 14. Dry wall cracking (Photo: Chadwell).

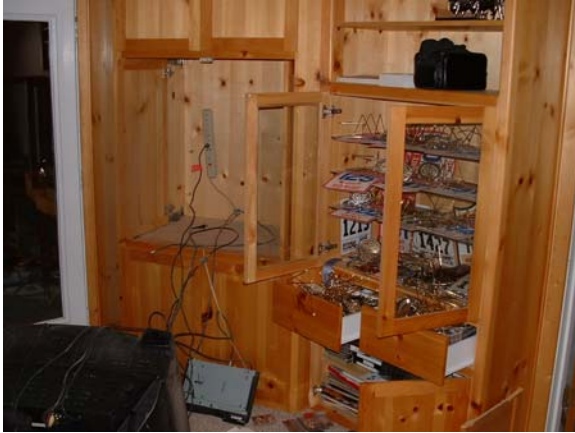
Figure 15. Damage to contents of the entertainment center (Photo: Chadwell).

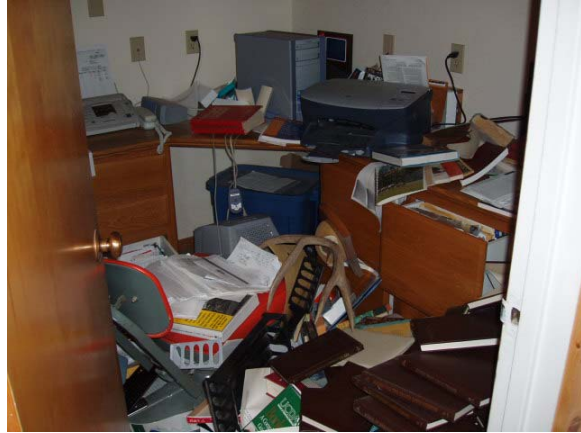
Figure 16. Damage to office area of the house (Photo: Goel).

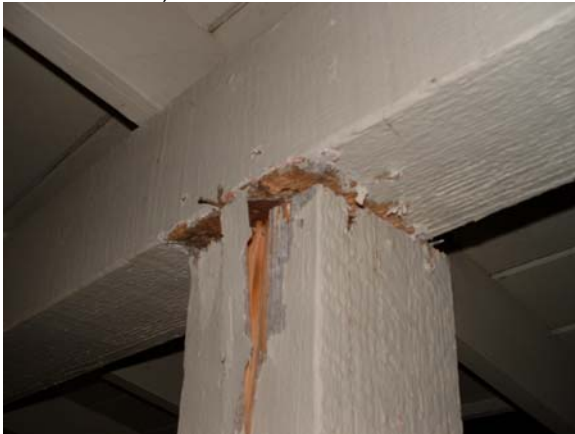
Figure 17. Damage to the timber canopy outside the house (Photo: Chadwell).

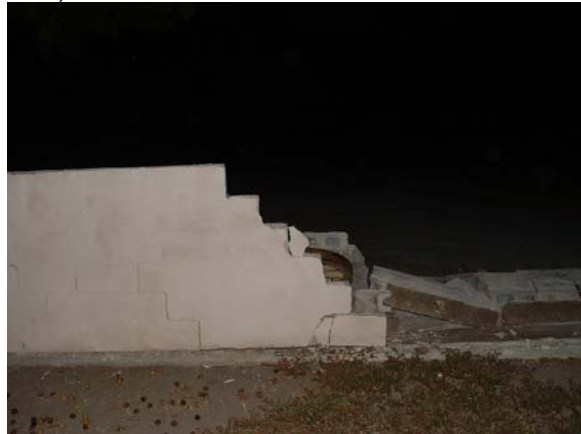
Figure 18. Collapsed unreinforced masonry boundary wall (Photo: Chadwell).

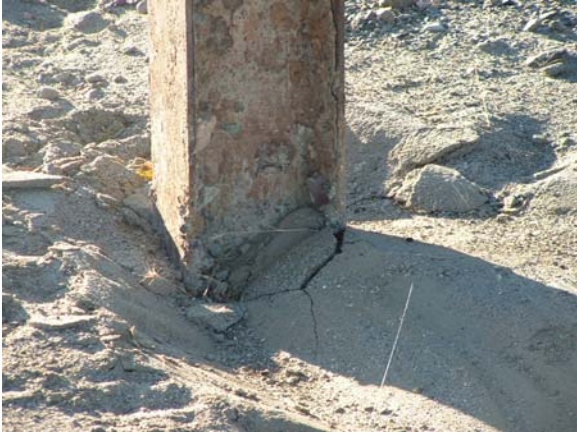
Two bridges were investigated in the reconnaissance. The first bridge, located approximately 8 km south of Parkfield, is typical of many bridges in the area: multi-span, steel riveted viaduct bridge with a concrete steel composite roadway. This bridge showed no signs of distress. There was evidence of ground shaking from surface cracking found surrounding the pile extensions (Figure 19) and some signs of minor distress apparent from fresh peeling of paint at the girder-column joint (Figure 20).

Figure 19. Surface cracking surrounding the pile extension (Photo: Chadwell).

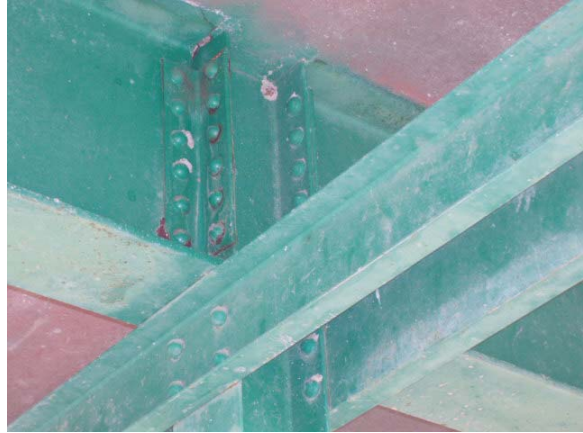
Figure 20. Signs of distress at girder-column joint (Photo: Goel).

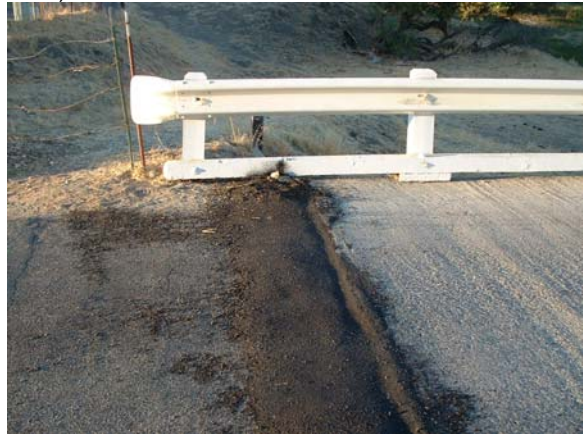
Local bridges showed minor to no damage and were open with immediate occupancy post event. The bridge located at the intersection of Cholame Road and Parkfield-Coalinga Road (Figure 8) in Parkfield, which crosses the San Andreas Fault, did show approximately 4 cm of separation between the approach slab and abutments that was quickly filled with asphalt by the bridge maintenance crew.

The second bridge investigated is located at the intersection of Cholame Road and Parkfield-Coalinga Road (Figure 8) in Parkfield and crosses the San Andreas Fault (Figure 21). This bridge had apparently undergone a recent retrofit and performed adequately. The minor distress to the bridge included roughly 4 cm separation between the approach slab and the bridge deck, which was filled up quickly by the bridge maintenance crew (Figure 22). Below the deck level, the concrete bent caps had minor shear cracking through the knee joints (Figure 23 and 24) as well as evidence of the flexural cracking at the top of the pile extension (Figure 25). The pile extensions at the ground level also exhibited noticeable movement (Figure 26). In addition, there was evidence of recent motion (approximately 4 cm) in the bridge bearings supporting the superstructure. Angle iron apparently installed in an effort to restrain transverse motion of the superstructure at the bearings was knocked free (Figures 27 and 28).

Figure 22. Separation between the approach slab and the bridge deck (Photo: Chadwell).

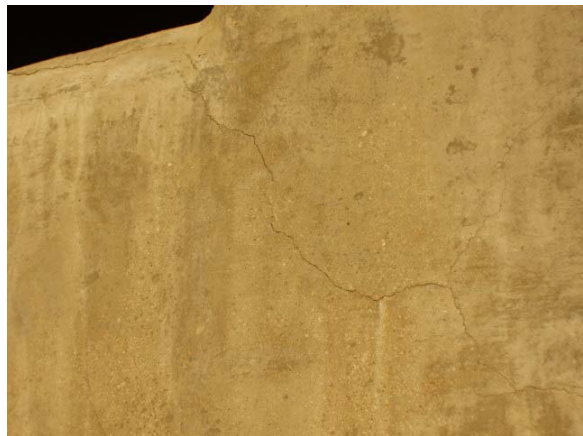
Figure 24. Fresh shear cracks in the knee joint of the bent cap (Photo: Goel).

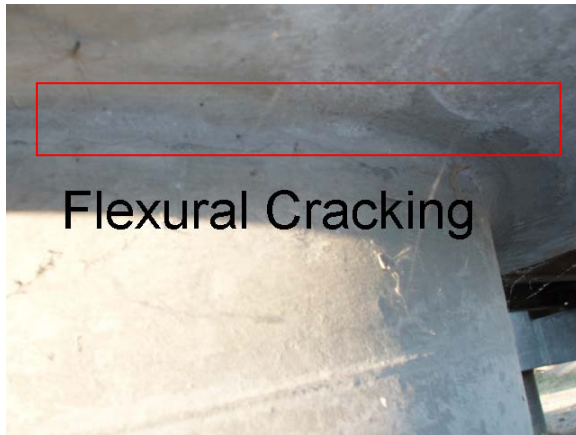
Figure 25. Flexural cracks (digitally enhanced) at the top of pile extension (Photo: Goel).

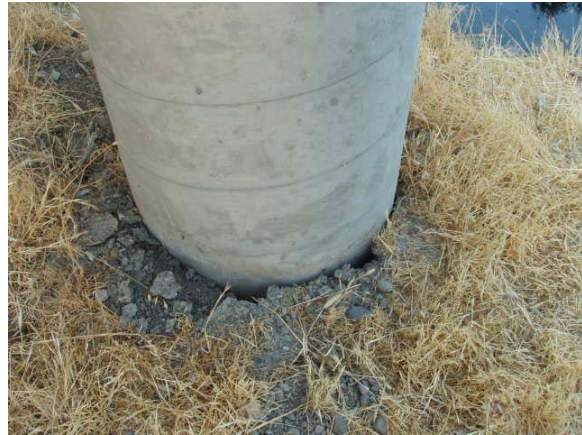
Figure 26. Movement of the pile extensions at the ground level (Photo: Goel).

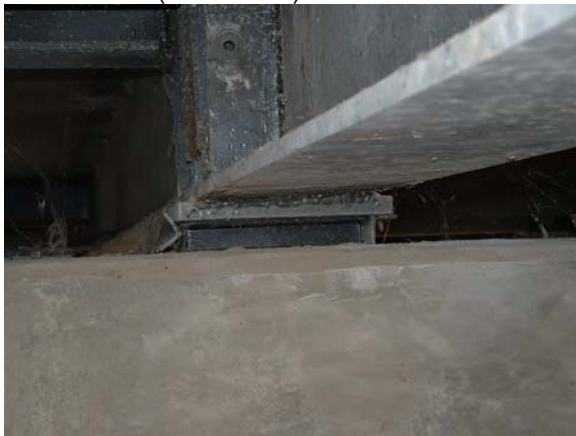
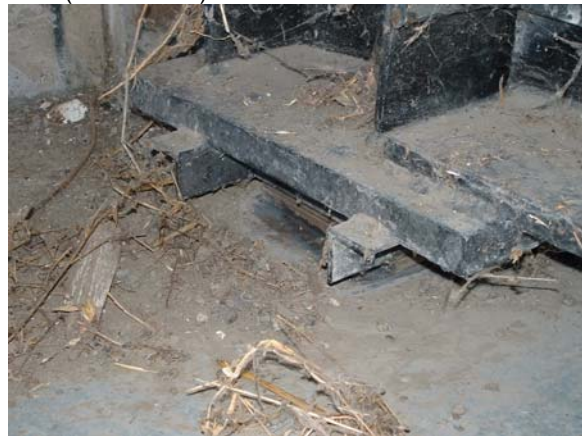
Figure 27. Bridge bearing support (Photo: Chadwell).

Figure 28. Movement at the bridge bearing (Photo: Chadwell).
