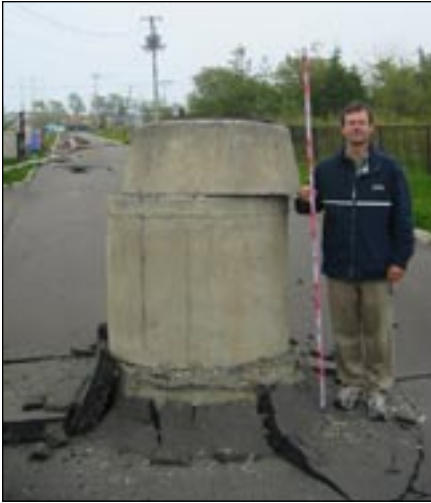
By far, the most widespread damage to lifelines was to the storm and sanitary sewer systems. Significant uplift of manholes was reported from Urakawa in the west to Hamanaka in the east. The team observed uplifts as high as 2 m in Otsu (Figure 5) and dozens as high as 1.5 m in a single subdivision of Shintoyo-Cho, immediately east of Kushiro City. In all cases, the uplift appeared to be related to liquefaction of the pipeline backfill material, and damage was aligned with the layout of the pipe network. Many sanitary sewers had been repaired by the time the team came through.

**Figure 5.** Uplifted manhole near sewage treatment facility in Otsu.

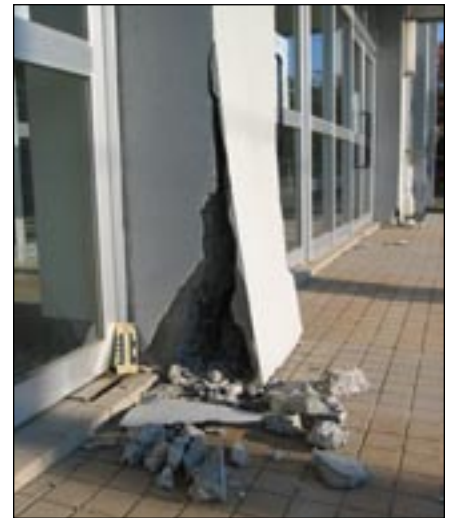
way collapsed after the two columns supporting it failed. The windowed roof observatory of the Taiki Town Hall collapsed as a result of strong shaking. In both cases, no other damage was reported in the main structures. Other buildings were damaged by excessive settlement, for example, the Urakawa Elementary School, where concrete spalled on columns after the entrance settled (Figure 7). The airport at Kushiro was closed for one day due to the collapse of the nonstructural hanging ceilings in the control tower and terminal building.

**Figure 7.** Damage to Urakawa Elementary School.
